Inspection Photos
Operator: Merrion
API: 067-09173
Date: 8/17/2021

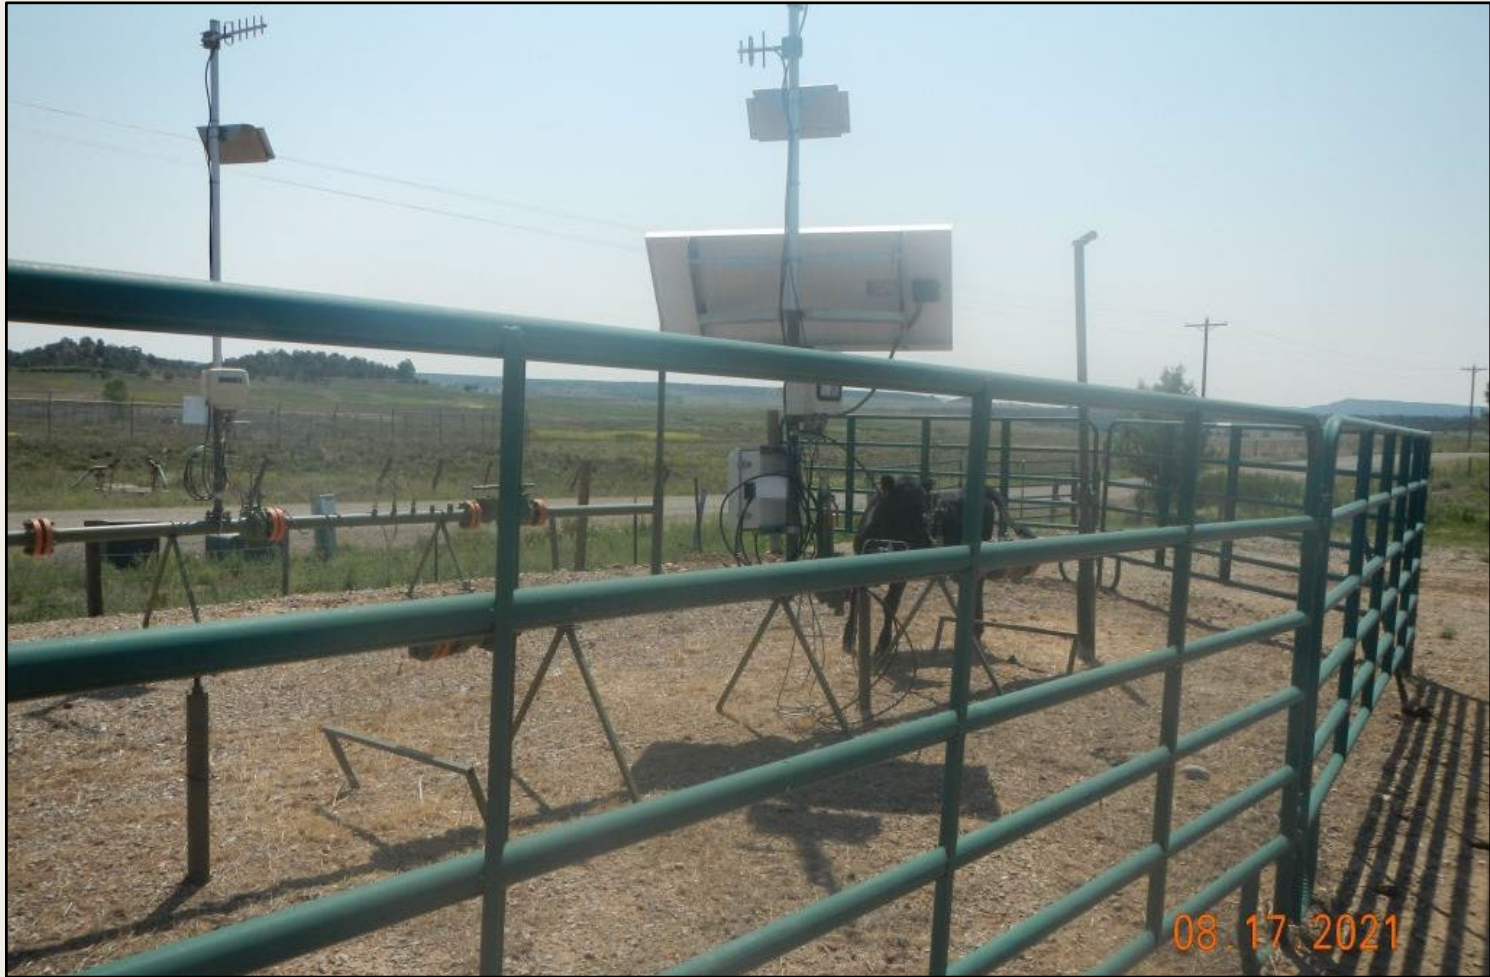
Photo 1. View of calf stuck within facilities area.

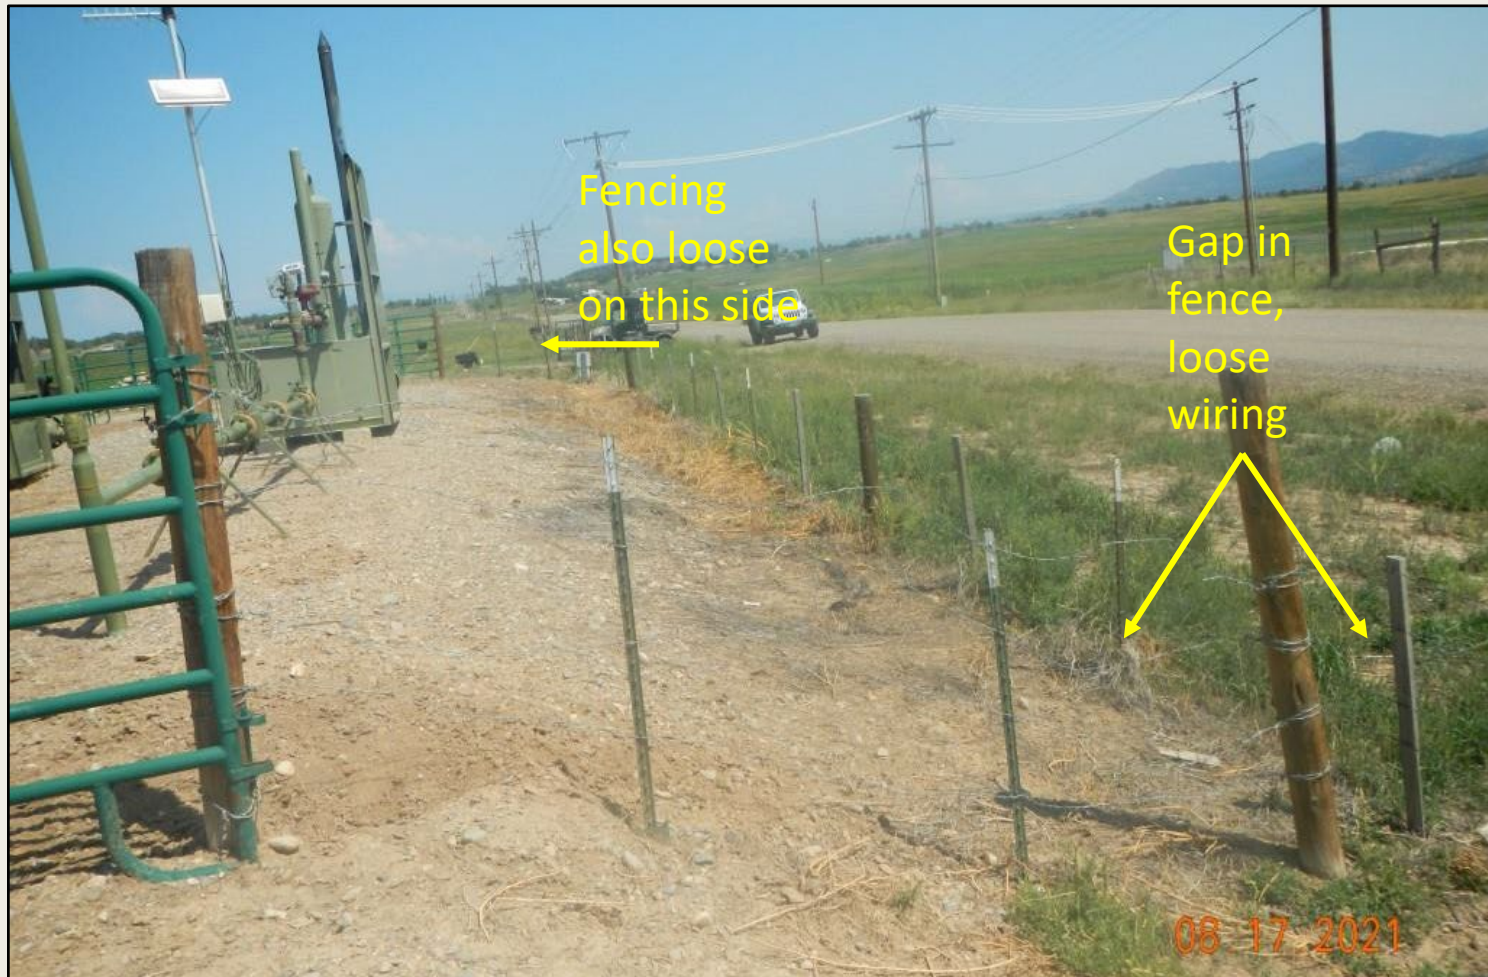
Photo 2. View of inadequate fencing around the separator where it appears calf got into facility area. It appears additional panels are needed here.

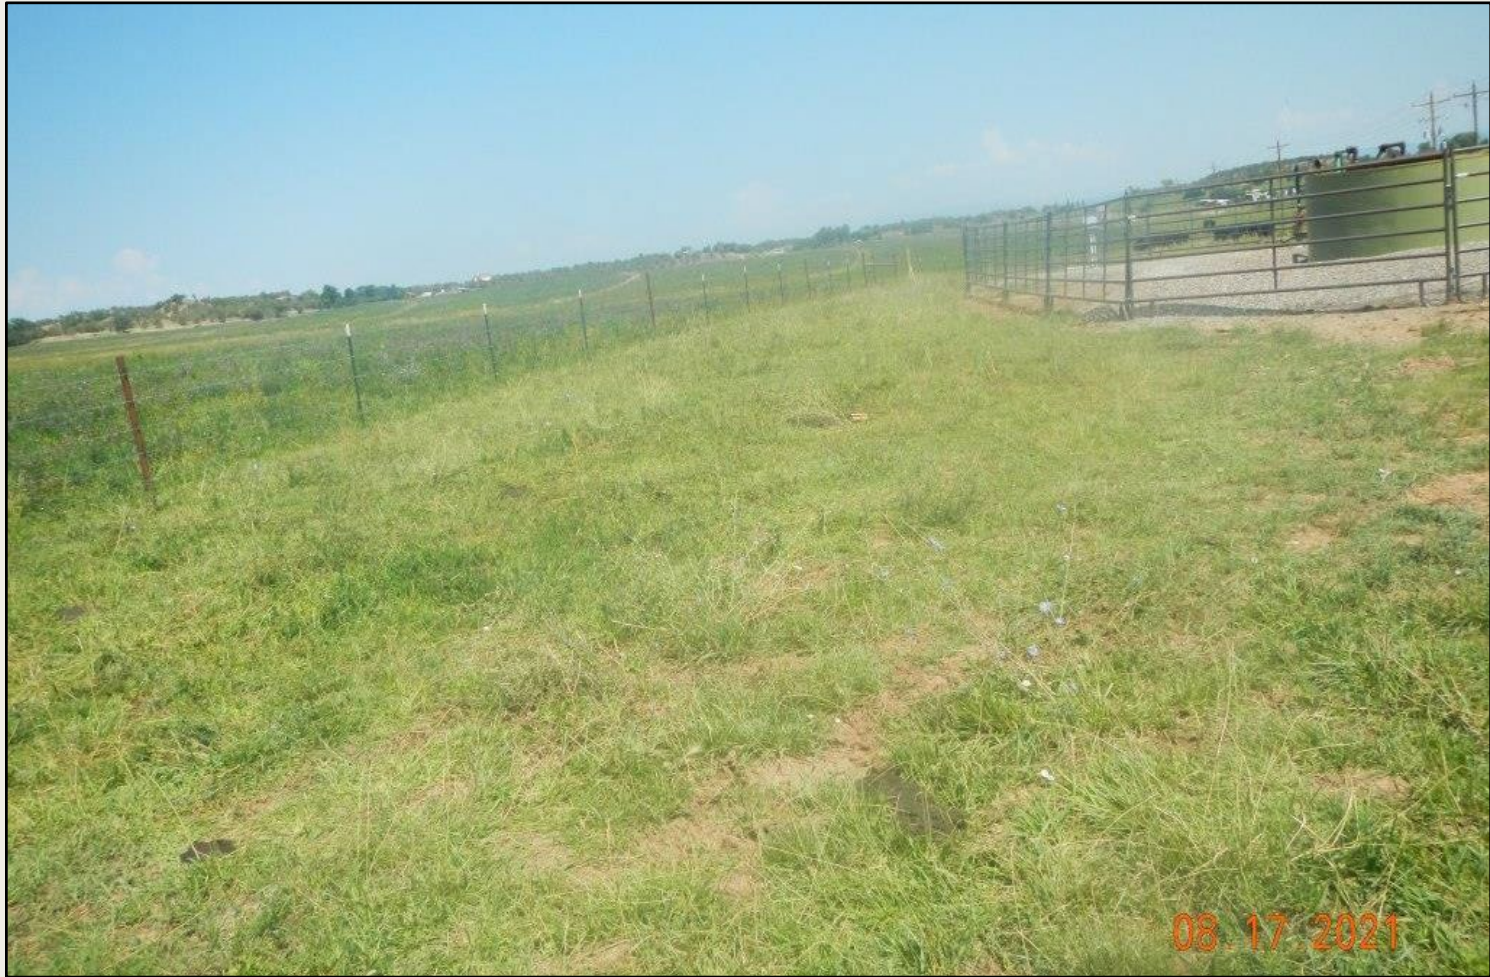
Photo 3. View of the western project area from the southwestern corner facing northward. Revegetation is progressing with grasses similar to those observed in the reference area, such as smooth brome, orchard grass, tall fescue, and perennial ryegrass.

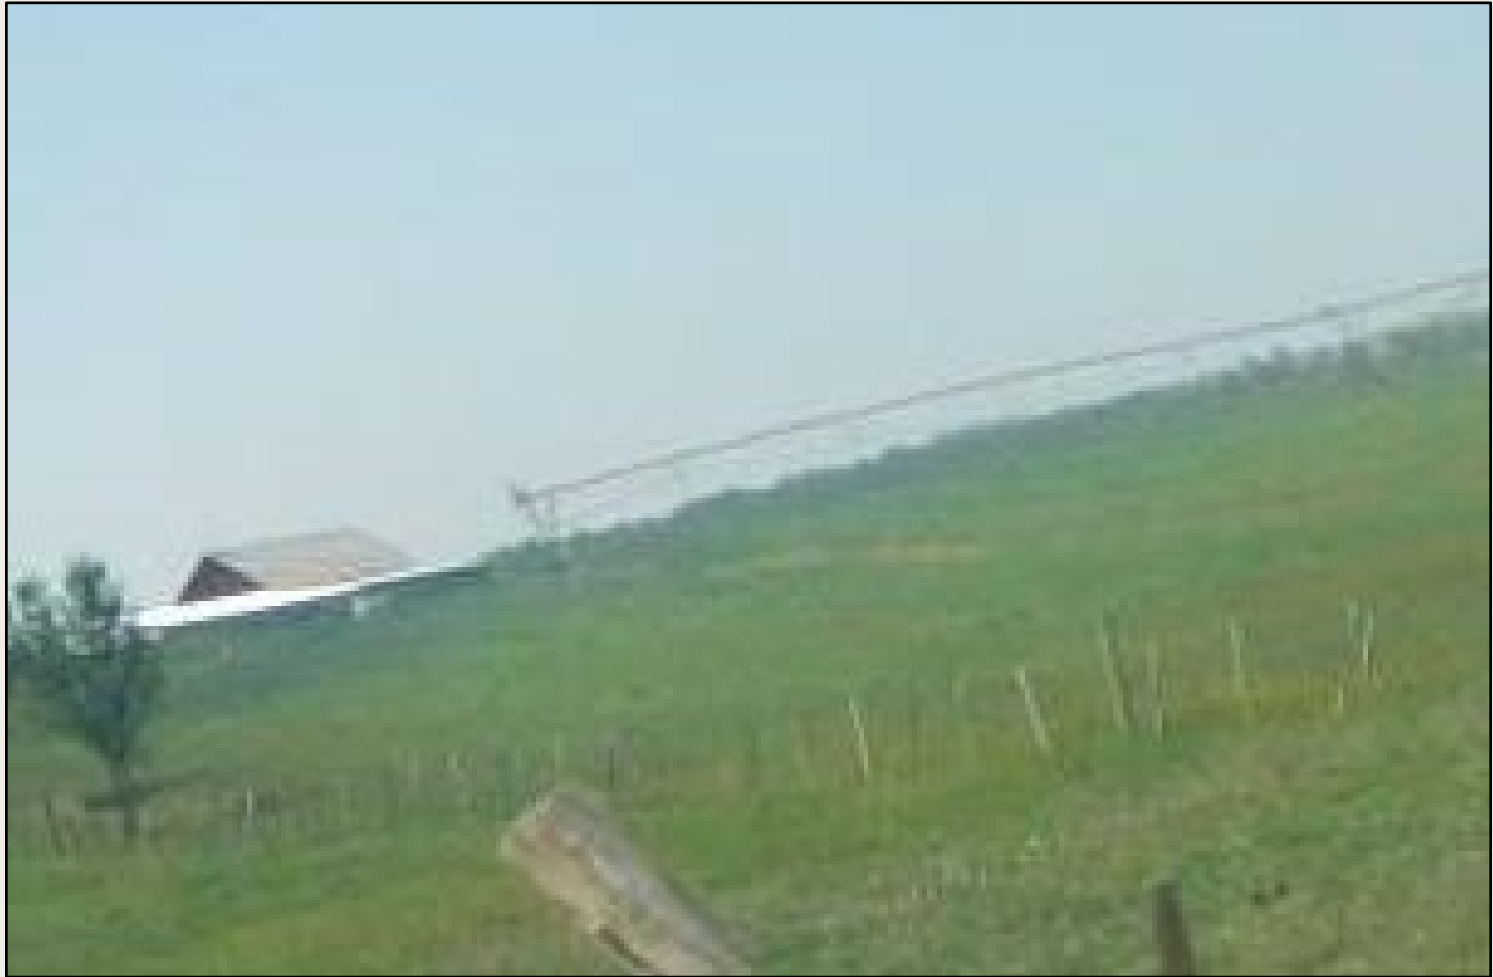
Photo 4. View of the reference area comprised of irrigated crop fields, comprised of grasses and forbs typically used in irrigated grass fields within the region.
