Inspection Photos

API: 071-08082

Operator: EVERGREEN NATURAL RESOURCES

Inspection Date: 8/16/2021

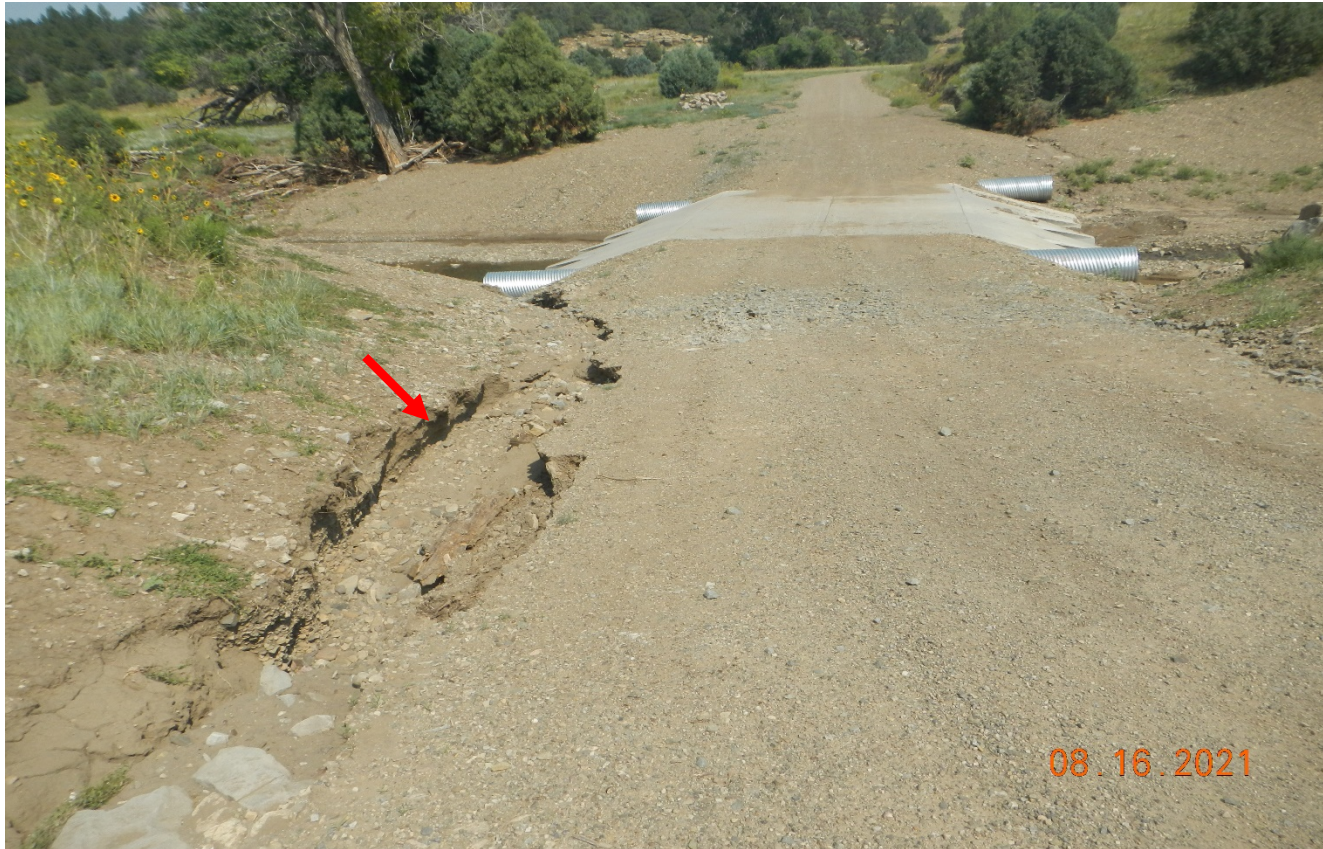
Photo 1. Facing east toward the access road stream crossing which was washed out during the flood event. The road side area shown at red arrow is beginning to erode and needs to be stabilized.

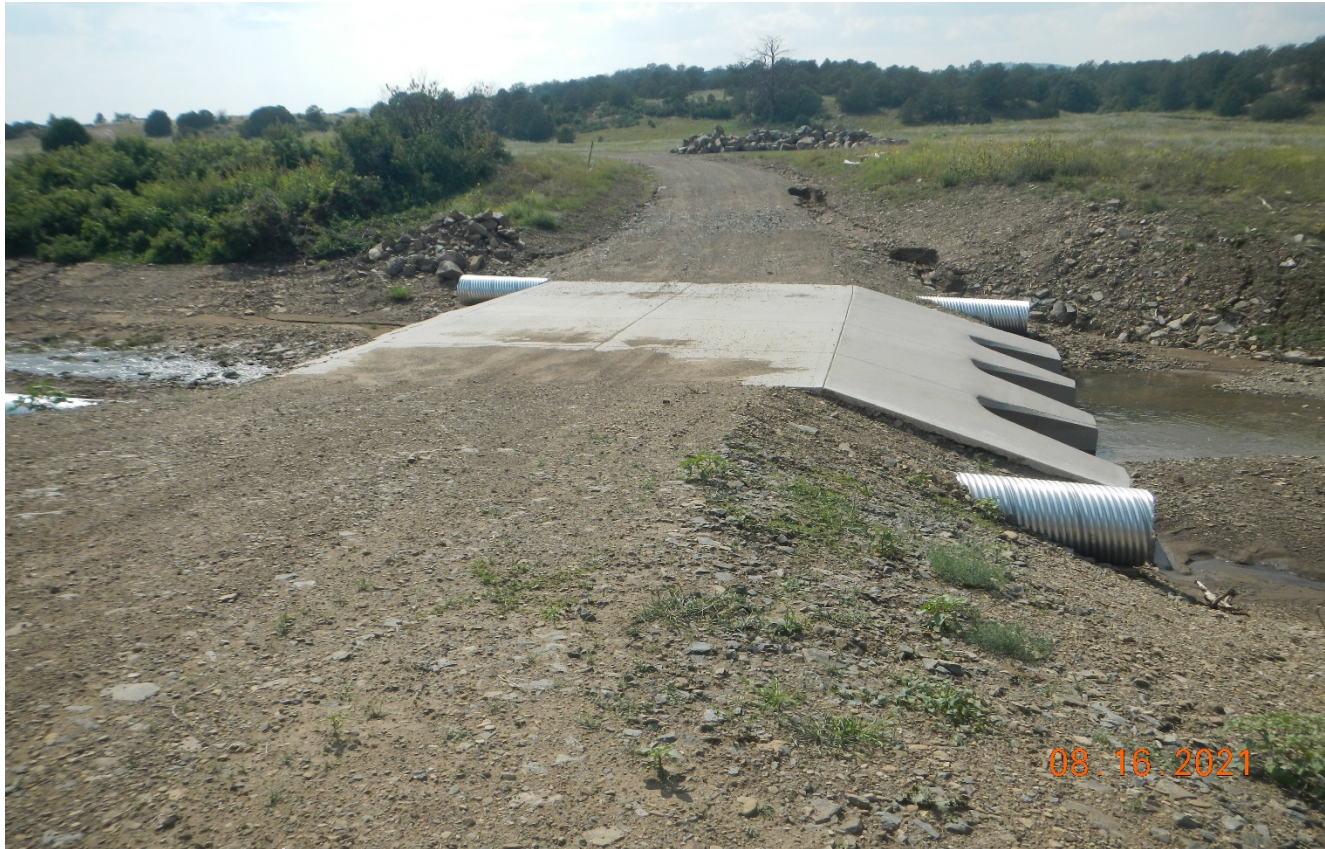
Photo 2. Facing back west at the stream crossing. There are two additional culverts installed.

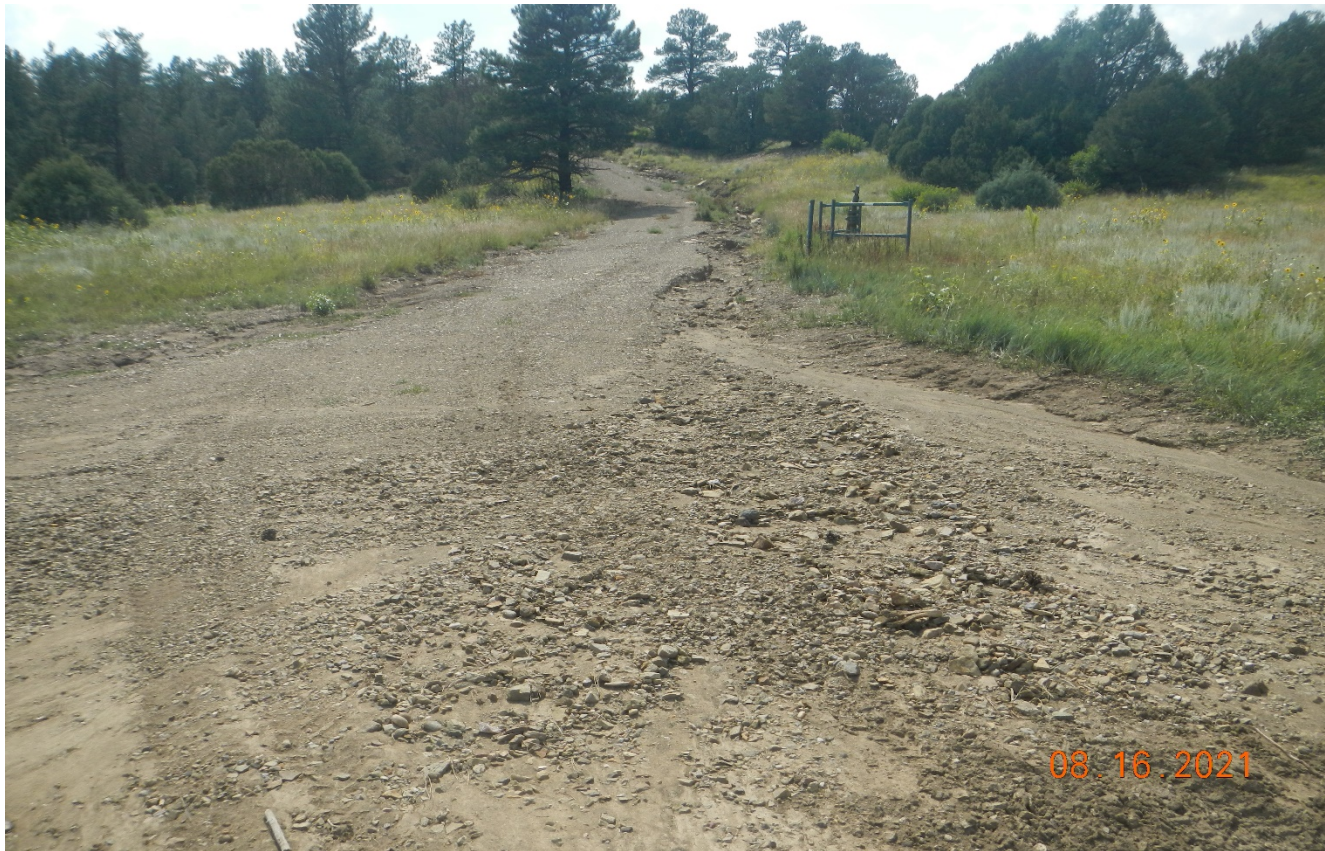
Photo 3. Facing southwest toward the access road. Stormwater further up the road is directed toward this area. There are insufficient BMP's along the road side.

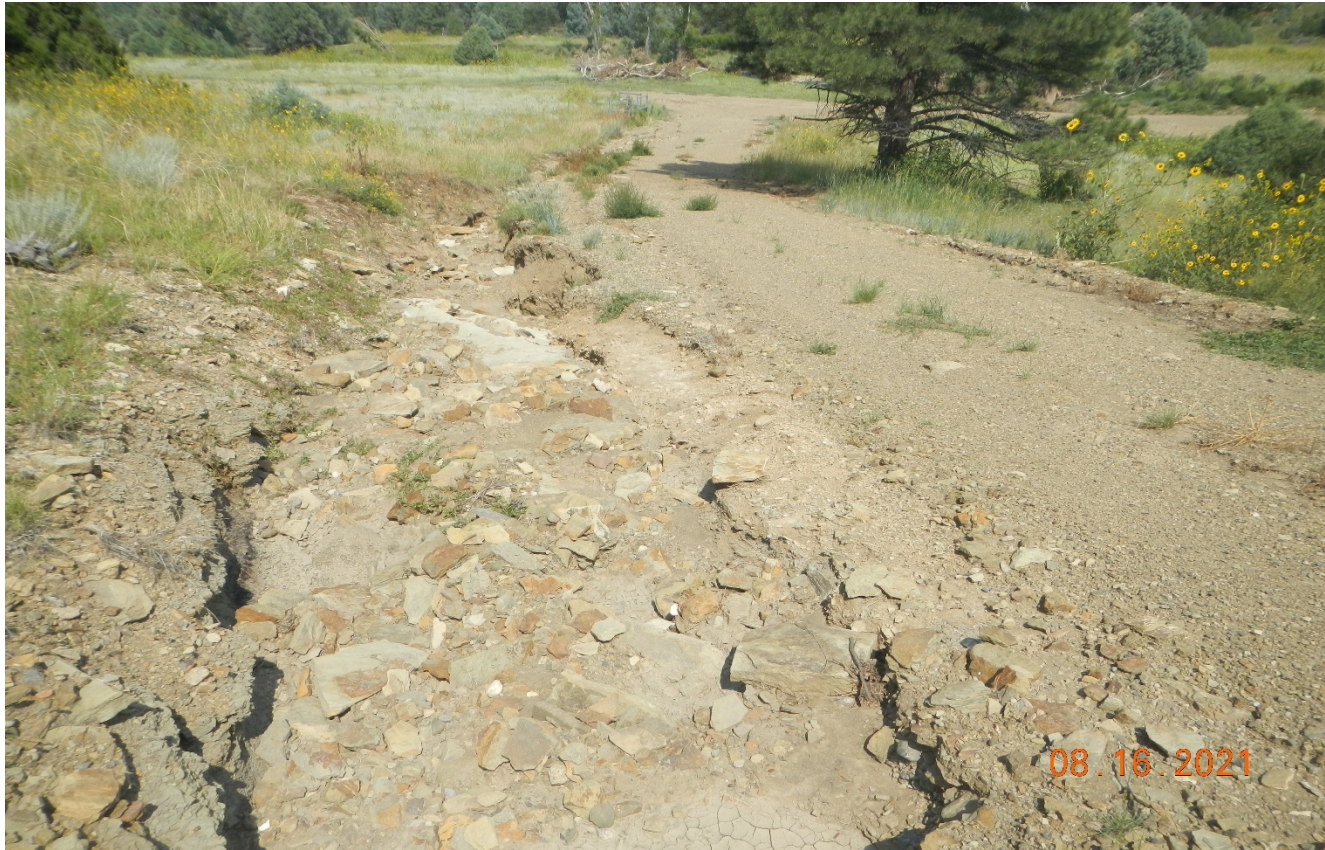
Photo 4. Facing back down the road. The erosion along the road side will need to be repaired and stabilized.

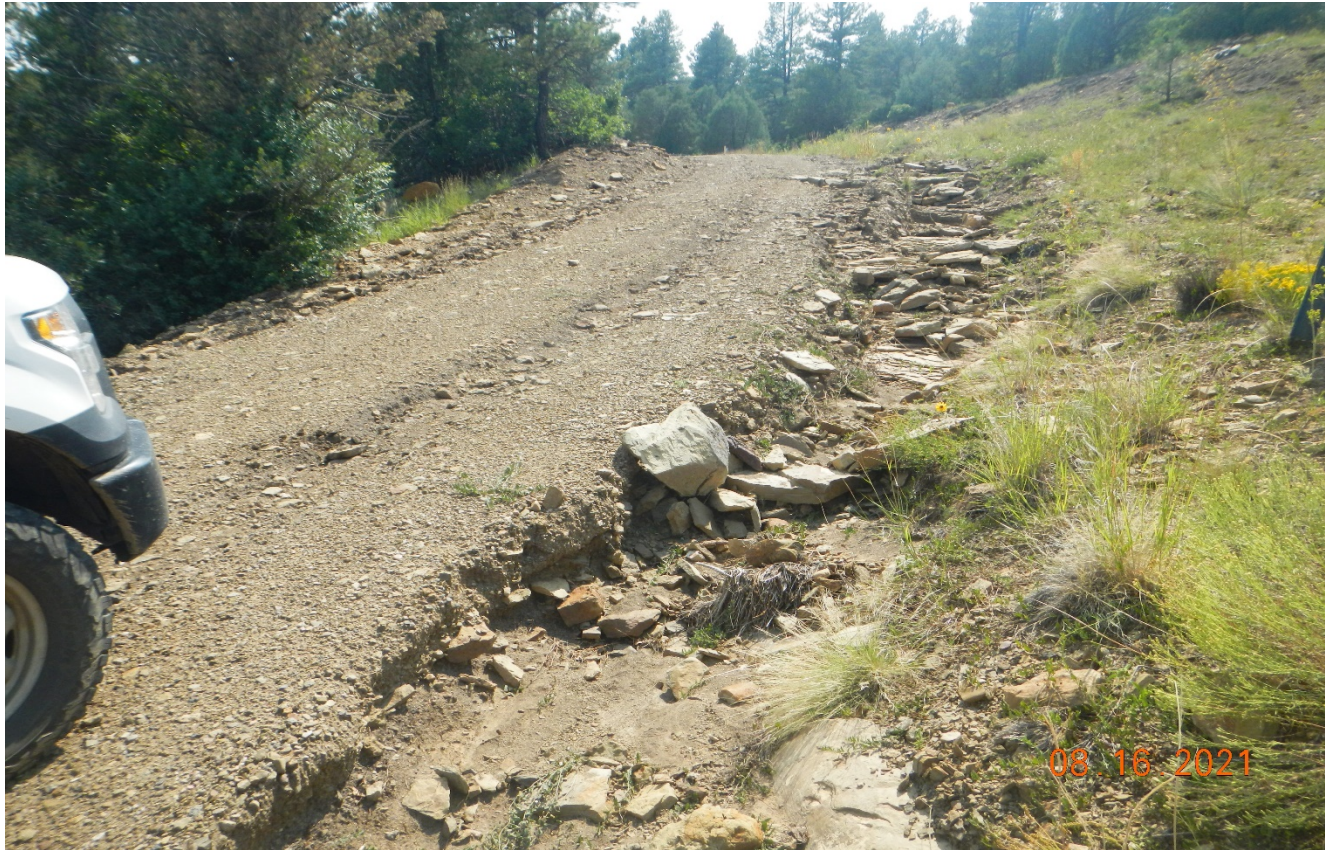
Photo 5. Further up the access road. The erosion along the road side will need to be repaired and stabilized.
