Stormwater Inspection Report

Operator:	Laramie Energy, LLC
Project:	Cascade Creek
Location:	CC 610-22-43 Pad
Date:	Wednesday, June 2, 2021
Weather:	Partly Cloudy, Light Wind, 88°, Lo 51°

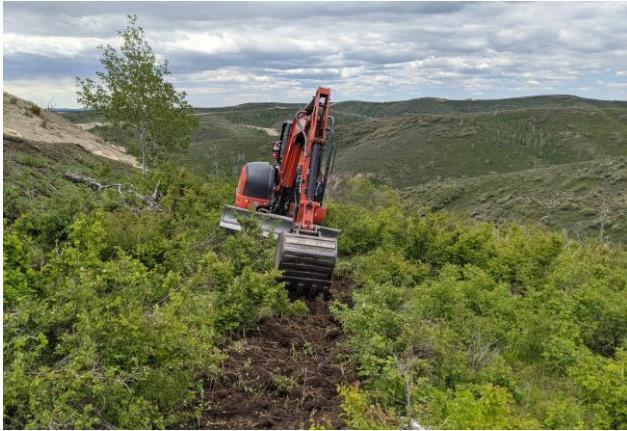
Photo 1

Clearing Vegetation in Preparation for Wattle Installation

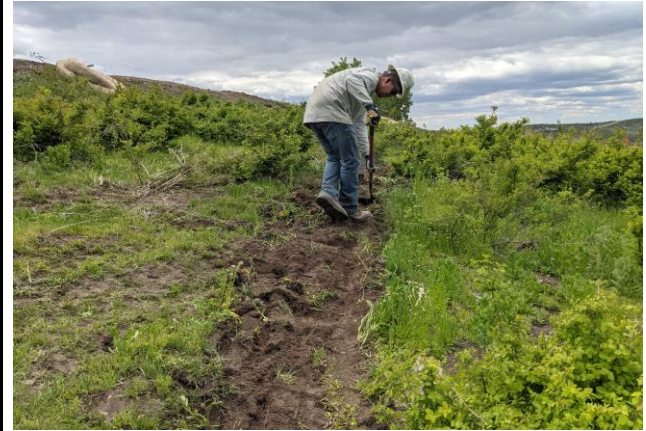
Photo 2

Installing Trench for Wattle Installation by Hand

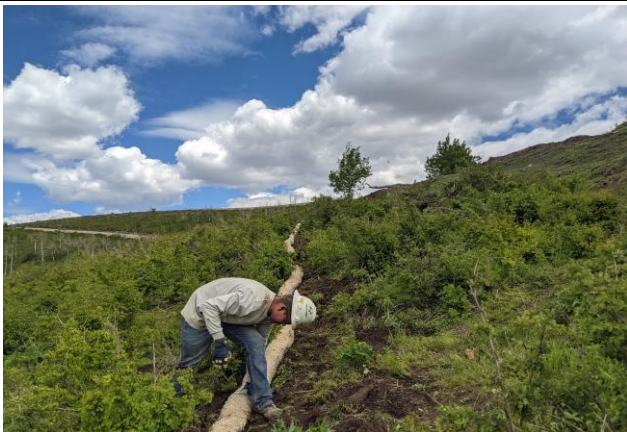
Photo 3

Stringing Out Wattle to be Installed

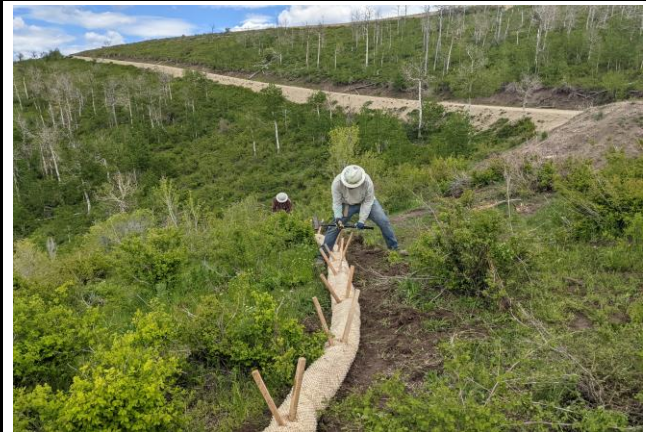
Photo 4

Installing Wattle on the CC 610-22-43 Pad

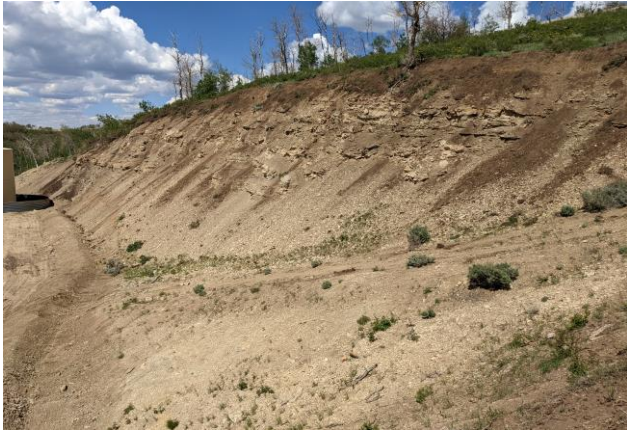
Photo 1

Containment Berm Installed below CC 610-22-43 Cut Slope

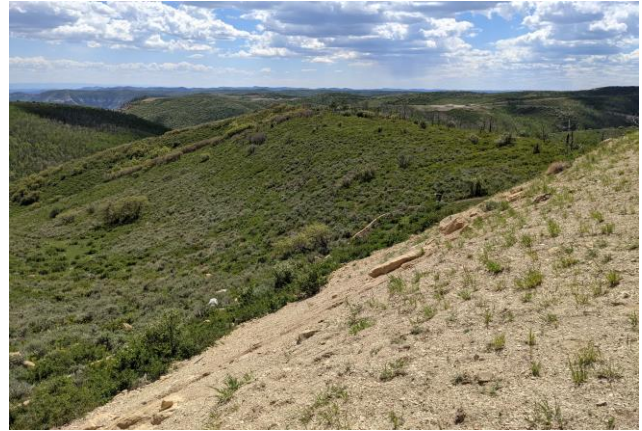
Photo 2

Wattle Installed below CC 610-22-43 Fill Slope

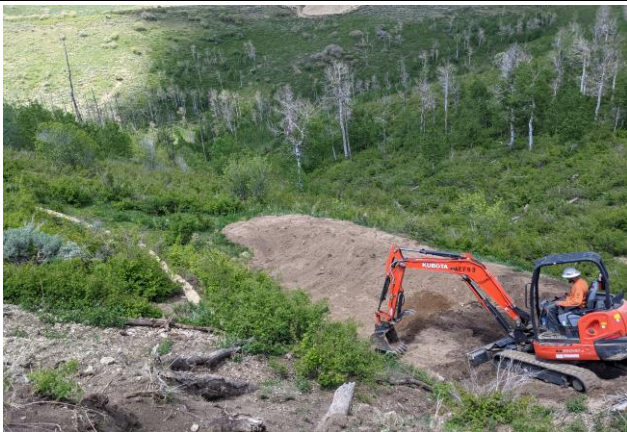
Photo 3

Maintaining Sediment Trap near the Pad Entrance

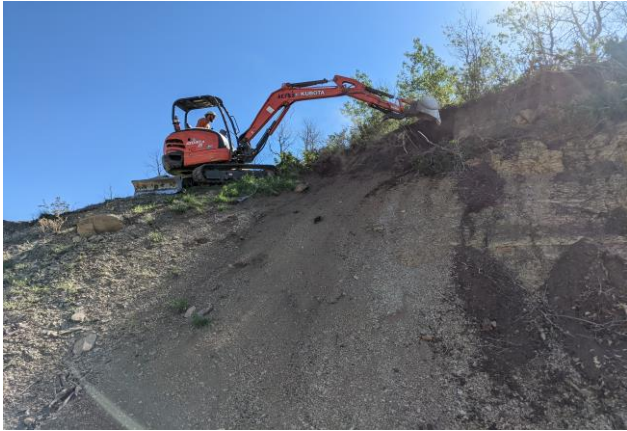
Photo 1

Shaping Verticle Cut above Cut Slope

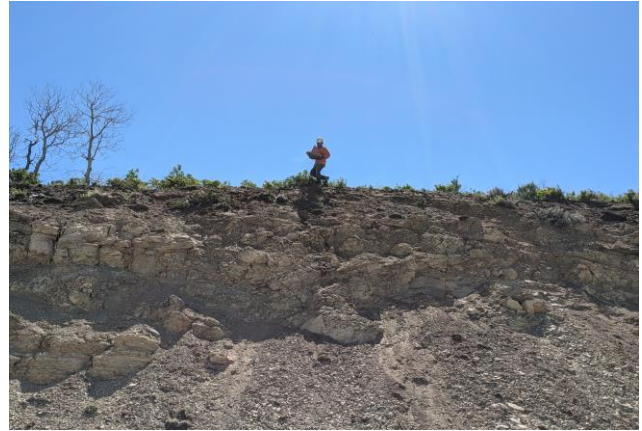
Photo 2

Broadcast Seeding Cut Slope on CC 610-22-43

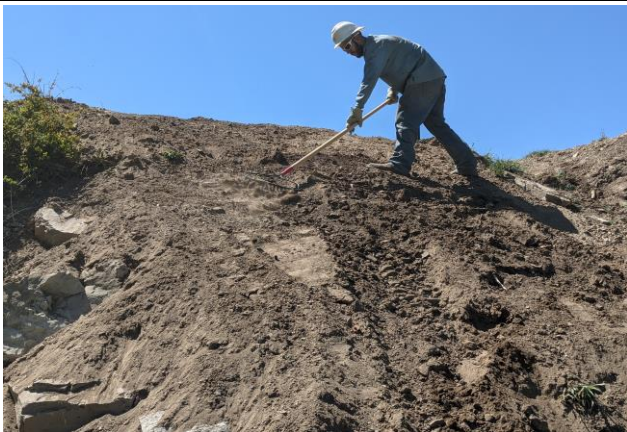
Photo 3

Hand Raking Seed to Incorporate into Soil

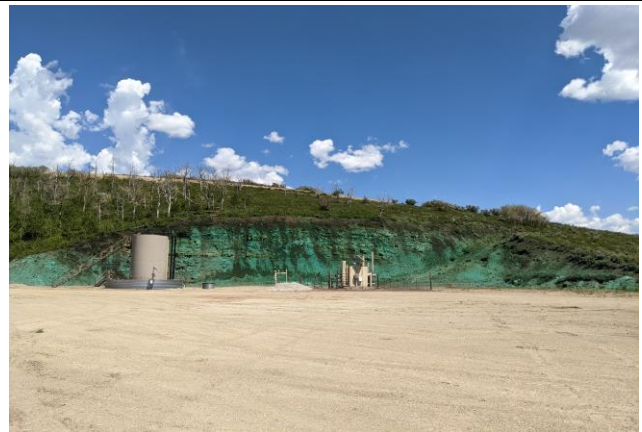
Photo 4

Location after Treating Cut Slope with Liquid Amenities and Nutrients

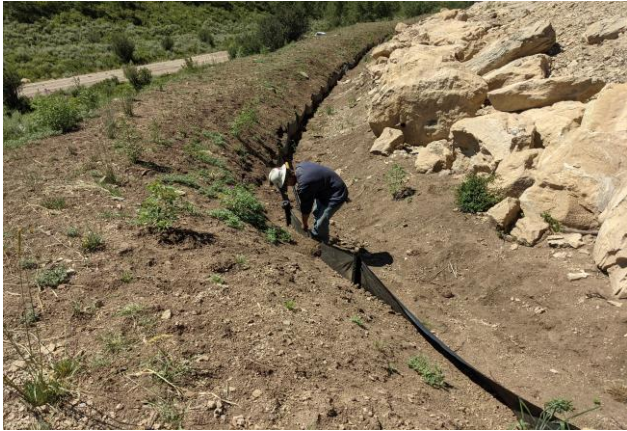
Photo 1

Mending Silt Fence on CC 604-12-13 Annex Pad

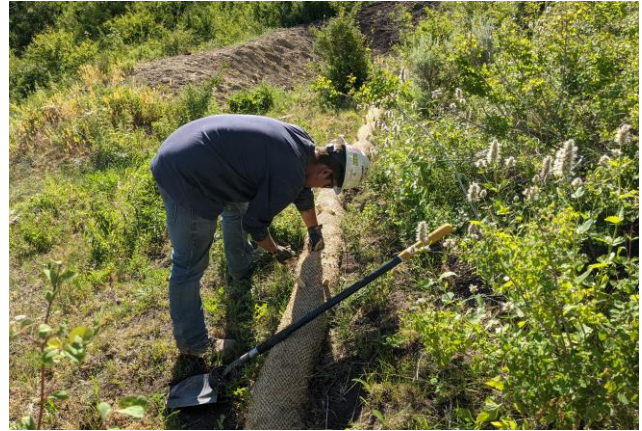
Photo 2

Maintaining Wattle on CC 610-22-43 Pad

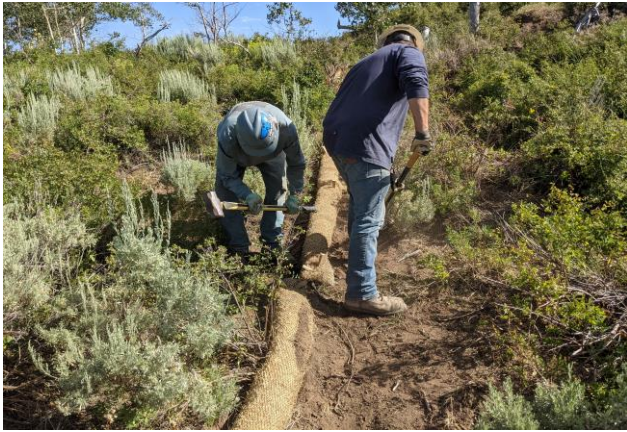
Photo 3

Maintaining Wattle on CC 610-22-43 Pad

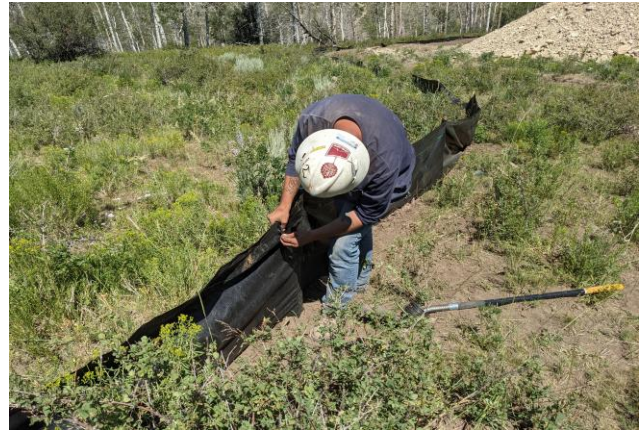
Photo 4

Repairing Silt Fence on CC 697-03-07 Pad

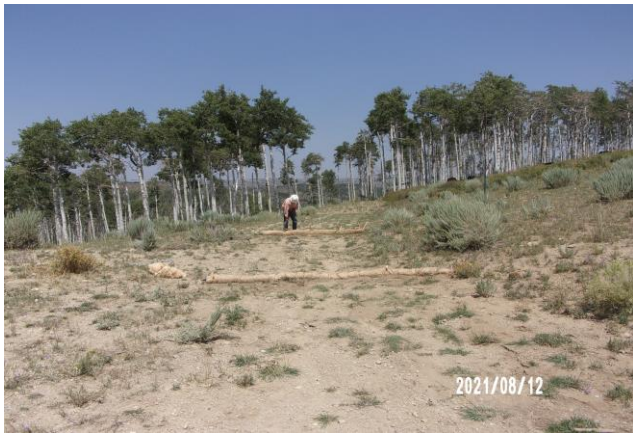
Photo 1

Maintaining Wattle on the CC 603-23-32 Pad

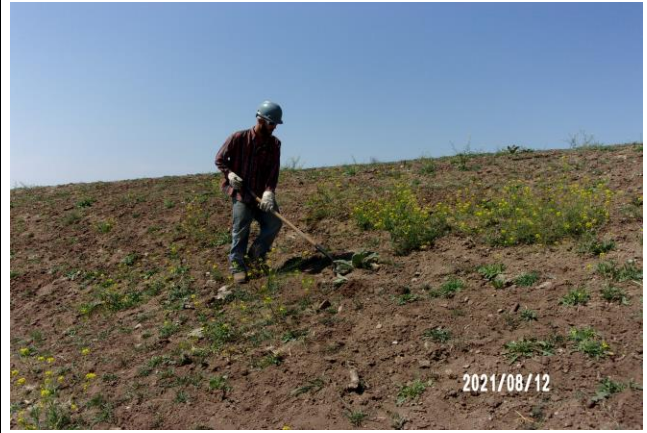
Photo 2

Hand Removing Noxious Weeds on the CC 604-41-32 Pad

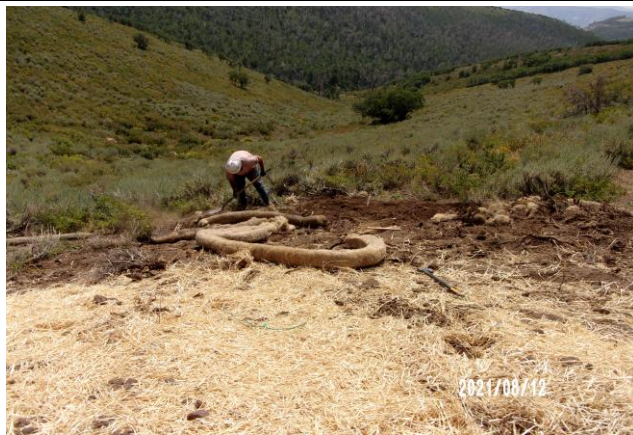
Photo 3

Replacing Section of Wattle on the CC 610-22-43 Pad

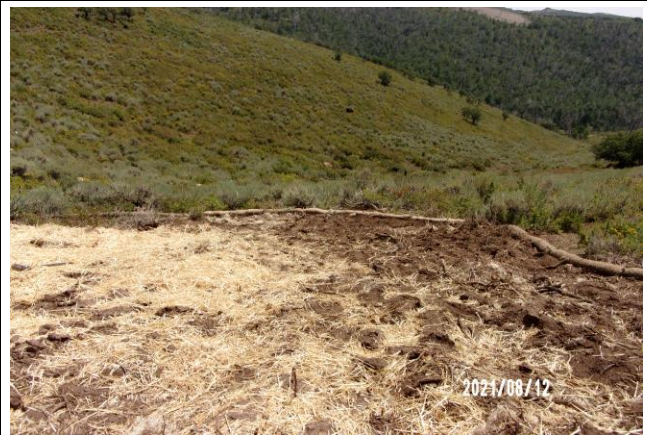
Photo 4

After Maintaining Wattle on the CC 610-22-43 Pad

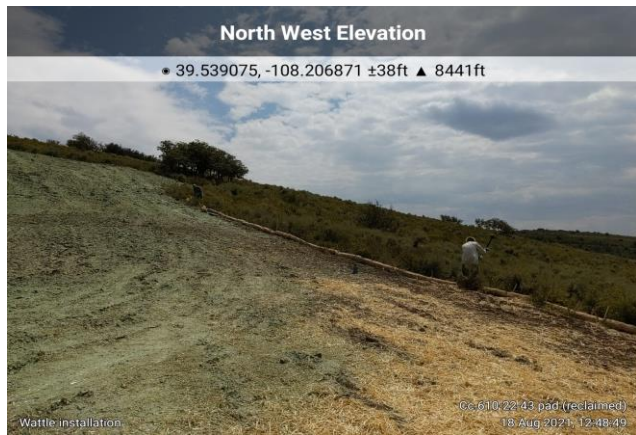
Photo 1

Installing Excelsior Wattle around the Perimeter of the Reclaimed CC 610-22-43 Location
