Stormwater Inspection Report

Operator:	Laramie Energy, LLC
Project:	Cascade Creek
Location:	Cascade Creek 604-41-32 Pad
Date:	Friday, May 7, 2021
Weather:	Mostly Sunny, Windy, 77°, Lo 41°

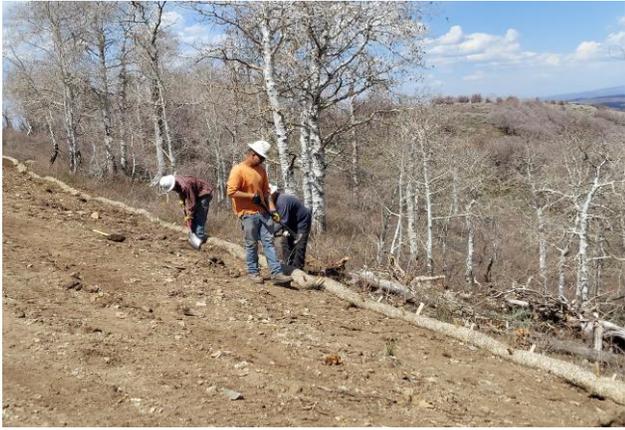
Photo 1

Maintaining Perimeter Wattle on CC 604-41-32

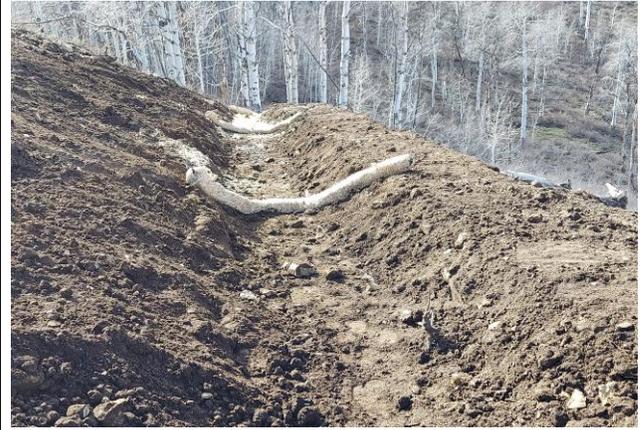
Photo 2

New Sediment Trap Outlet Installed

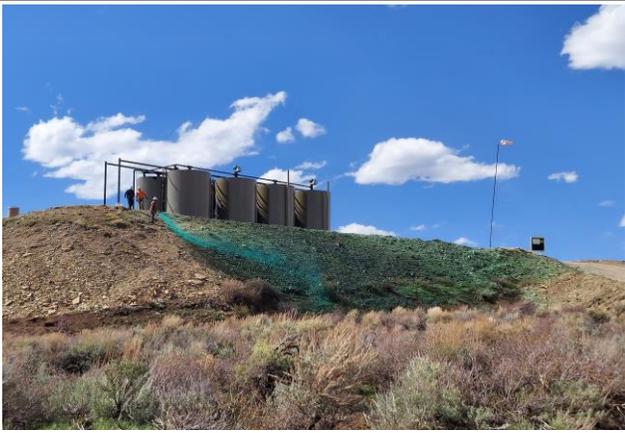
Photo 3

Applying Hydroseed Mix over Cut Slope

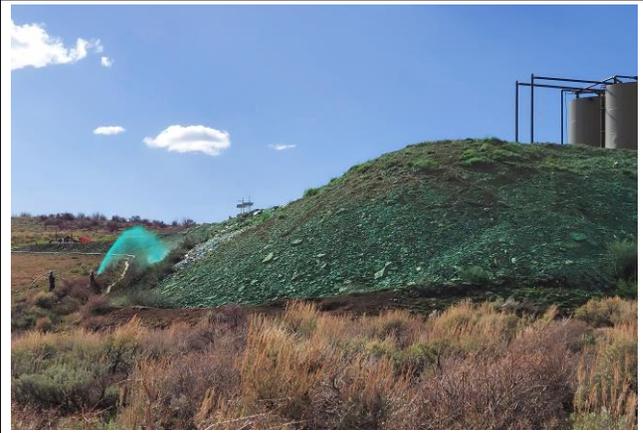
Photo 4

Applying Hydroseed Mix over Cut Slope

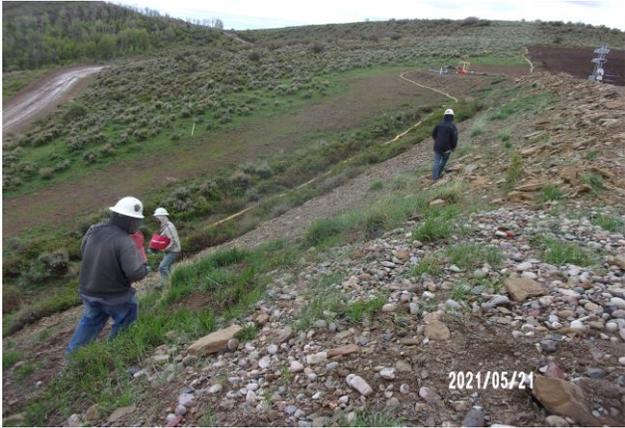
Photo 1

Broadcasting Seed on the CC 604-41-32 Pad

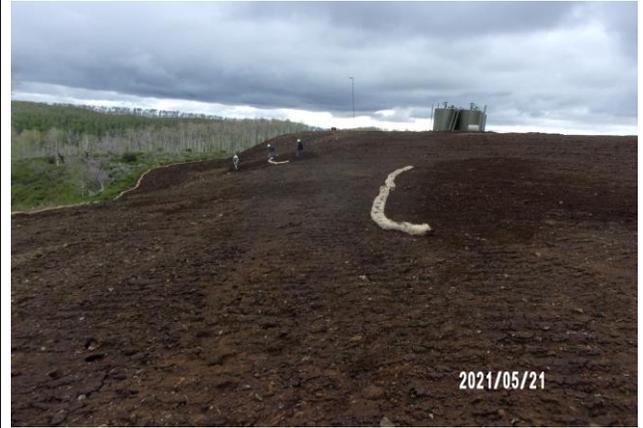
Photo 2

Wattle Installed below Minor Erosion

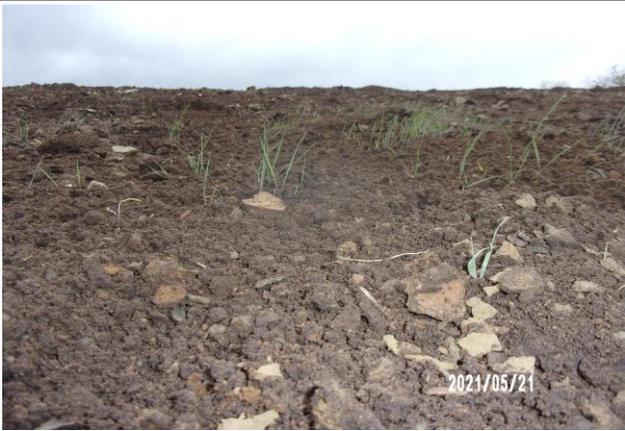
Photo 3

Seed Germinating on the CC 604-41-32 Pad

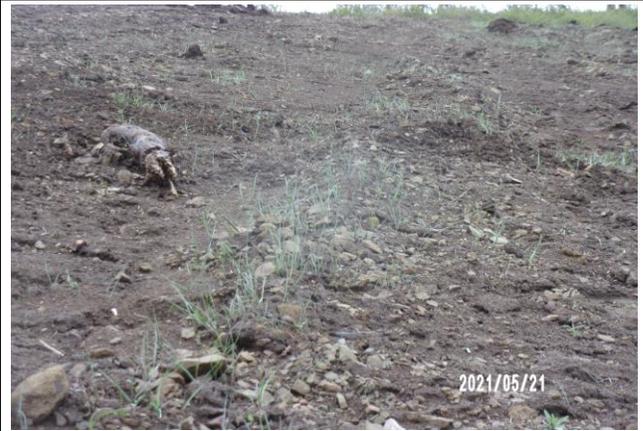
Photo 4

Seed Germinating on the CC 604-41-32 Pad

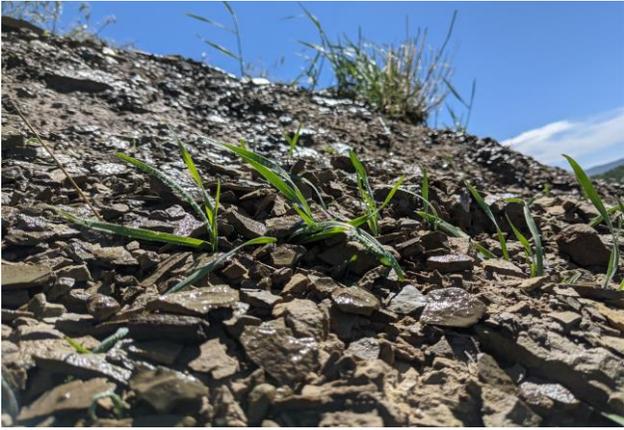
Photo 1

Seed Germinating on the CC 604-41-32 Pad

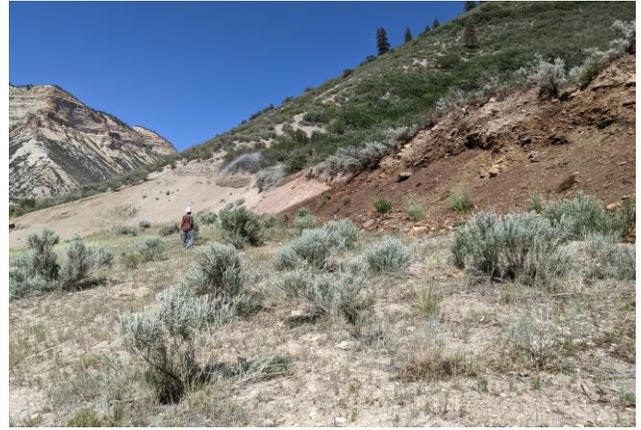
Photo 2

Irrigating the CC 629-2 Pad Cut Slope

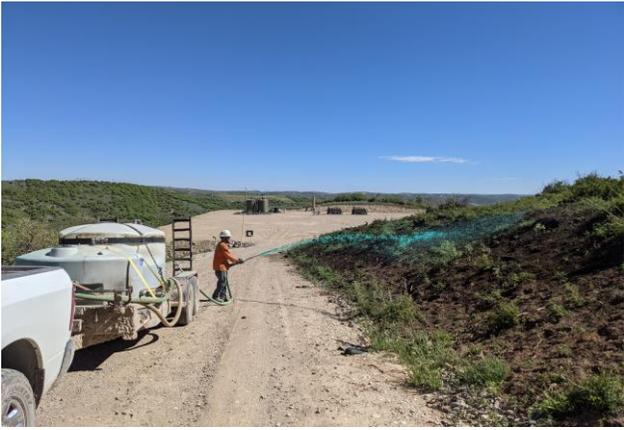
Photo 3

Irrigating the CC 697-03-07 Access Road Cut Slope

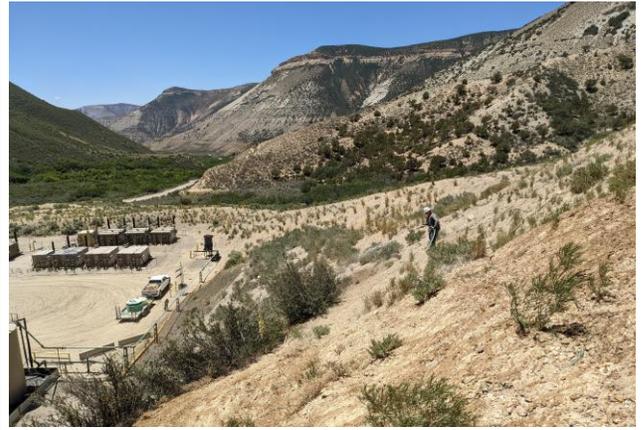
Photo 4

Irrigating the Shell 797-03B Cut Slope

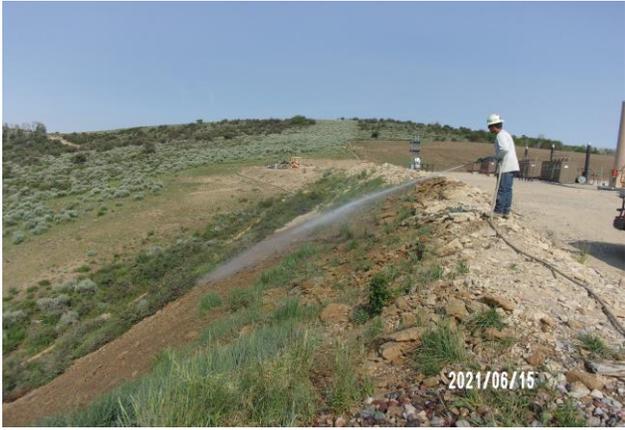
Photo 1

Applying Additional Water, Nutrients, and Soil Amenities on CC 604-41-32 Fill Slope

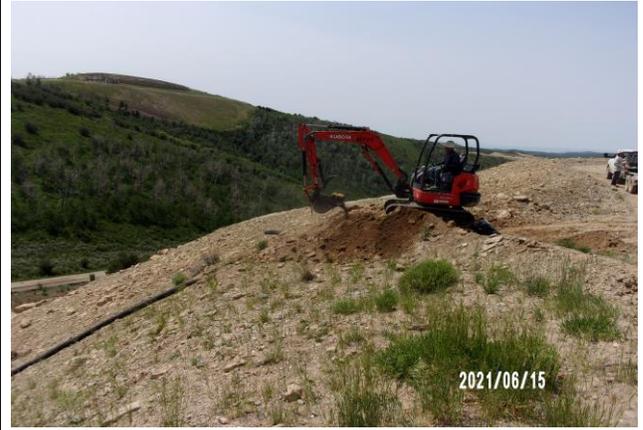
Photo 2

Installing Flex Hose Outlet on CC 604-12-13 Annex Pad

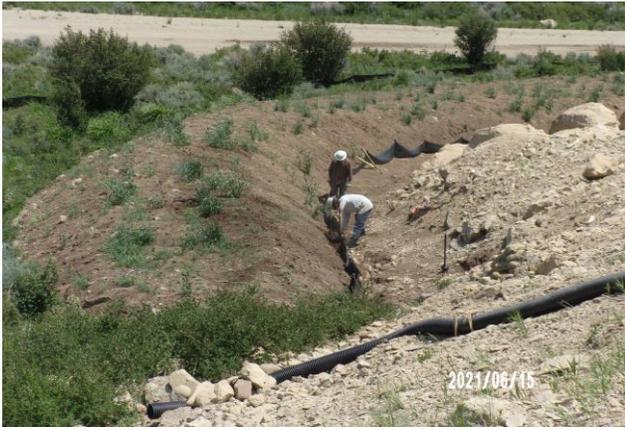
Photo 3

Mending Silt Fence Installed on CC 604-12-13 Annex Pad

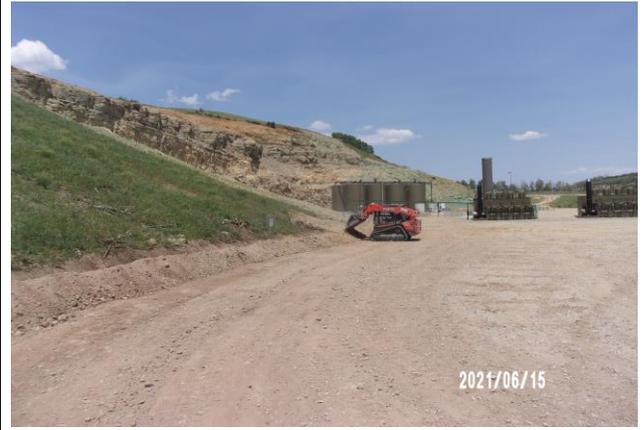
Photo 4

Installing Containment Berm Below CC 604-12-13 Annex Cut Slope

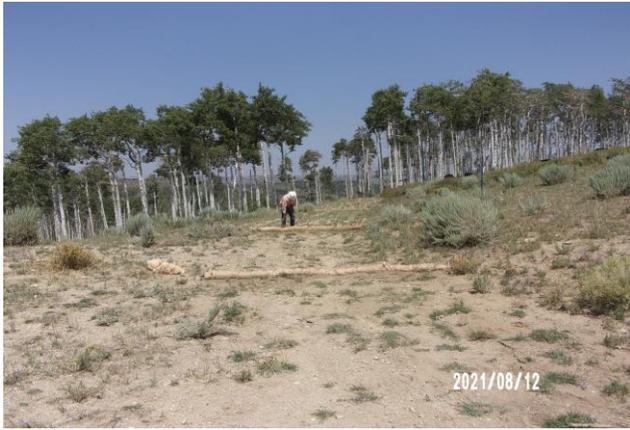
Photo 1

Maintaining Wattle on the CC 603-23-32 Pad

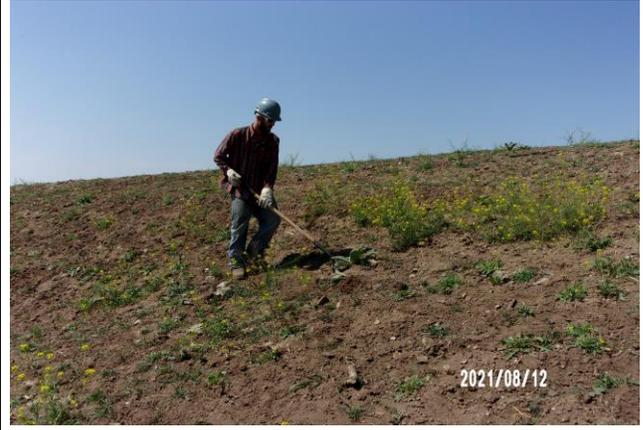
Photo 2

Hand Removing Noxious Weeds on the CC 604-41-32 Pad

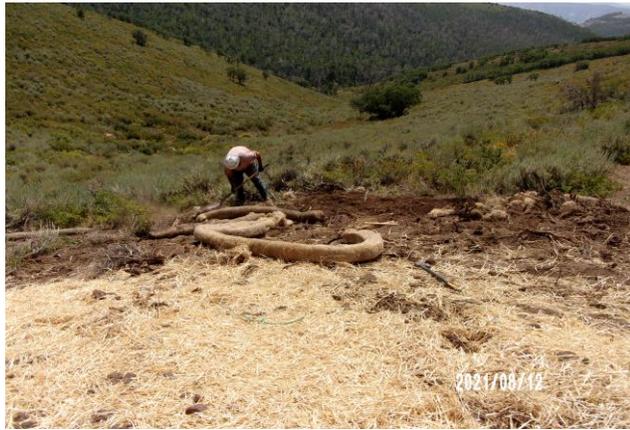
Photo 3

Replacing Section of Wattle on the CC 610-22-43 Pad

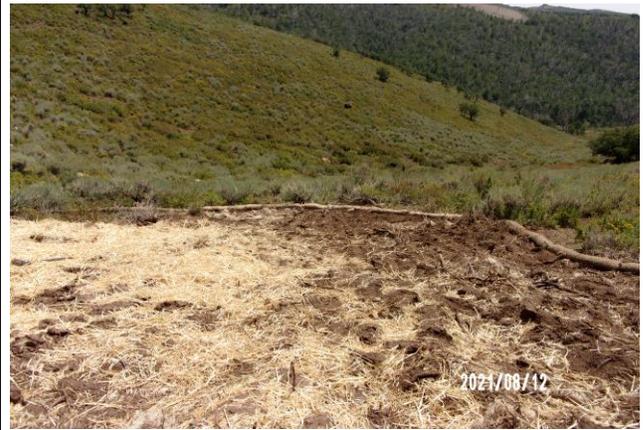
Photo 4

After Maintaining Wattle on the CC 610-22-43 Pad

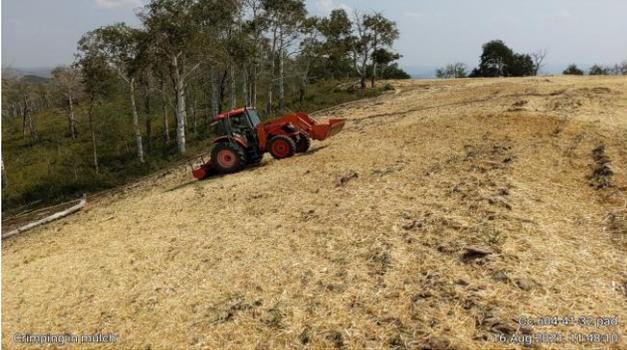
Photo 1

Crimping Straw Mulch on CC 604-41-32 Pad

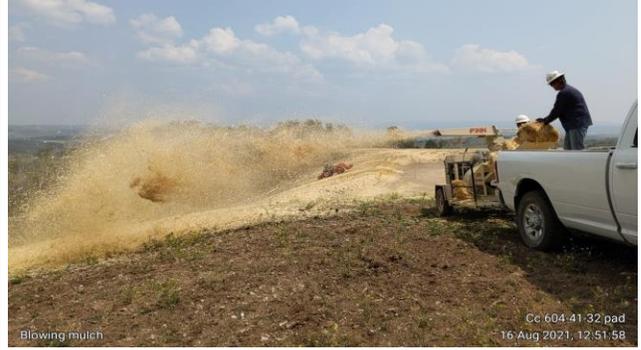
Photo 2

Blowing Straw Mulch on CC 604-41-32 Pad

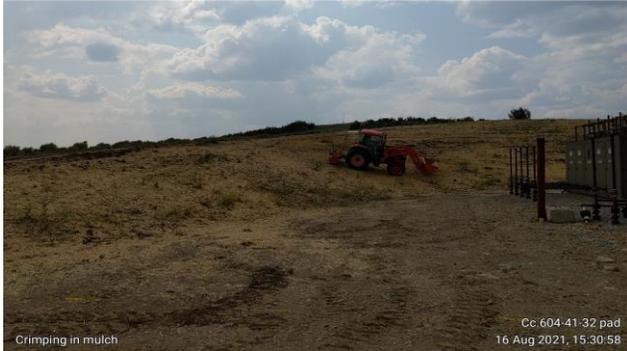
Photo 3

Crimping Straw Mulch on CC 604-41-32 Pad

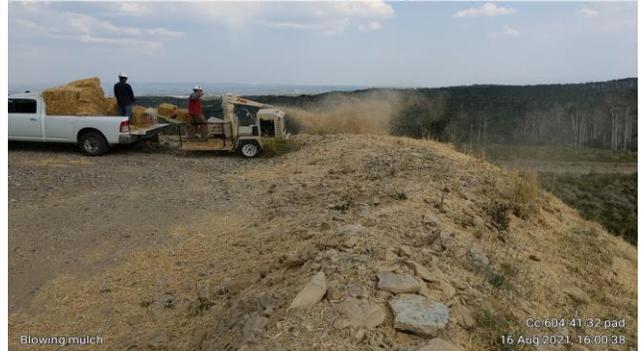
Photo 4

Blowing Straw Mulch on CC 604-41-32 Pad

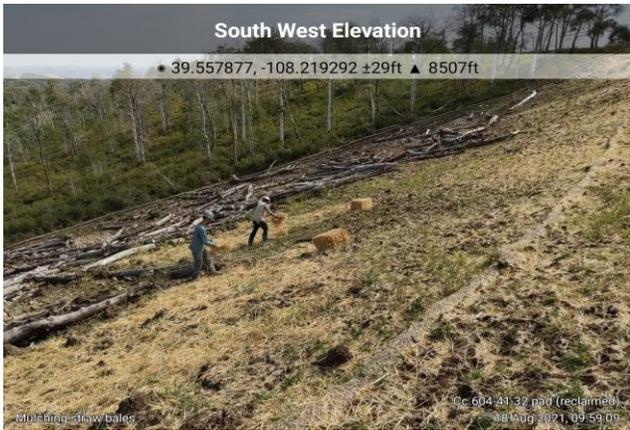
Photo 1

Hand Mulching the Cascade Creek 604-41-32 Pad

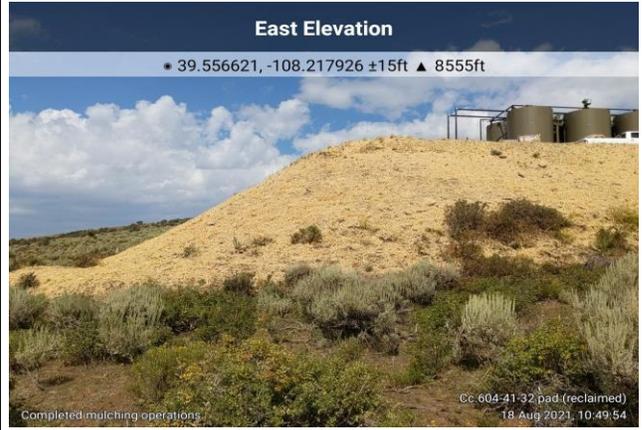
Photo 2

Fill Slope Mulched on the CC 604-41-32 Pad

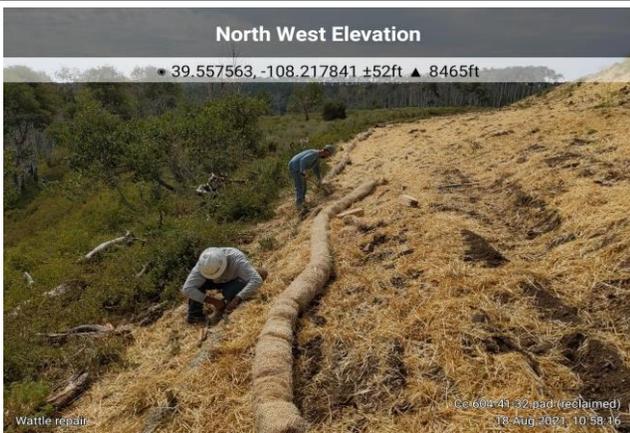
Photo 3

Maintaining Excelsior Wattle on the CC 604-41-32 Pad
