Inspection Photos

API: 025-06022

Operator: GRAND MESA OPERATING CO

Inspection Date: 8/23/2021

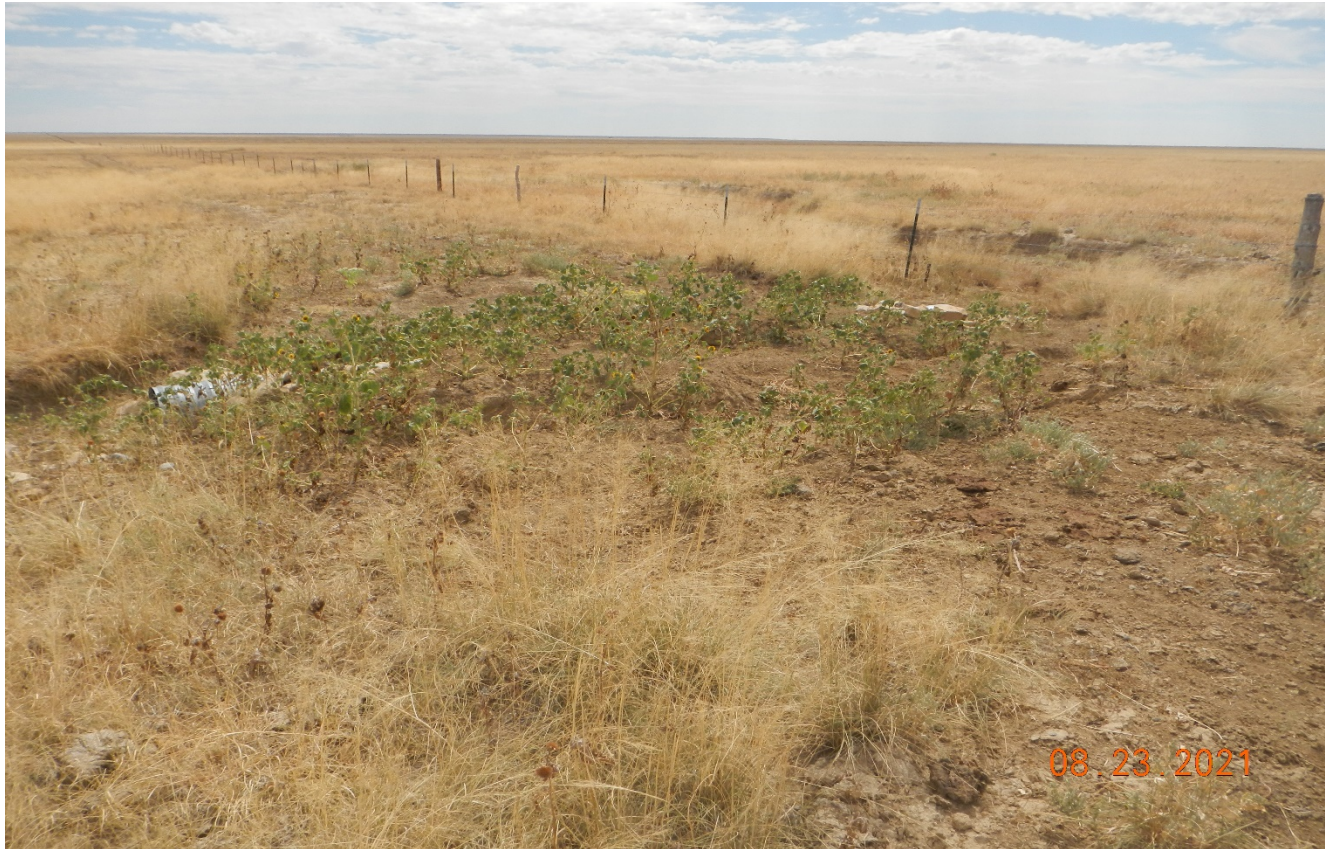
Photo 1. Facing southeast at the drainage crossing located at Lat/Long:38.343699,-103.638603. The drainage crossing has eroded and is impassible with vehicle. This needs to be repaired and designed to allow access across this drainage.

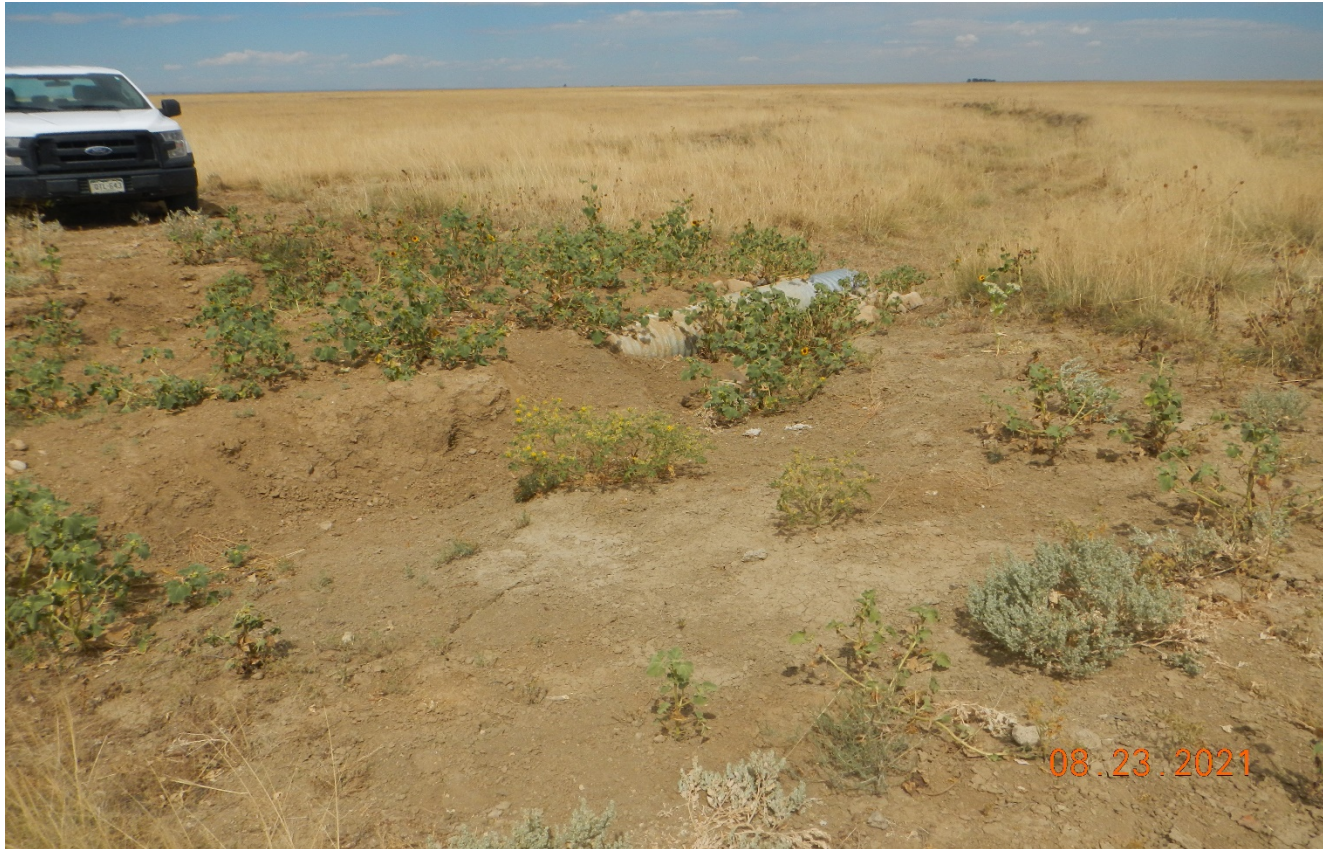
Photo 2. Facing northwest at the drainage crossing that eroded shown in previous photo. This drainage crossing needs to be repaired per good engineering practice.

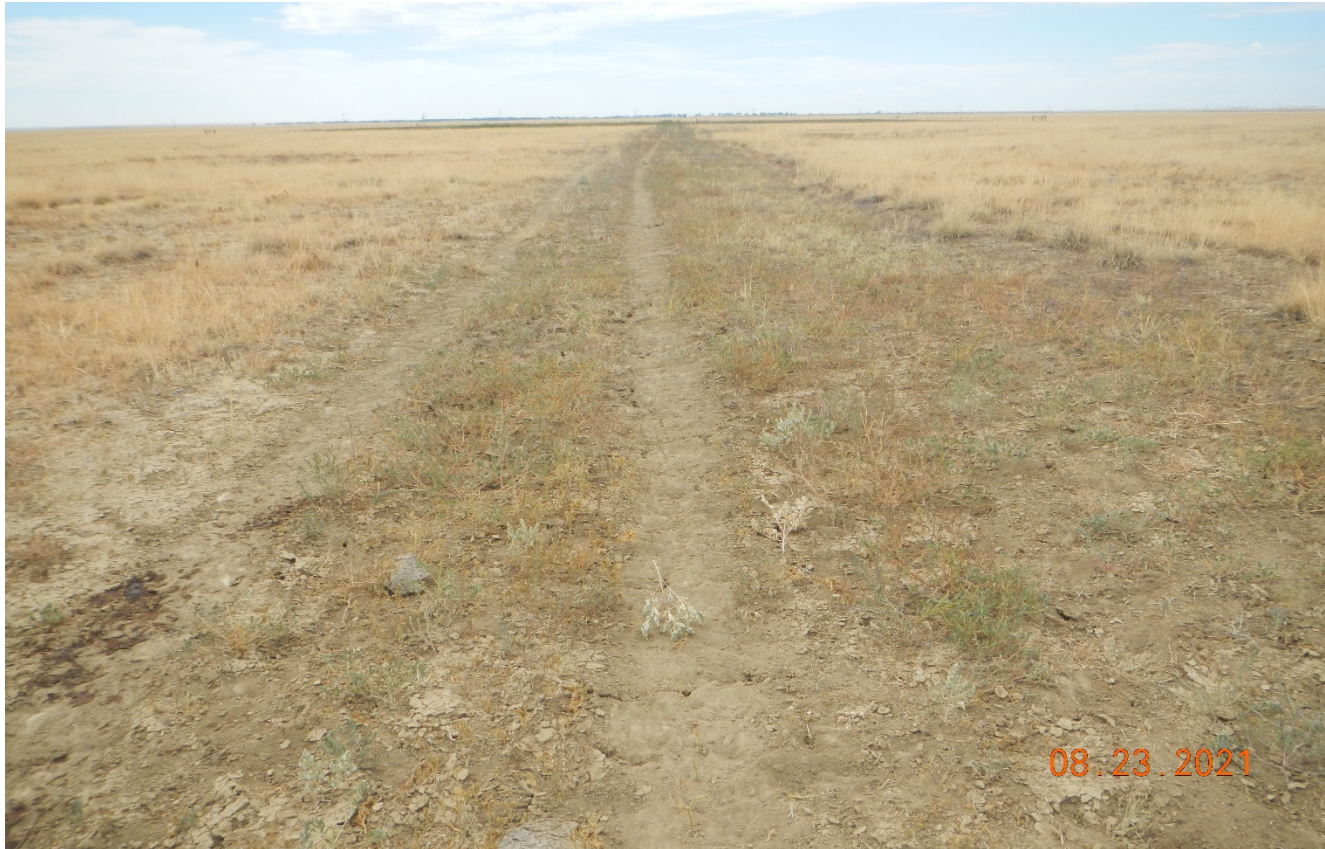
Photo 3. Facing southwest toward the access road which had been reclaimed. The desirable vegetation has failed to establish and will need to be reseeded.

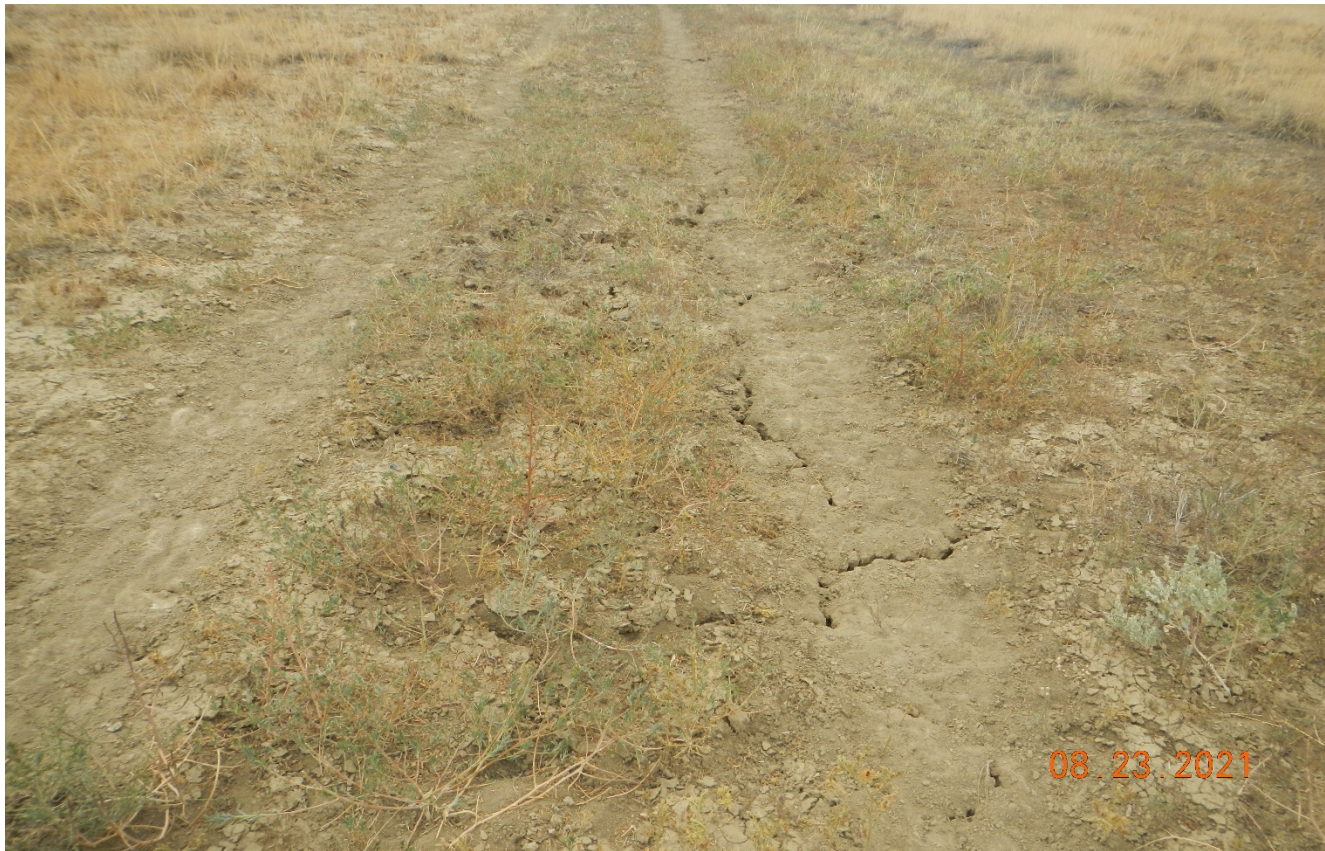
Photo 4. View of vegetation along the access road shows mostly bare soil and weeds.

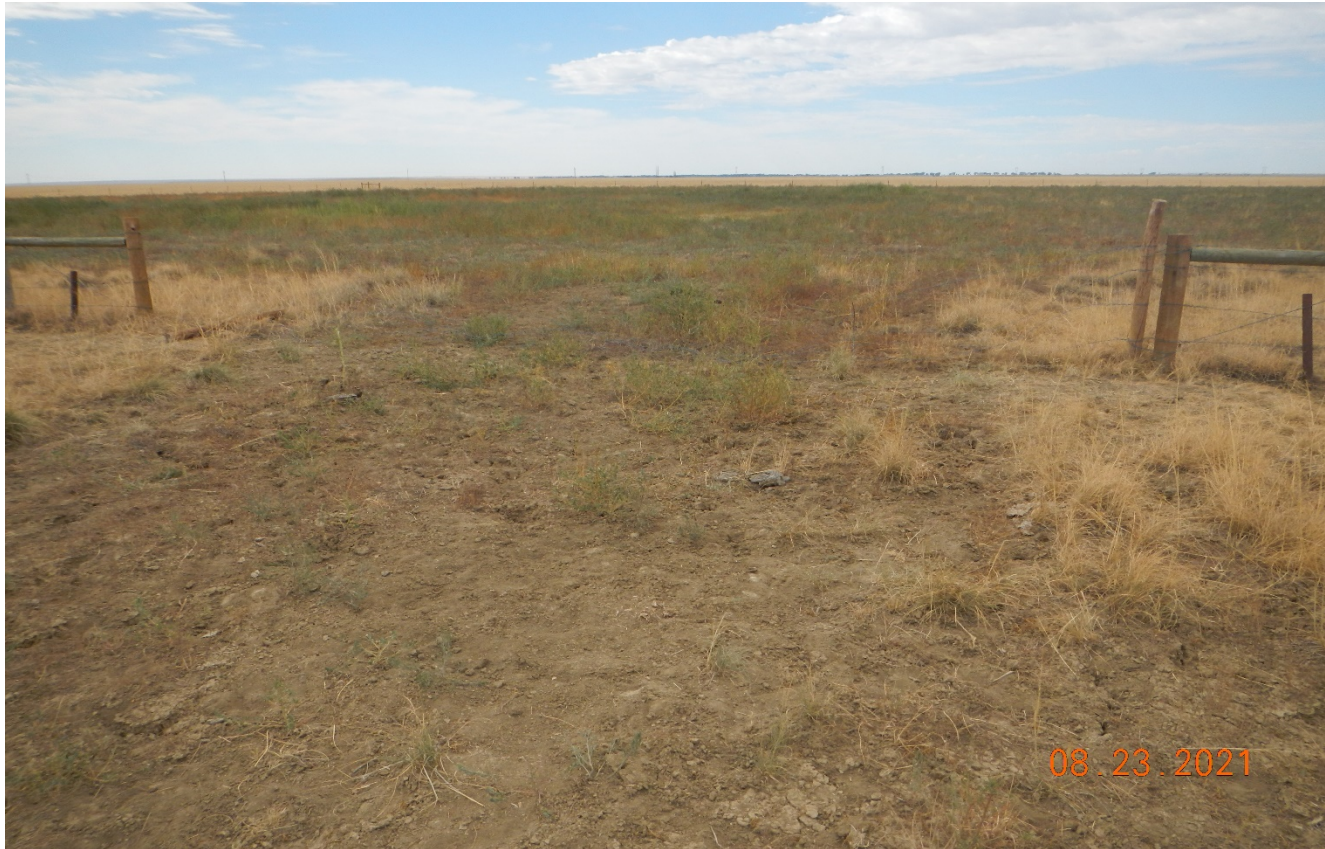
Photo 5. Facing southwest toward the location which is fenced.

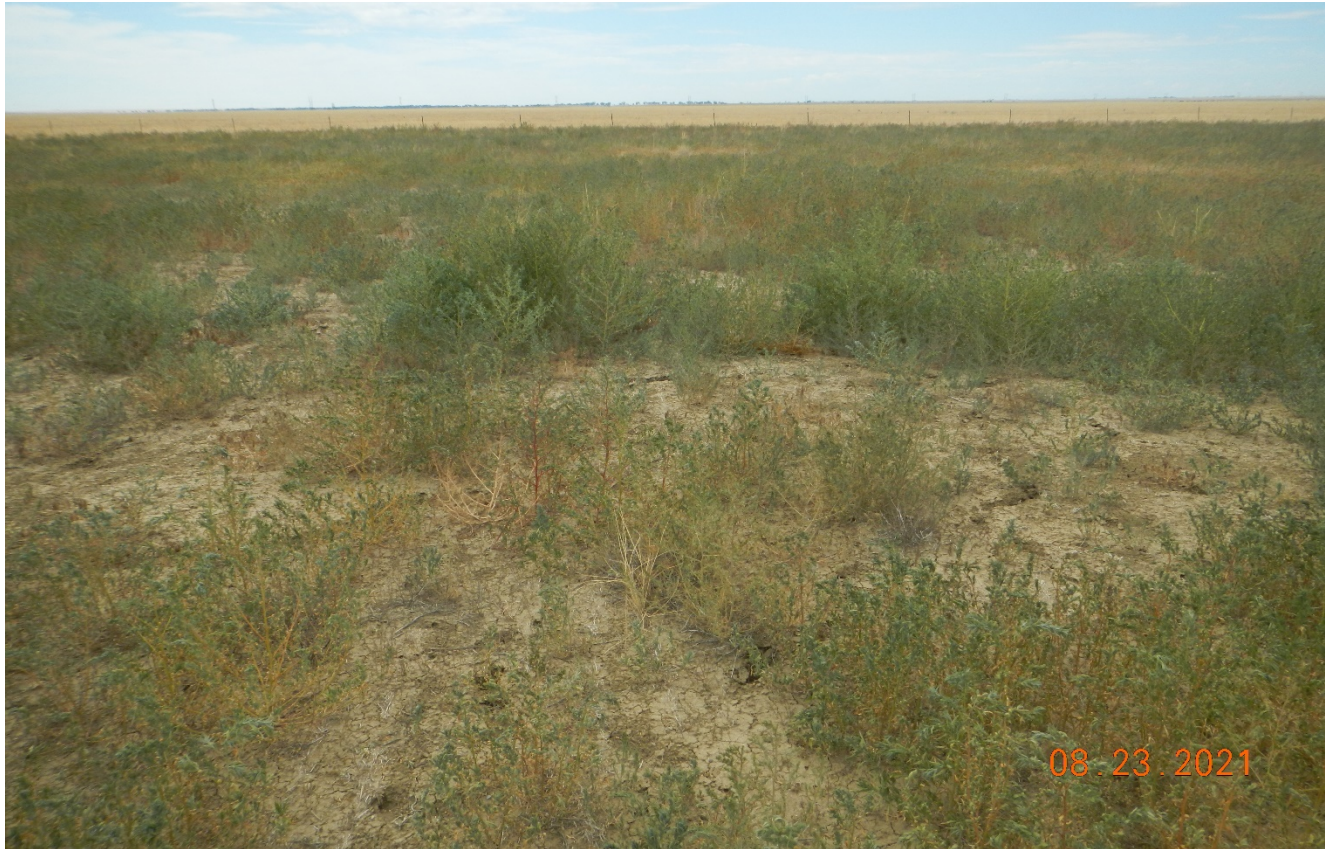
Photo 6. Center of the location facing south. The location has not established desirable vegetation and consists mostly of undesirable weeds.

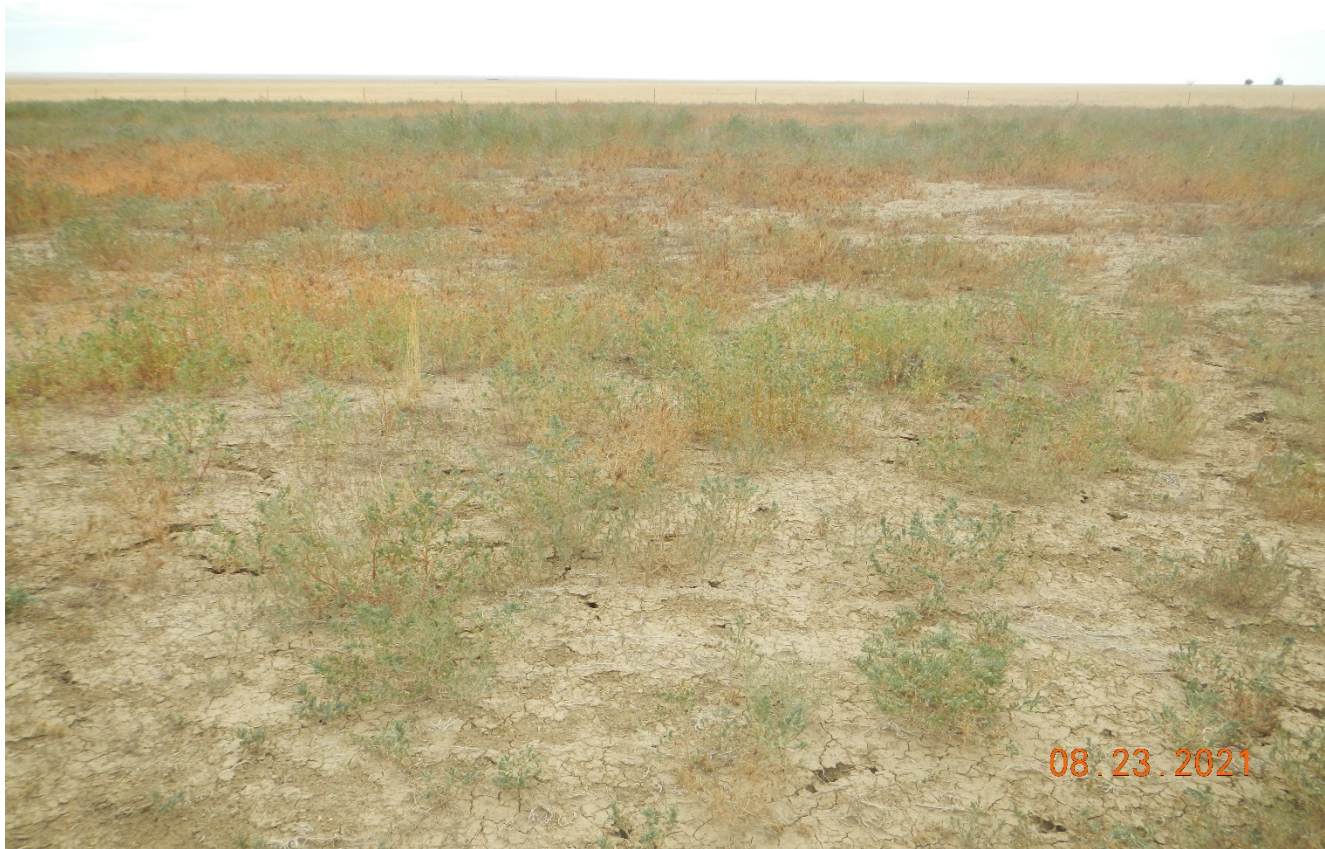
Photo 7. Center of the location facing east. The

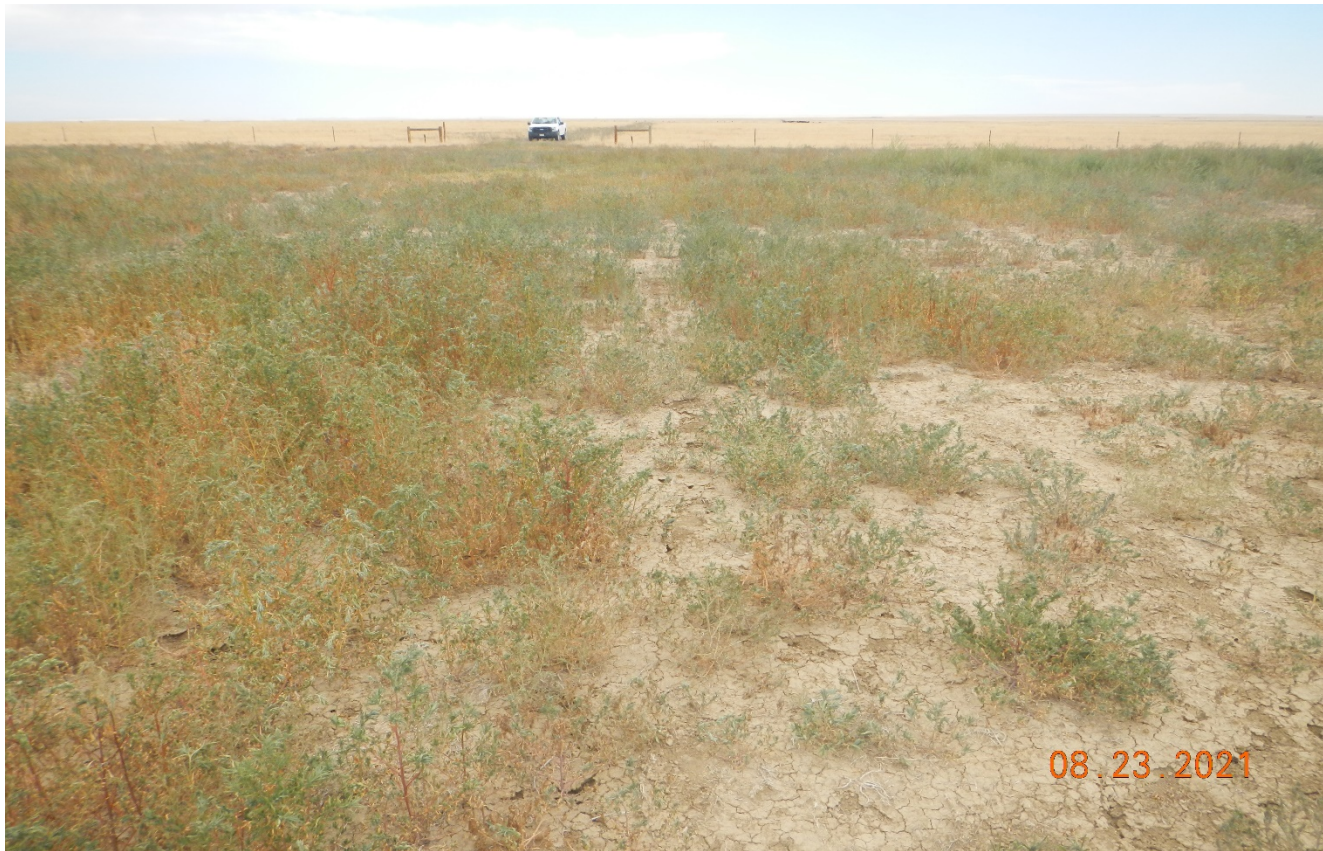
Photo 8. Center of the location facing north.

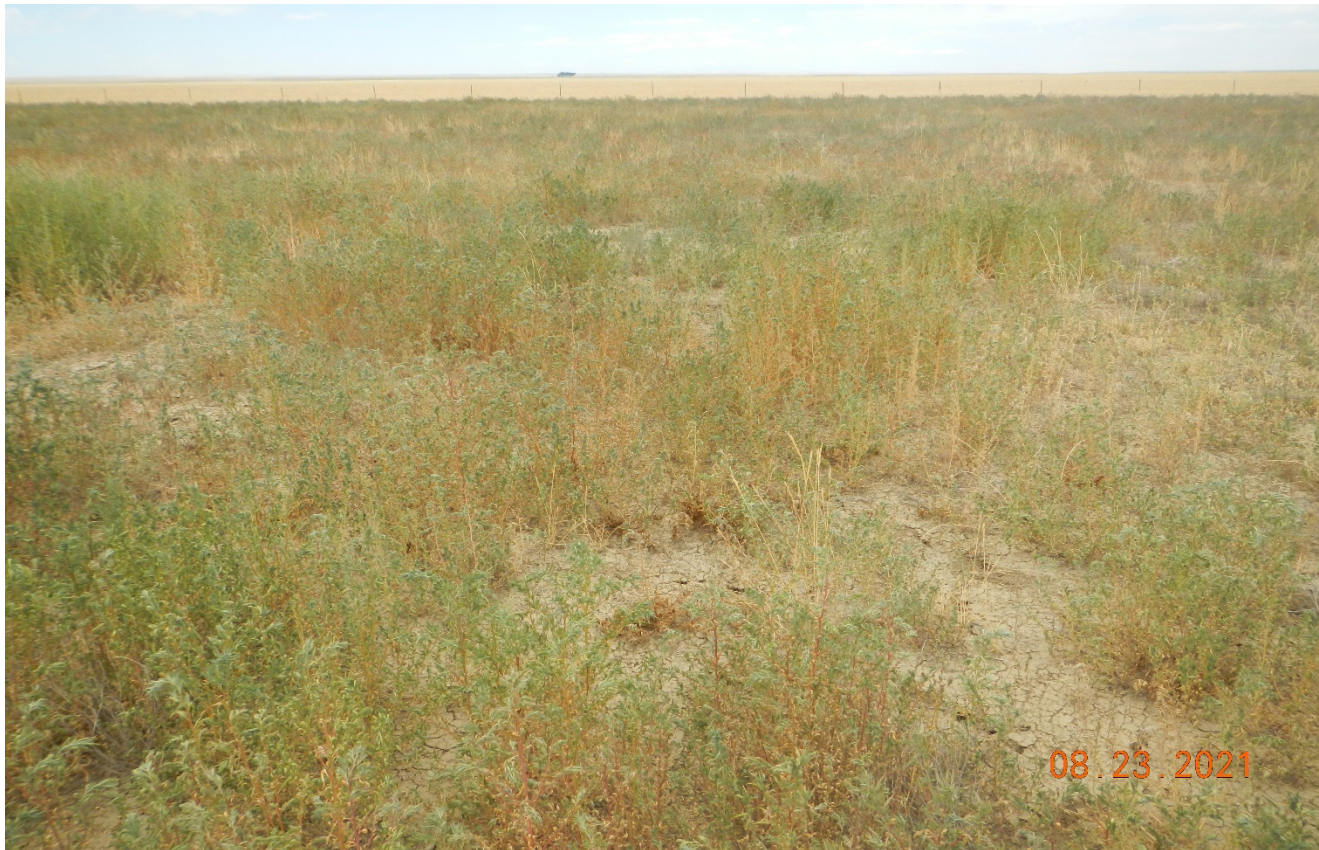
Photo 9. Center of the location facing west.

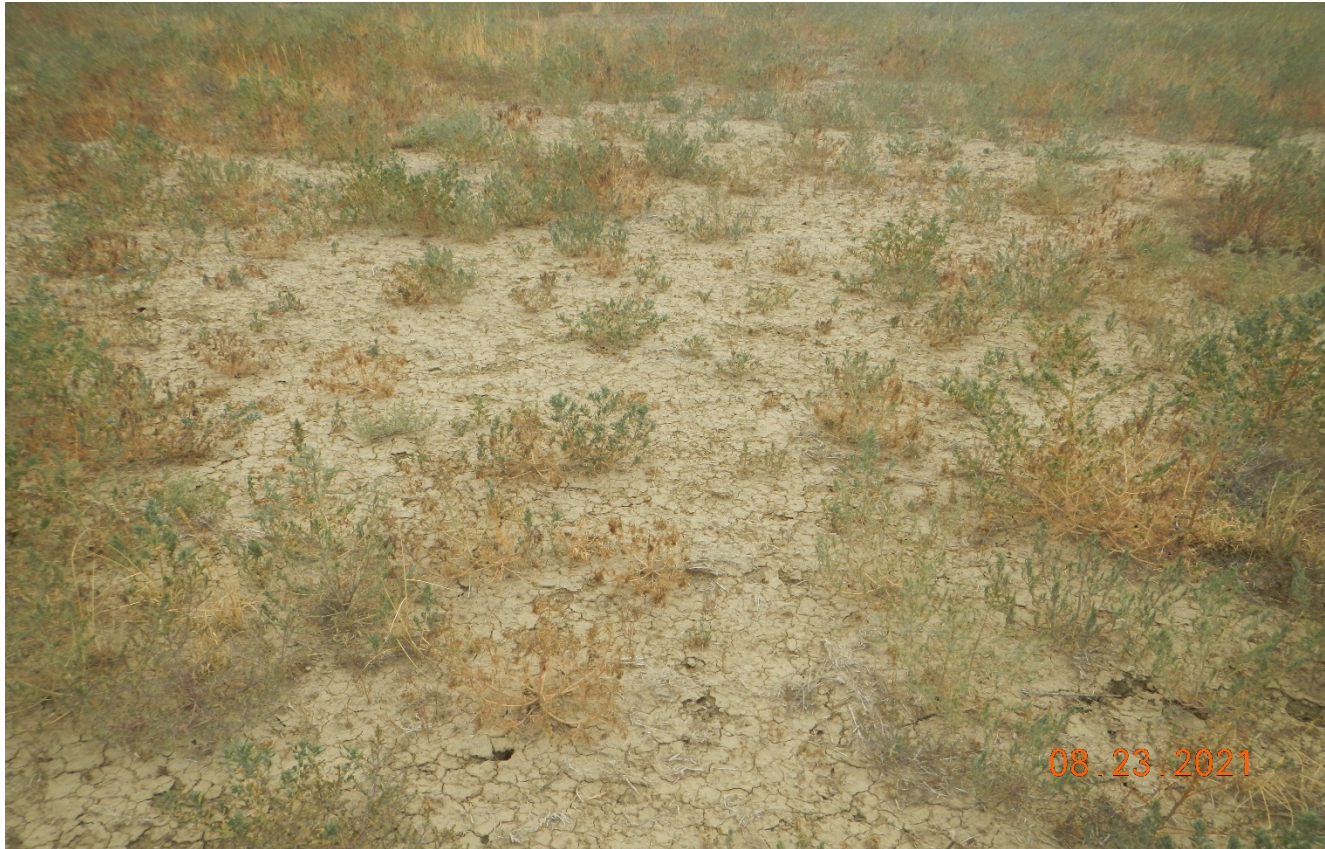
Photo 10. View of ground cover shows undesirable vegetation growth; Kochia, Russian thistle. Desirable vegetation has not established.

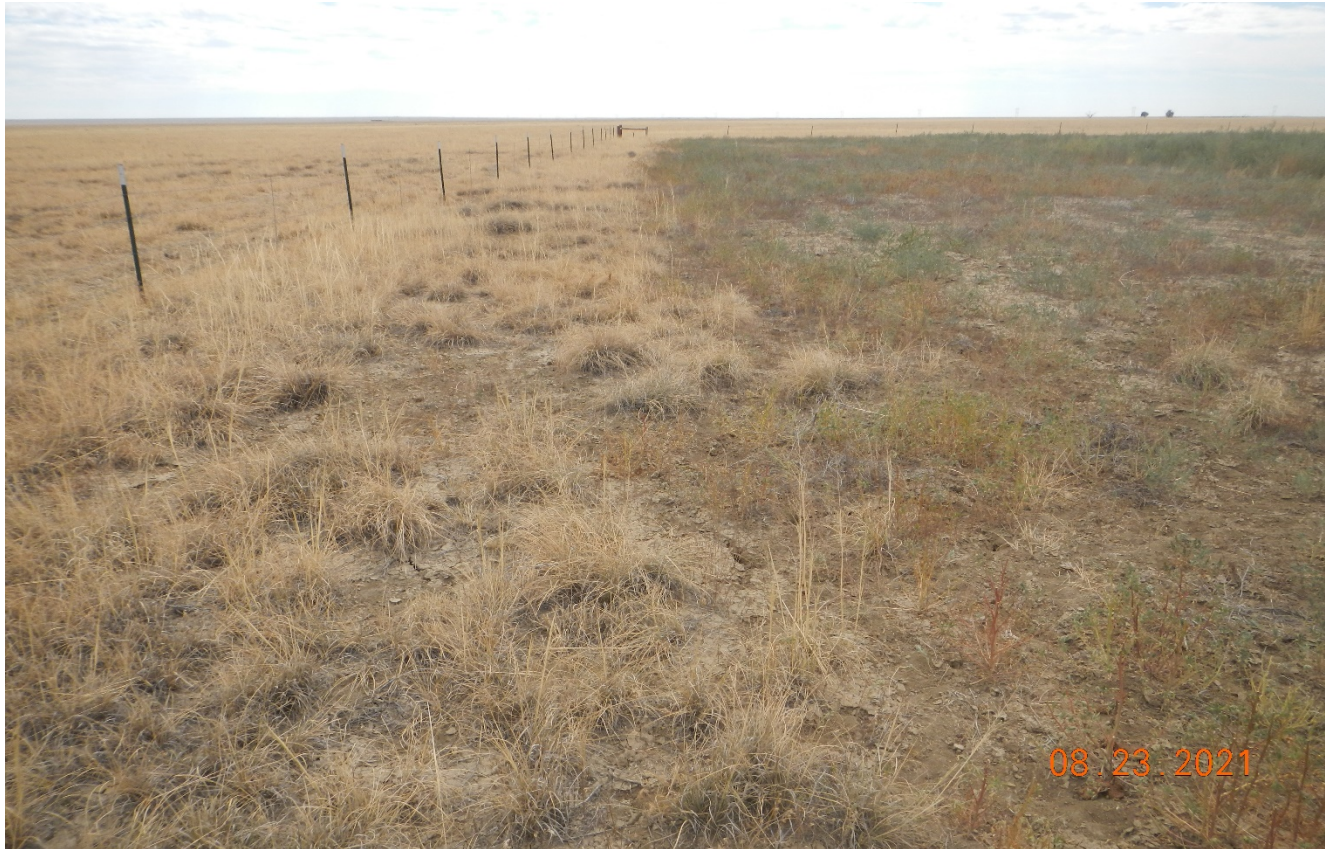
Photo 11. Facing southeast showing the undisturbed area on the left and the disturbance of the location on the right.
