Inspection Photos  
Operator: Simcoe  
API: 067-09679  
Date: 8/12/2021

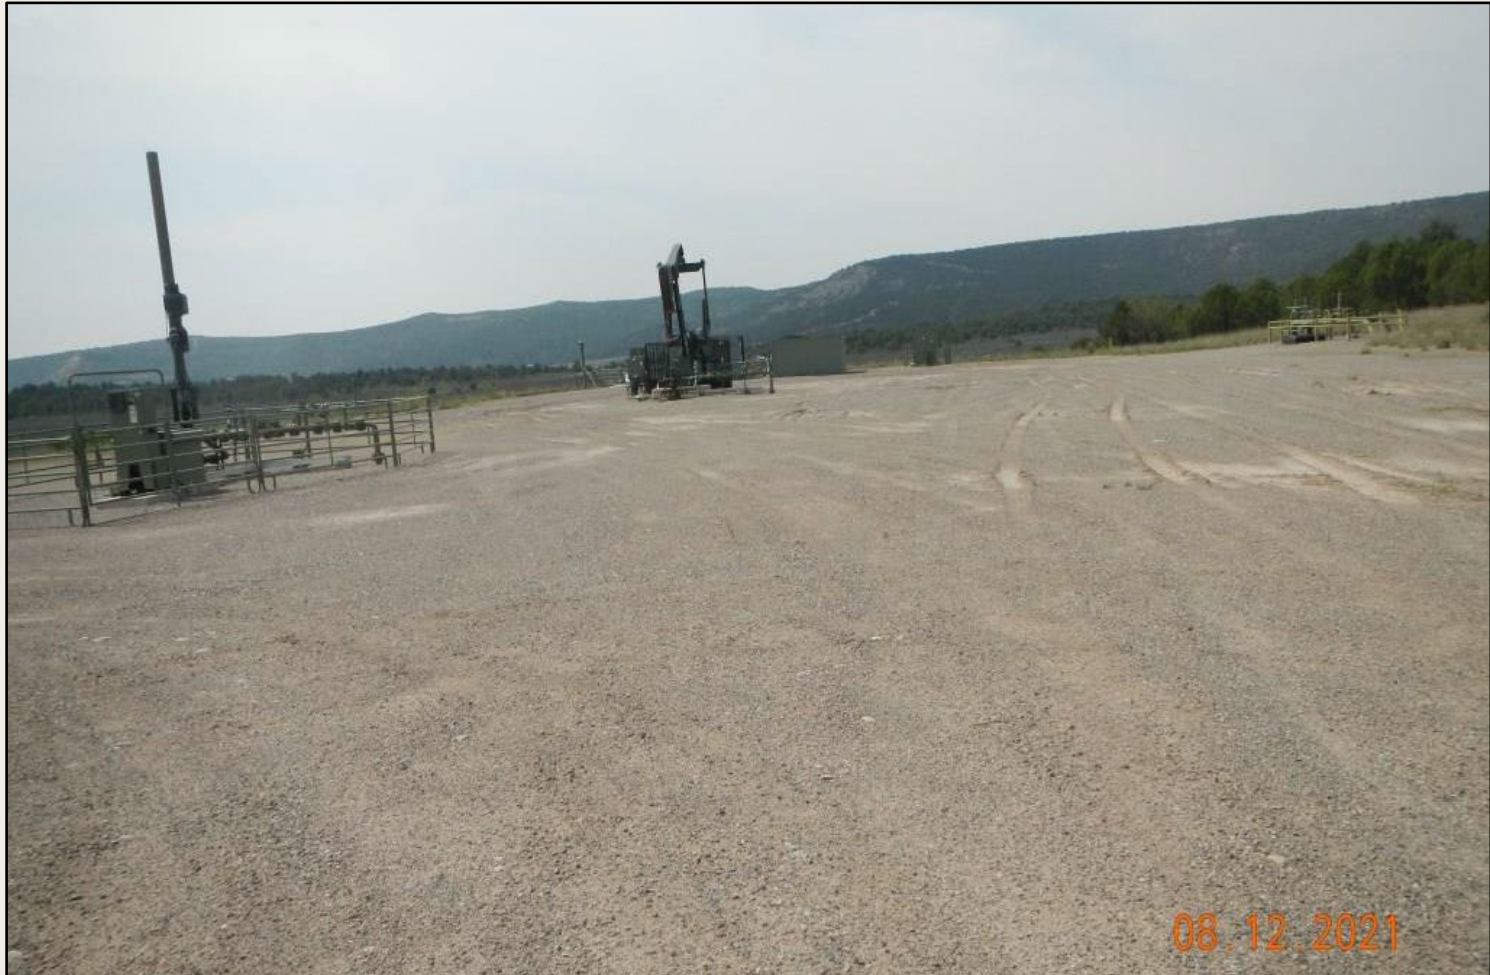
Photo 1. View of the project area from the well pad entrance facing center.

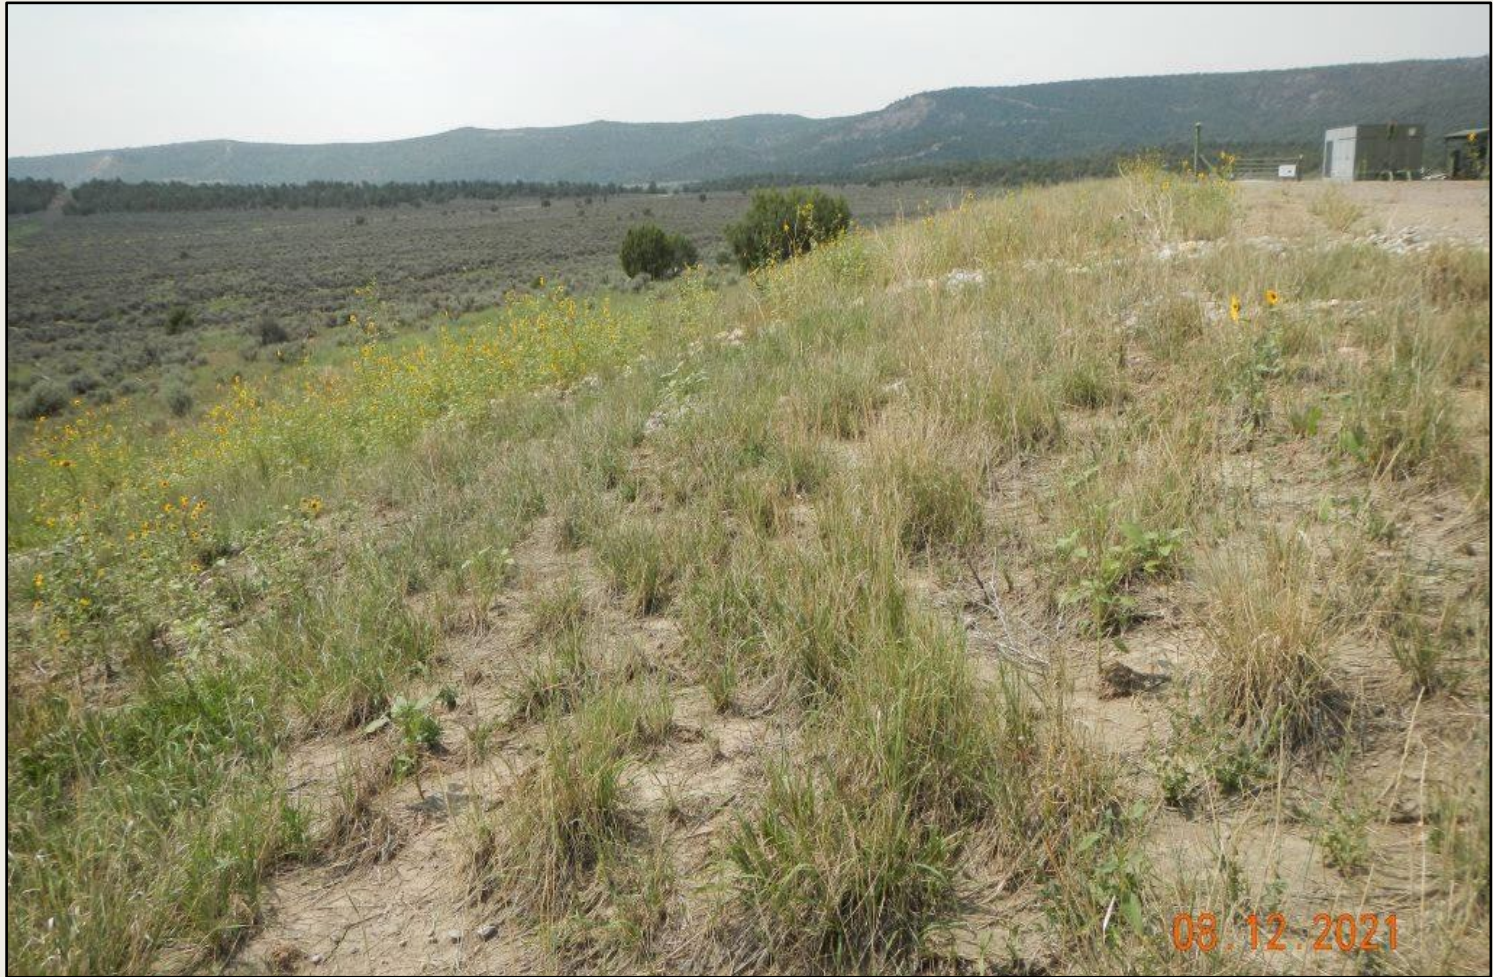
Photo 2. View of the eastern project area from the northeastern corner facing southward.

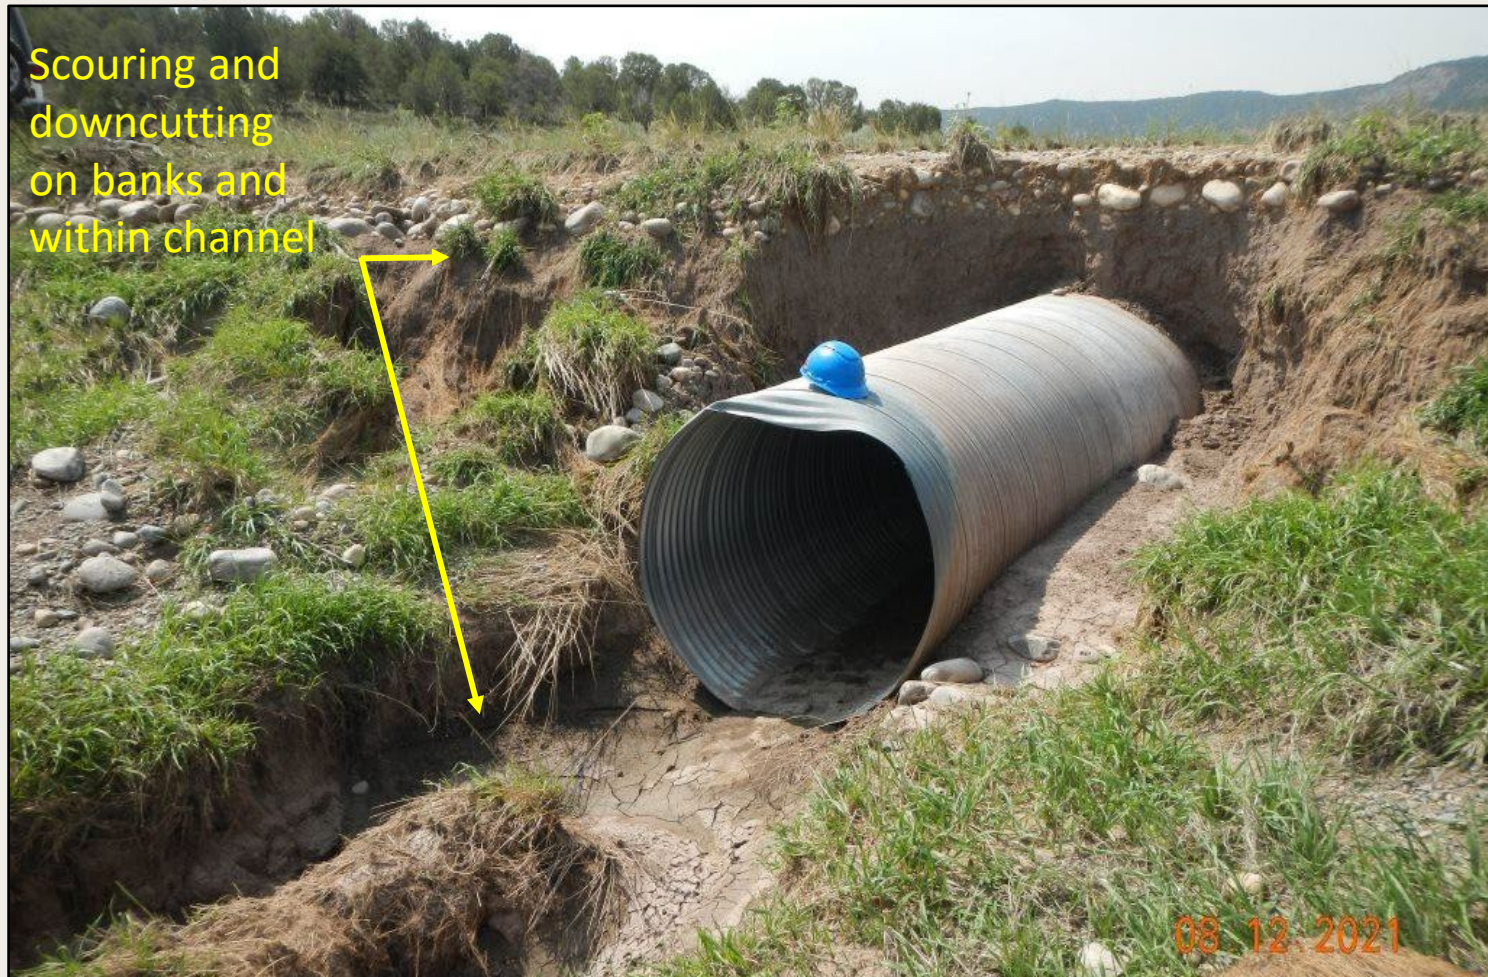
Photo 3. View of erosion occurring at culvert outlet along access road, indicating that this culvert is not adequate to support flows in this drainage. An area approximately 3ft x 8ft volume of material is eroded around the culvert, as well as scouring and transport of road materials.

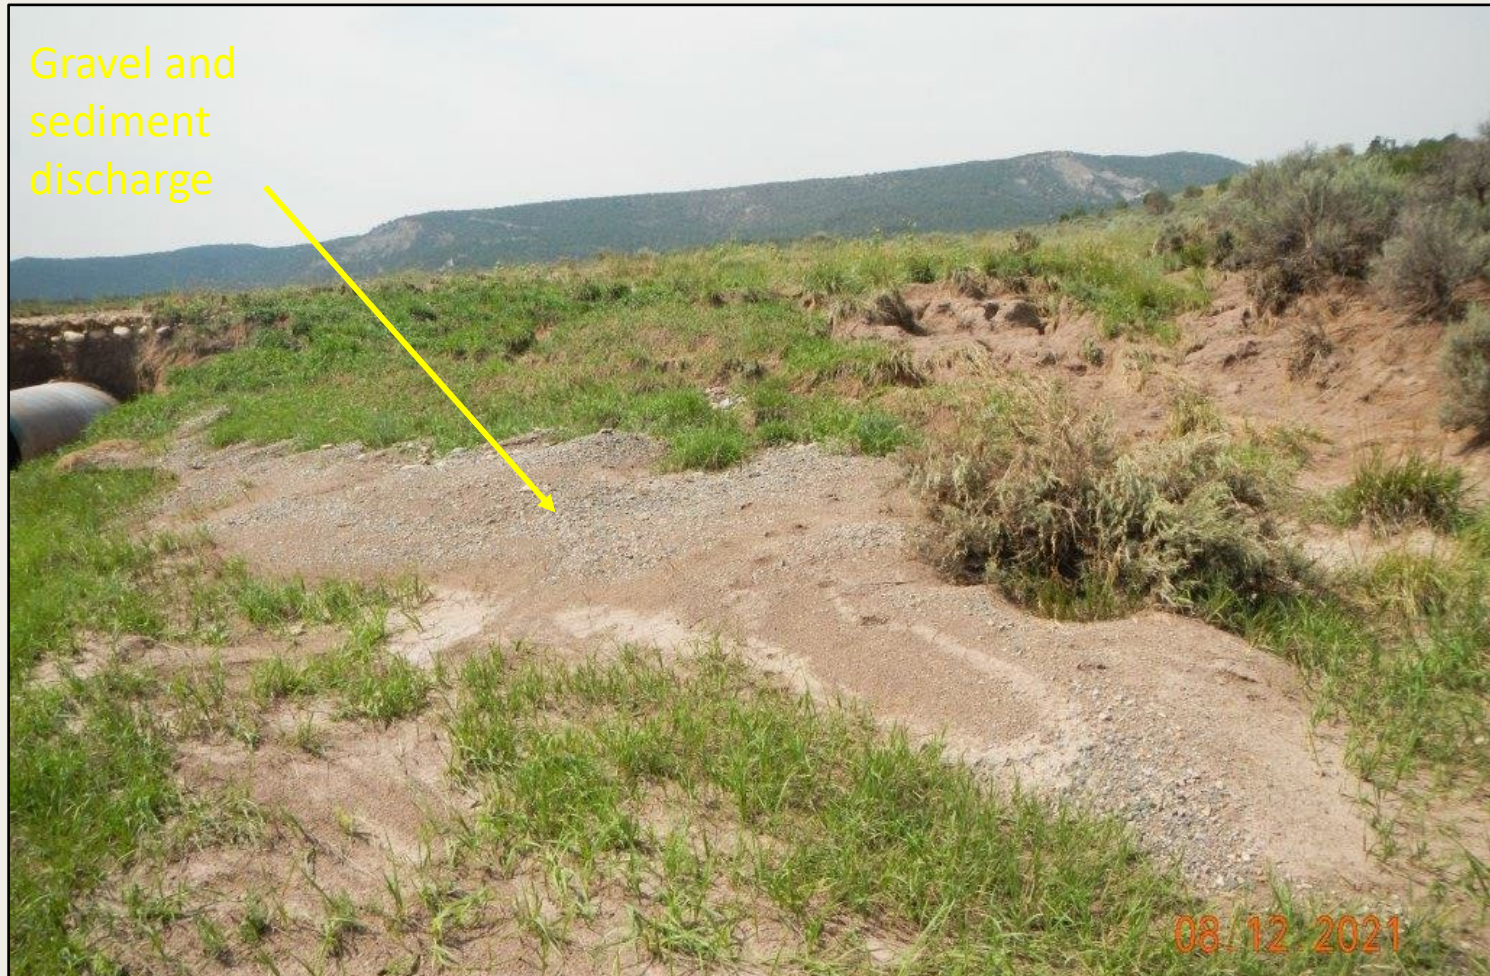
Photo 4. View of gravel, road, material and scoured soils downstream from area where stormwater event flowed over the access road. Sediment discharge in this area is approximately 25 feet long and 4 feet wide, depth unknown.

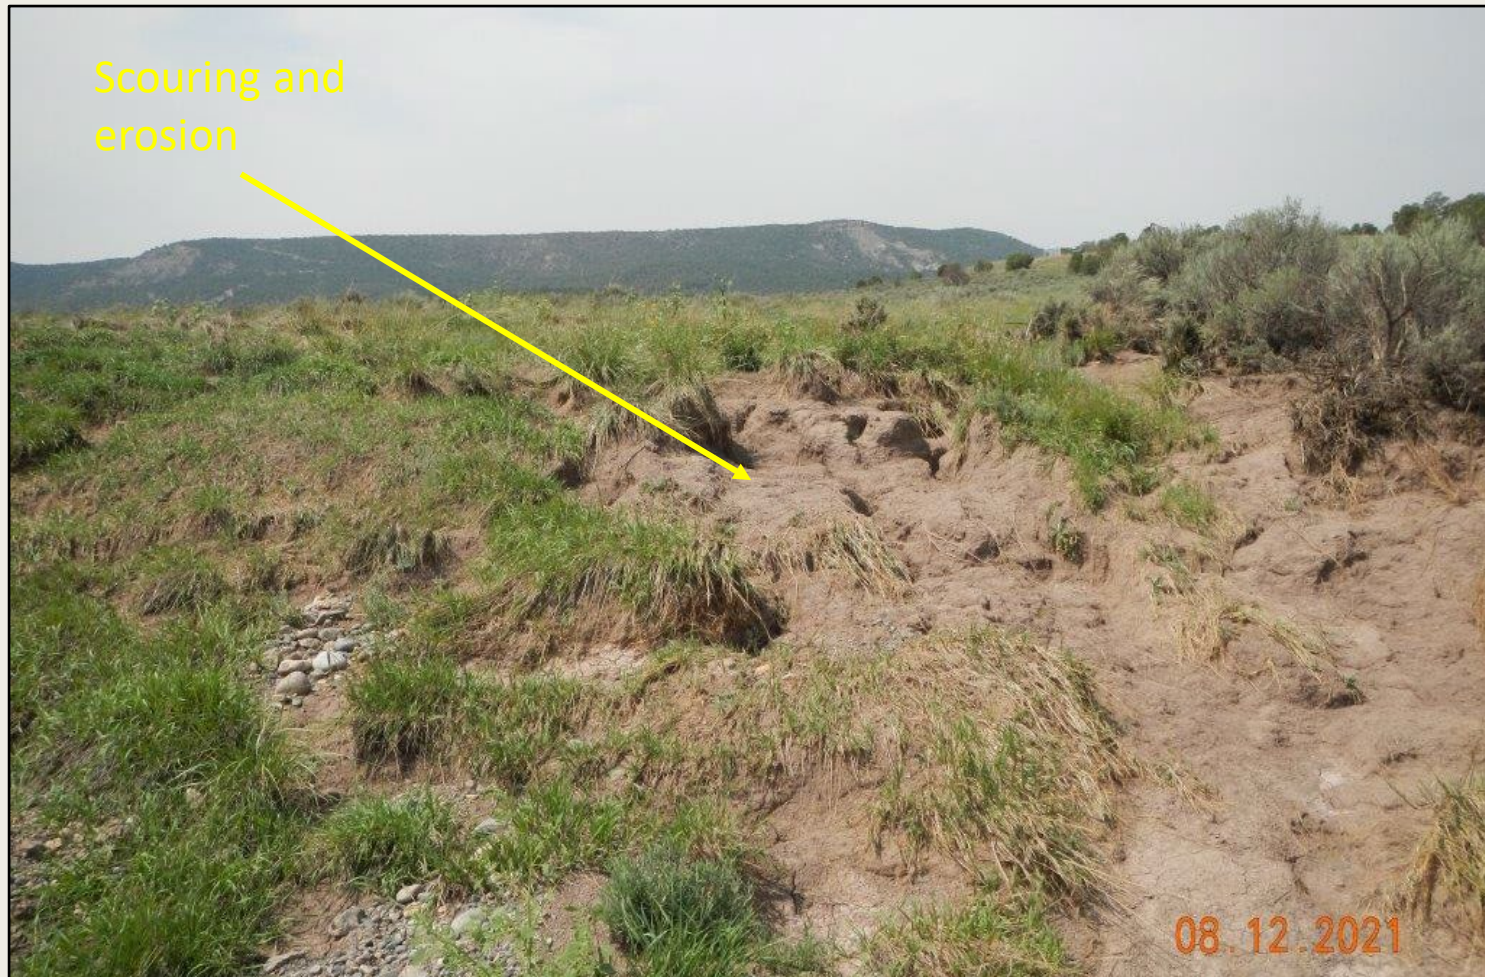
Photo 5. View of scouring and erosion on soils down-slope from the access road.

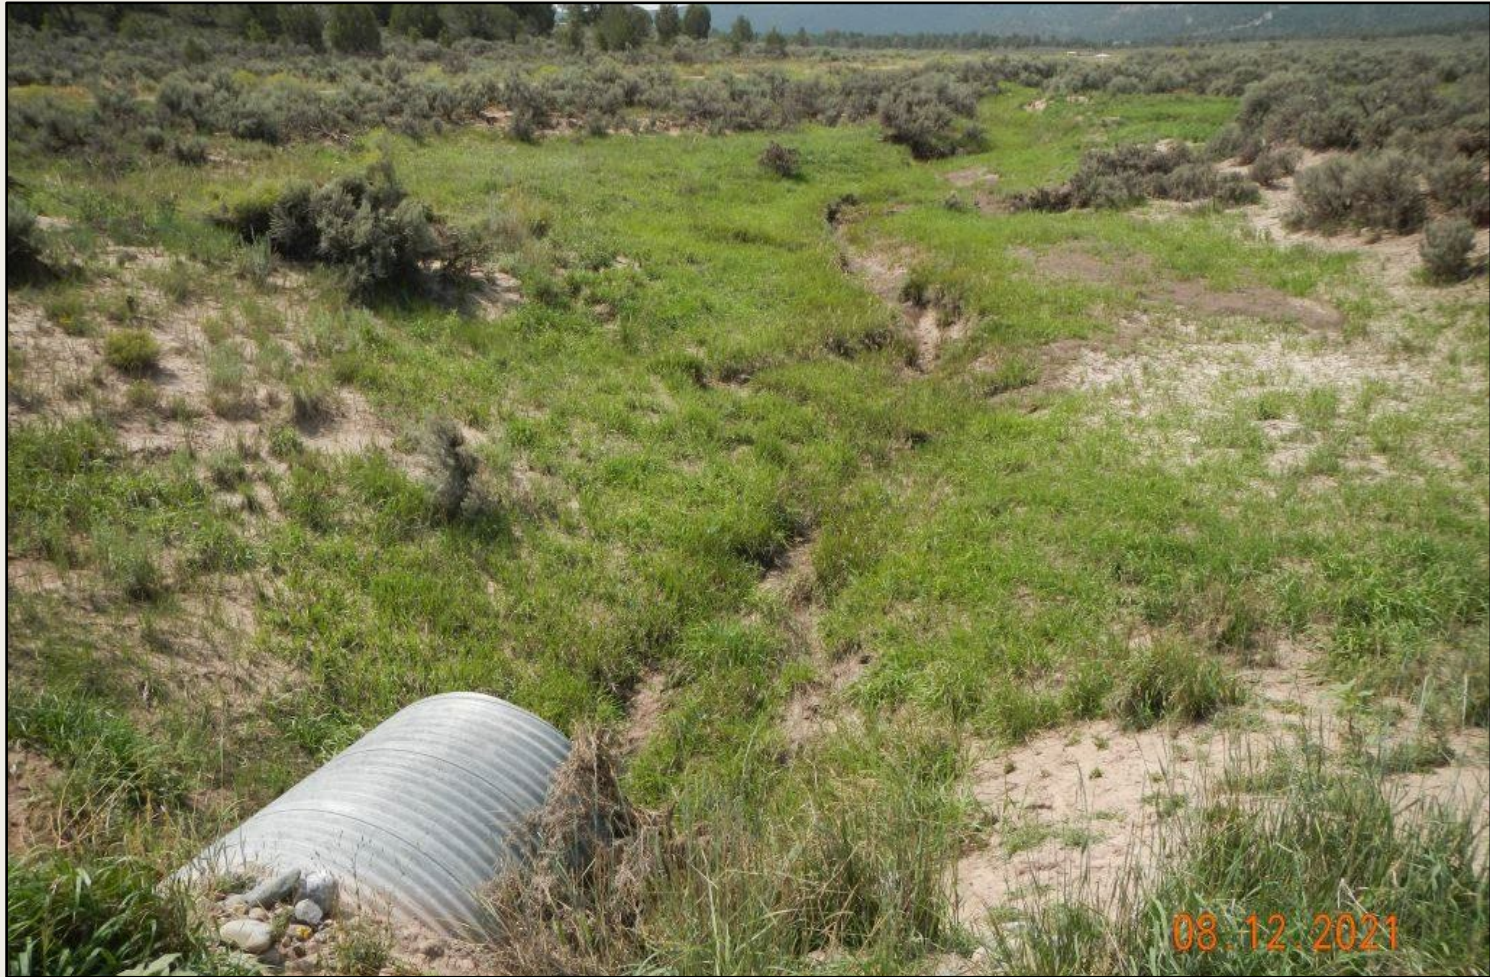
Photo 6. View of culvert inlet on upstream side of access crossing. Significant erosion is not observed upstream from access road crossing.

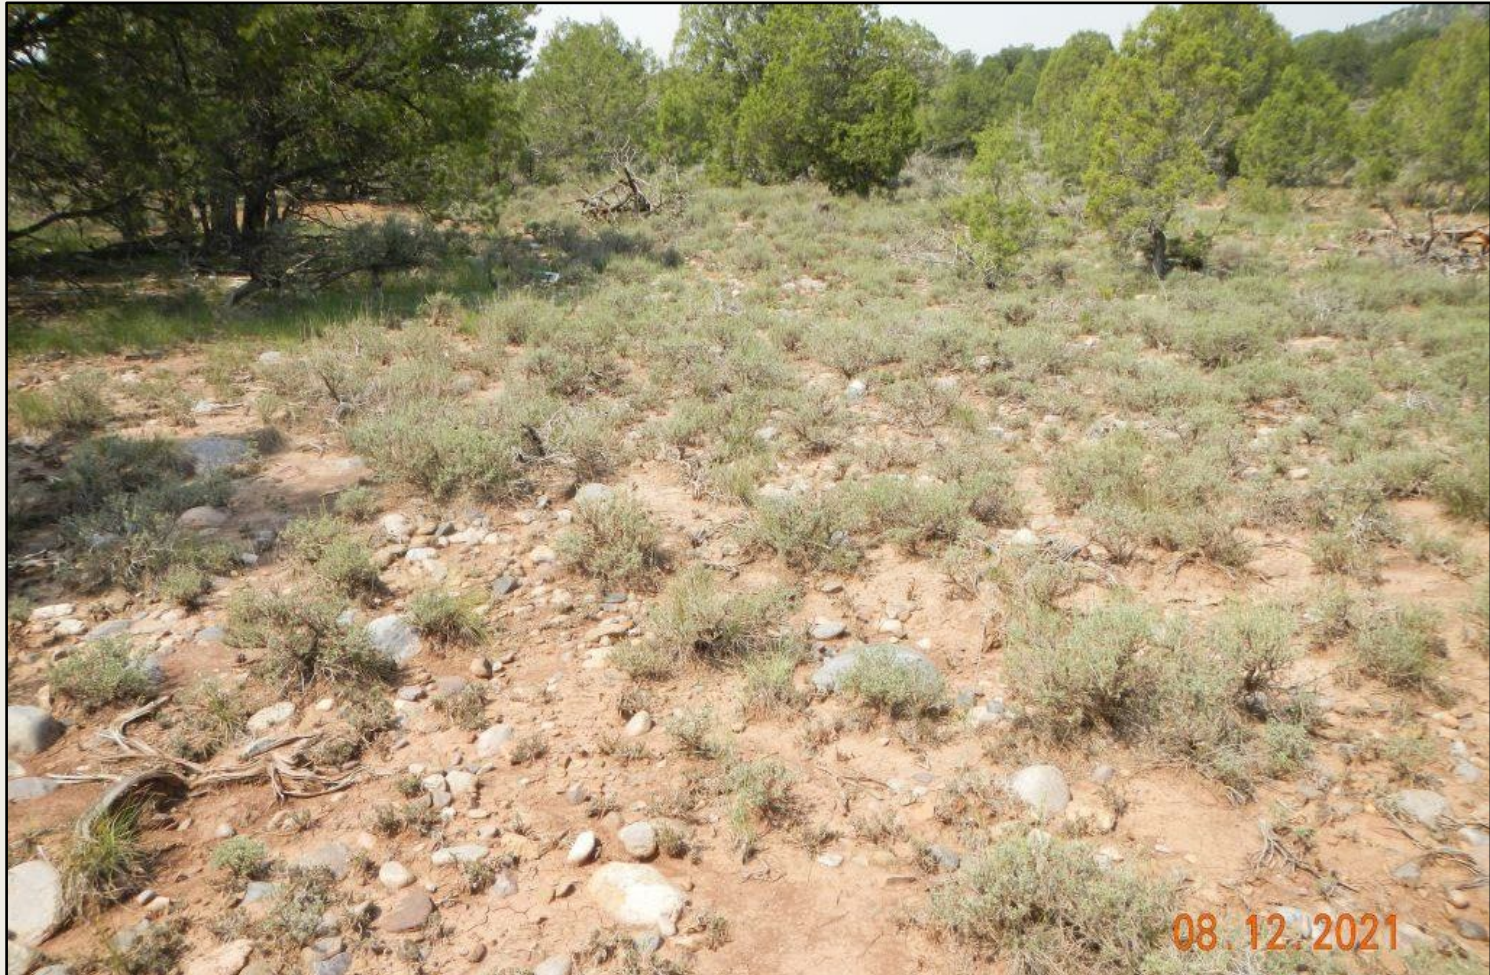
Photo 7. View of the reference area comprised of pinyon and juniper woodland with black sage, prickly pear, penstemon, squirreltail, and James galleta.
