Inspection Photos
Operator: Simcoe
API: 067-05796
Date: 8/12/2021

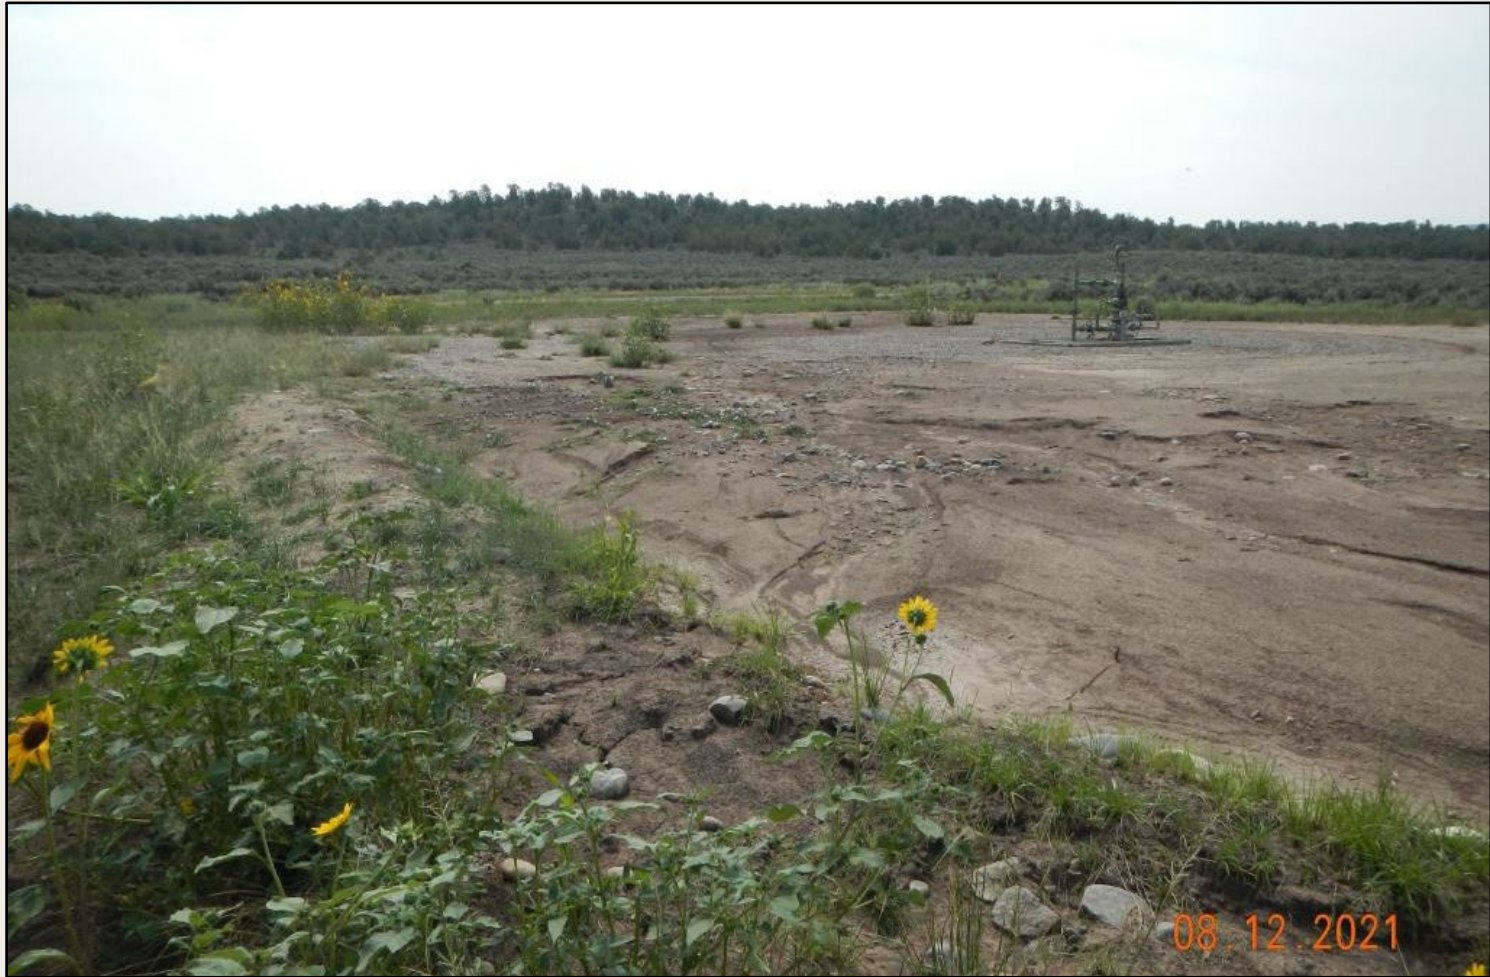
Photo 1. View of the southern portion of the working area from the western edge facing center. Stormwater flows over the well pad largely appear contained by a silt trap along the western edge. Monitoring and maintenance will be needed to maintain site stabilization due to site layout.

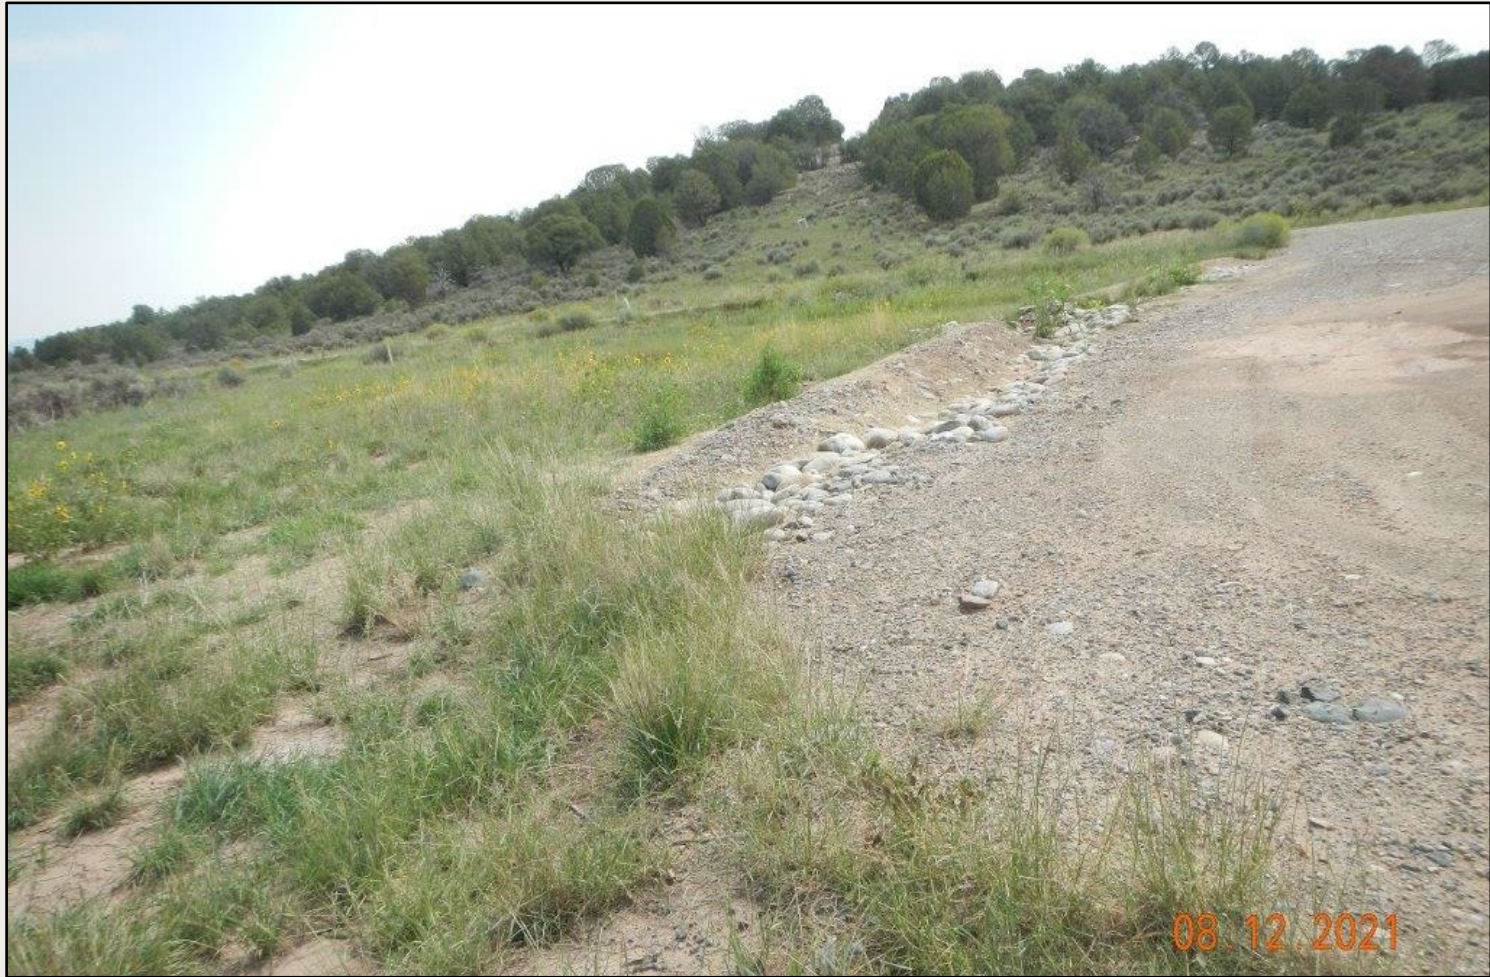
Photo 2. View of the northern project area from the northwestern corner facing eastward. Reinforced berms and silt trap are installed.

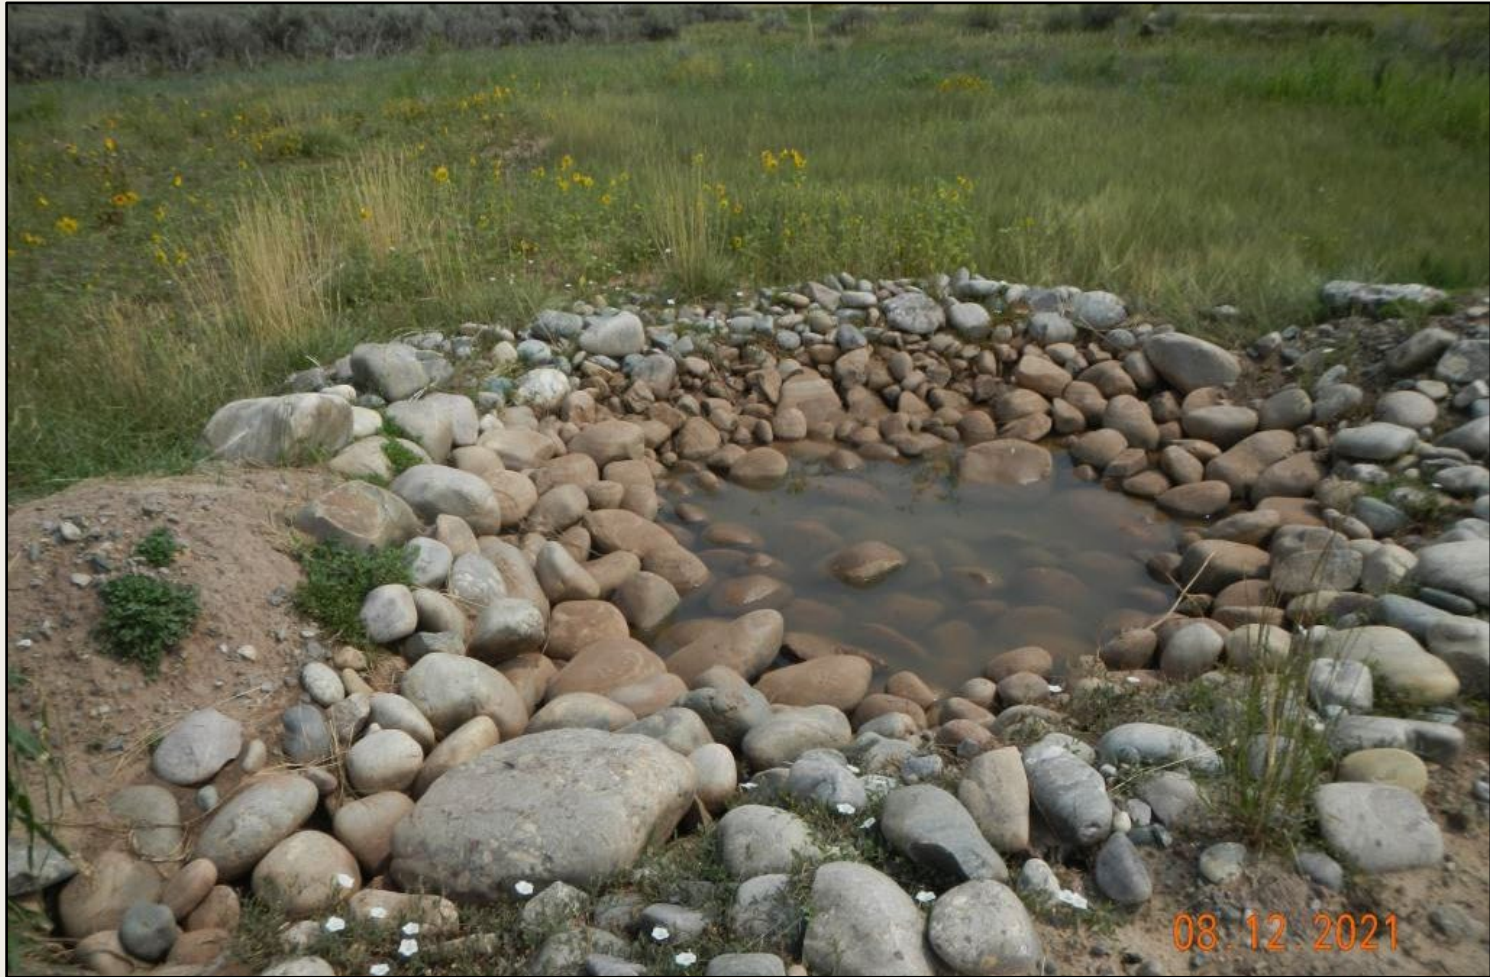
Photo 3. View of silt trap observed within the northern project area.

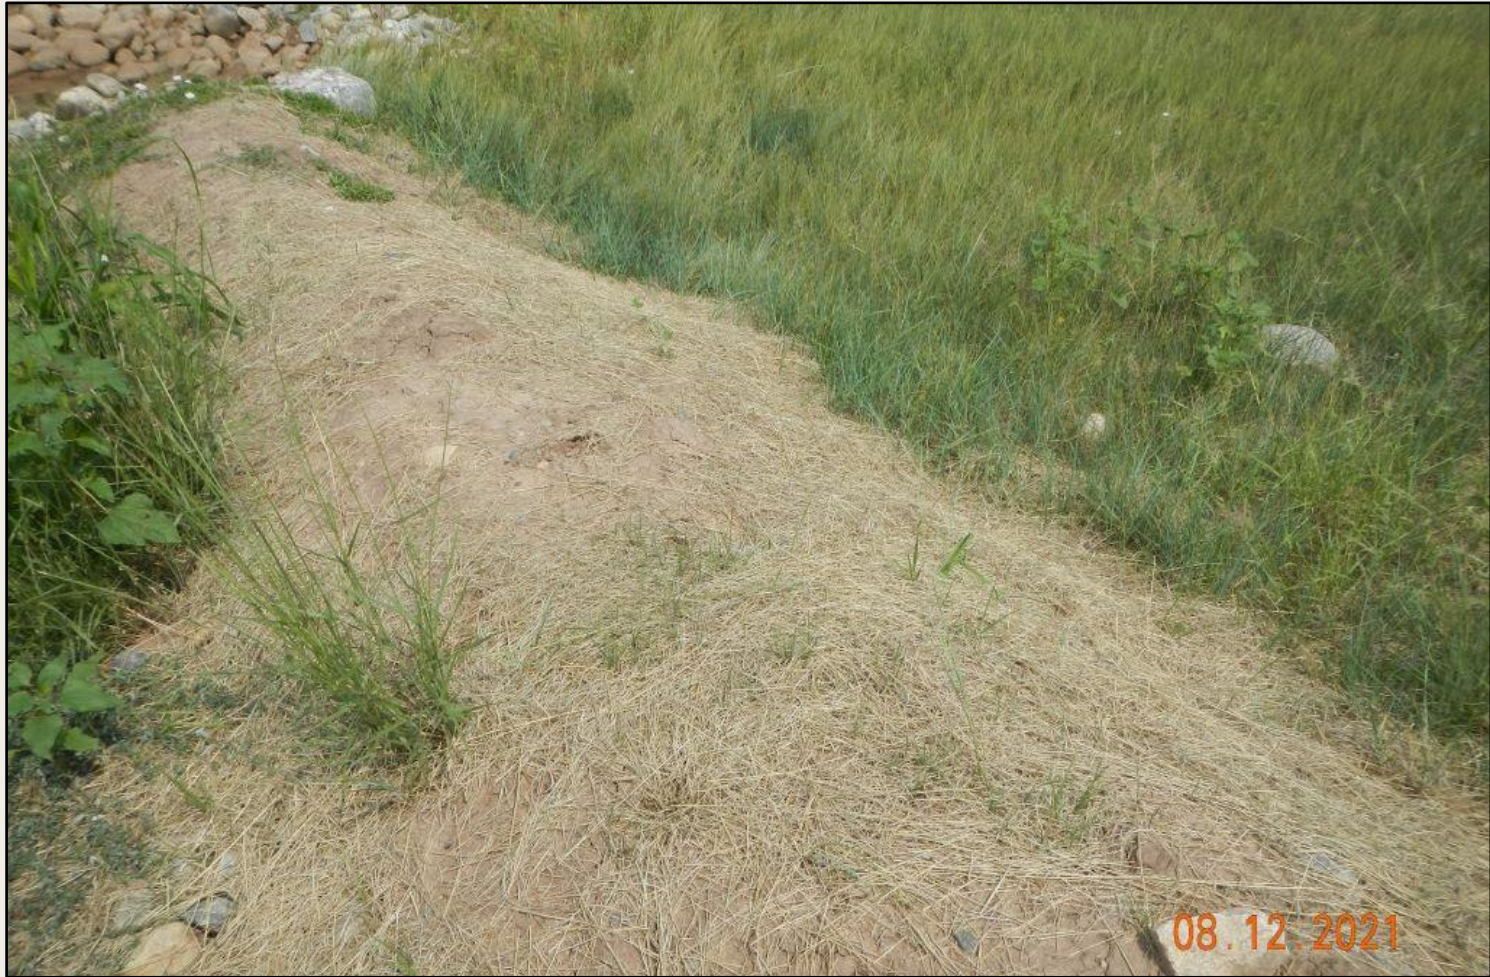
Photo 4. View of hay mulch on berm and germination observed.

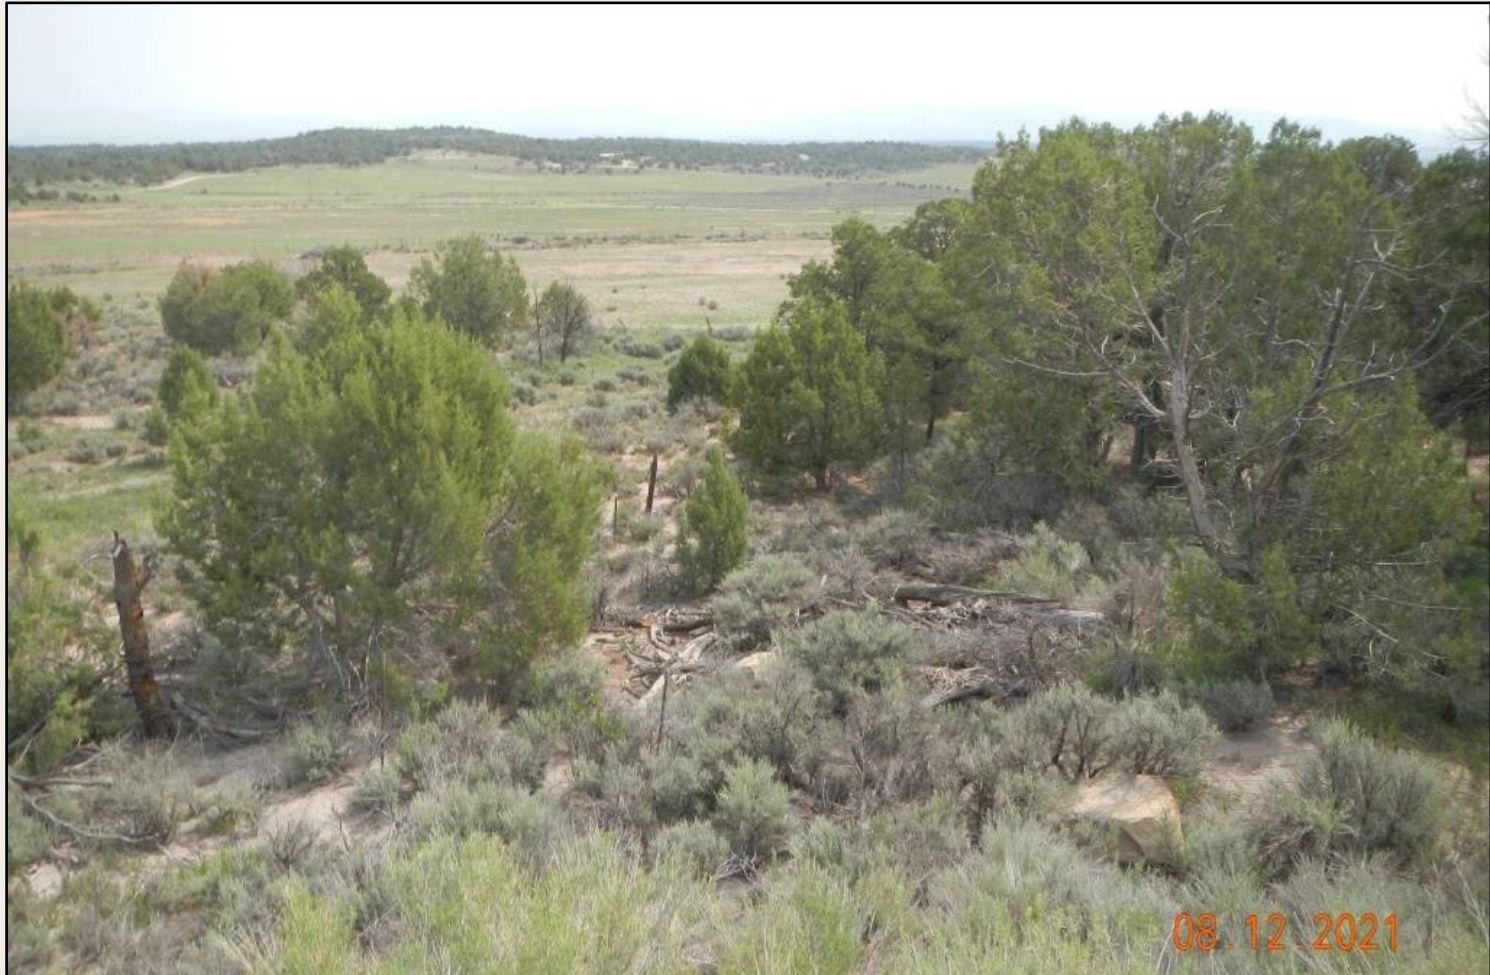
Photo 5. View of the reference area comprised sagebrush shrubland with James galleta, squirreltail, penstemon, and snakeweed.
