Inspection Photos

Operator: Hilcorp Energy
API: 067-06664
Date: 8/17/2021

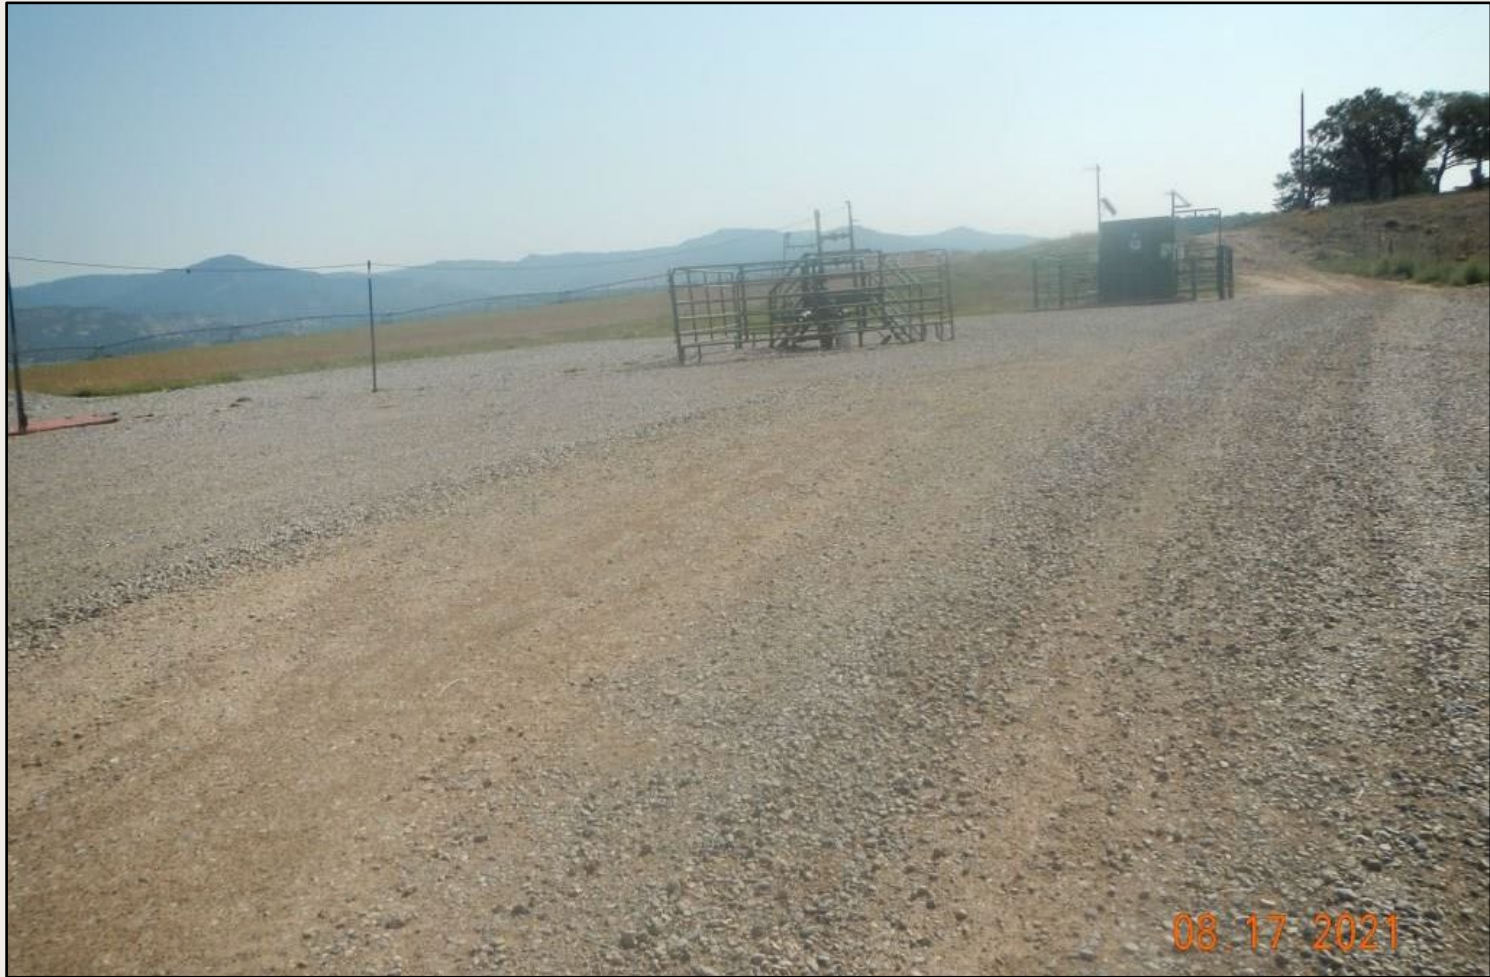
Photo 1. View of the project area from the well pad entrance facing center.

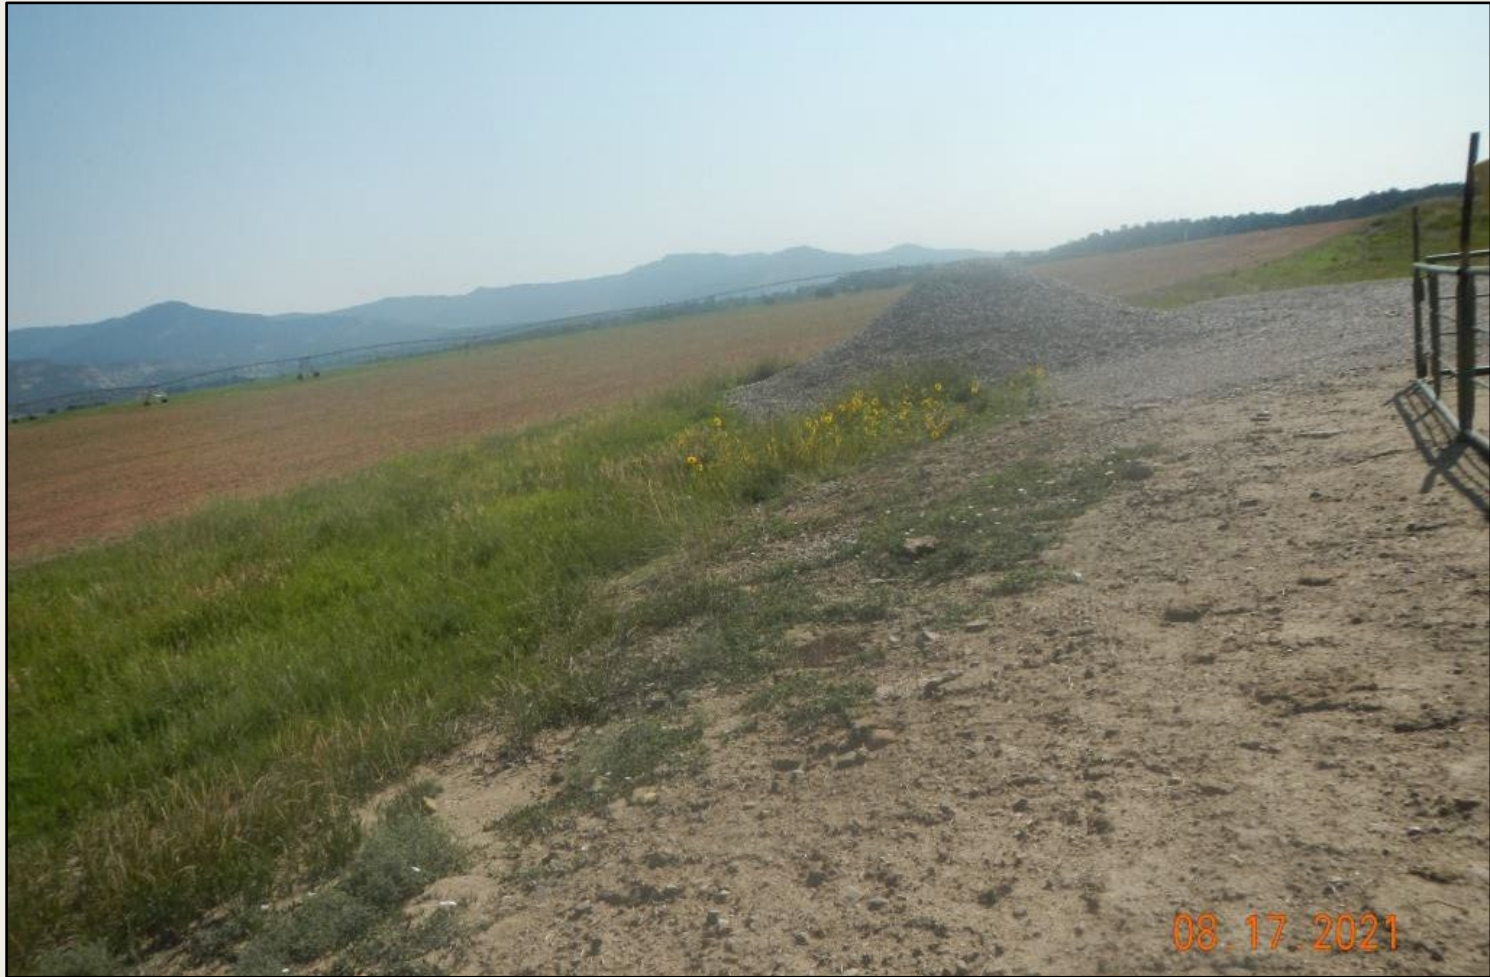
Photo 2. View of the northern project area facing eastward. Vegetation is progressing within the interim reclamation areas, with irrigated grasses such as smooth brome.

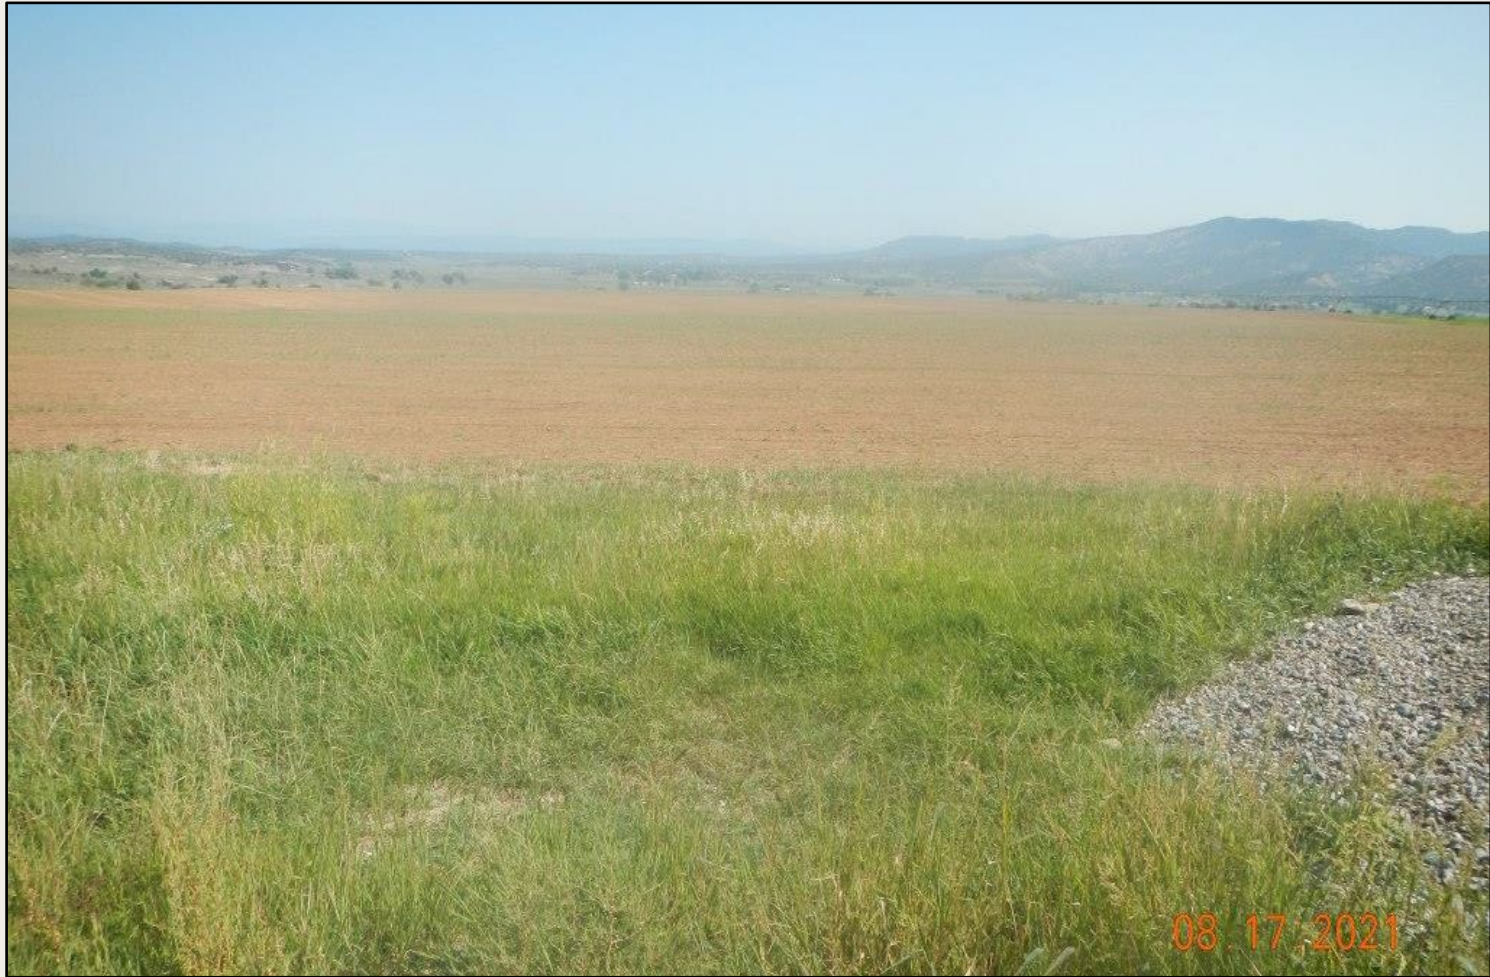
Photo 3. View of the eastern project area facing southward. Reference area in background is comprised of irrigated crop grasses.
