Inspection Photos
Operator: Merrion
API: 067-09209
Date: 8/17/2021

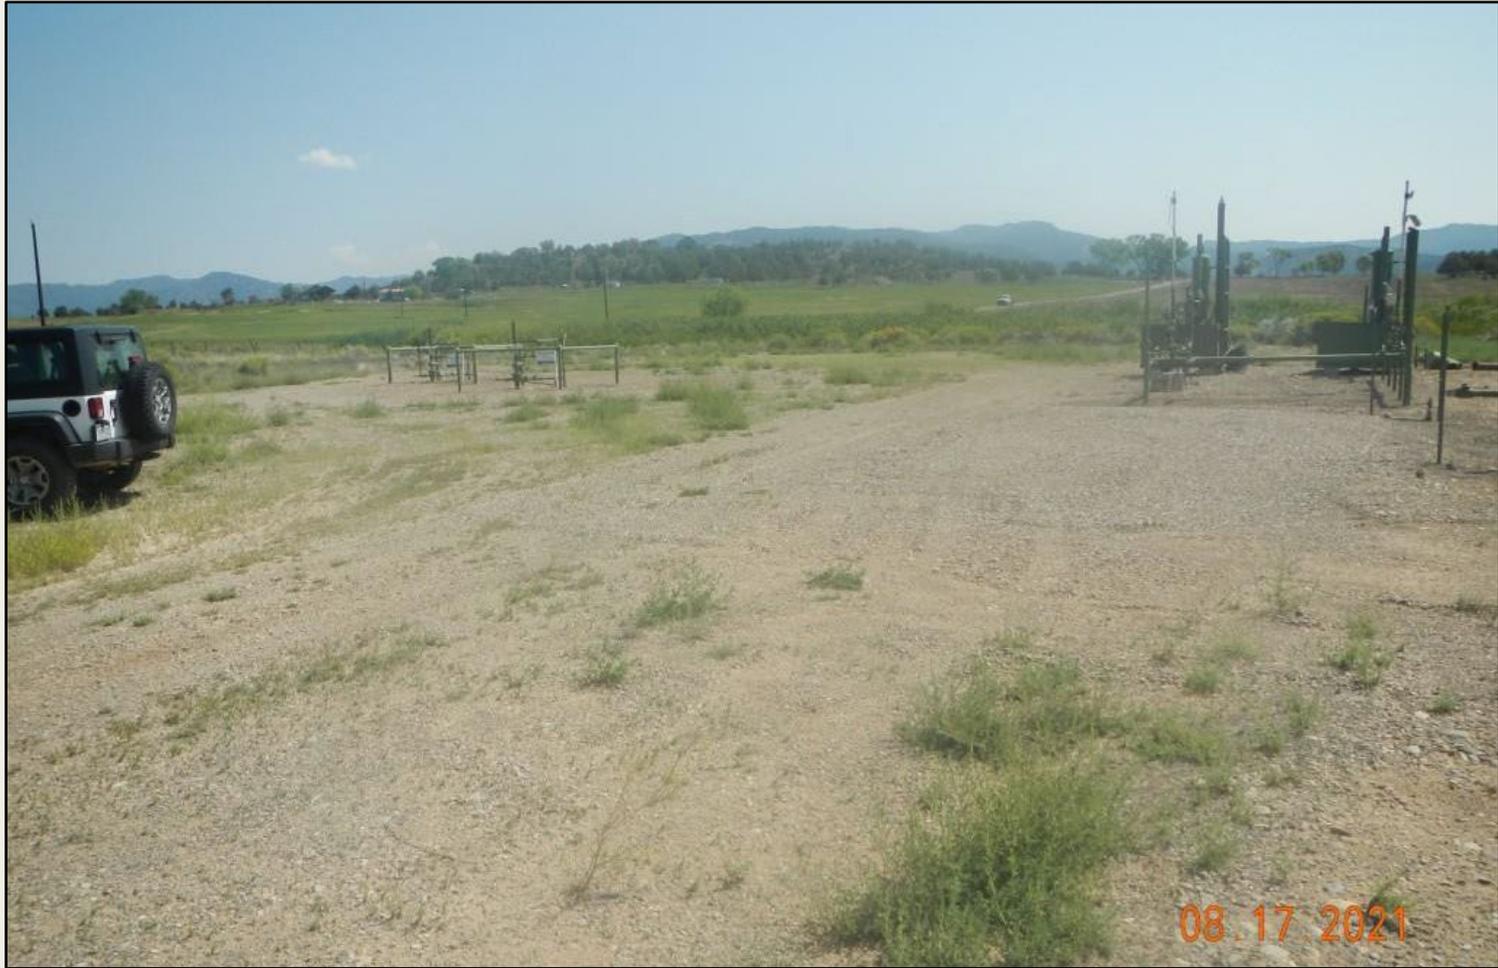
Photo 1. View of the project area from the well pad entrance facing center.

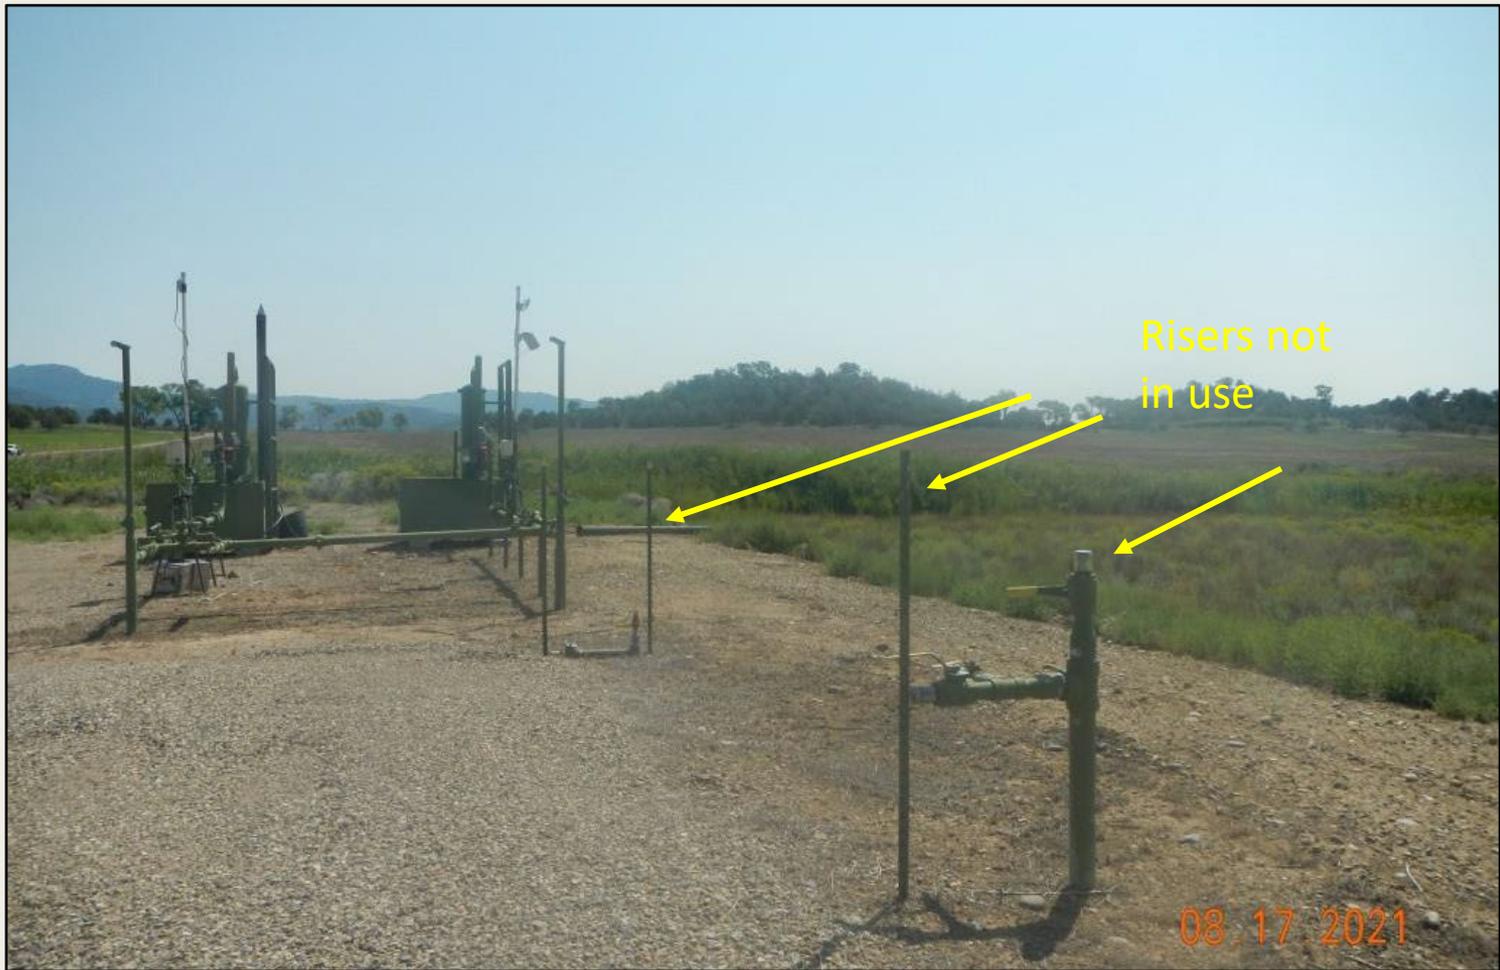
Photo 2. View of risers and unused equipment within the project area.

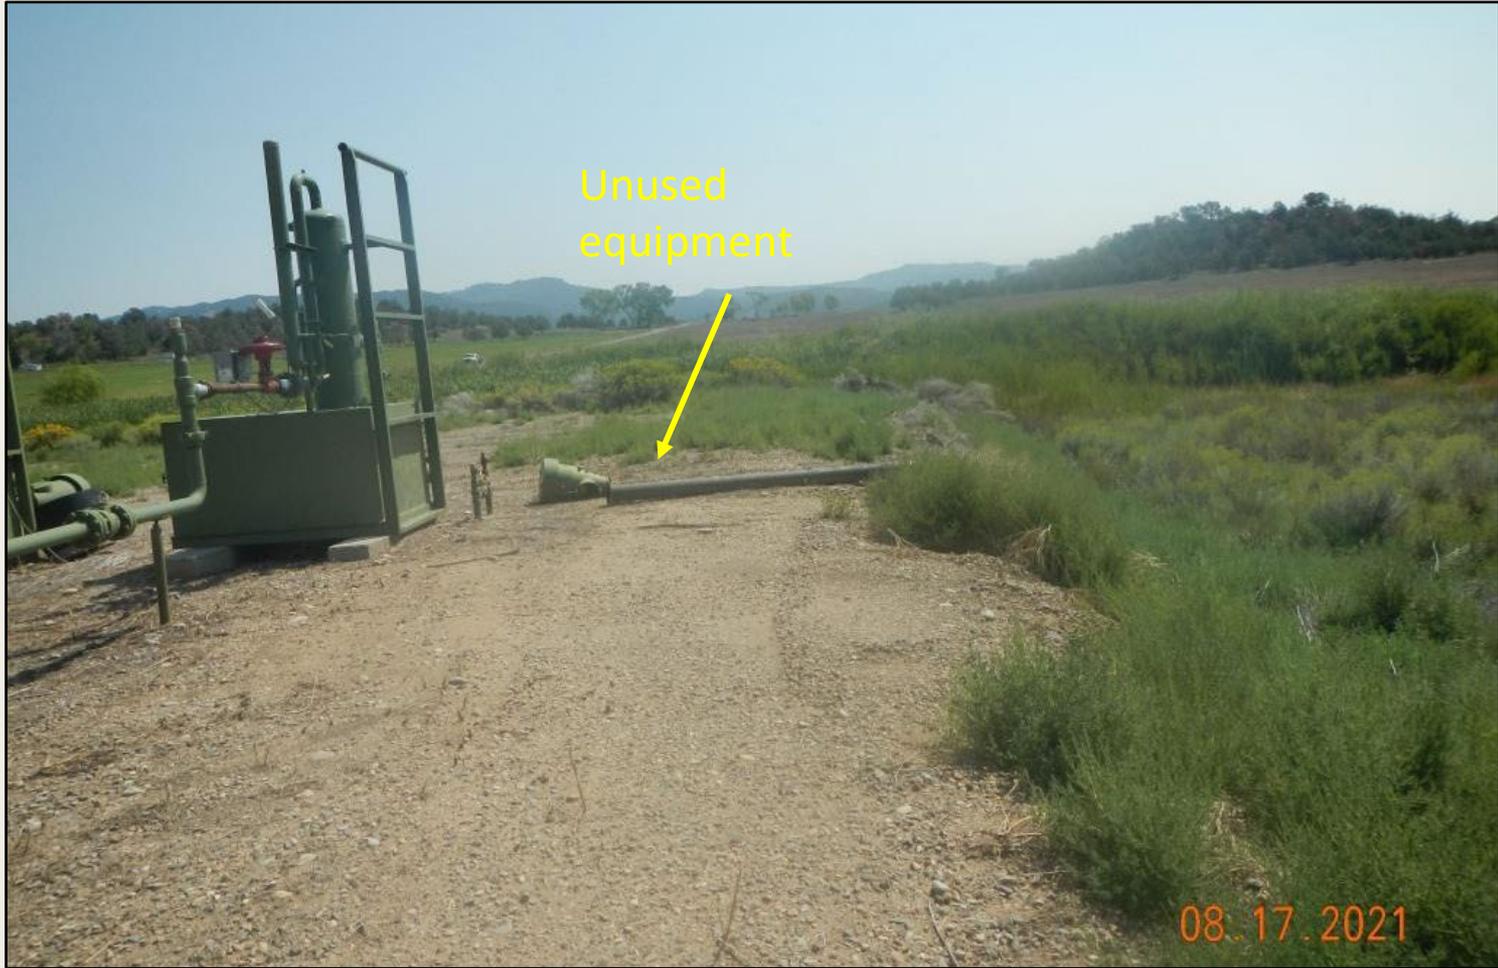
Photo 3. View of the southern project area facing eastward. Revgetation is progressing on fill slopes, largely with rubber rabbitbrush. Kochia weeds need to be managed to prevent debris. Unused equipment also present here.

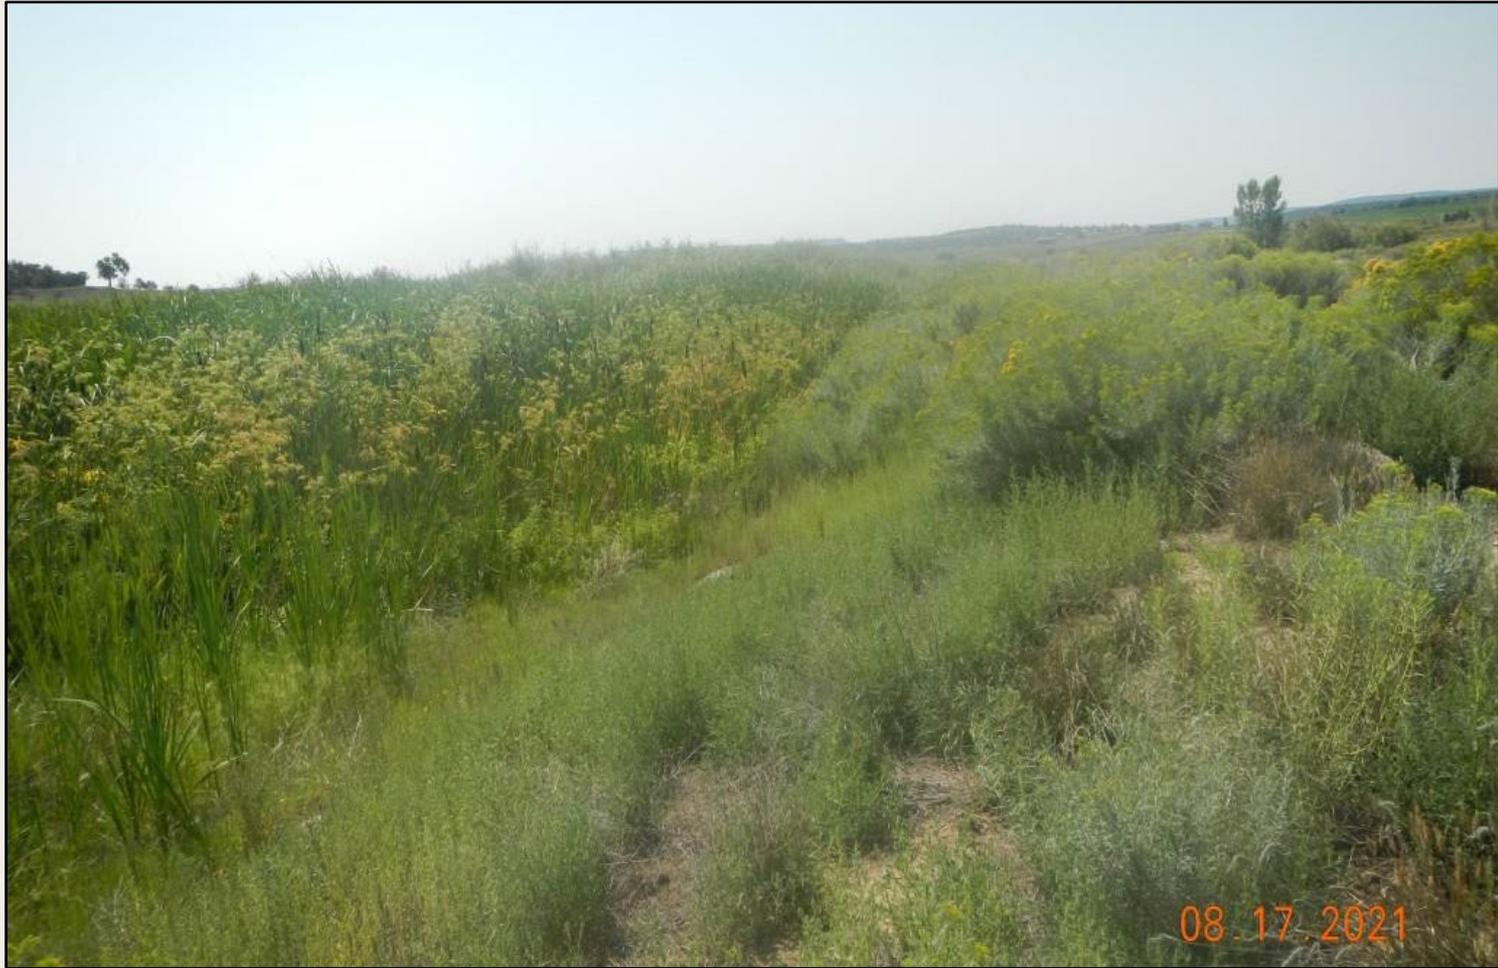
Photo 4. View of the eastern project area facing southward.

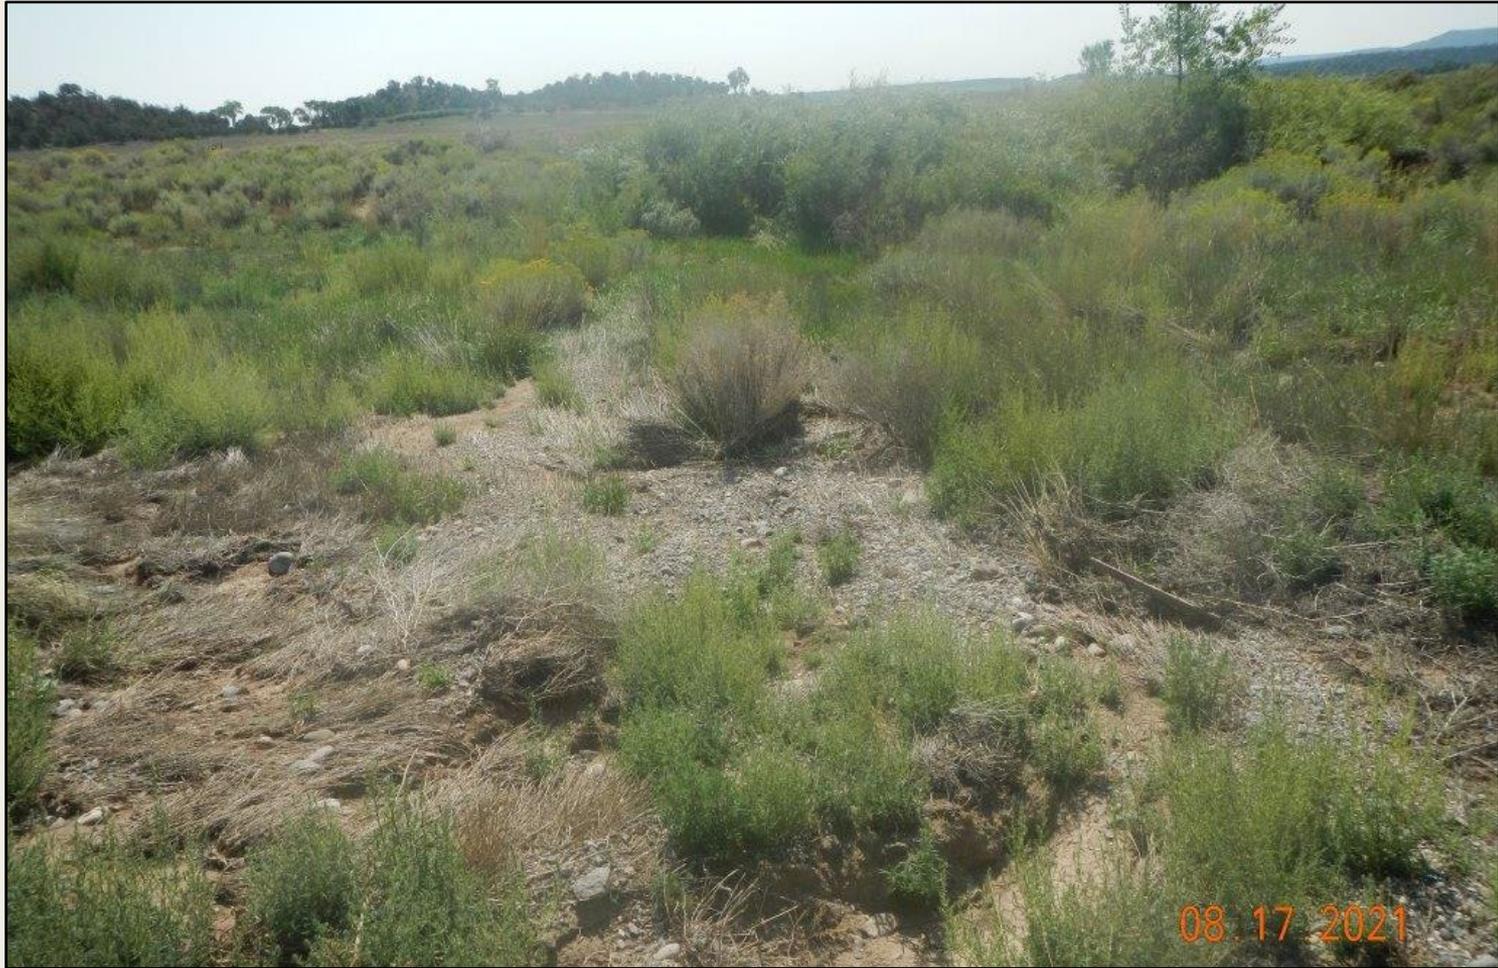
Photo 5. View of gravel and sediment discharged from overflow of stormwater downstream from the access road (area approx. 15ft wide x 25ft long)

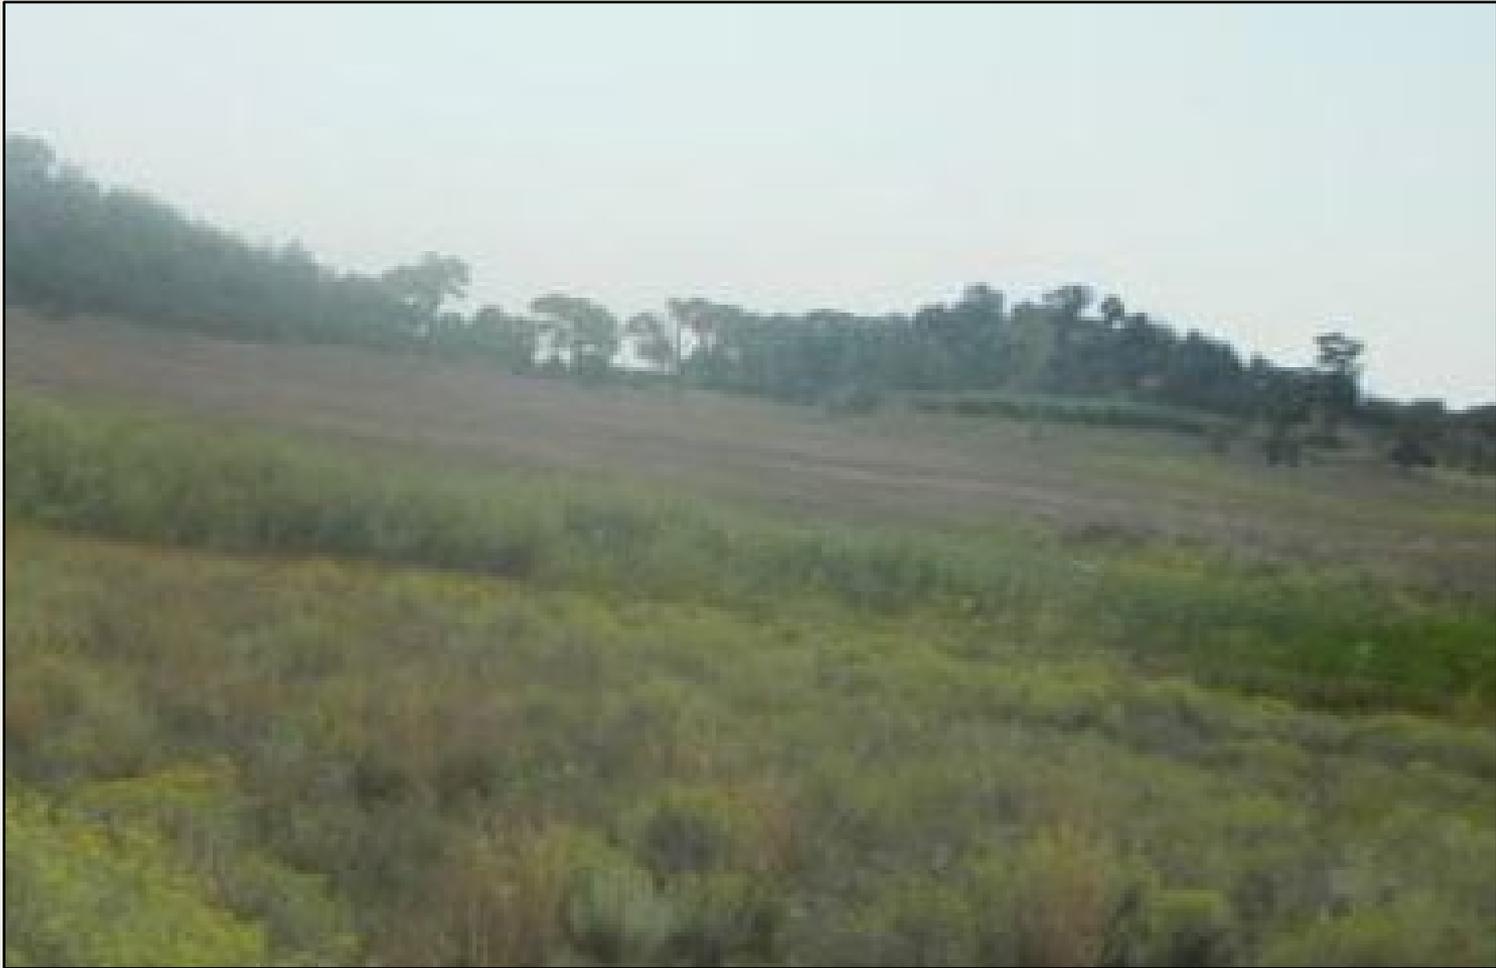
Photo 6. View of the reference area comprised of a mosaic of wetland (cattails and rushes), as well as greasewood, sagebrush, and rabbitbrush shrubland.
