Inspection Photos

081-06189

Spill 480526

Inspection Date: 8/26/2021

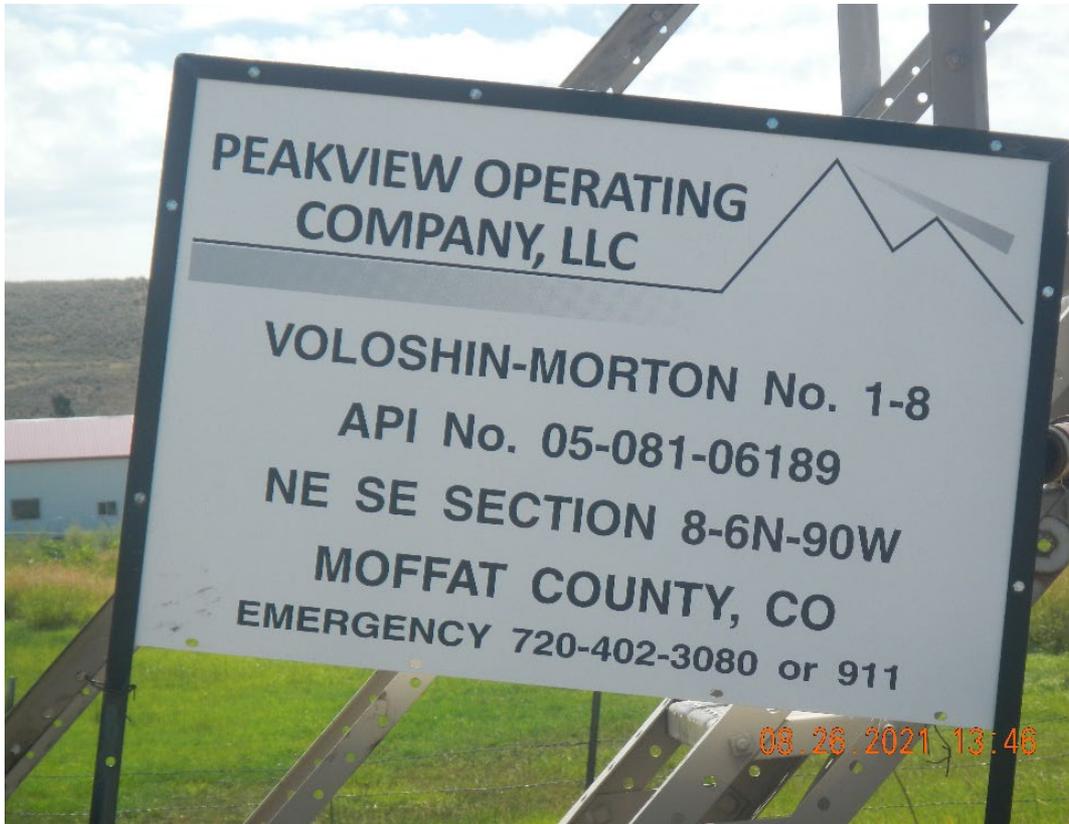
Photo #1 sign at tank battery

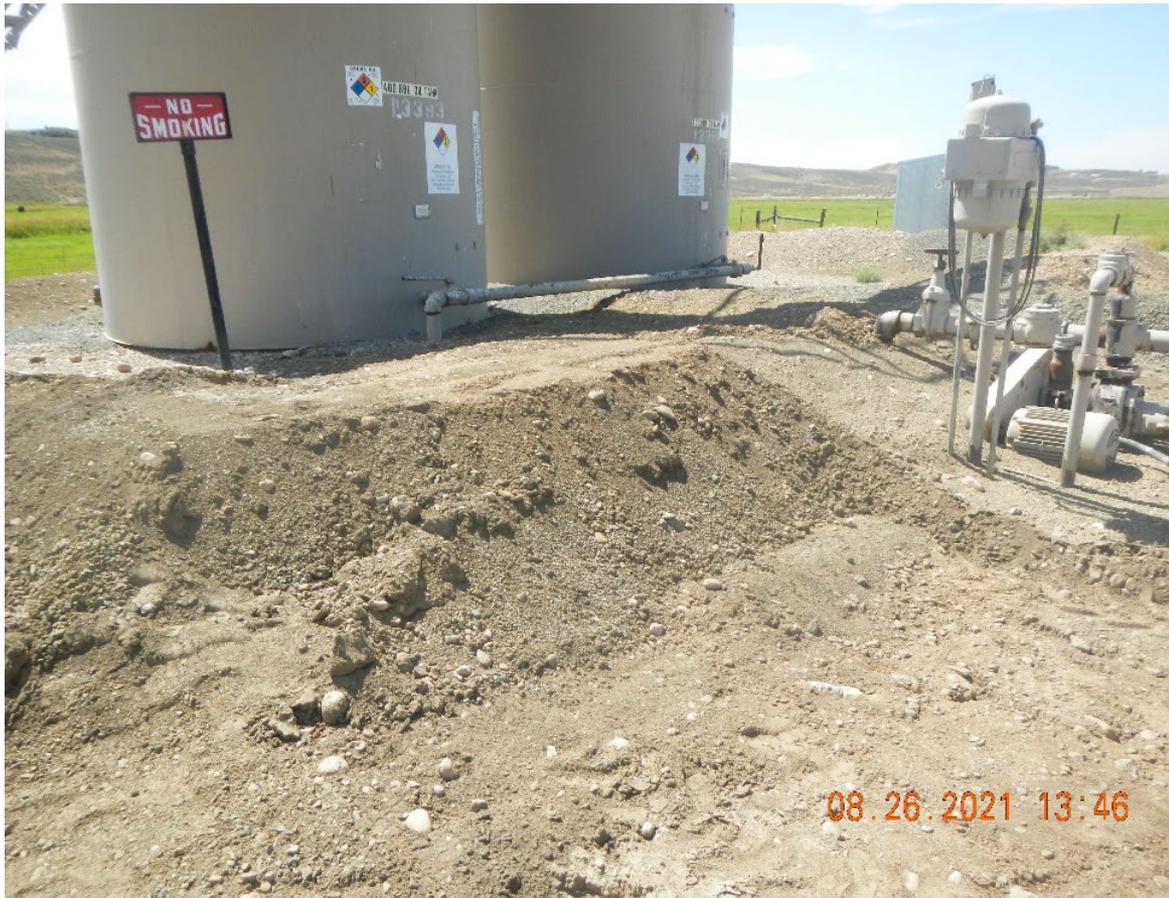
Photo #2 Tank Battery, dirt berm. The operator should assure that the volume of secondary containment is adequate.

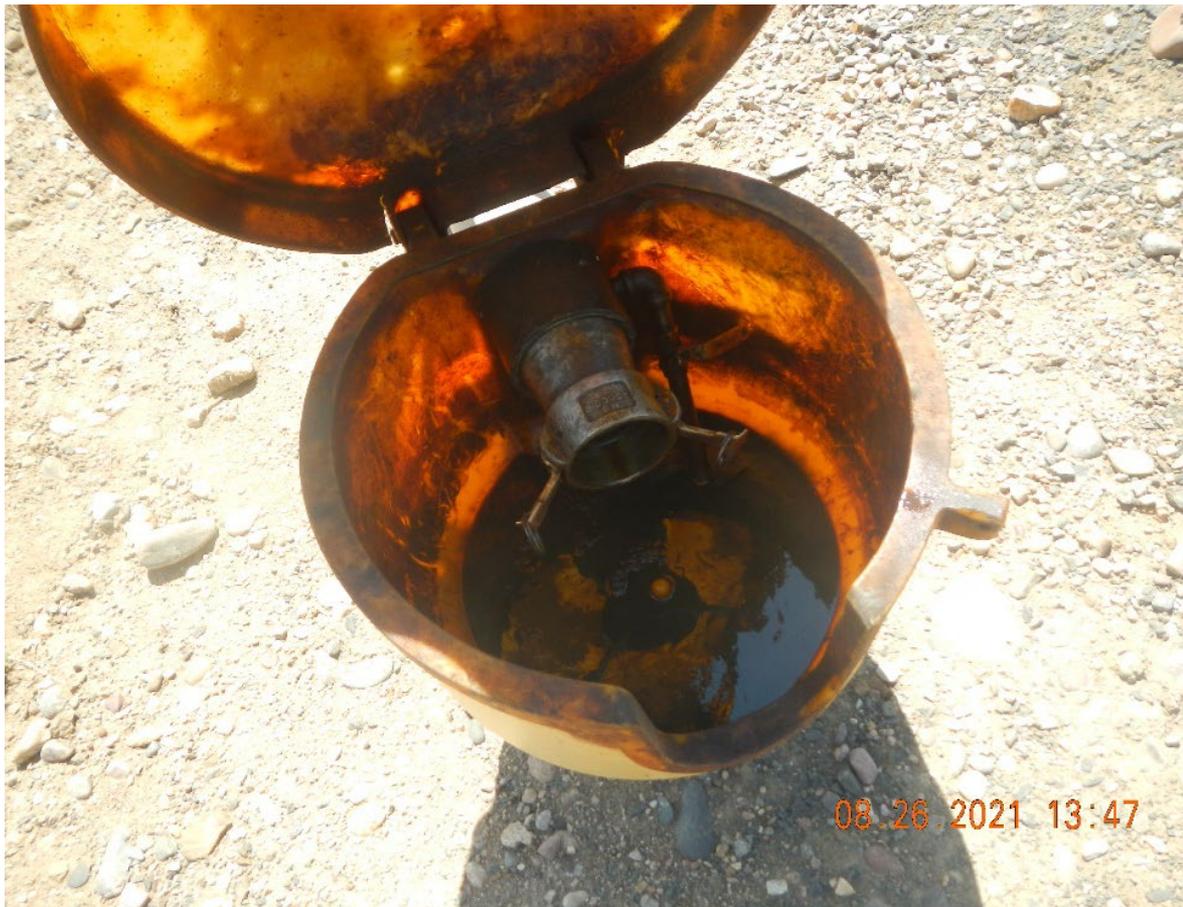
Photo #3 drip pot at tank battery

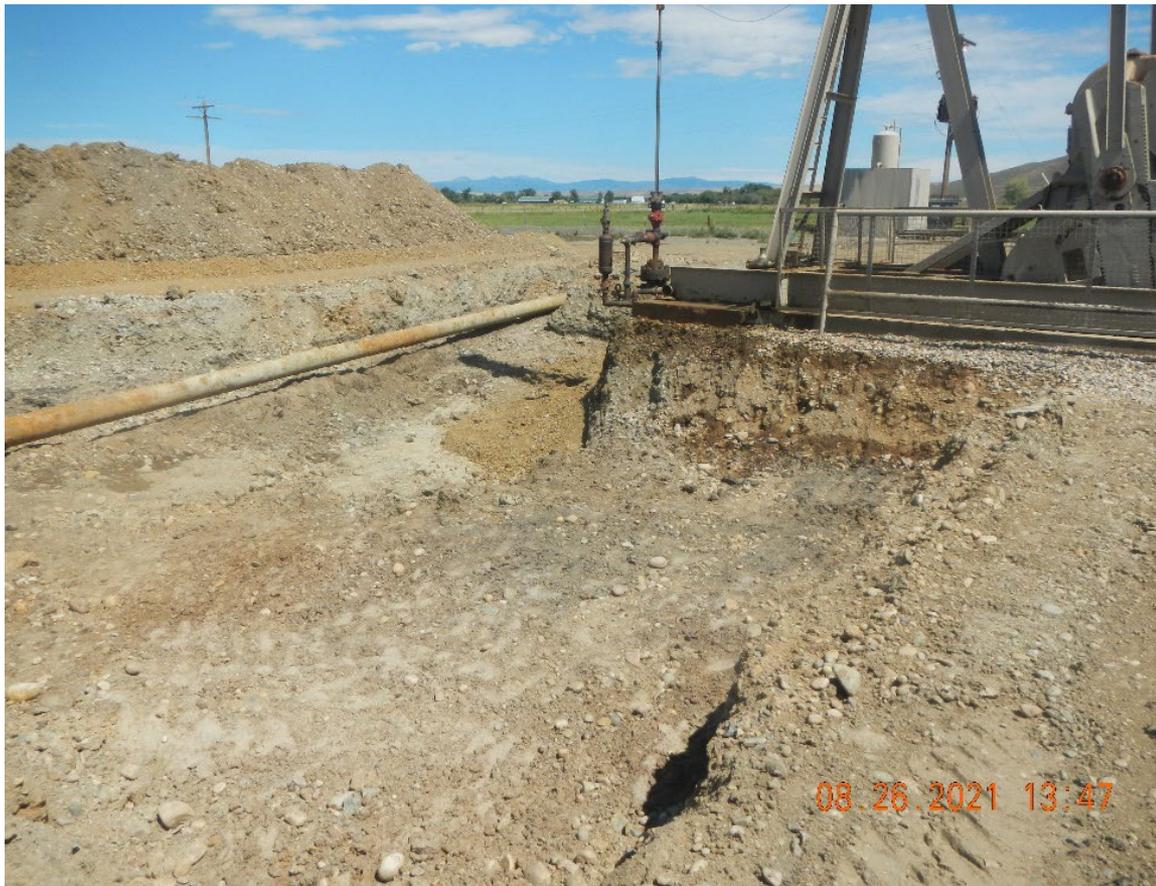
Photo #4 looking northeast. Excavation. This Line, large pipe to left of photo is used to transfer irrigation water to the other side of the pad.

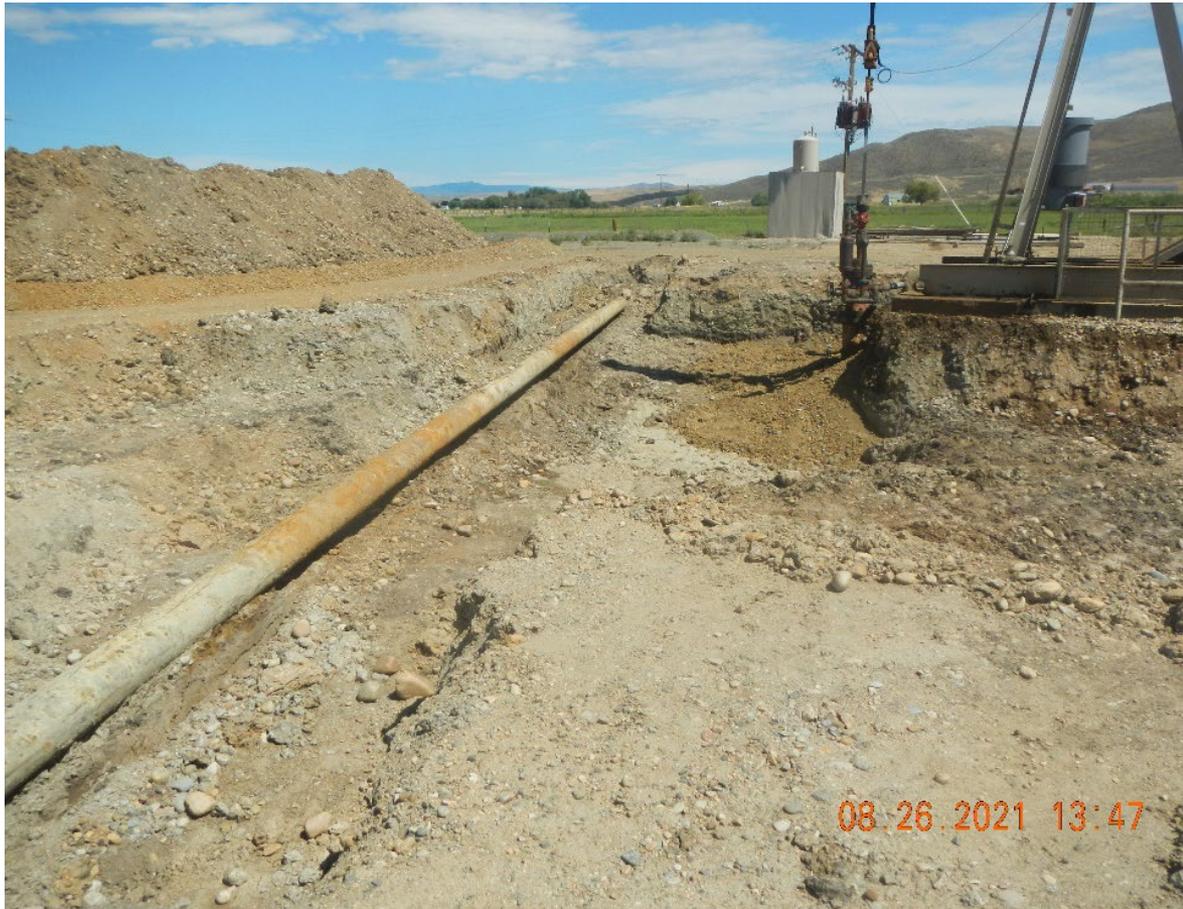
Photo #5 looking mostly east at wellhead. It appeared that contaminated soil remains below Pumpjack.

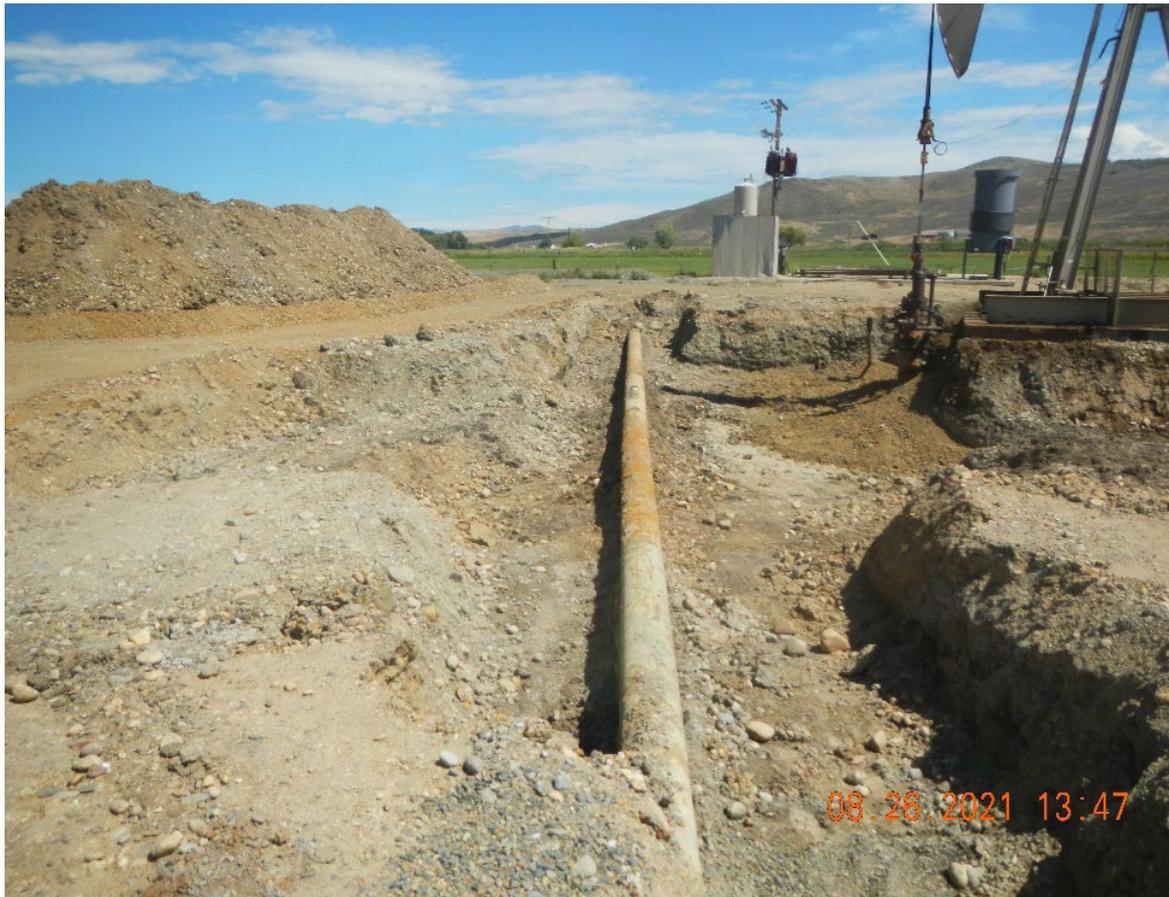
Photo #6 looking east. What is the flowline in the center of photo? The flowline is not marked on surface, contents are not known by inspector.

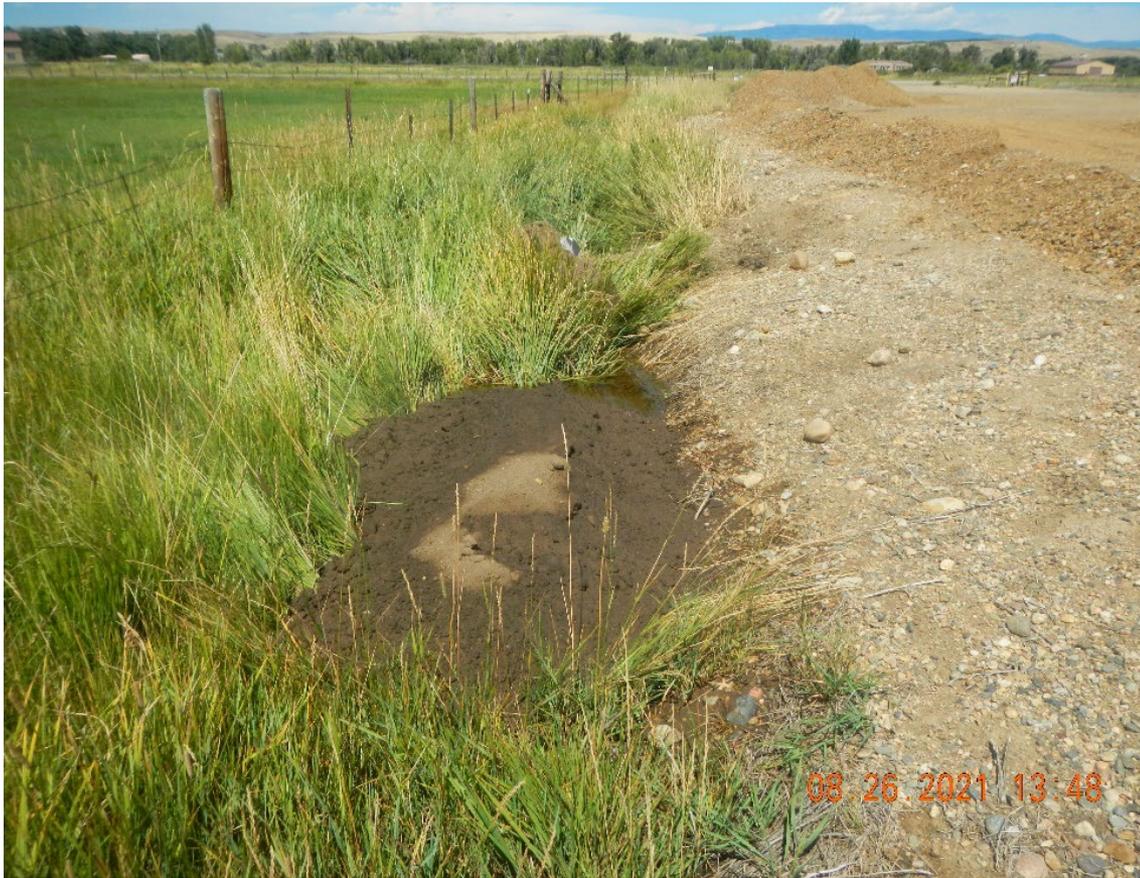
Photo #7 to right of photo is well pad, left of photo is hay field to the west of location. The soil pile appears to have been placed in irrigation water.

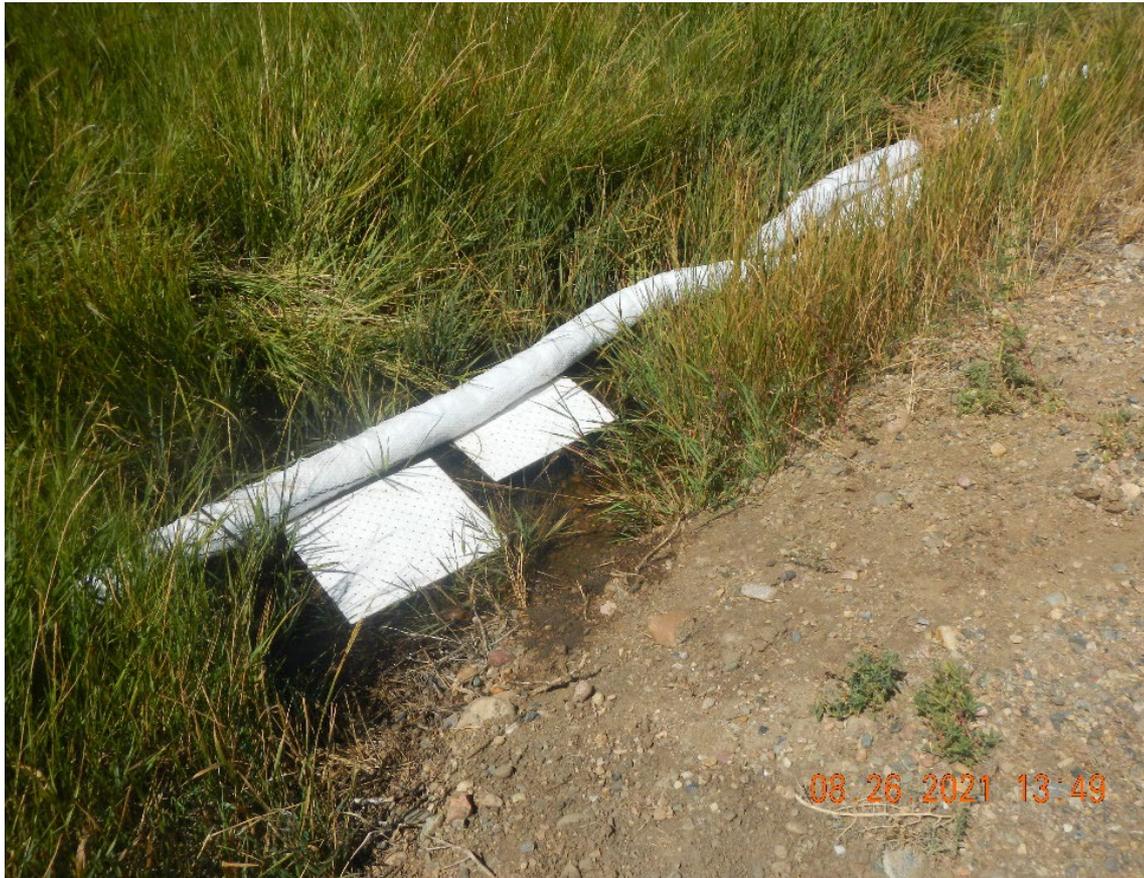
Photo #8 absorbent pad and boom observed on west side of location in ponded irrigation water. No oil was observed; in water or on booms or pads at the time of inspection.

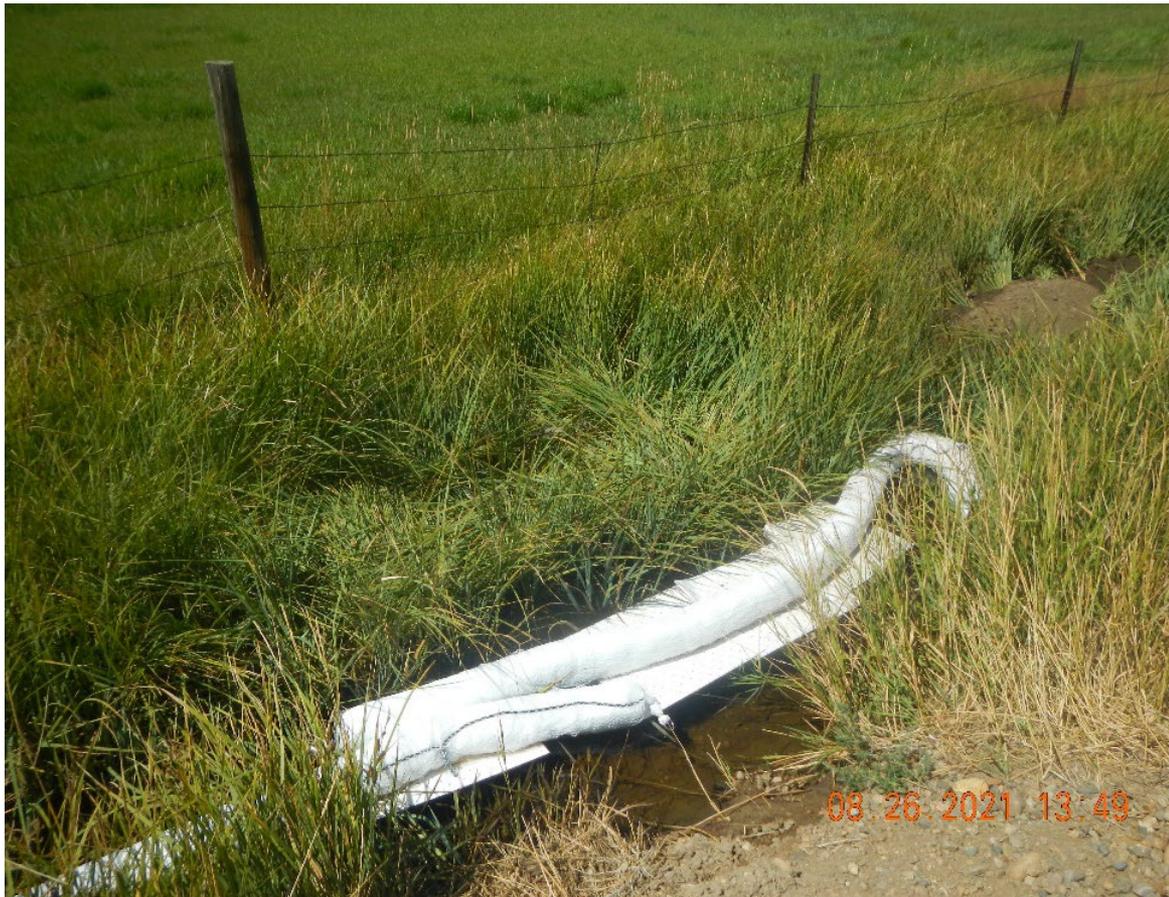
Photo #9 absorbent pad and boom observed on west side of location in ponded irrigation water.

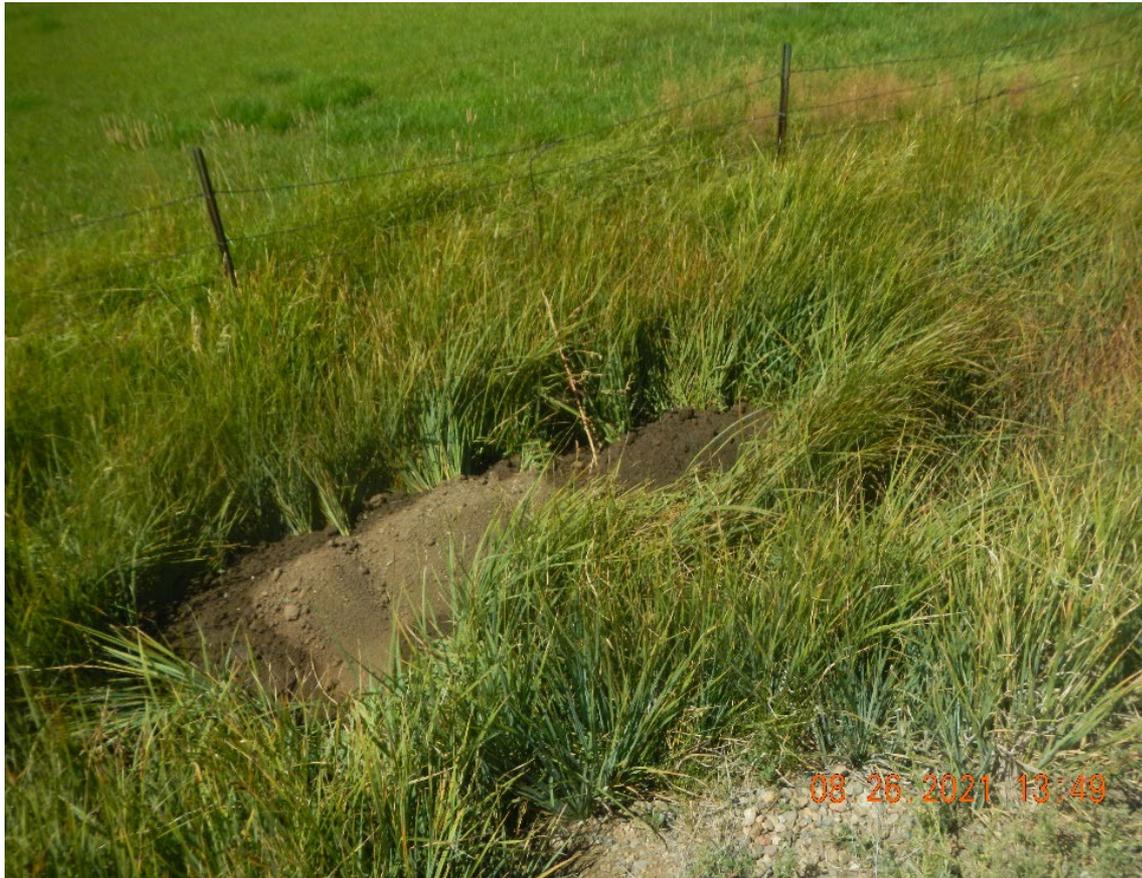
Photo #10 soil that appears placed in surface irrigation water that pools on the edge of location.

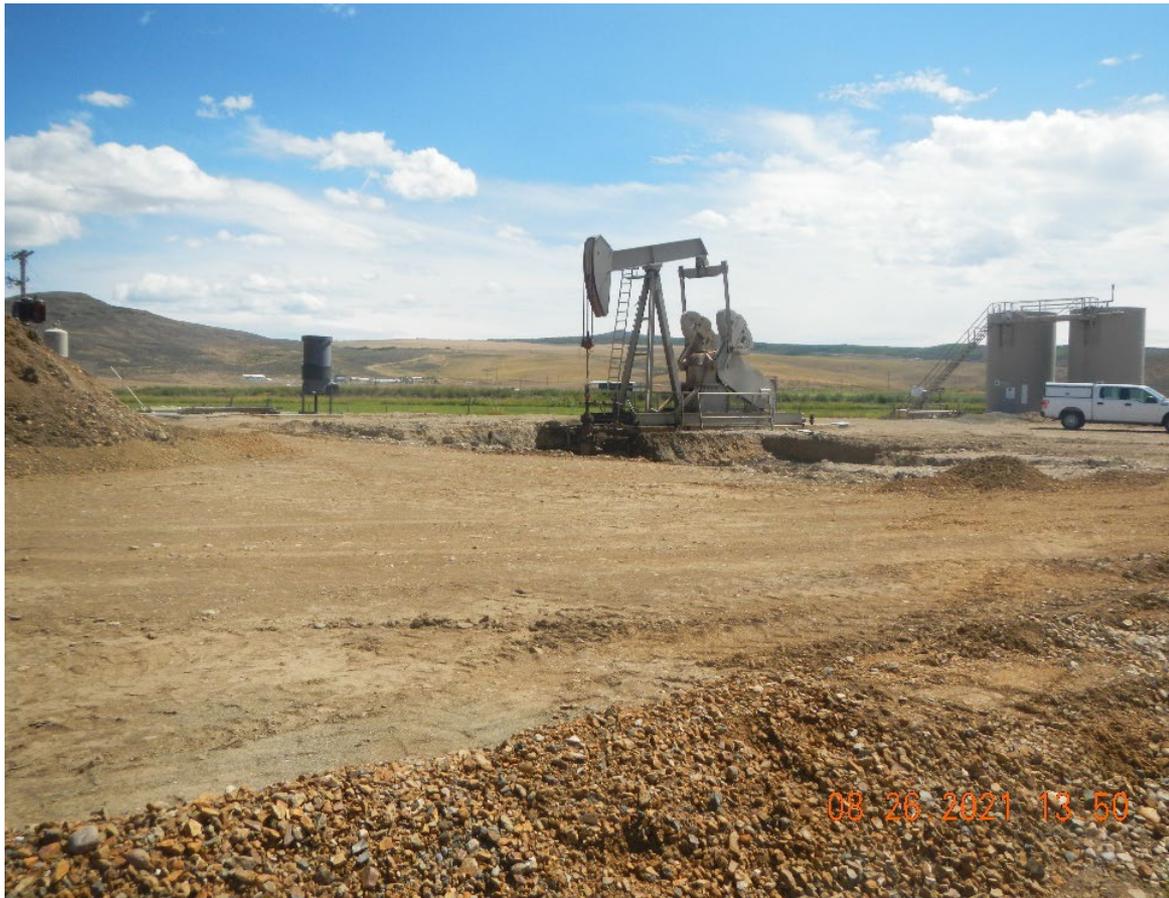
Photo #11 looking to the southeast, standing on the east side of location

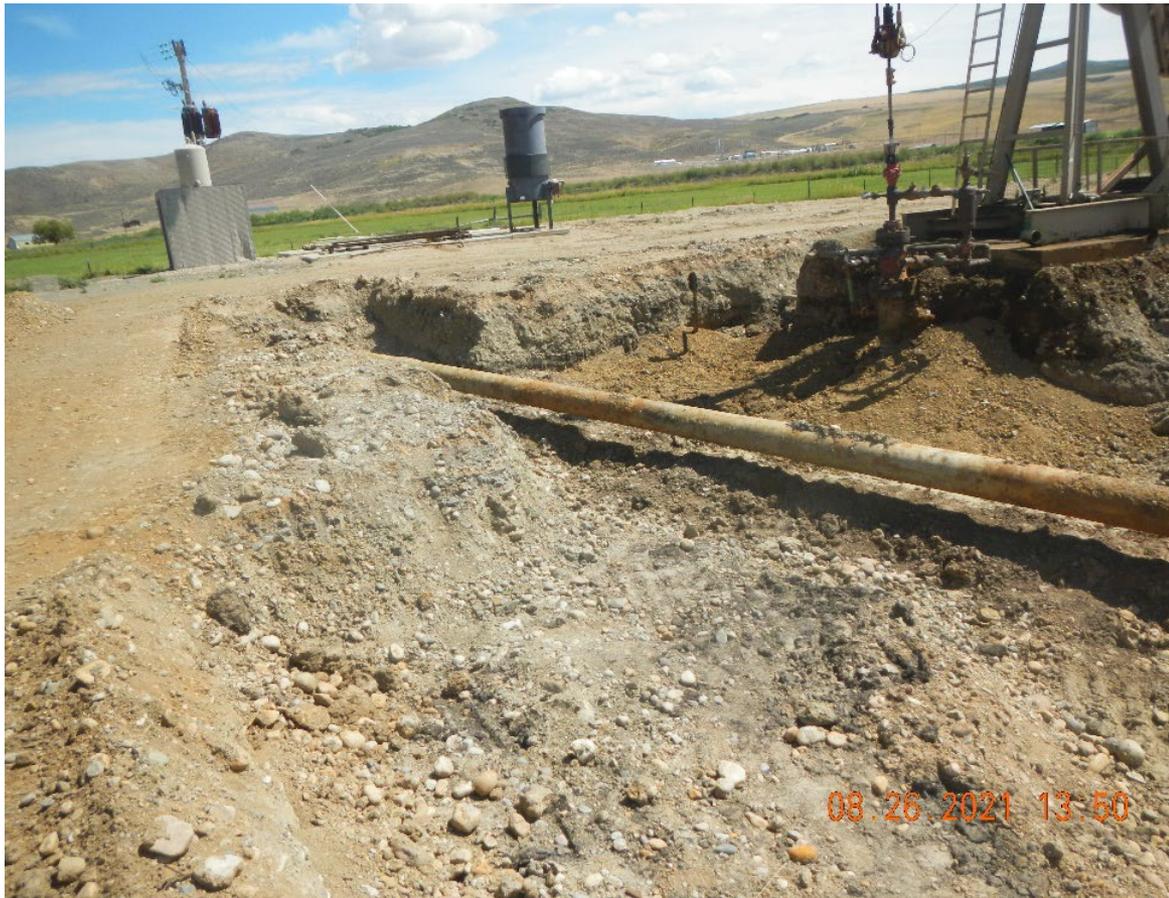
Photo #12 excavation.

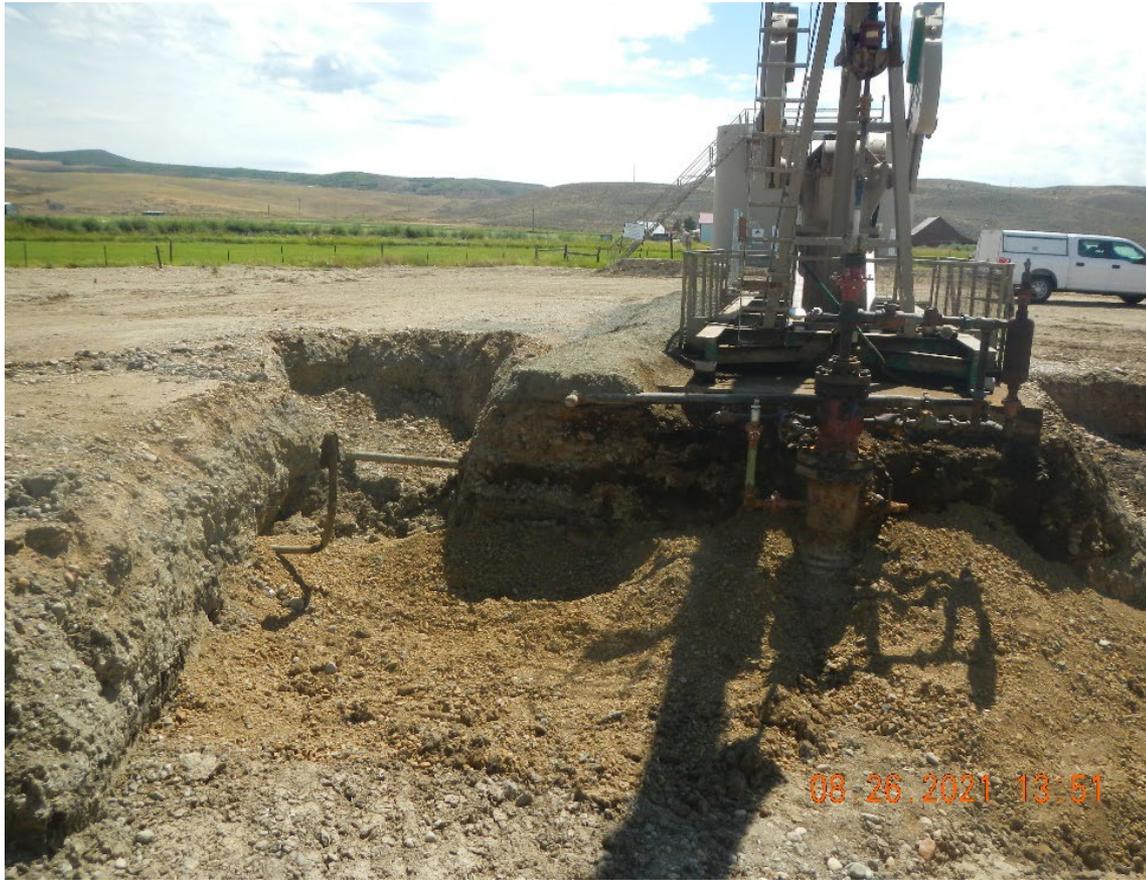
Photo #13 looking south at wellhead.

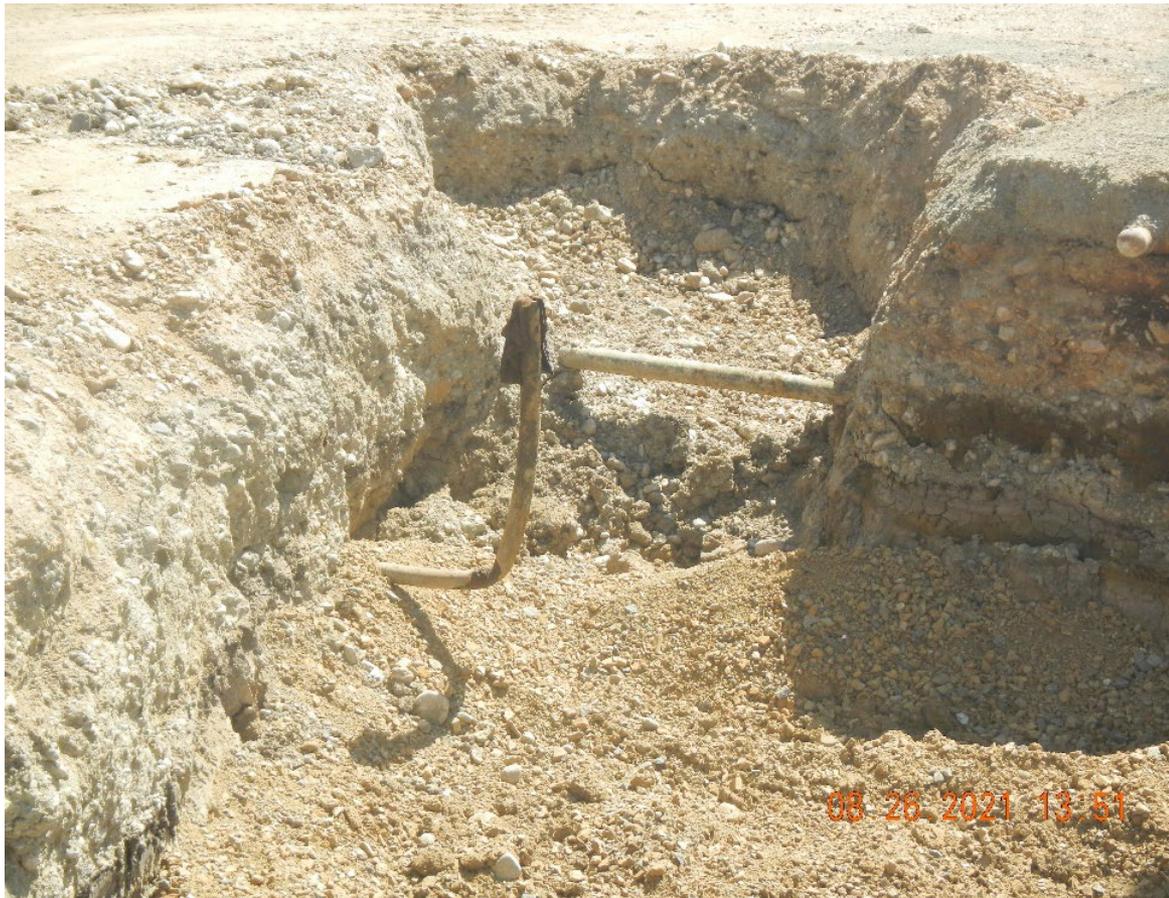
Photo #14 three flowlines observed in excavation: a production line that appears to run to the tank, a 3" line that appears toward gas burners, one line that is bent up with rag seal in center of photo. The Operator should ensure that all abandon flowlines are properly abandon.

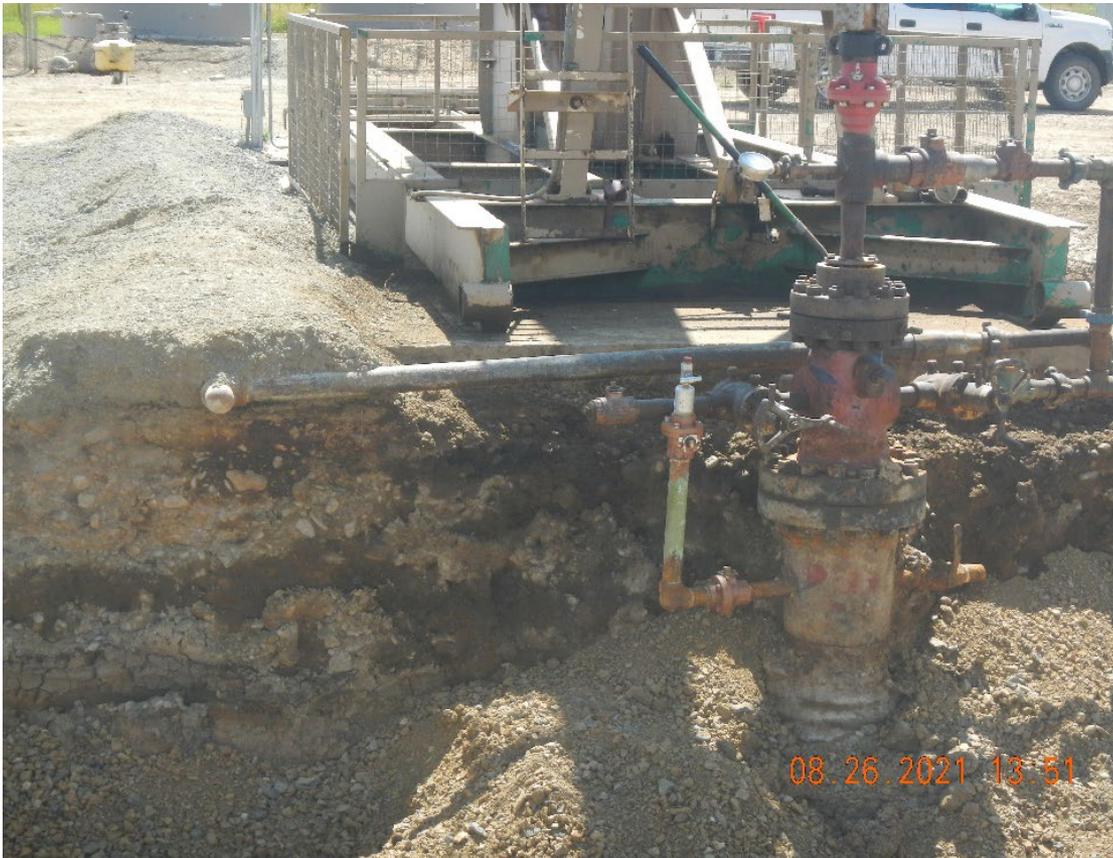
Photo #15 wellhead. Appears that hydrocarbon impacted soil present below Pumpjack.

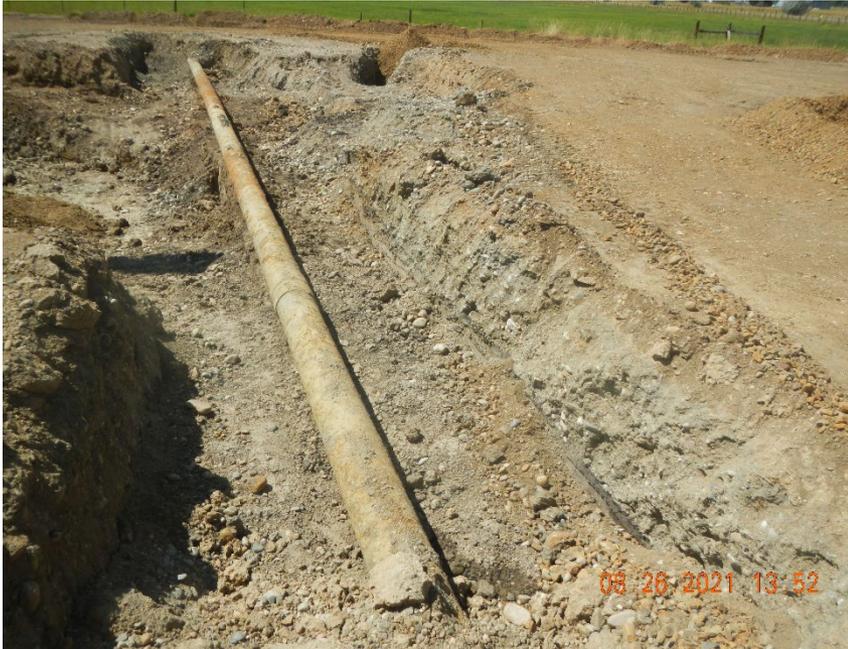
Photo #16 This Line, large pipe in center of photo is used to transfer irrigation water to the other side of the pad.

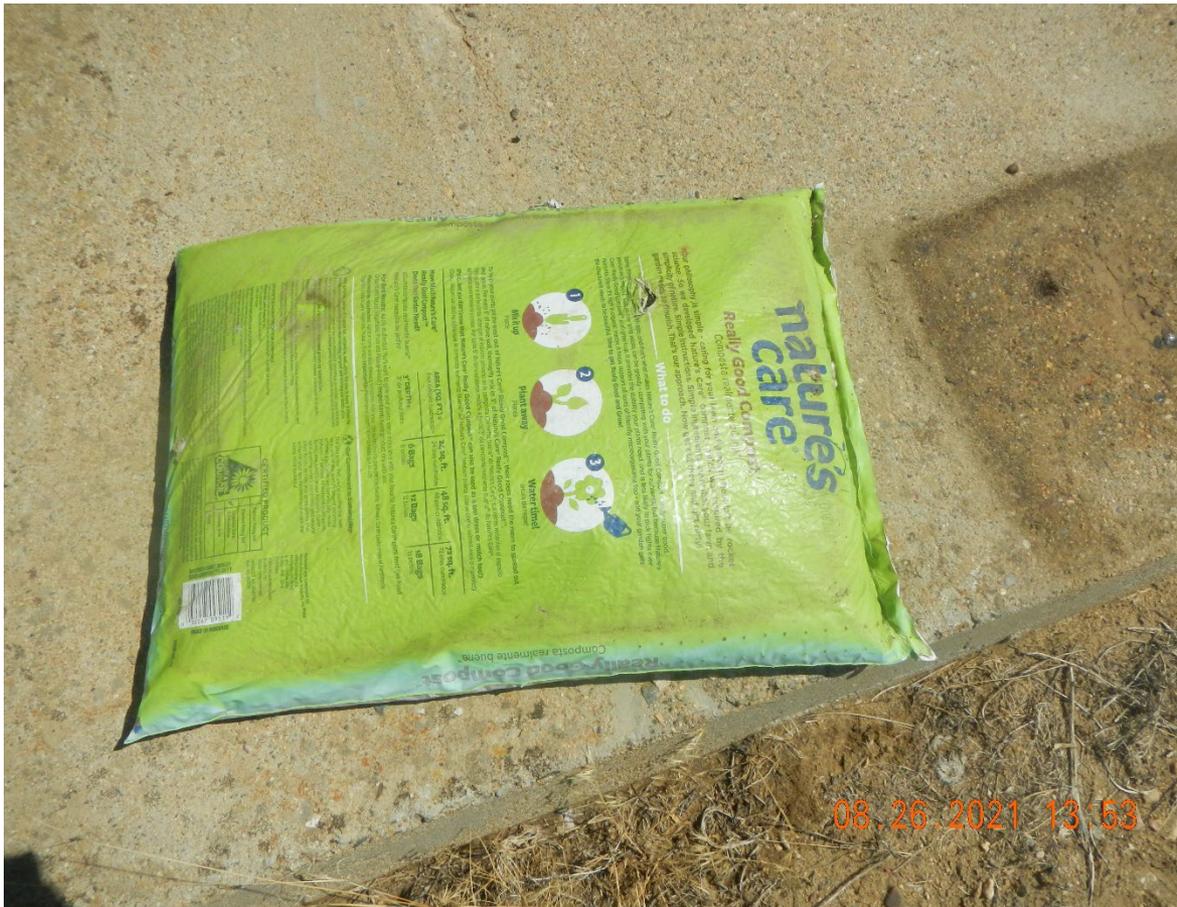
Photo #17 bag observed stored near Pumpjack.
