Inspection Photos
Location Name: Longmont Farms Unit 5
API 05-123-13222, Spill 479267, REM 18932

COLORADO
Oil & Gas Conservation
Commission
Department of Natural Resources

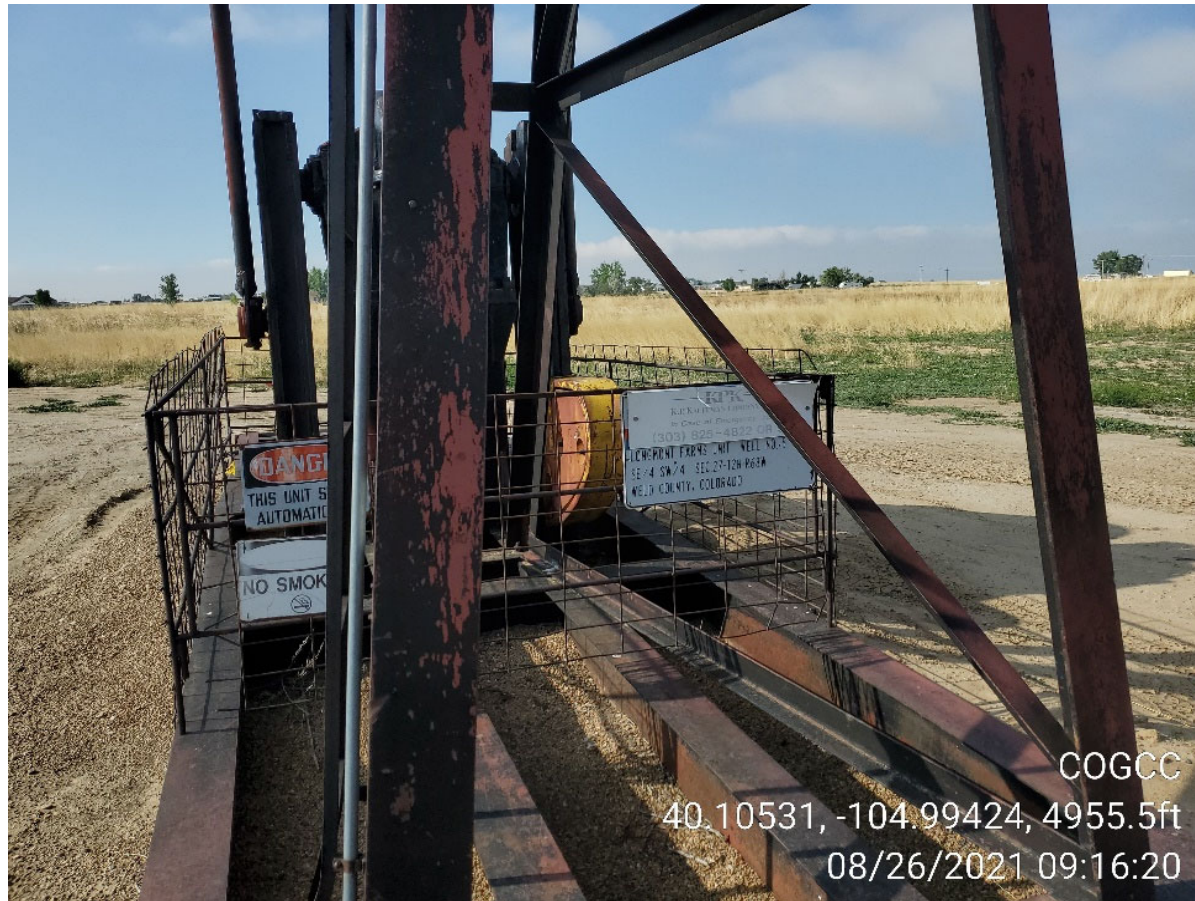
Photo 1: Longmont Farms Unit 5 well sign

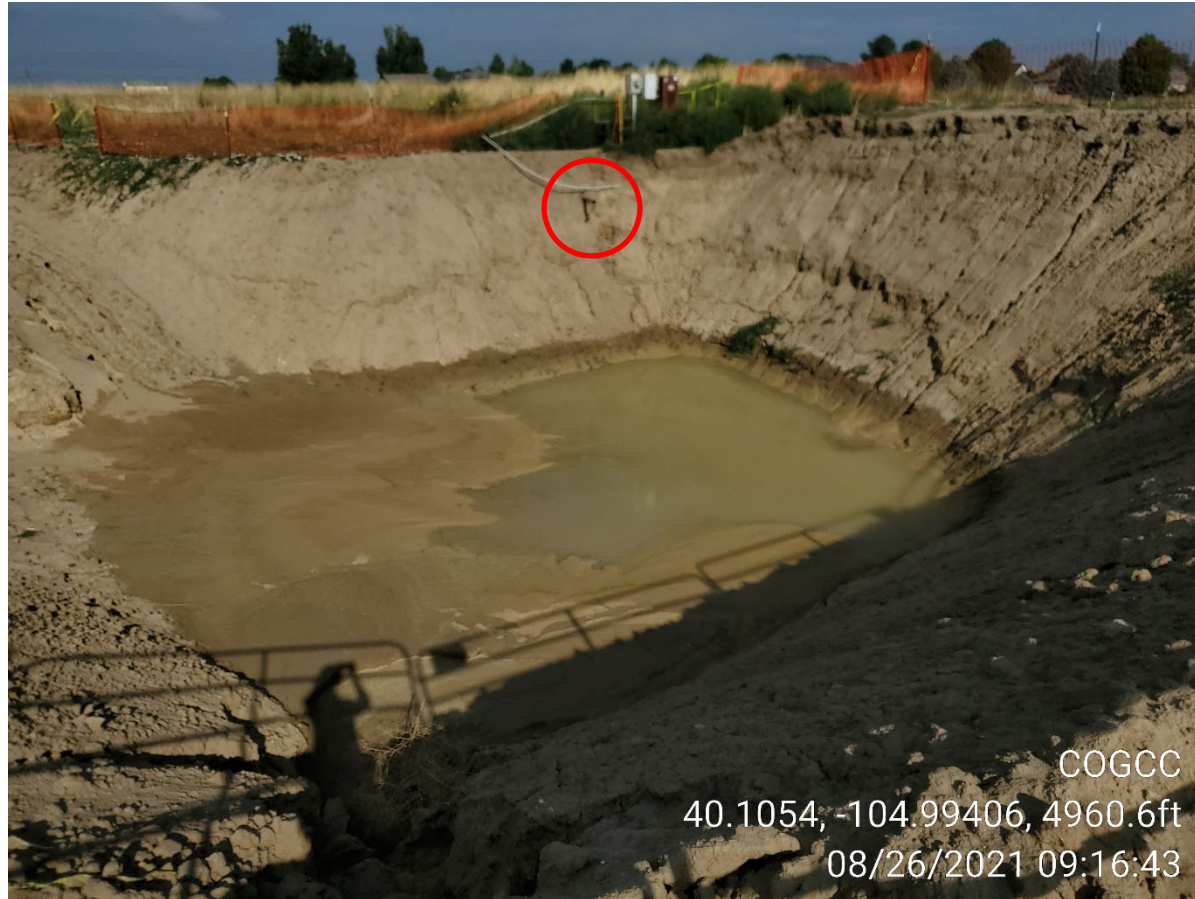
Photo 2: Excavation from southeast corner, looking northwest. Flowline exposed in northwest corner of excavation – highlighted by red circle.

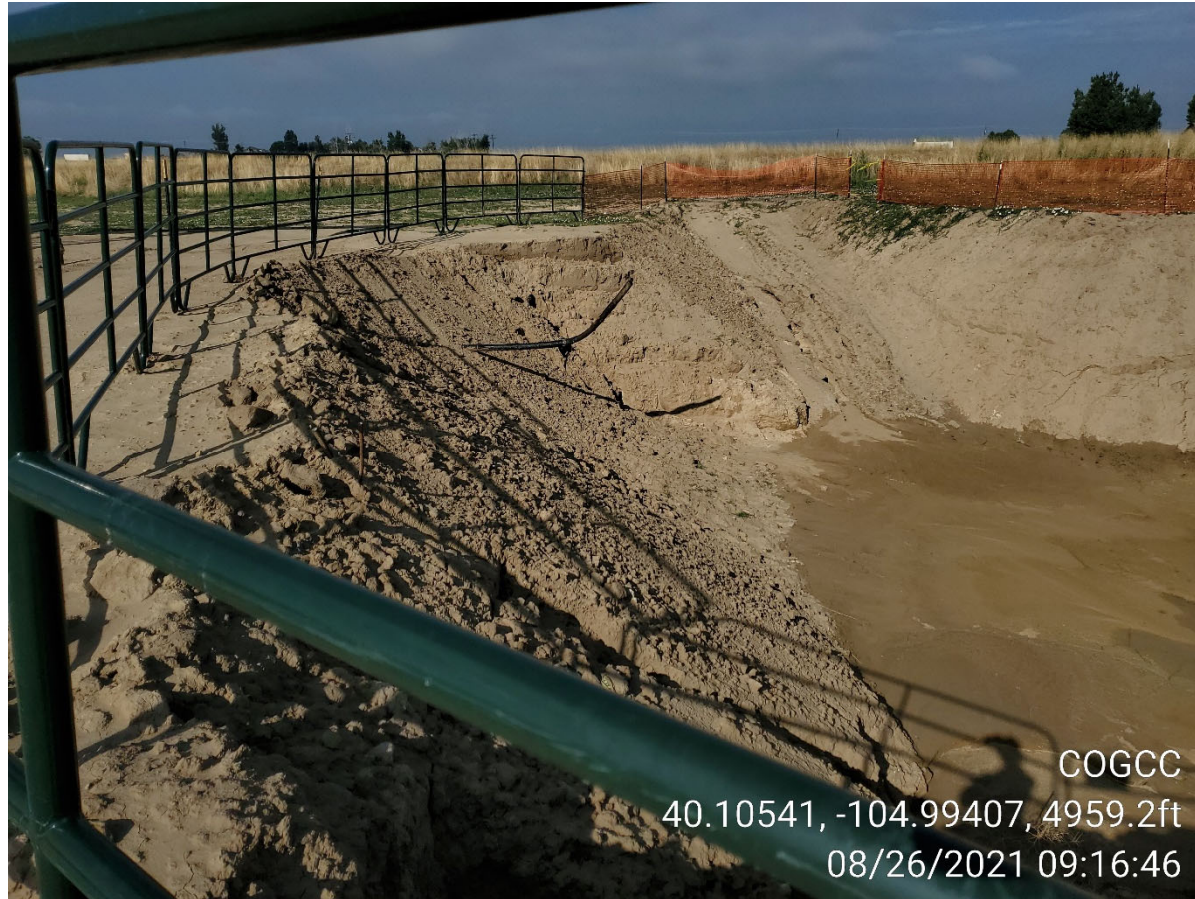
Photo 3: Excavation from southeast corner, looking west. Flowline exposed in south wall of excavation.

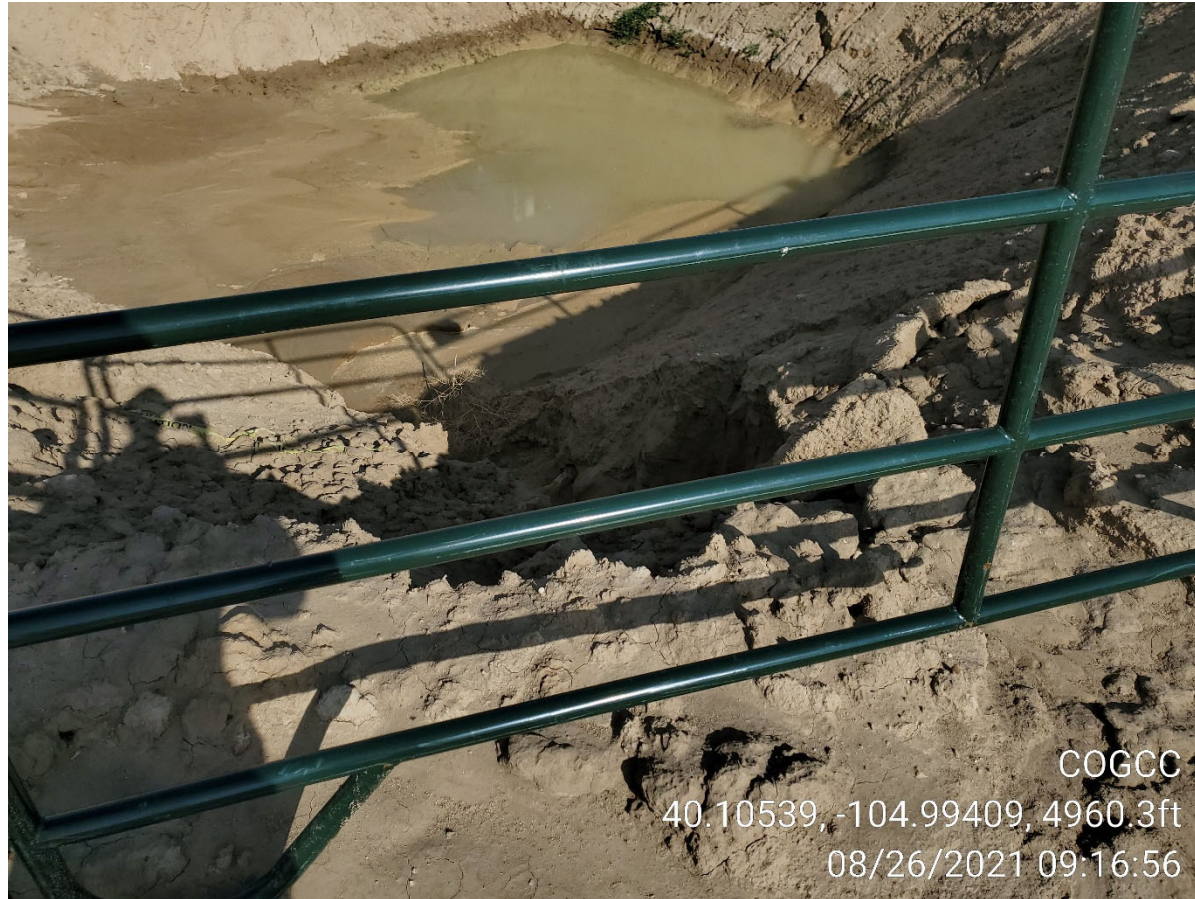
Photo 4: Excavation from southeast corner. Erosion of excavation wall in southeast corner.

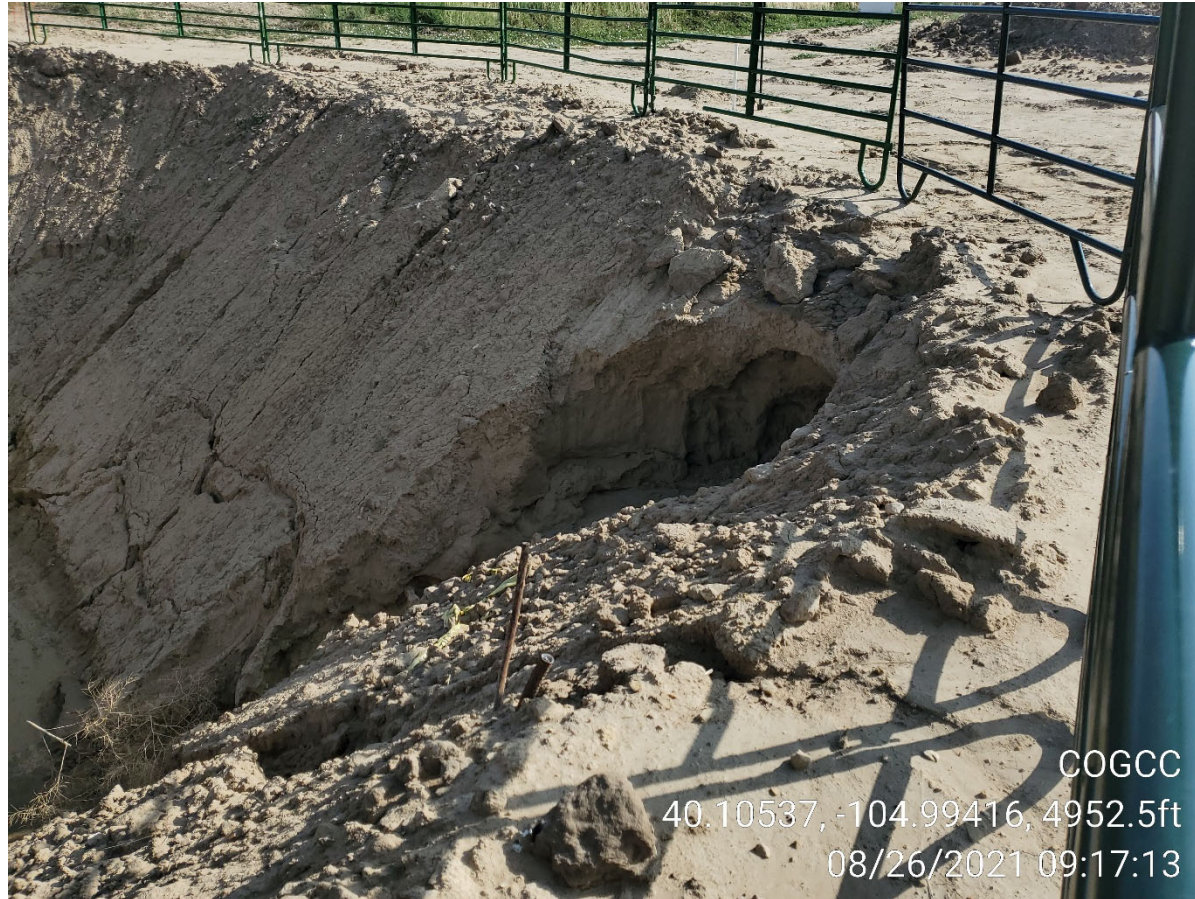
Photo 5: Excavation looking at southeast corner. Erosion of excavation wall in southeast corner.

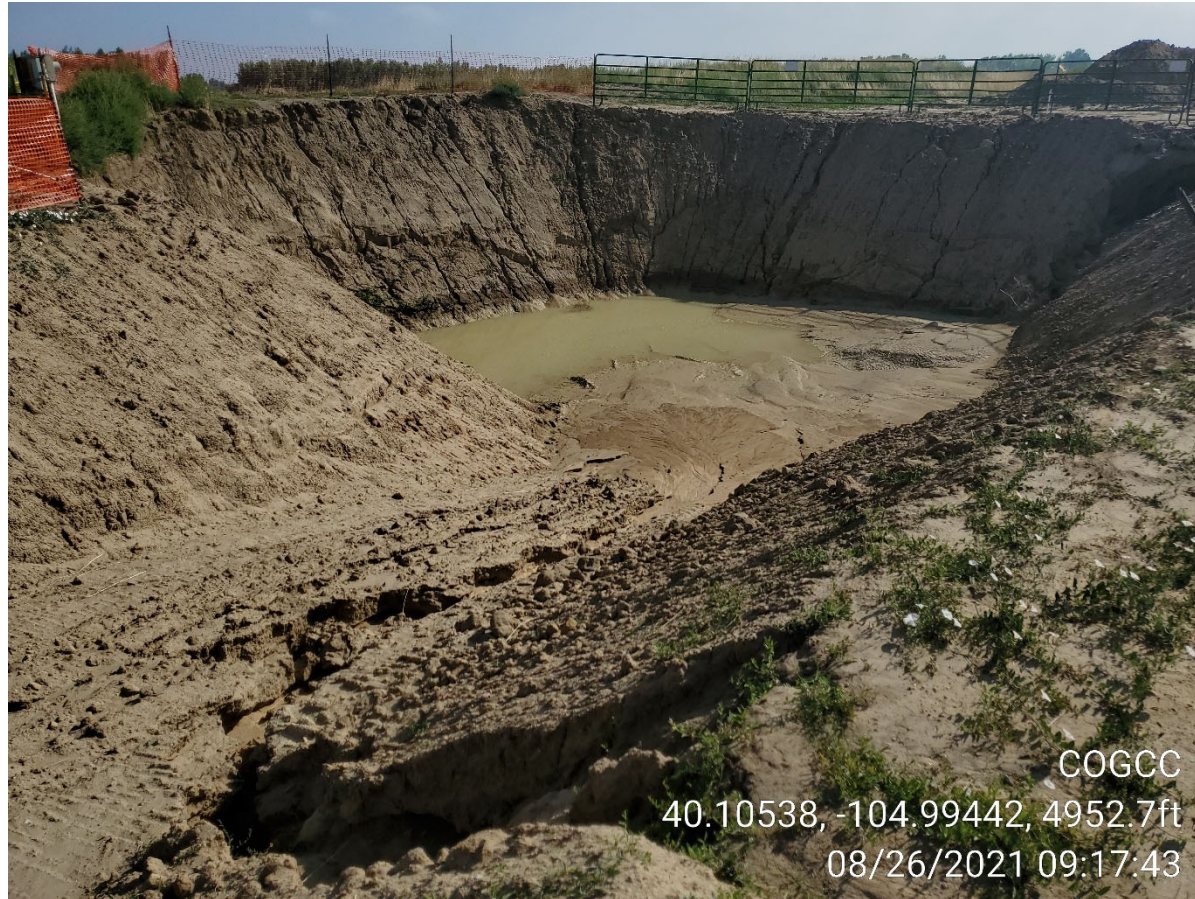
Photo 6: Excavation from southwest corner. Erosion is occurring in foreground, and in southeast corner in upper right of photo.

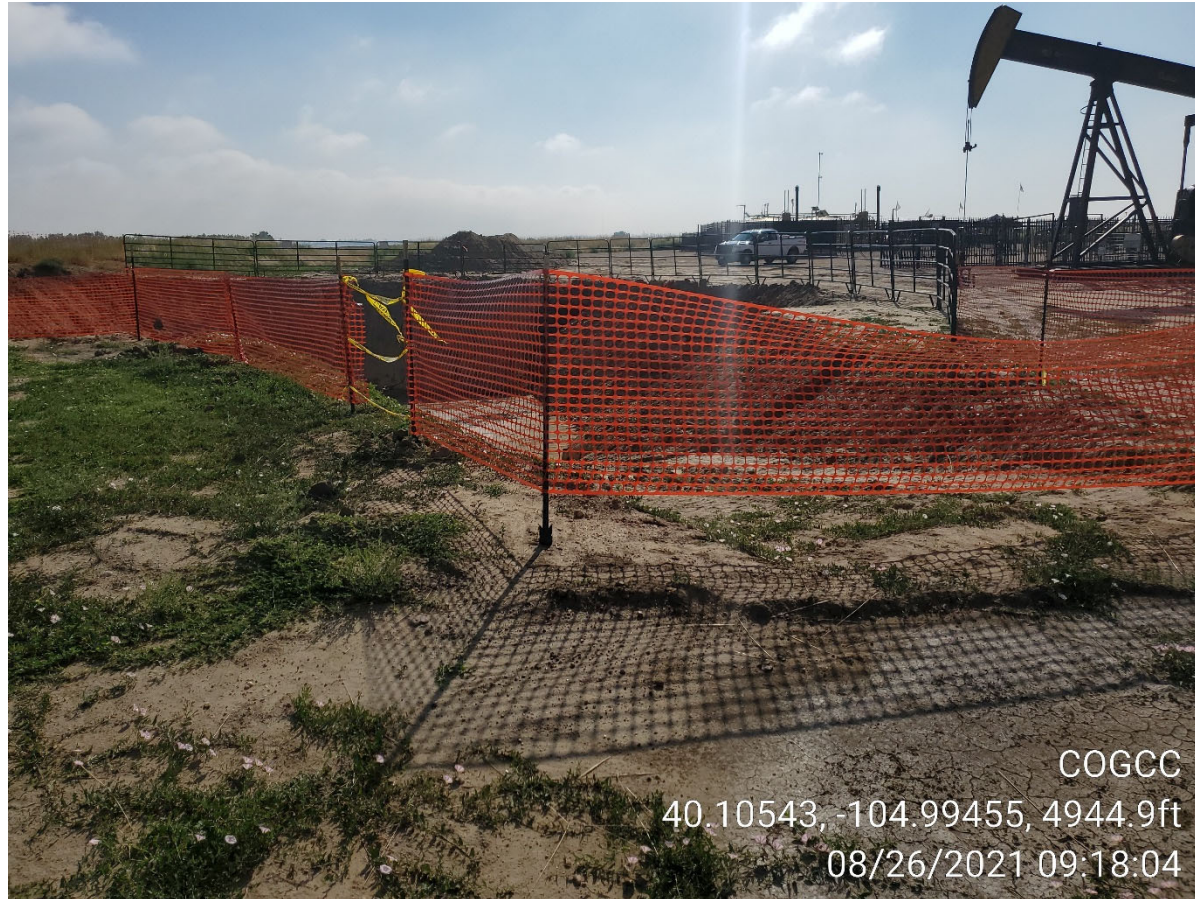
Photo 7: Excavation from northwest corner looking east. Fencing is a combination of cattle panels, snow fence and caution tape.

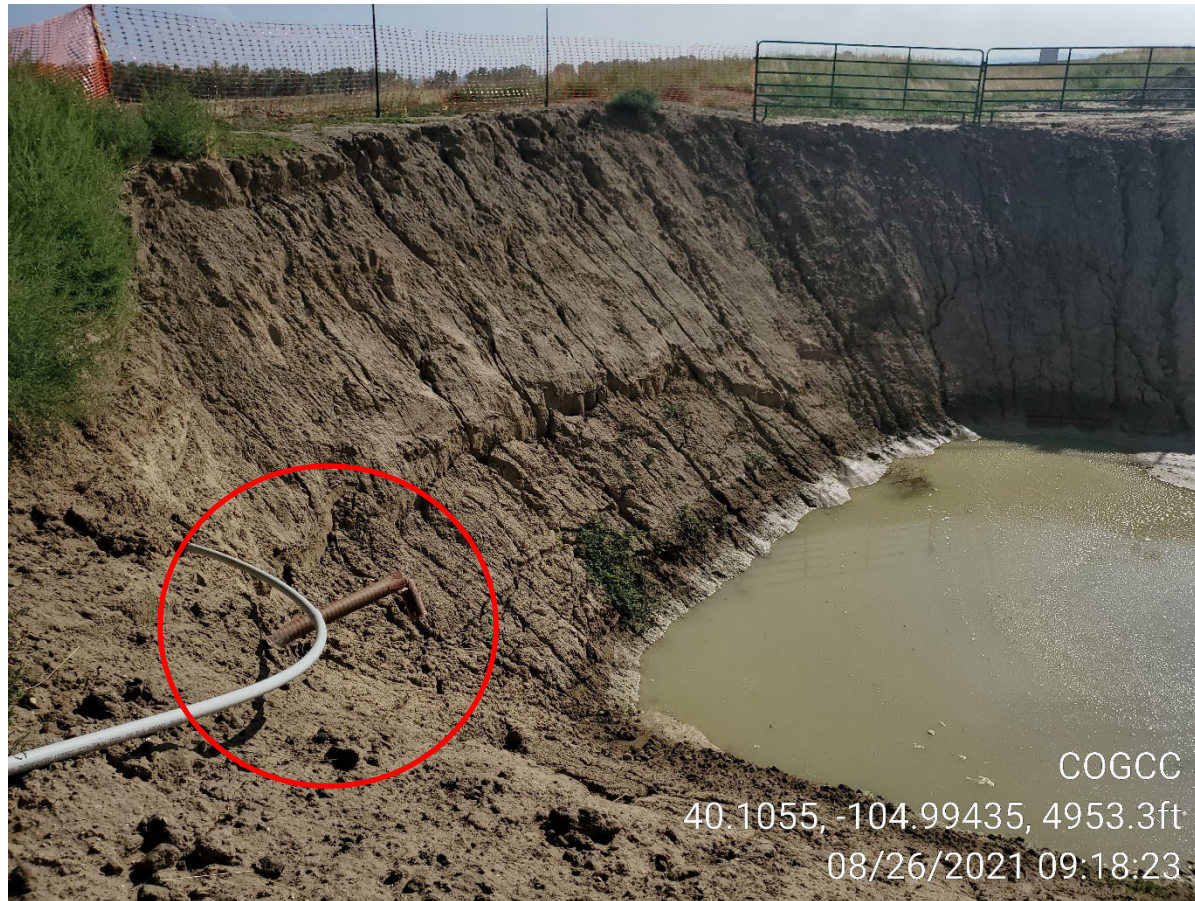
Photo 8: Northwest corner of excavation looking along north wall. Flowline is exposed in northwest corner of excavation (highlighted by red circle).

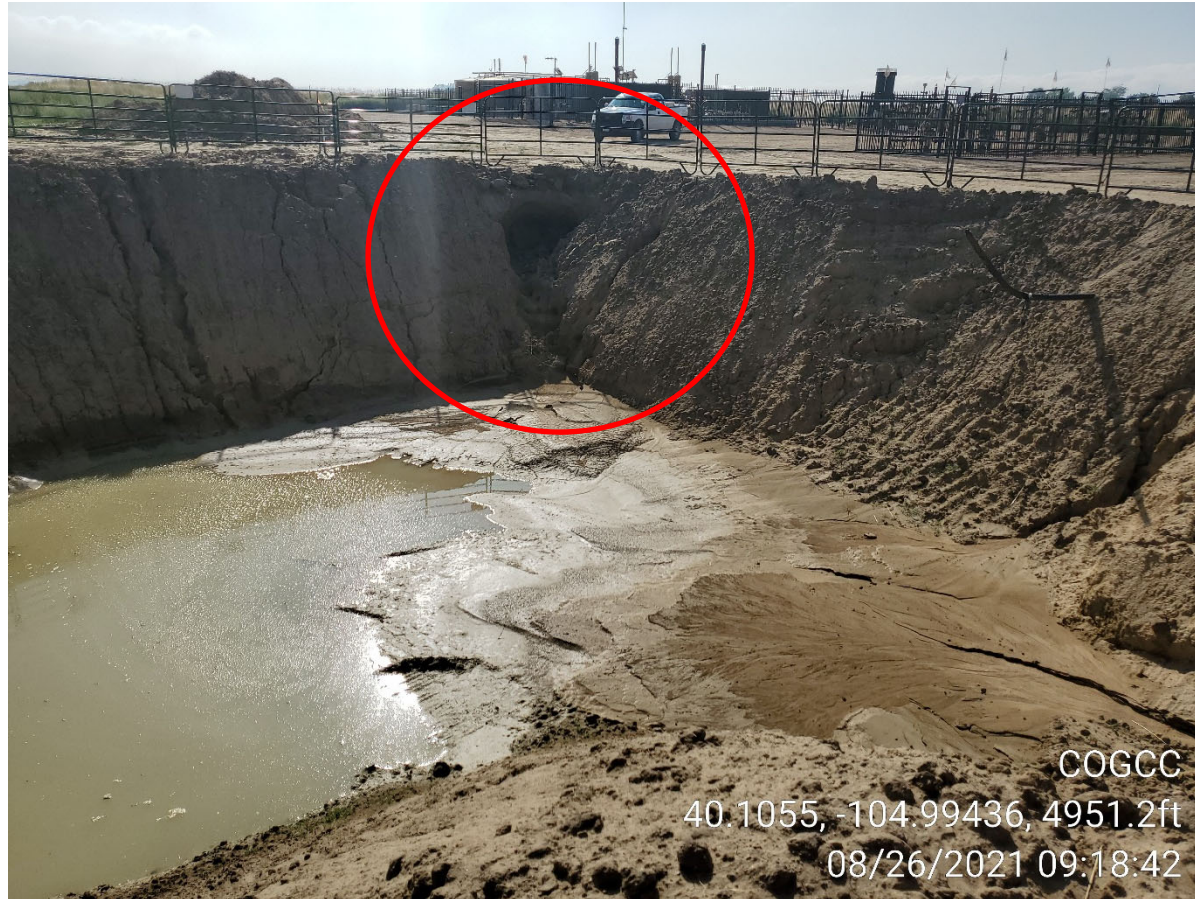
Photo 9: Northwest corner of excavation looking along southeast. Erosion of southeast corner visible.

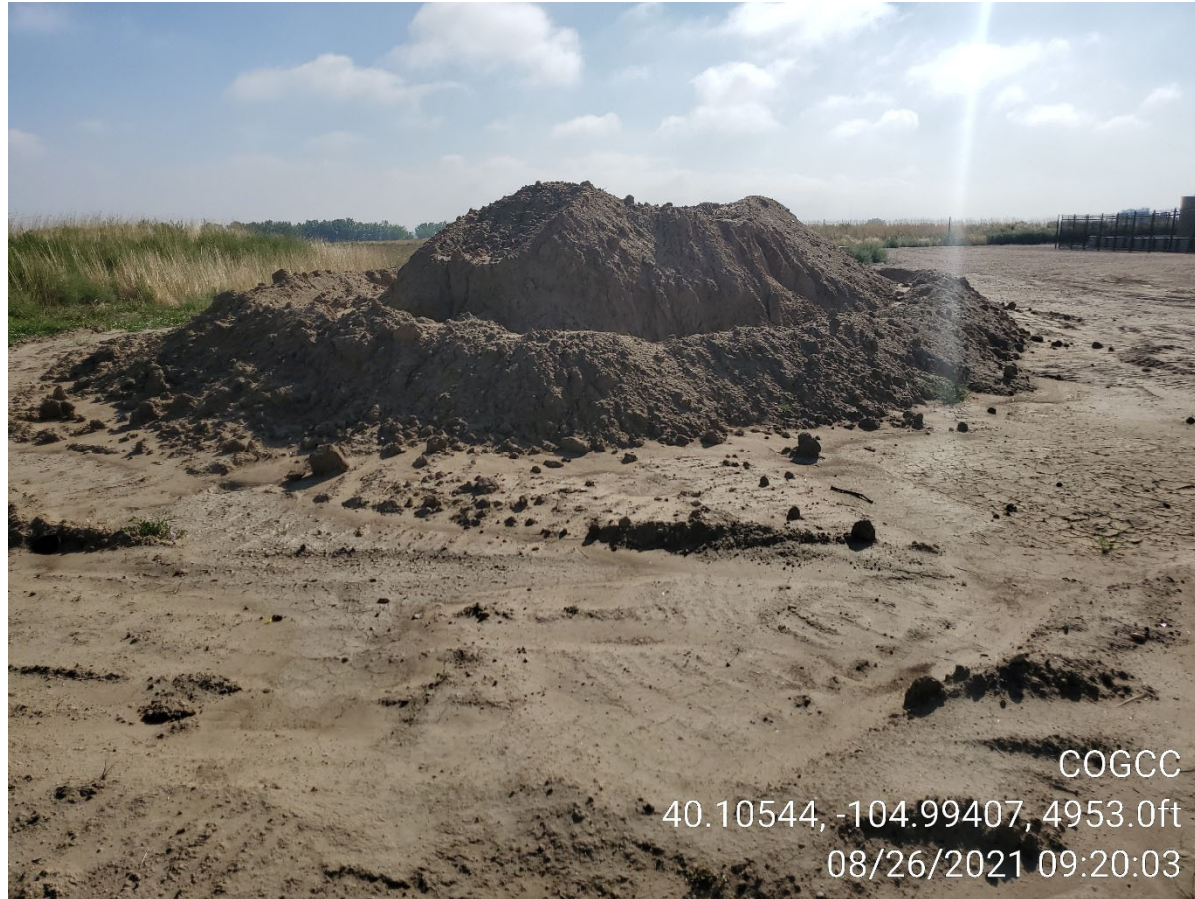
Photo 10: Material stockpile east of excavation.

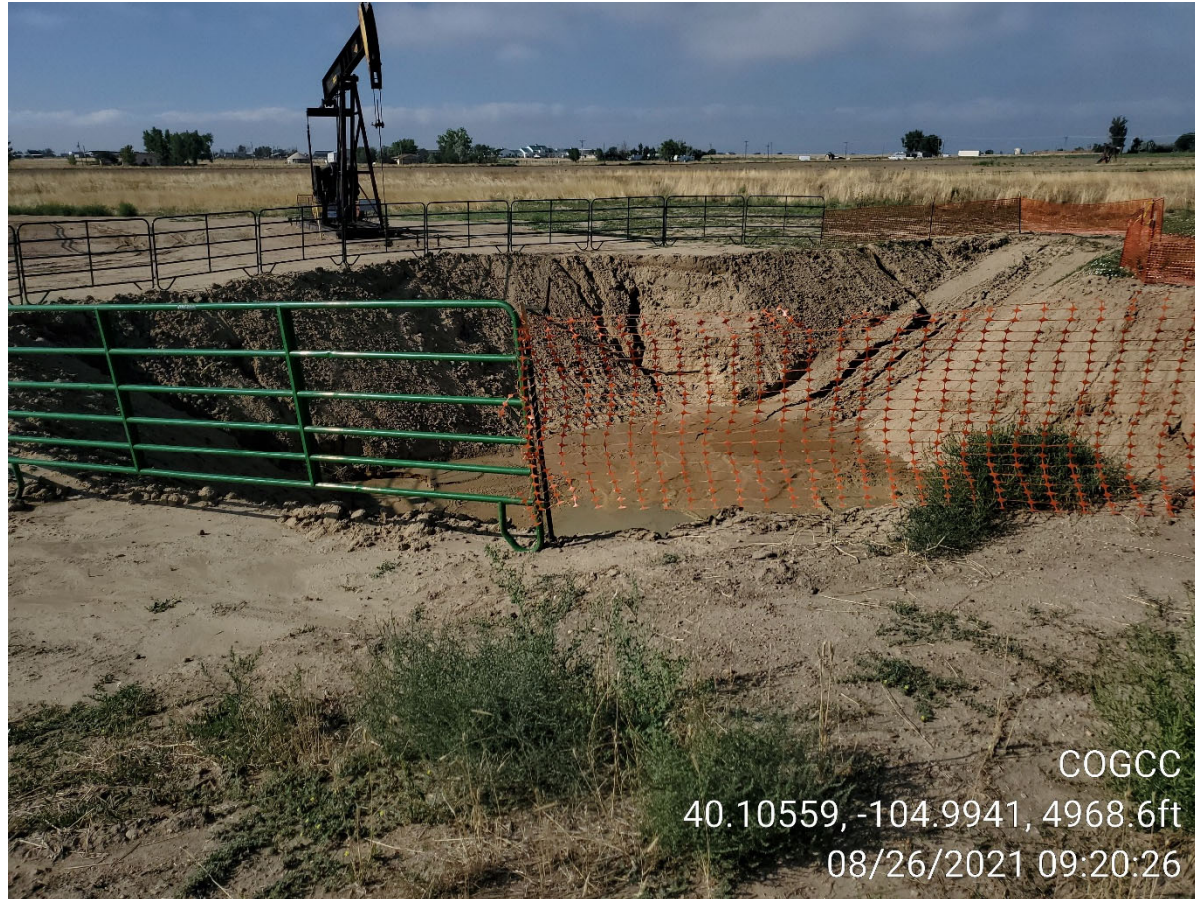
Photo 11: Overview of excavation from east, looking west.
