Inspection Photos

8/23/2021

Operator: NONSUCH NATURAL GAS INC

Location ID: 453726

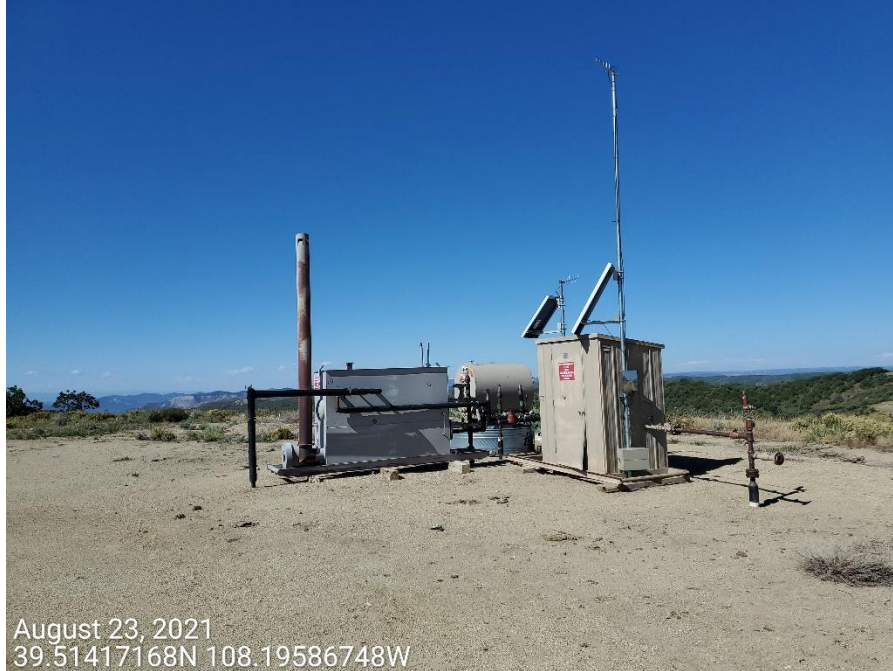
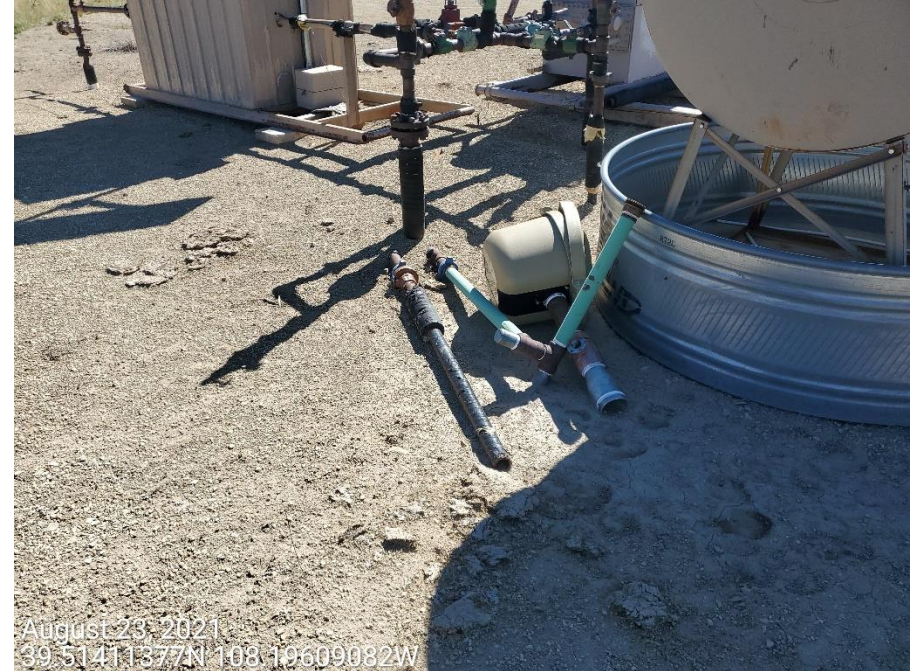
Photo 1: Photo shows unused equipment, and/or equipment not necessary for production on the Location. Previous inspections required Operator to submit a Form 4 with records identifying equipment's (Methanol tank, separator, meter shed) current statuses and use for production on the Location by 10/2/2020; Operator failed to submit Form 4 with records; Inspection #696202916 required Operator to comply with Rule 606.a and remove equipment not necessary for use on the Location. To date, records identifying equipment's use and need has not been submitted, and equipment has not been removed.

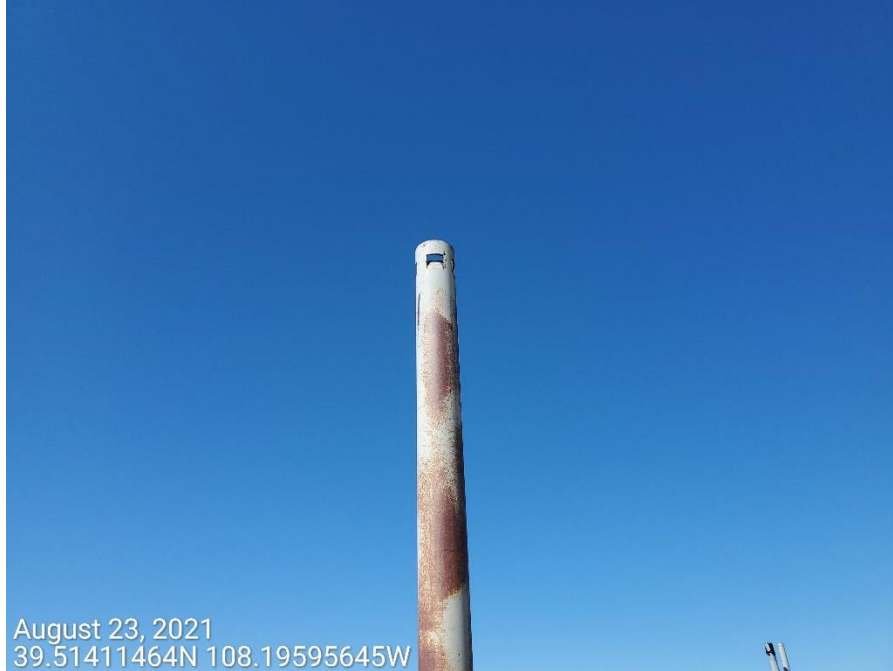
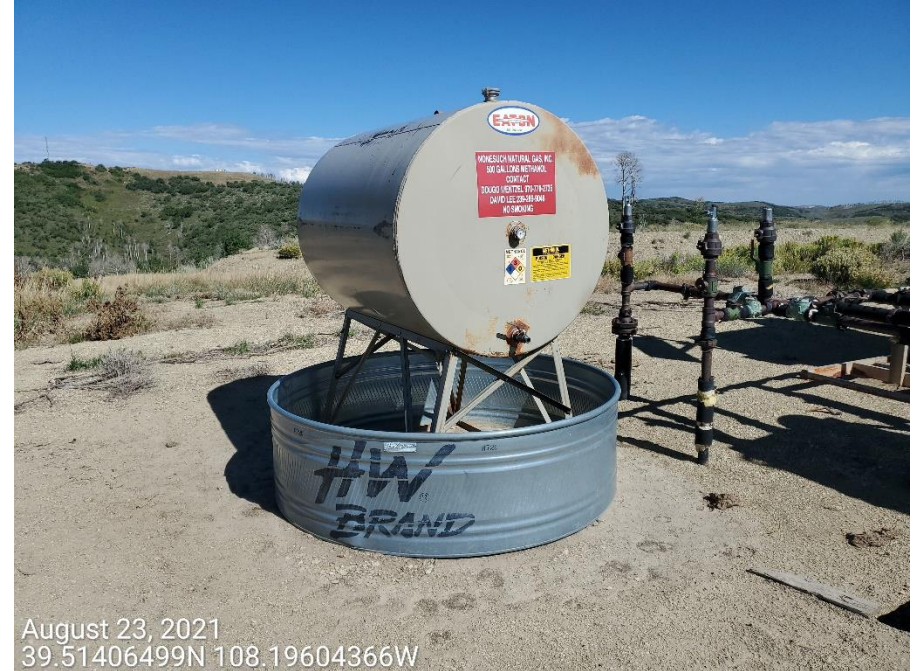
Photo 2: Previous inspection observed that protection equipment to prevent wildlife access to the secondary containment BMP at the 500 gallon methanol tank, and the separator was missing or insufficient. Photos show wildlife protection equipment remains missing or insufficient.

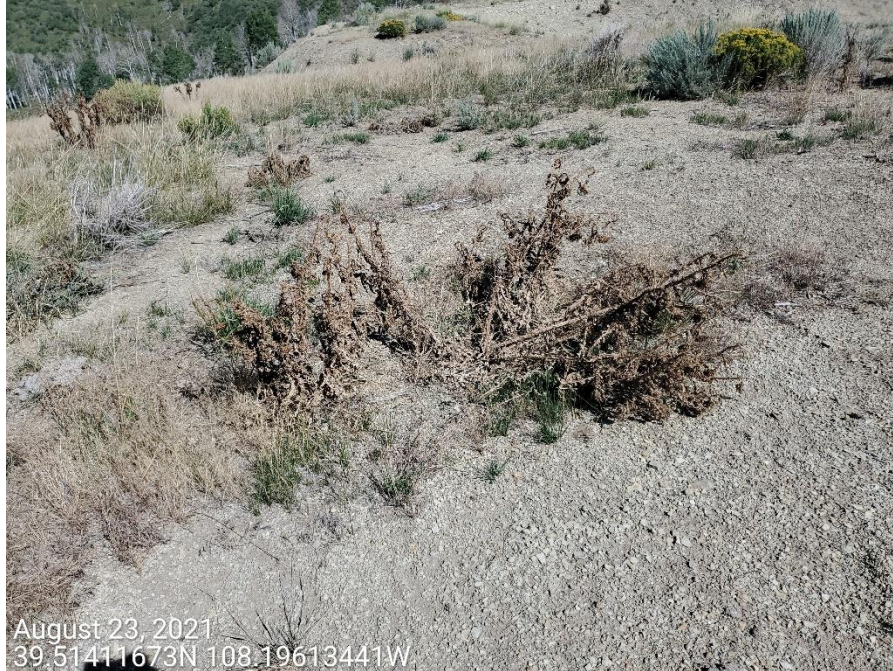
Photo 3: Photo shows example of noxious weeds on the Location that appear to have been sprayed; additional weed management appears to have been conducted; however a File Inspection Report Resolution form was not submitted by the Operator upon completion of the corrective action in accordance with Rule 210.b.

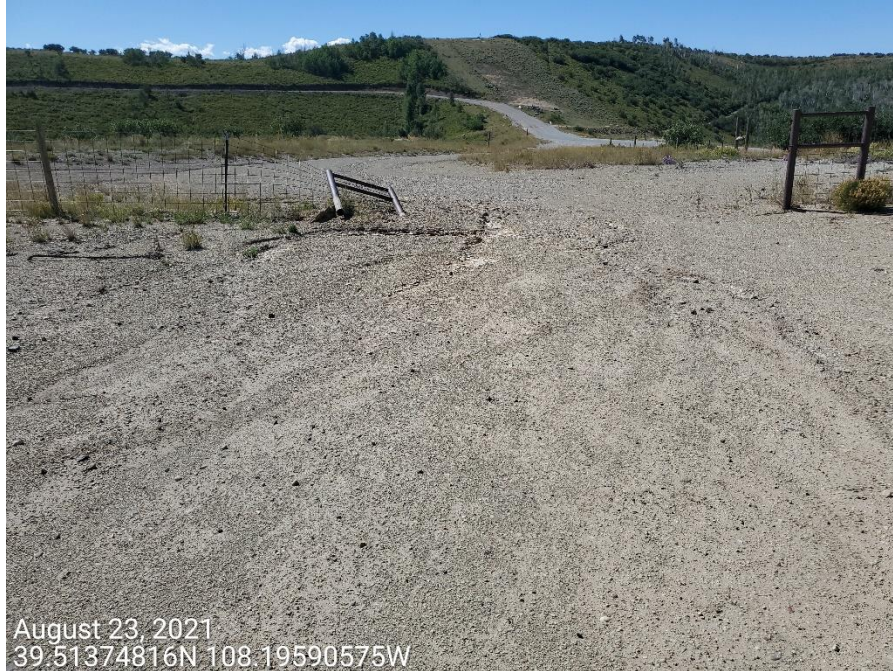
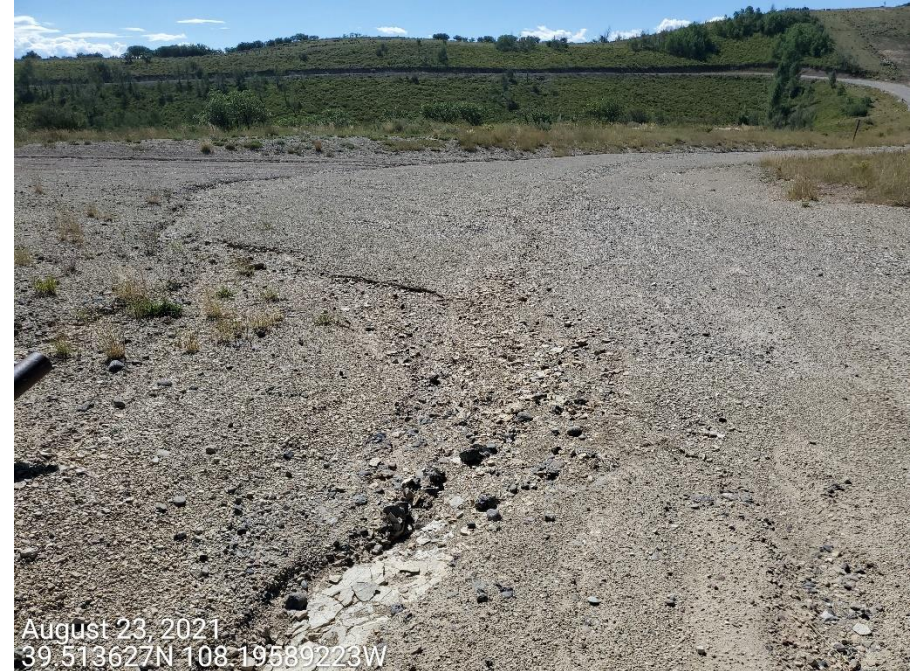
Photo 4: Photos taken from the south end of the Location. Photos show that BMPs to protect and stabilize unpaved areas of the Location and access road, and to allow for sediment laden-free stormwater discharge remain missing, or insufficient; stormwater runoff has resulted in erosion degradation and offsite sediment discharge at Location entrance and access road.

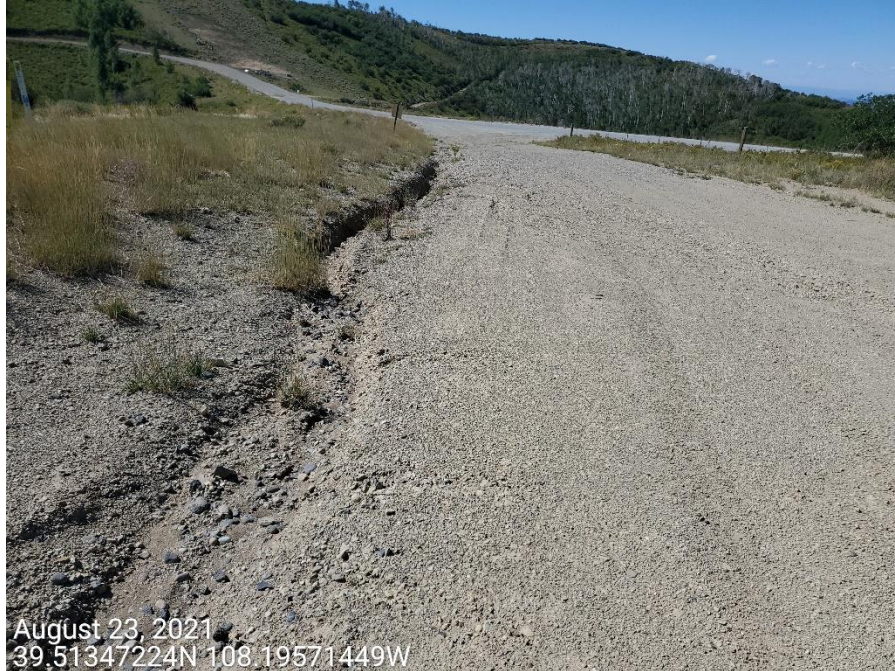
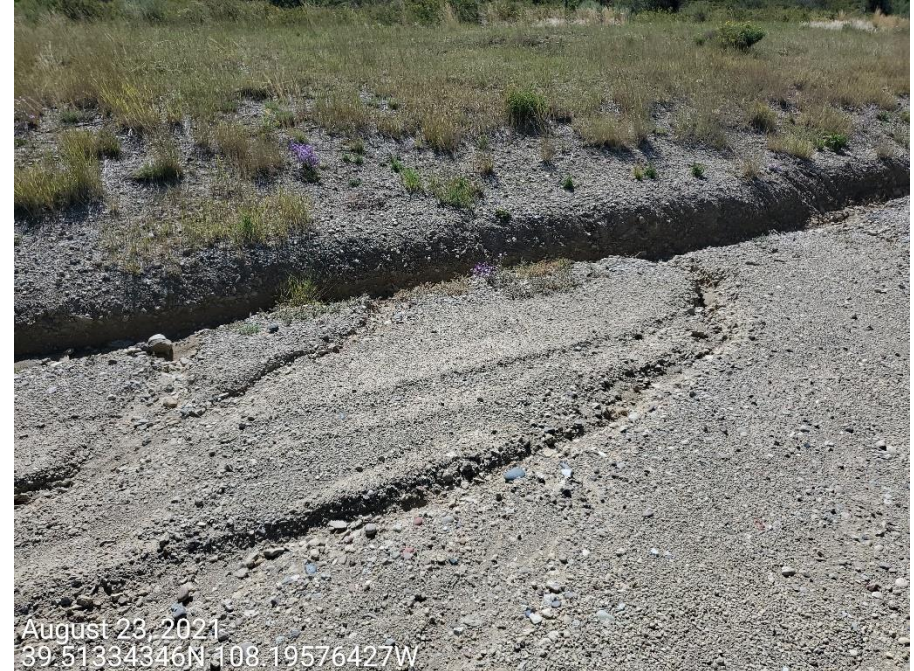
Photo 5: Photos taken from the access road, south of the Location. Photos show that BMPs to protect and stabilize unpaved areas of the Location and access road, and to allow for sediment laden-free stormwater discharge remain missing, or insufficient; stormwater runoff has resulted in erosion degradation and offsite sediment discharge at Location entrance and access road.

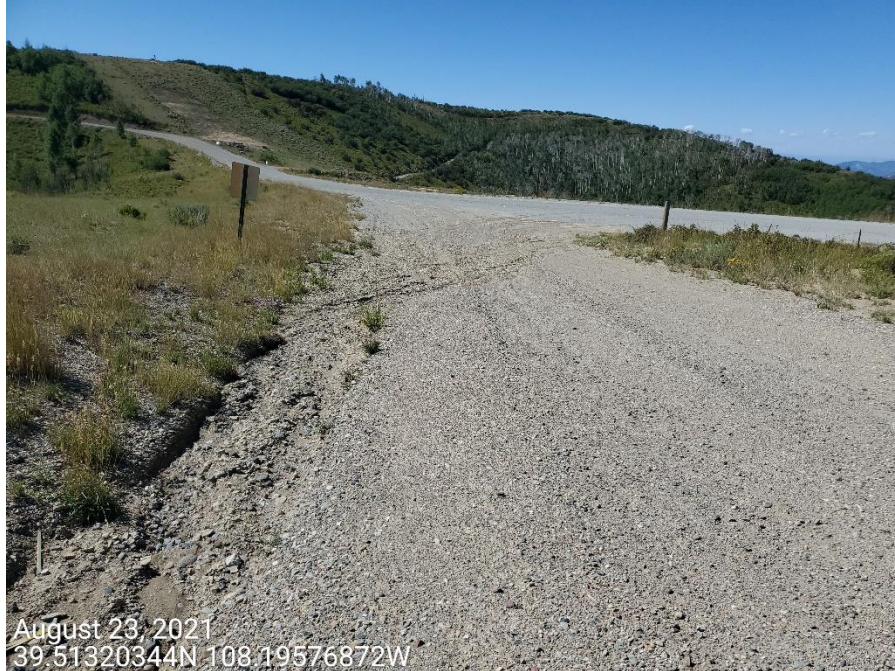
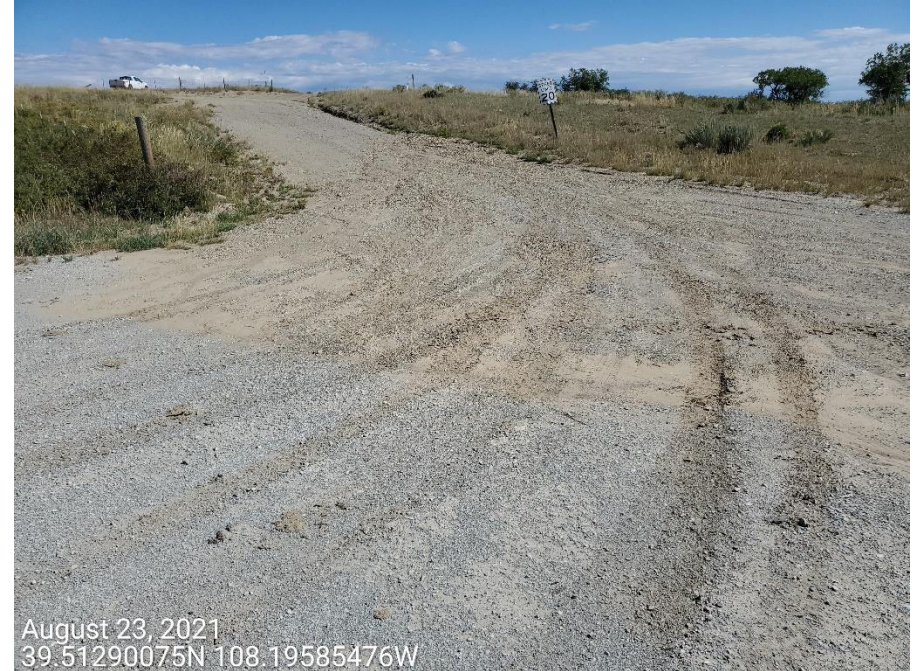
Photo 6: Photos taken from the access road, south of the Location. Photos show that BMPs to protect and stabilize unpaved areas of the Location and access road, and to allow for sediment laden-free stormwater discharge remain missing, or insufficient; stormwater runoff has resulted in erosion degradation and offsite sediment discharge at Location entrance and access road.. Photo on right also shows sediment deposition due to runoff from the Location.

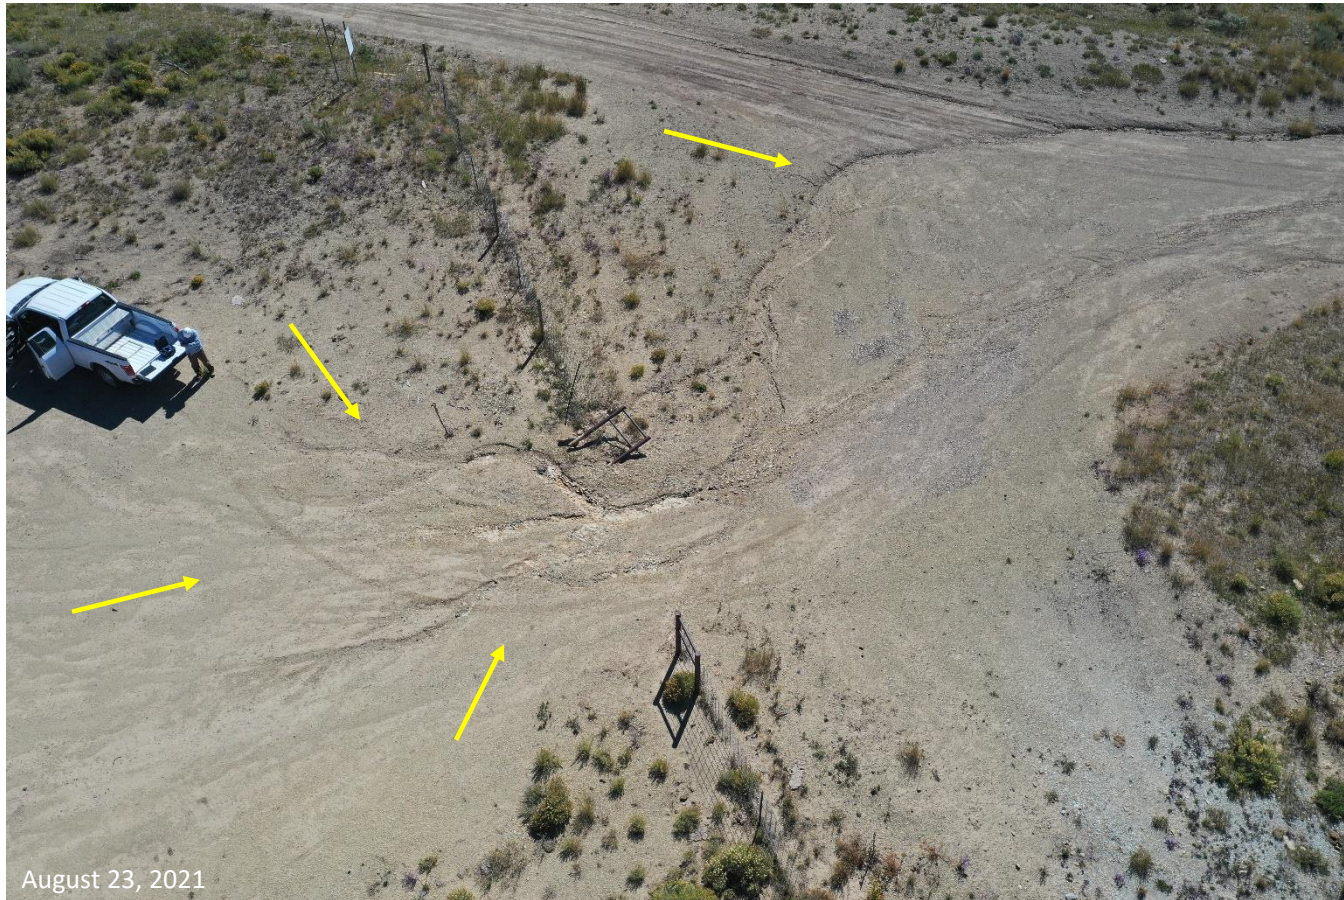
Photo 7: Photo taken with use of a sUAS; aerial photo shows south end of the Location/Location entrance and access road (see photos 4). Photo shows stormwater runoff from the Location has resulted in erosion degradation.

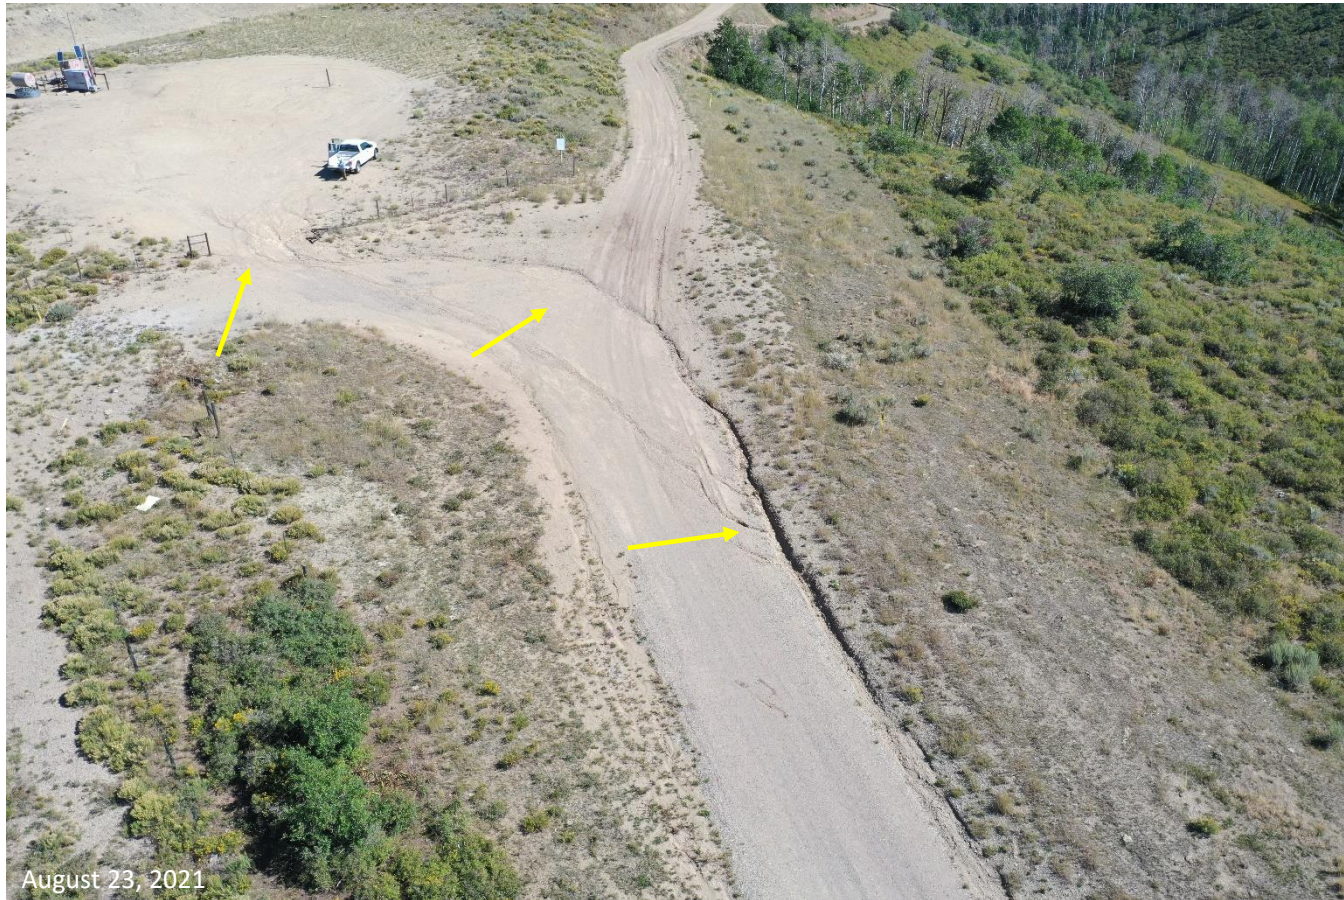
Photo 8: Photo taken with use of a sUAS; aerial photo shows access road and. Photo shows stormwater runoff from the Location has resulted in erosion degradation.

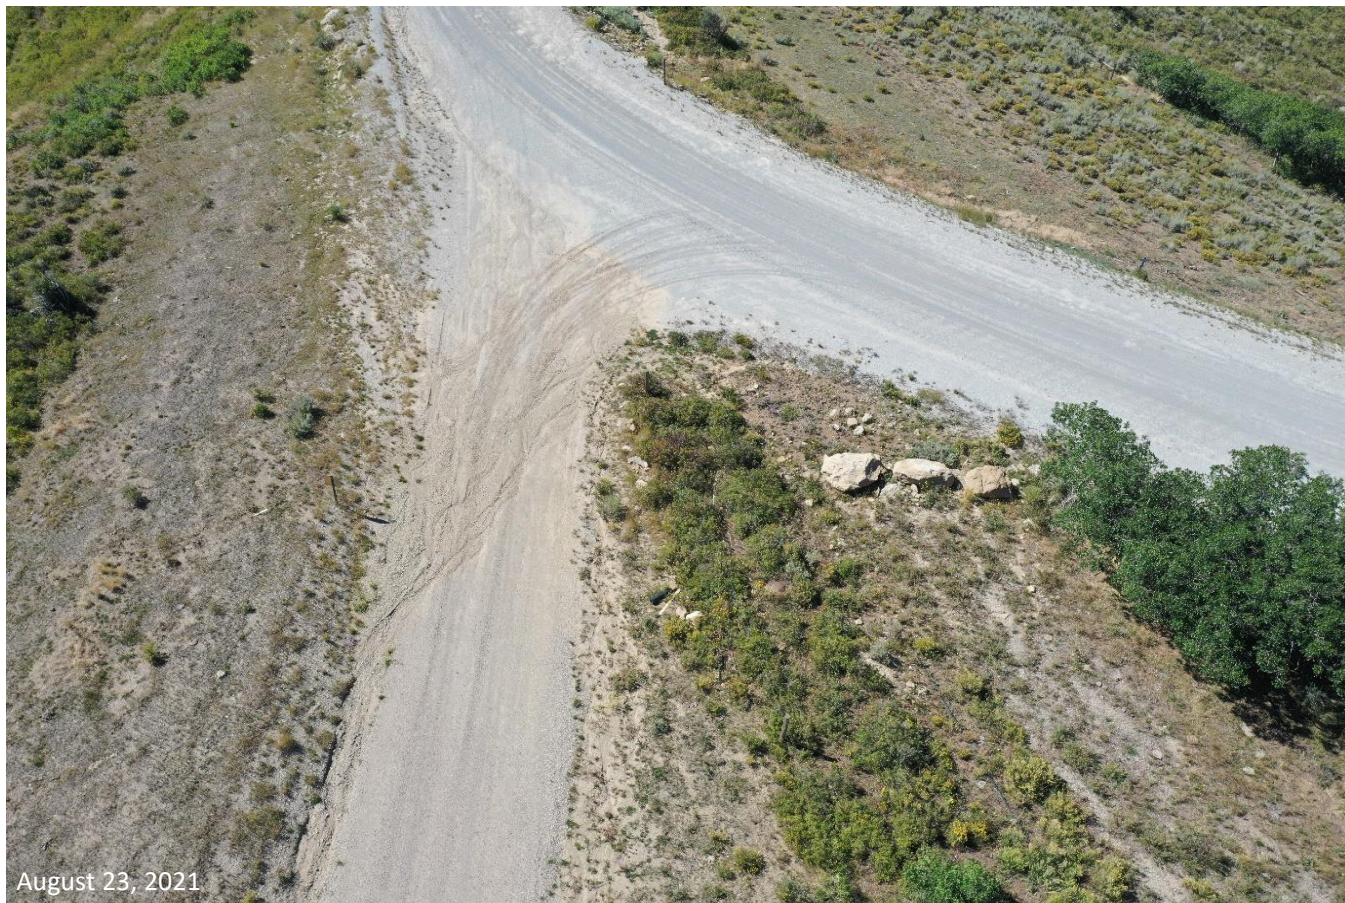
Photo 9: Aerial photo of sediment deposition observed in photo 6
