Final Reclamation Inspection

Operator: PDC ENERGY INC - 69175

Location ID: 331521

Inspection Photos
Location Name: FOE 33-20
Location ID: 331521

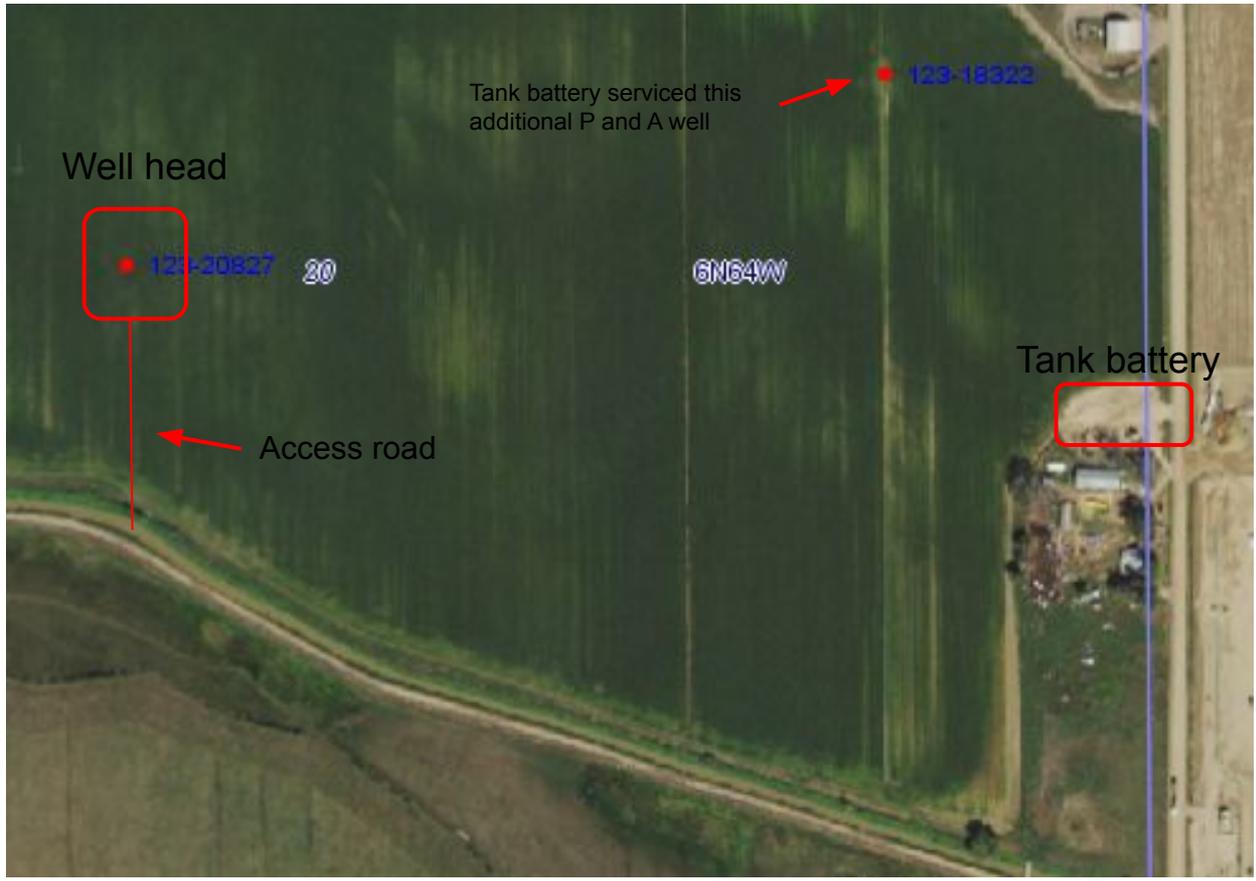
Photo 1. 2019 aerial imagery shows the well location, access road, and associated tank battery.

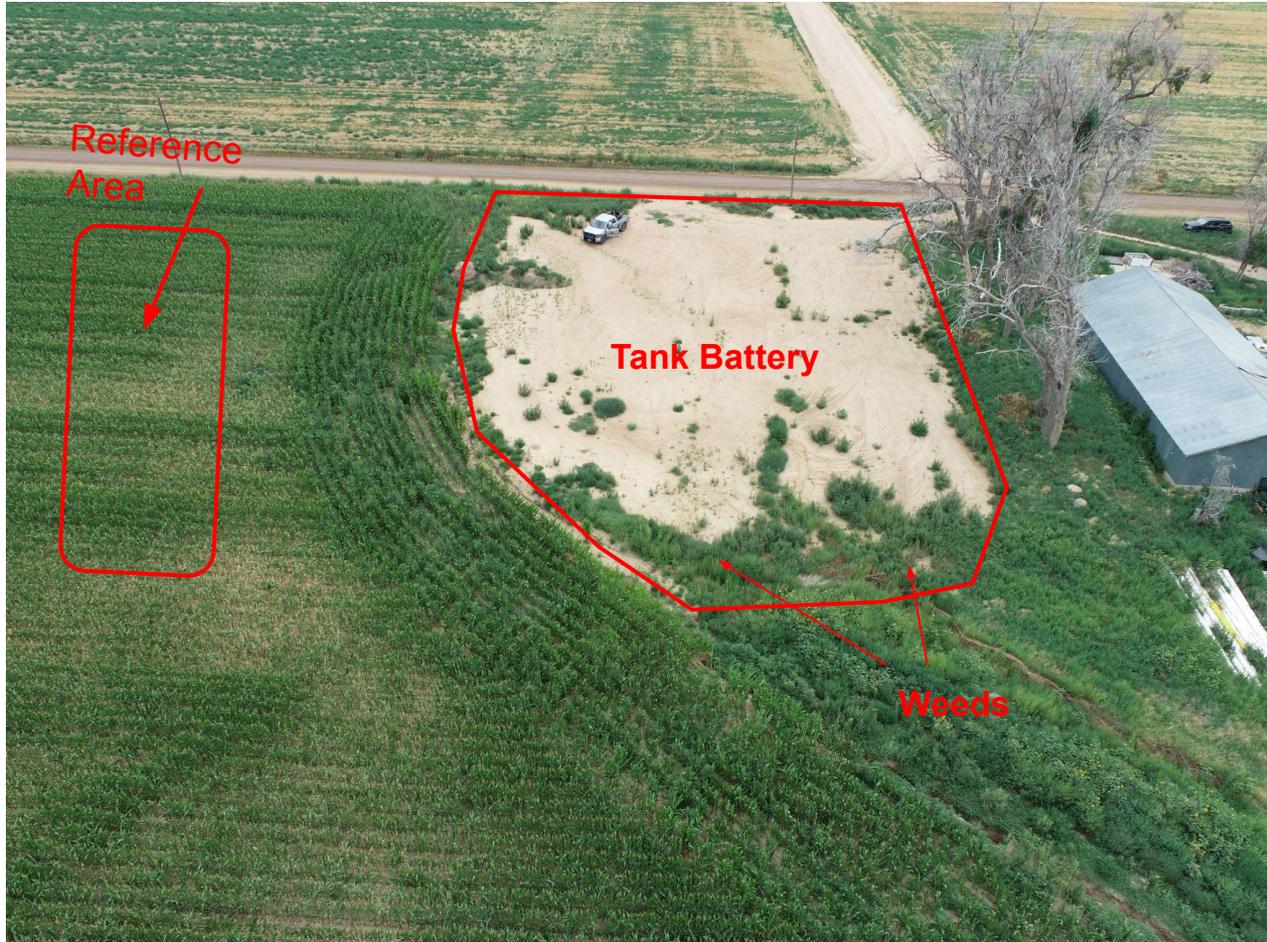
Photo 2. Overview photo of tank battery and reference area using a drone (looking east [up]). Photo illustrates that the tank battery does not comply with rule 1004. Crops have not been re-established to pre disturbance levels. Weedy, annual vegetation is present within portions of the site.

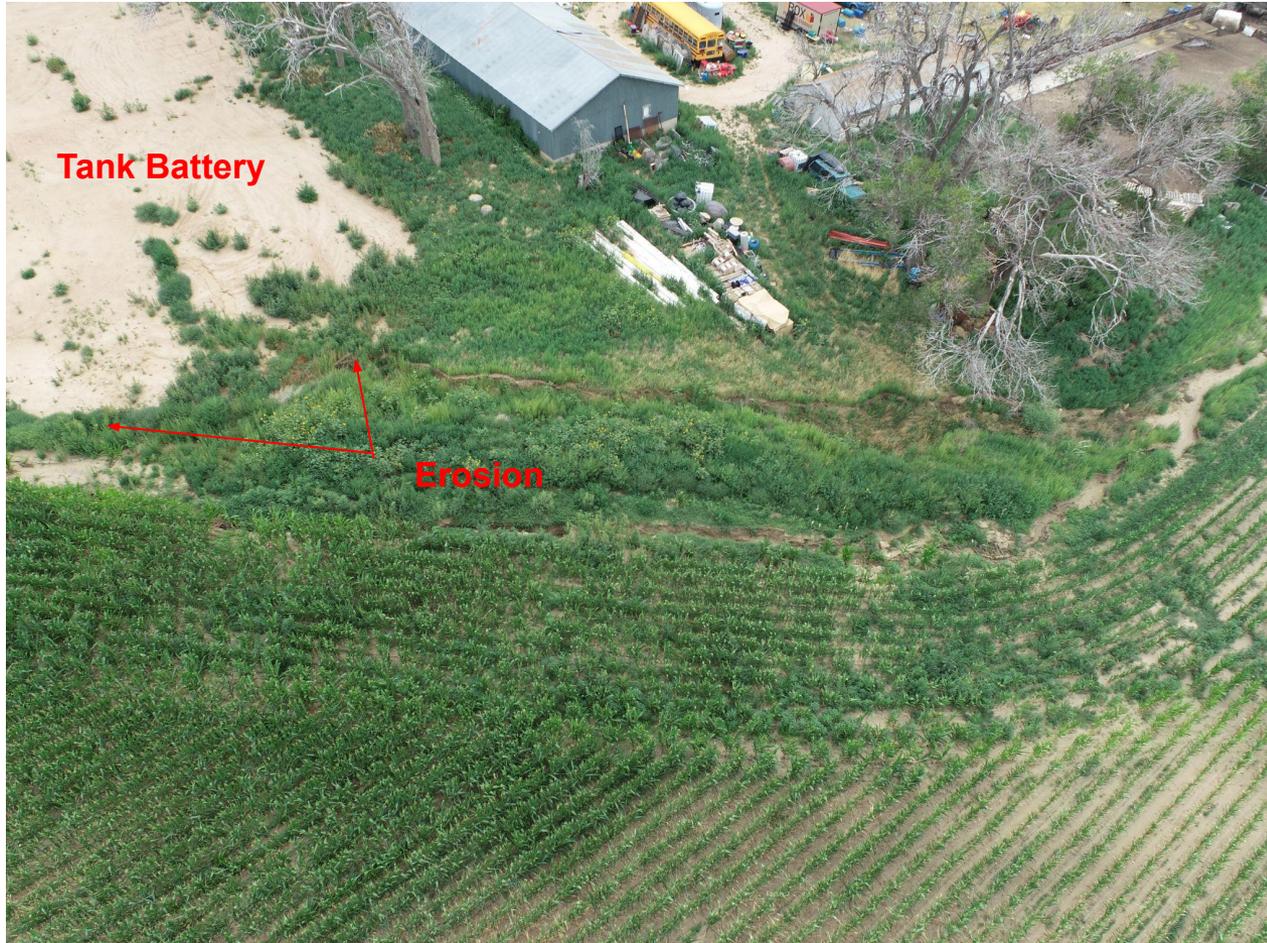
Photo 3. Overview photo of tank battery using a drone (looking southeast [up]). Photo illustrates that the tank battery does not comply with rule 1002.f. It appears that irrigation water from the adjacent crop fields are draining towards the western portion of the tank battery. This is causing channelized flows that are causing gully erosion associated with the site.

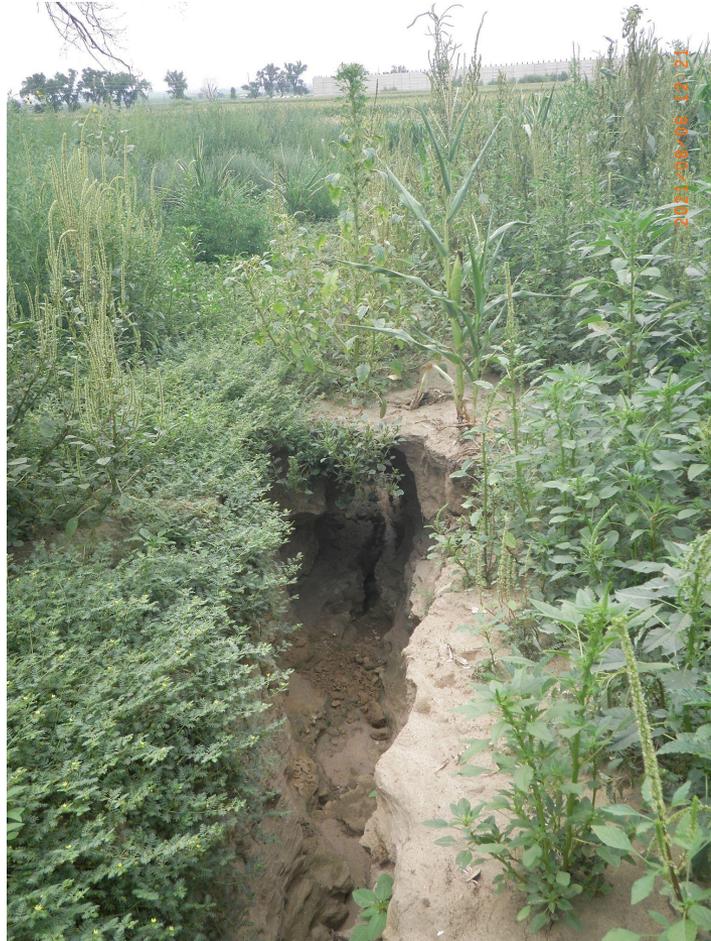
Photo 4. Photo along western edge of tank battery (looking southwest). Photo illustrates channelized flows that are causing gully erosion adjacent to the site. See comments in photo 3.

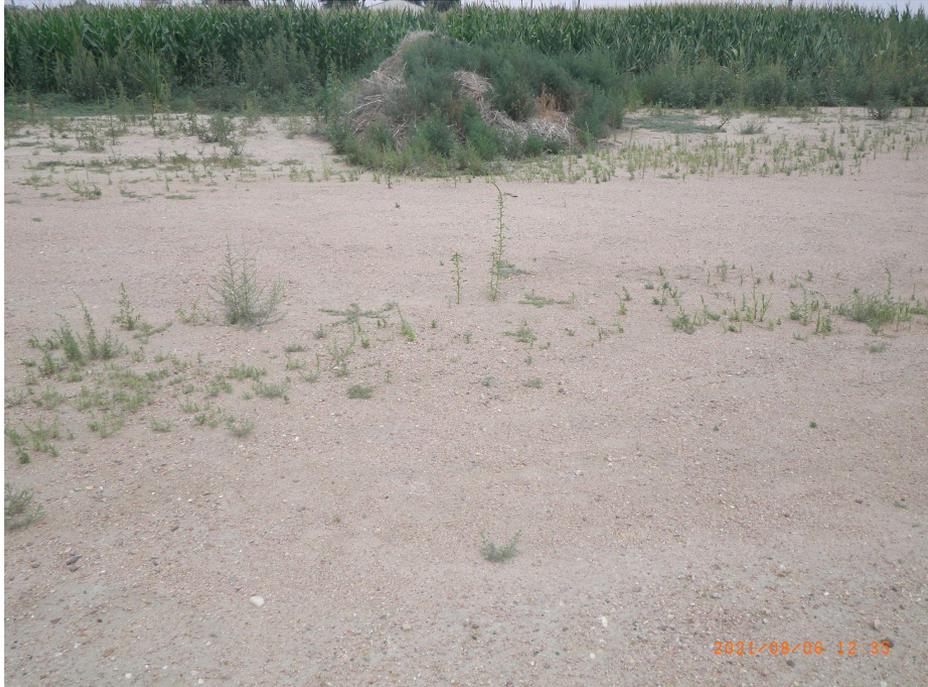
Photo 5. Photo taken from the tank battery, facing North. See comments under Photos 2 and 3.

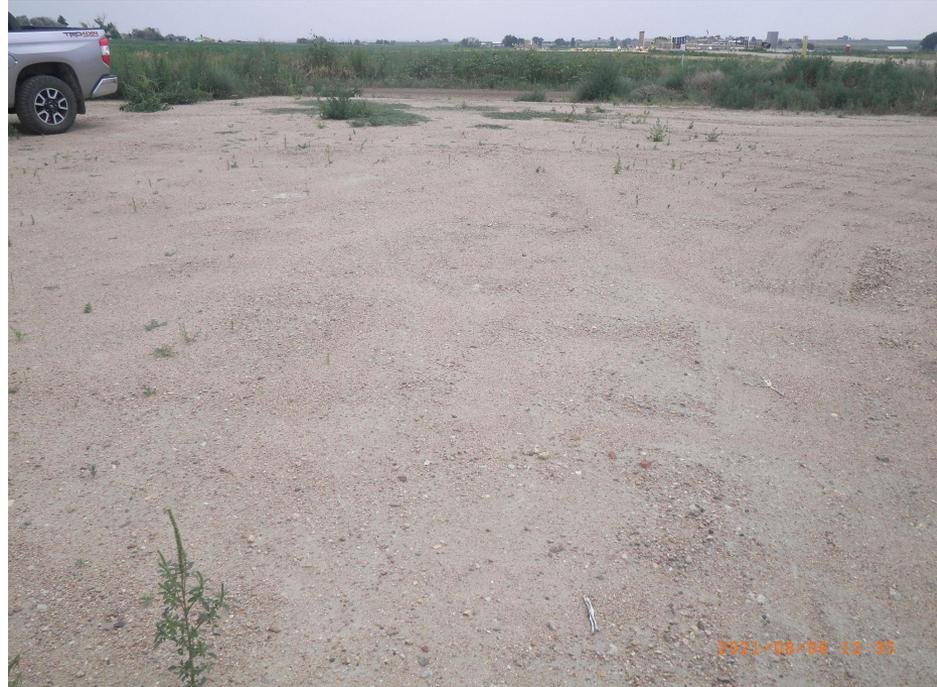
Photo 6. Photo taken from the tank battery, facing East. See comments under Photos 2 and 3.

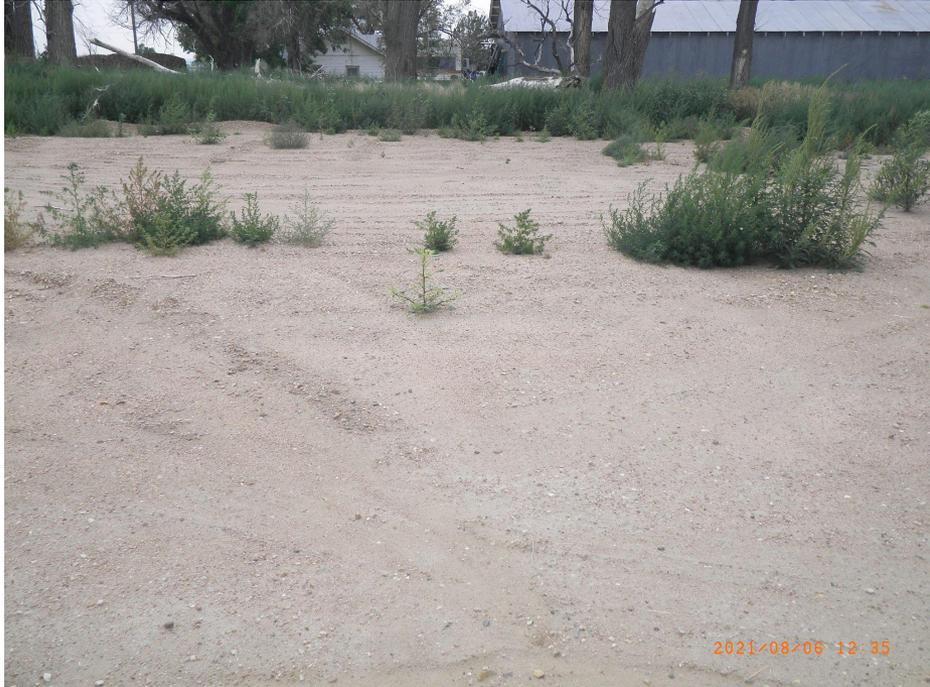
Photo 7. Photo taken from the tank battery, facing South. See comments under Photos 2 and 3.

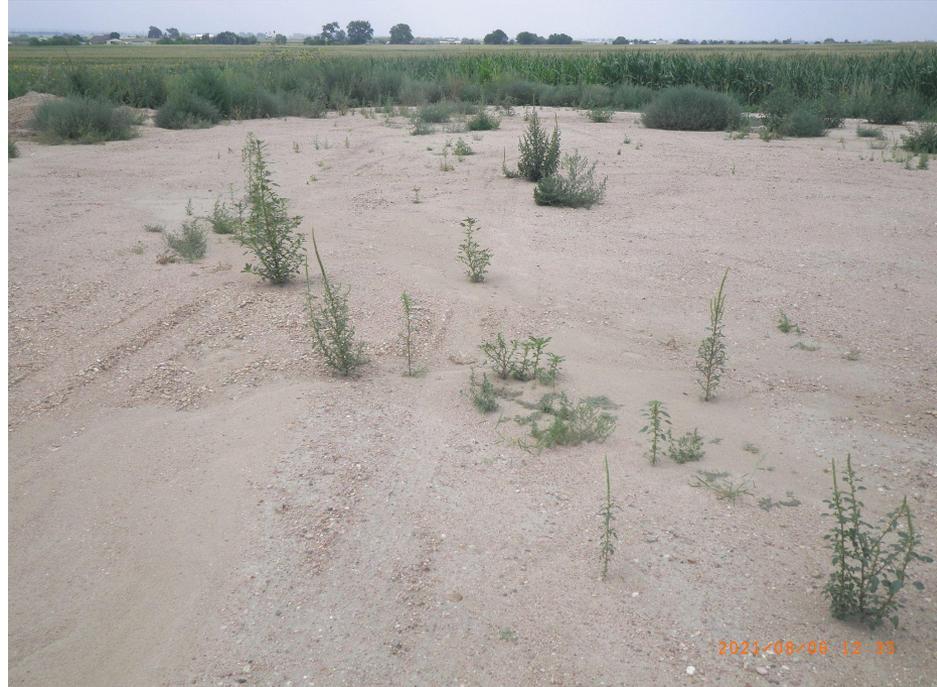
Photo 8. Photo taken from the tank battery, facing West. See comments under Photos 2 and 3.

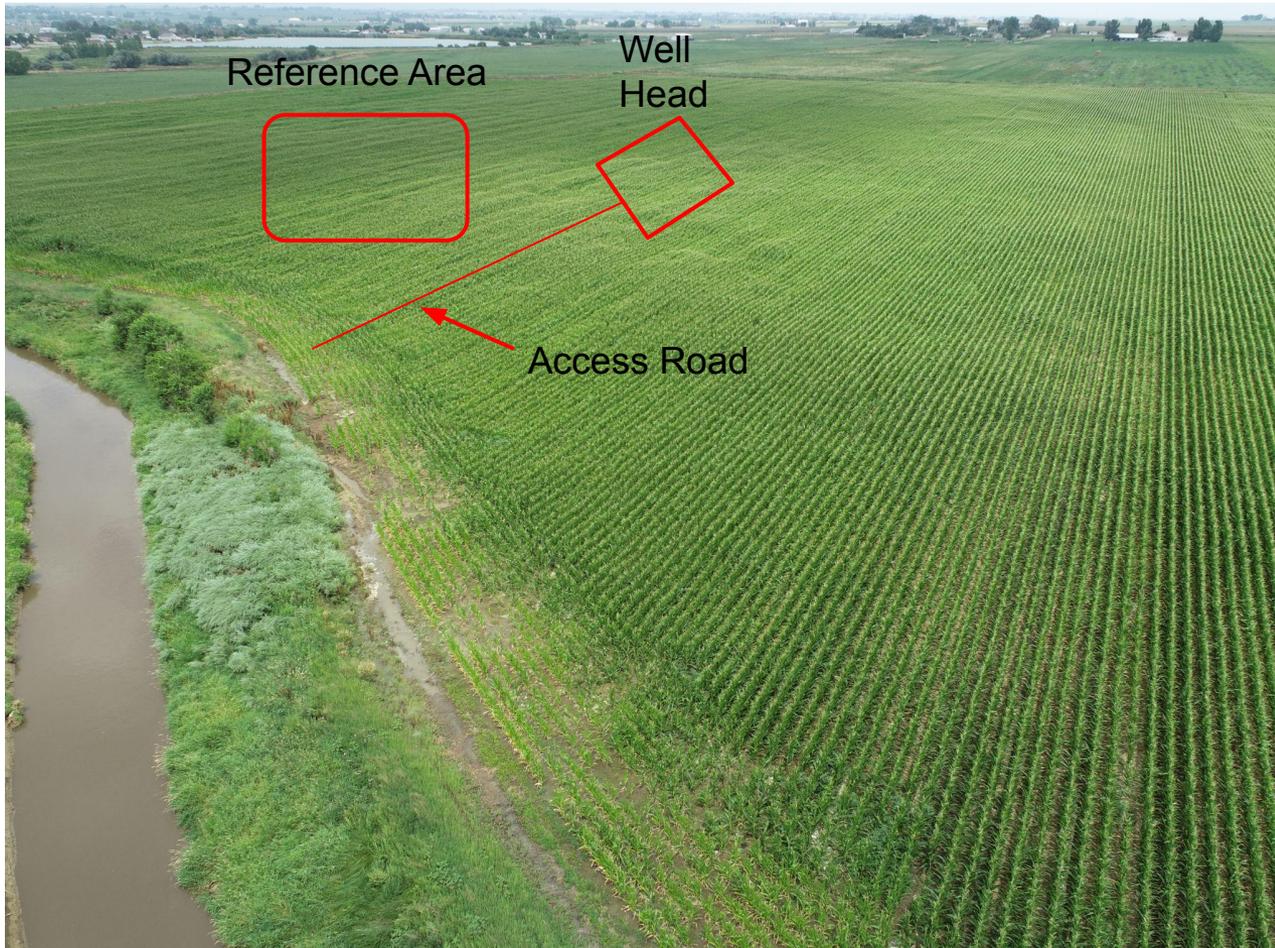
Photo 9. Overview photo taken using a drone, looking north towards the access road, well head, and reference area. Photo shows the well location and access road appear to meet final reclamation requirements.

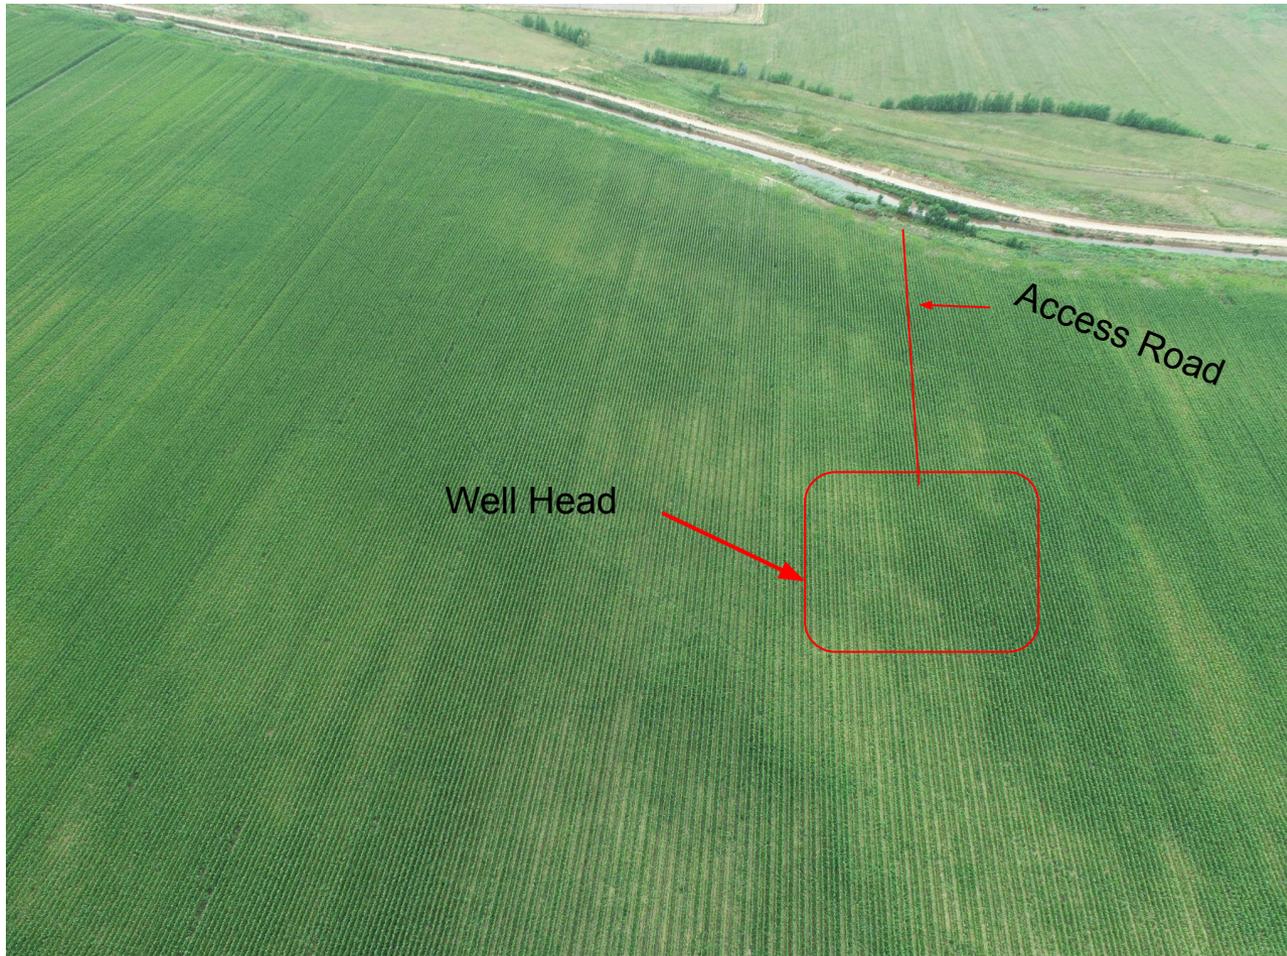
Photo 10. Overview photo taken using a drone, looking south towards the well head and access road. Photo shows the well location and access road appear to meet final reclamation requirements.
