RE: Taproot – Produced Water Release, Boomslang Pad, Briggsdale, CO

Taproot. ER for produced water at the Boomslang Pad near Briggsdale, CO.
EWI Project #212500. A1.

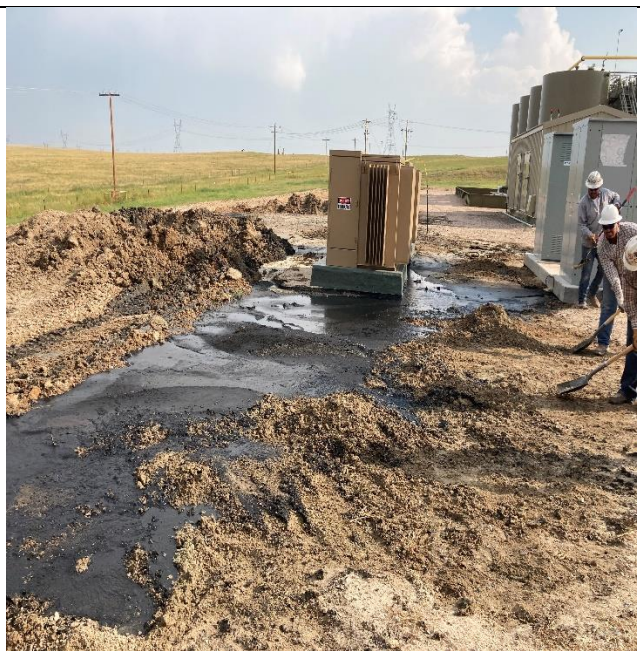
Photo: 1

Initial site conditions at the Boomslang Pad.

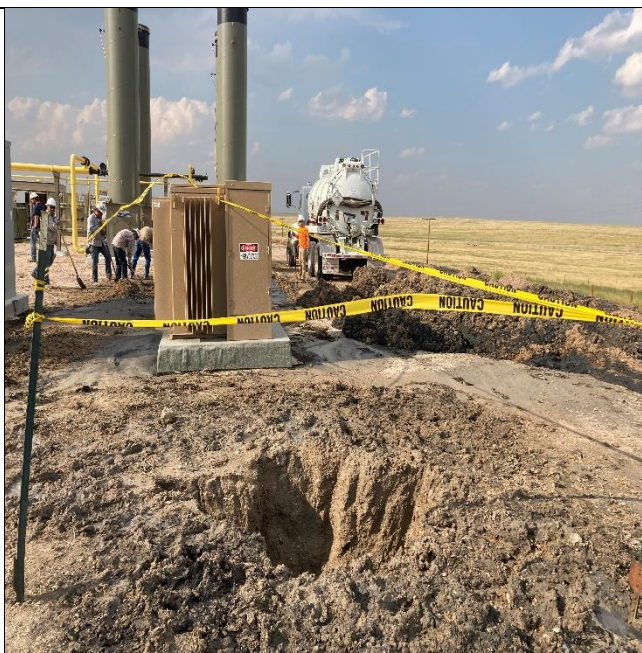
Photo: 2

Initial site conditions at the Boomslang Pad.

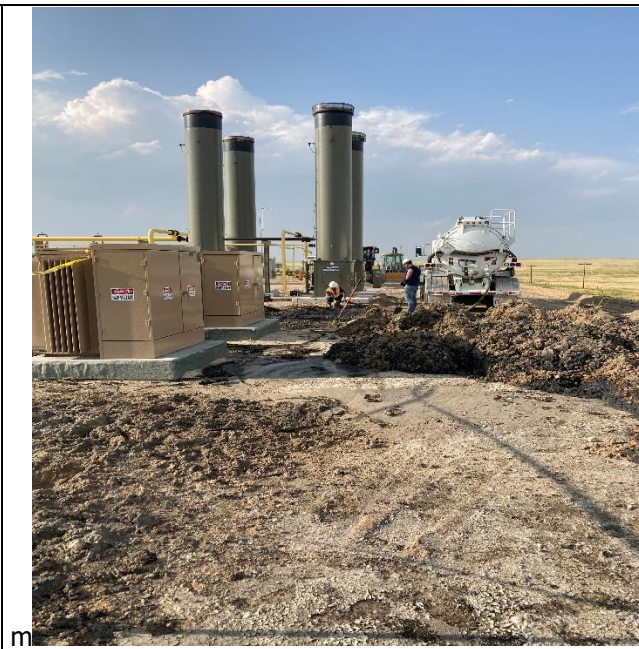
Photo: 3

Initial site conditions at the Boomslang Pad.

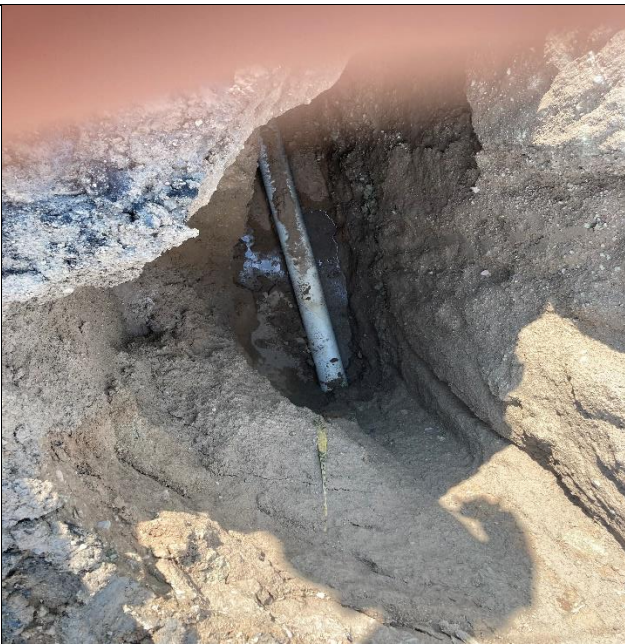
Photo: 4

A view where the line break occurred.

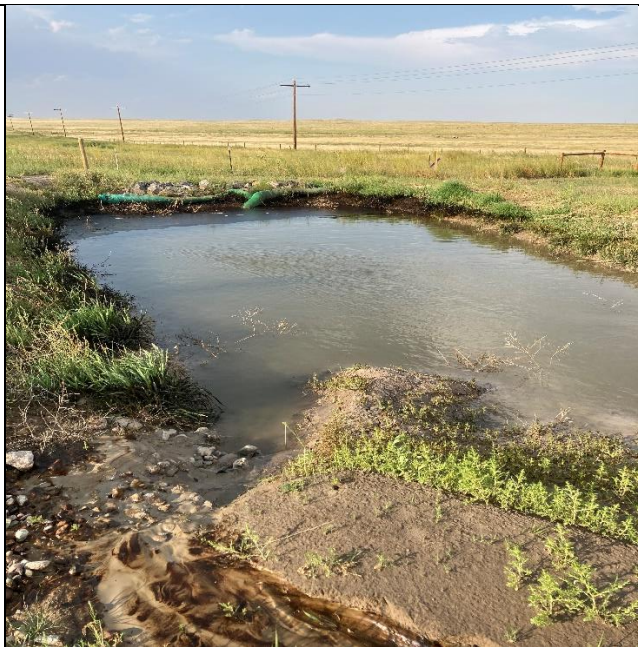
Photo: 5

A view of the collection area/retention pond impacted with product.

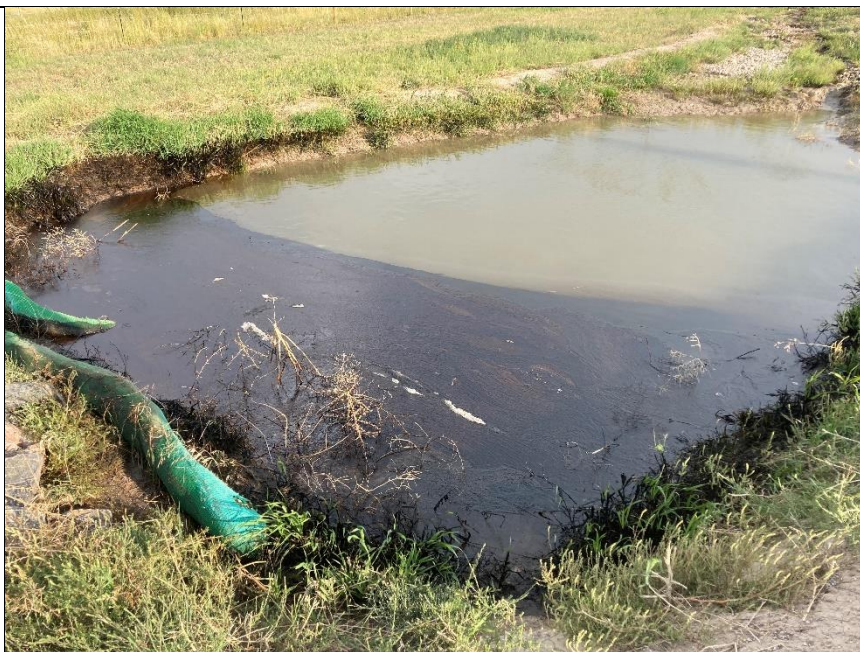
Photo: 6

Another view.

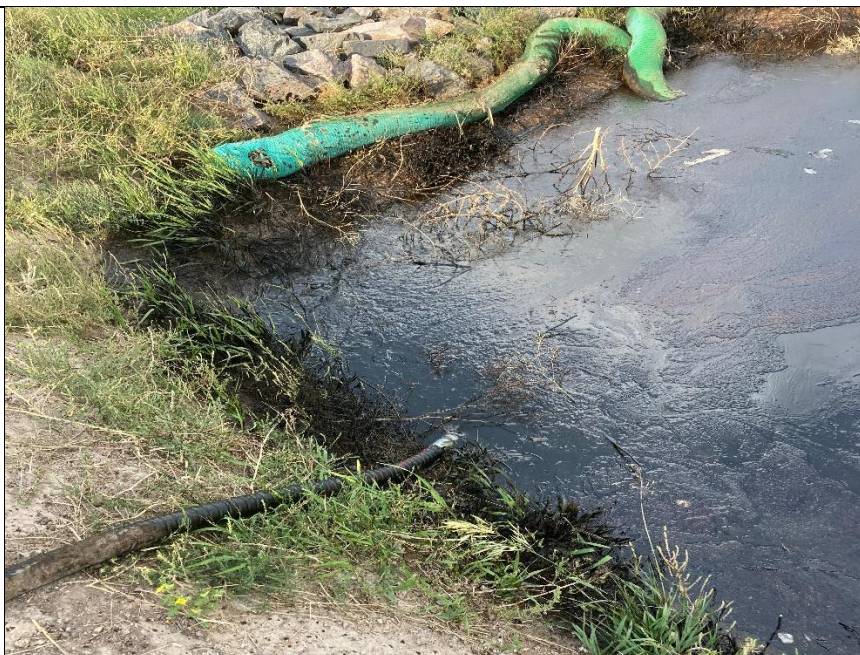
Photo: 7

Another view.

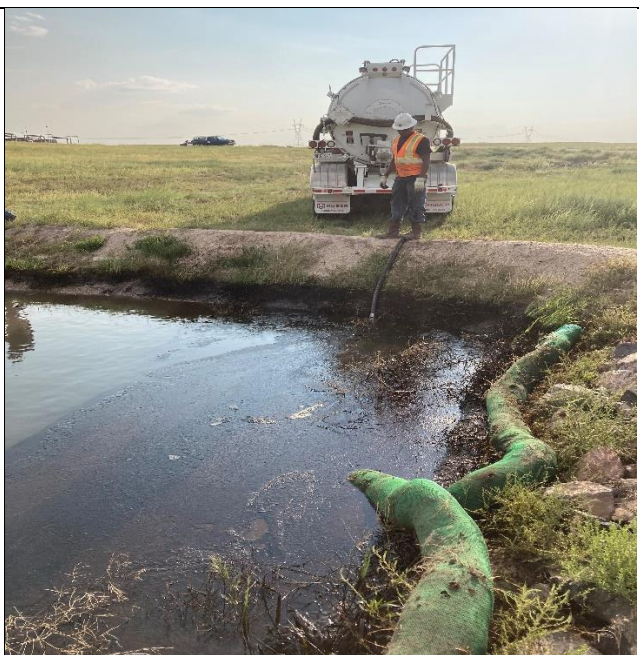
Photo: 8

EWI vacuum truck removing liquids from the pond.

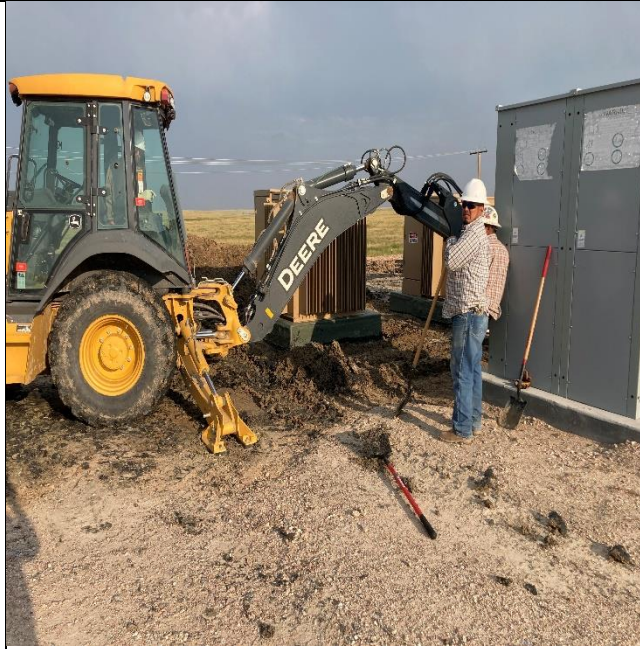
Photo: 9

Surface scrape at the Boomslang Pad.

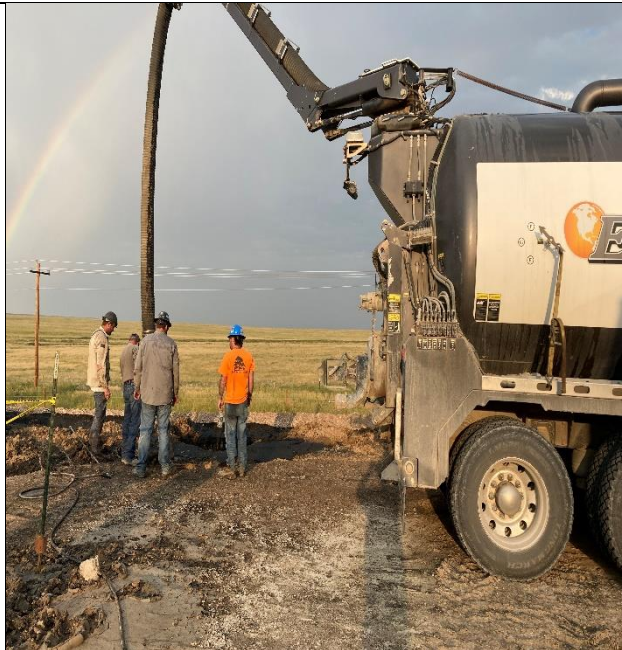
Photo: 10

The hydro-vac excavating and finding the line break.

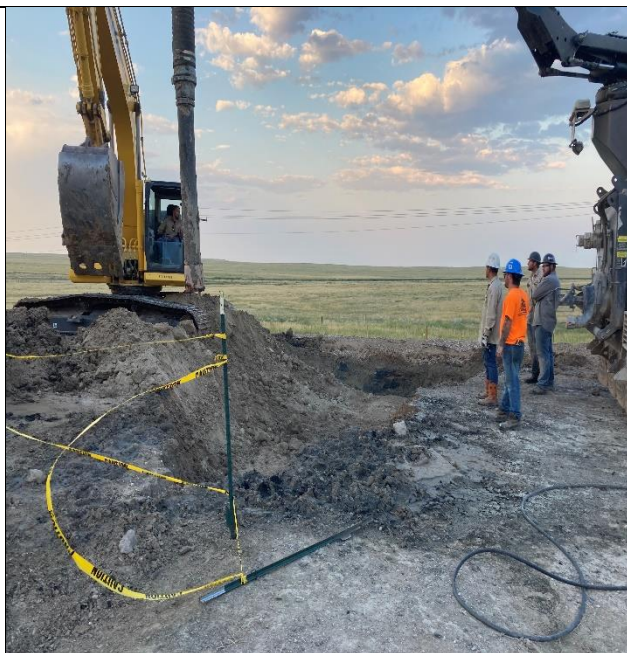
Photo: 11

Excavator onsite to excavate impacted soil.

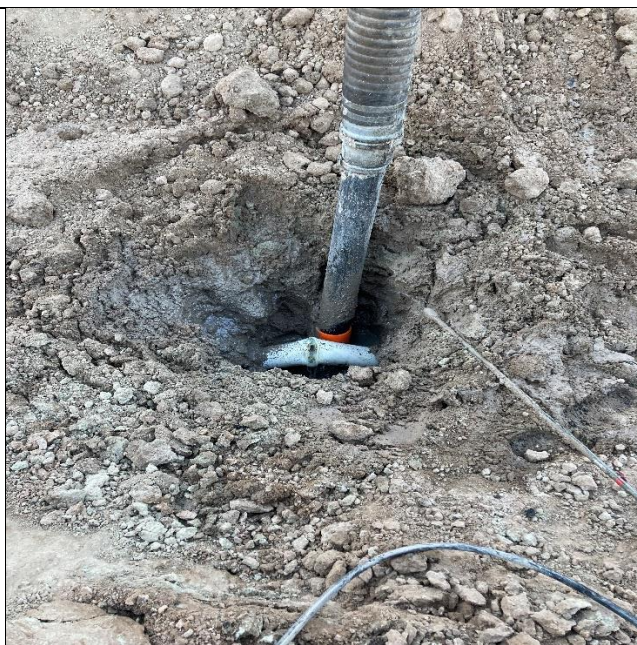
Photo: 12

Line break discovered.

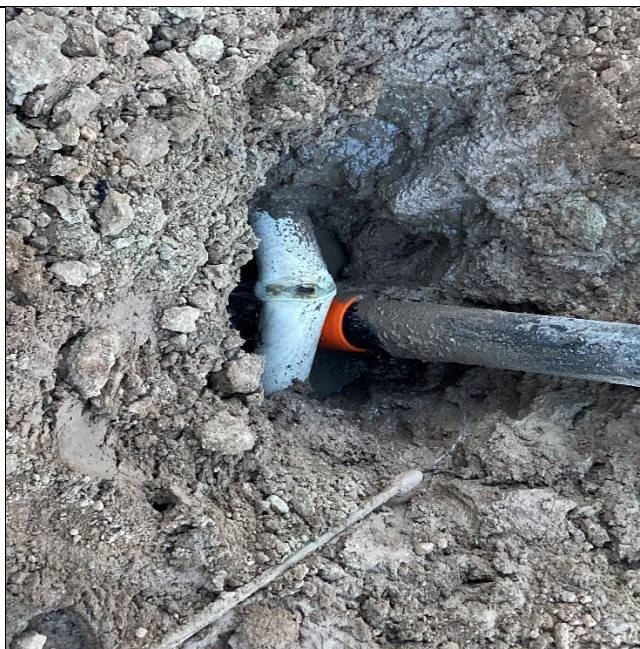
Photo: 13

Additional view of the line break.

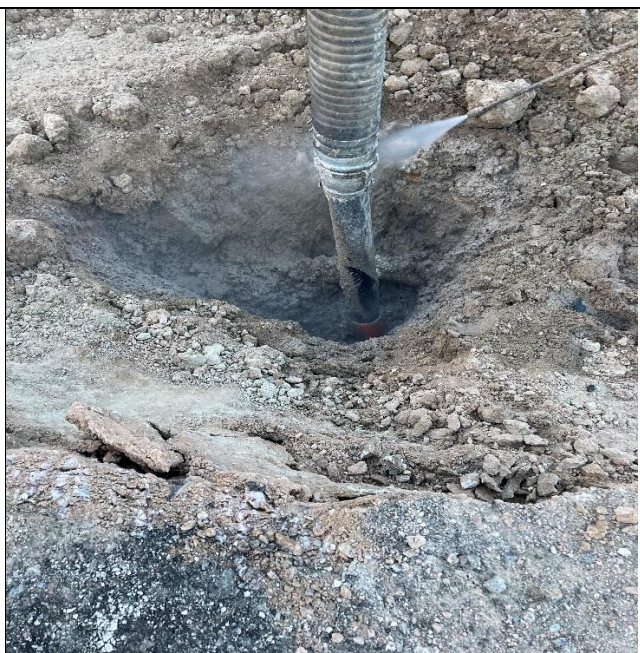
Photo: 14

Hydro excavator at work locating the line break.

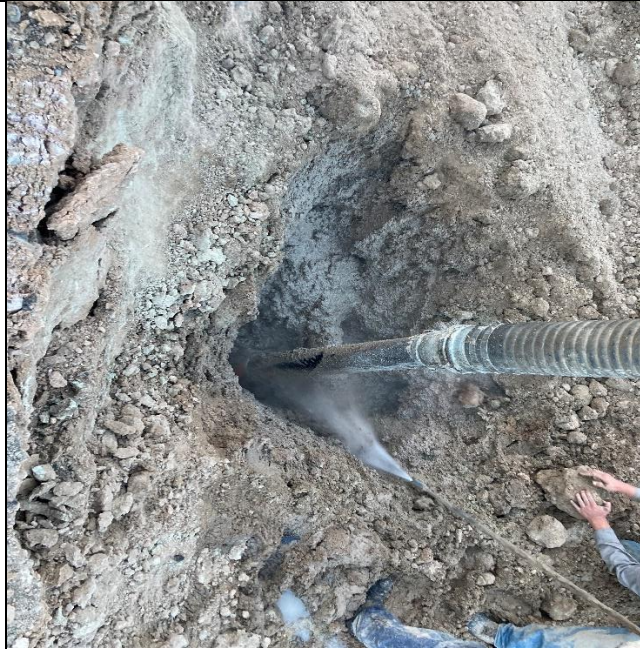
Photo: 15

Hydro excavator at work
locating the line break.
