# Inspection Photos

Operator: Western Gas Resources  
API: 067-06178  
Date: 8/26/2021

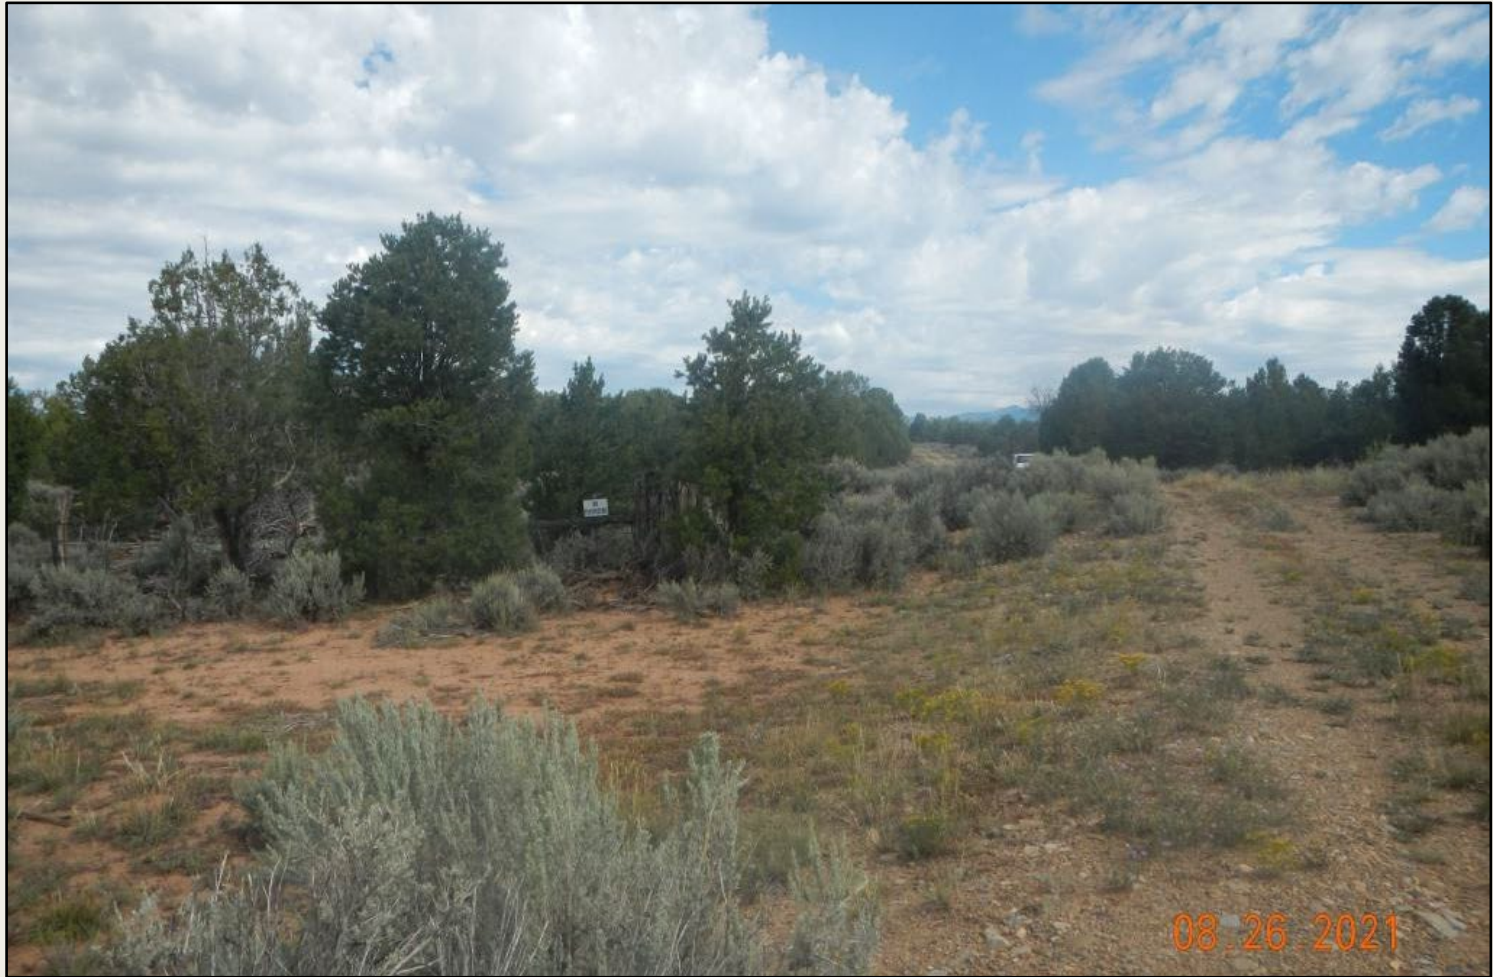
Photo 1. View of area where eastern riser (1 of 2 risers) was removed, southeast of well pad and access road, facing northward.

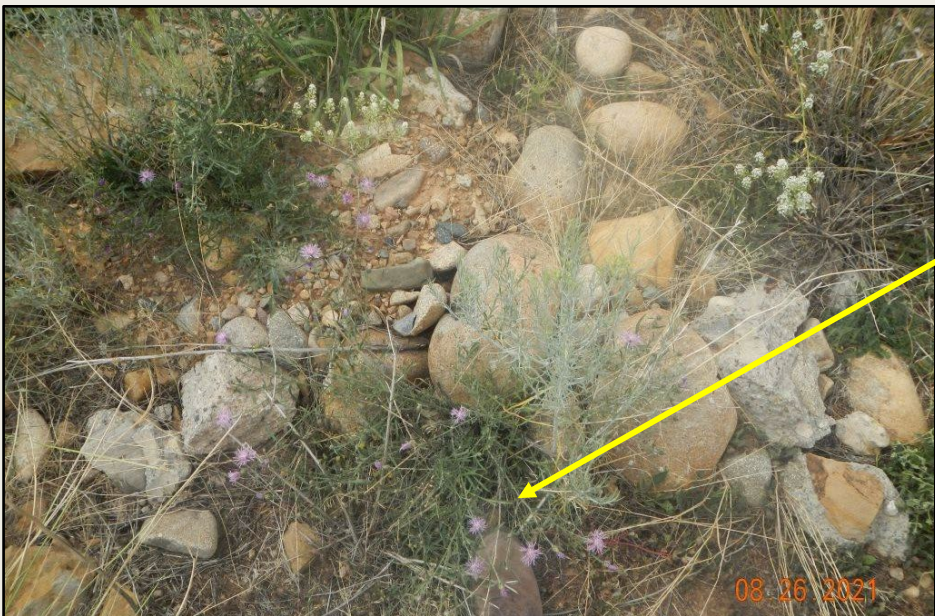
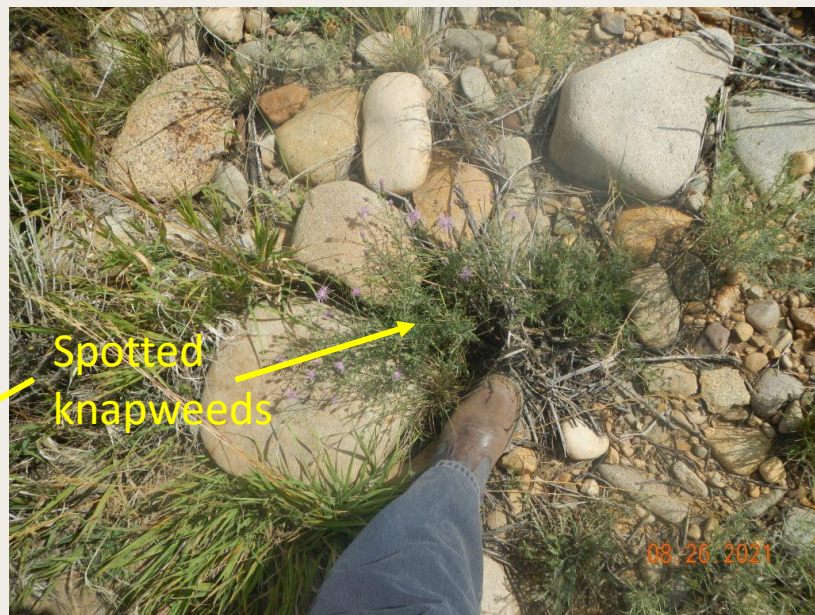
Photos 2/3. View of spotted knapweeds observed within the project area. Approximately 30 individuals observed, and less than 10 yellow toadflax.

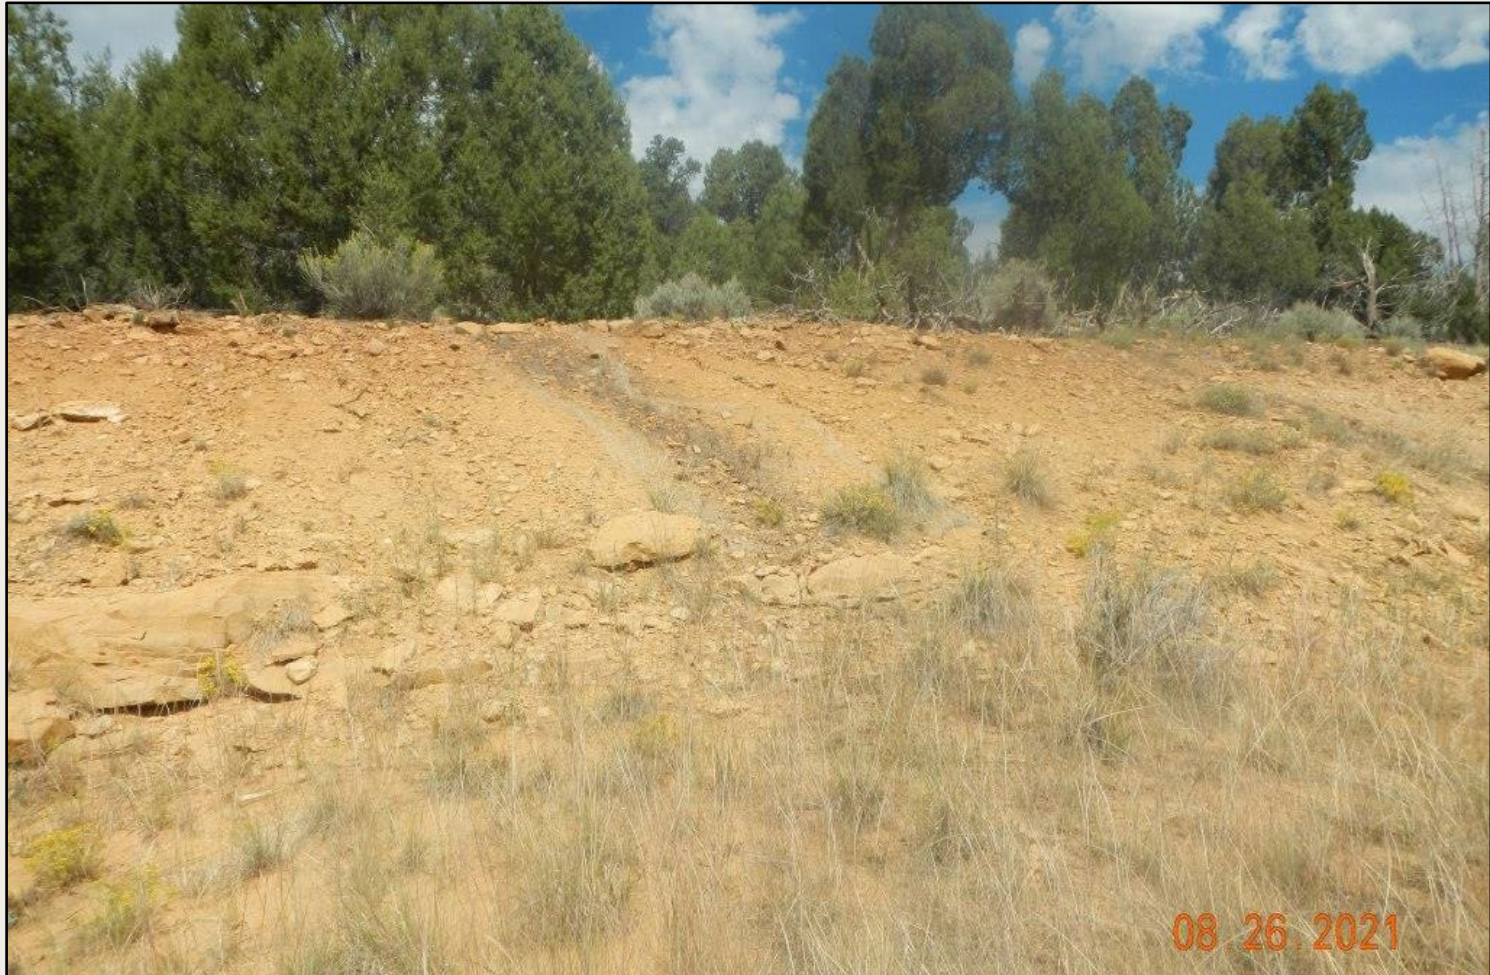
Photo 4. View of portion of the southwestern cut-slope that remains unstabilized and lacking revegetation.

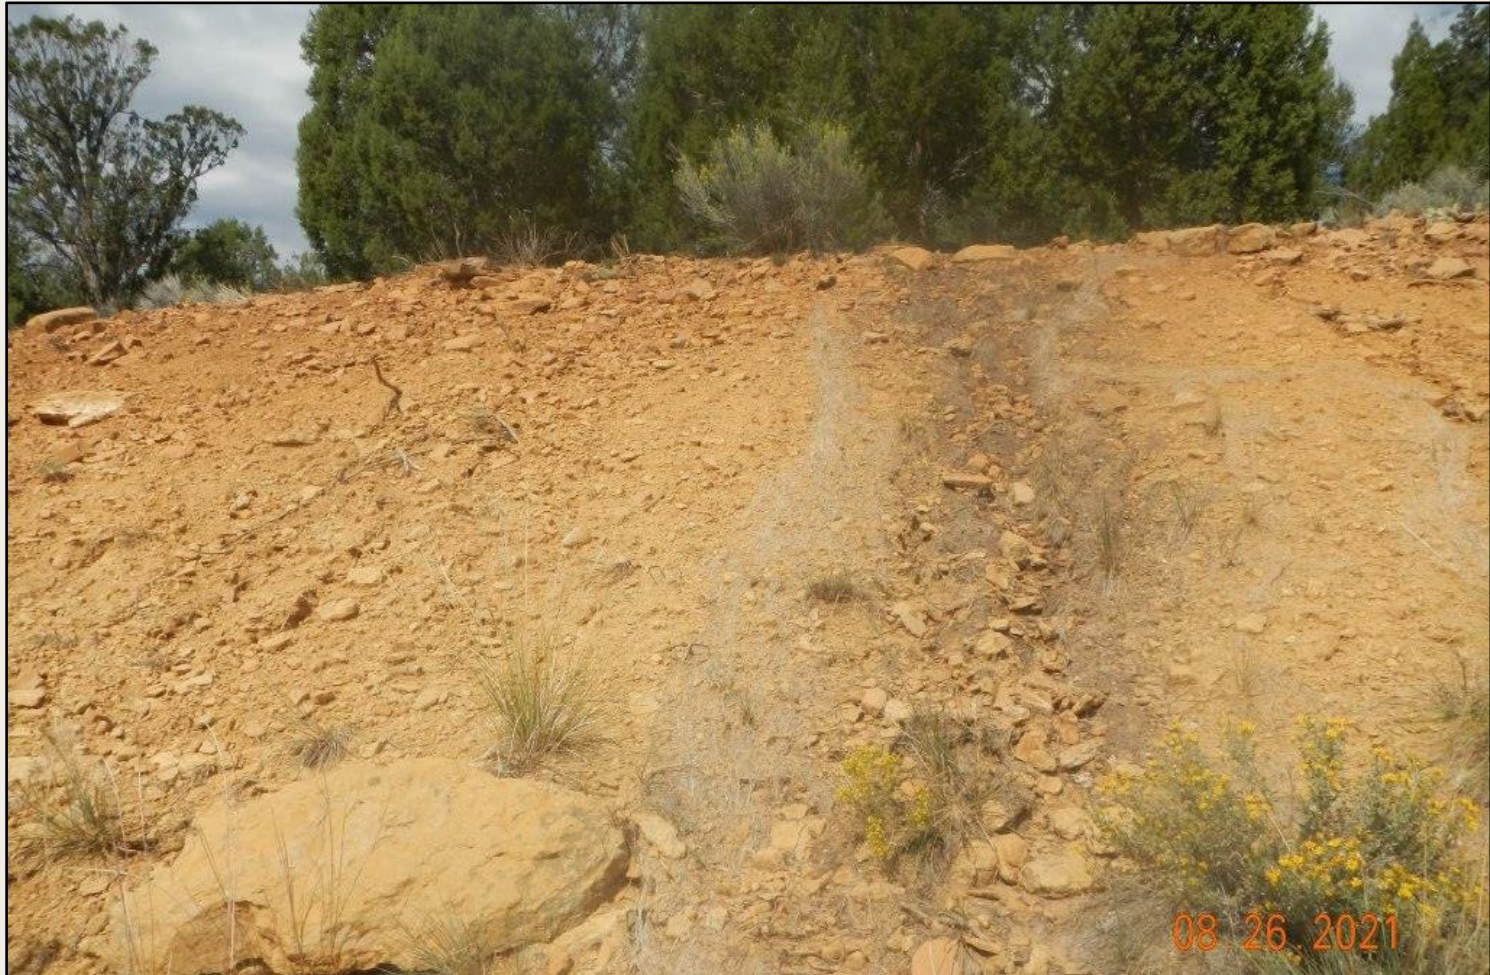
Photo 5. Closeup view of portion of cut-slope that remains unstabilized. BMP is degraded and rilling is occurring on the slope.

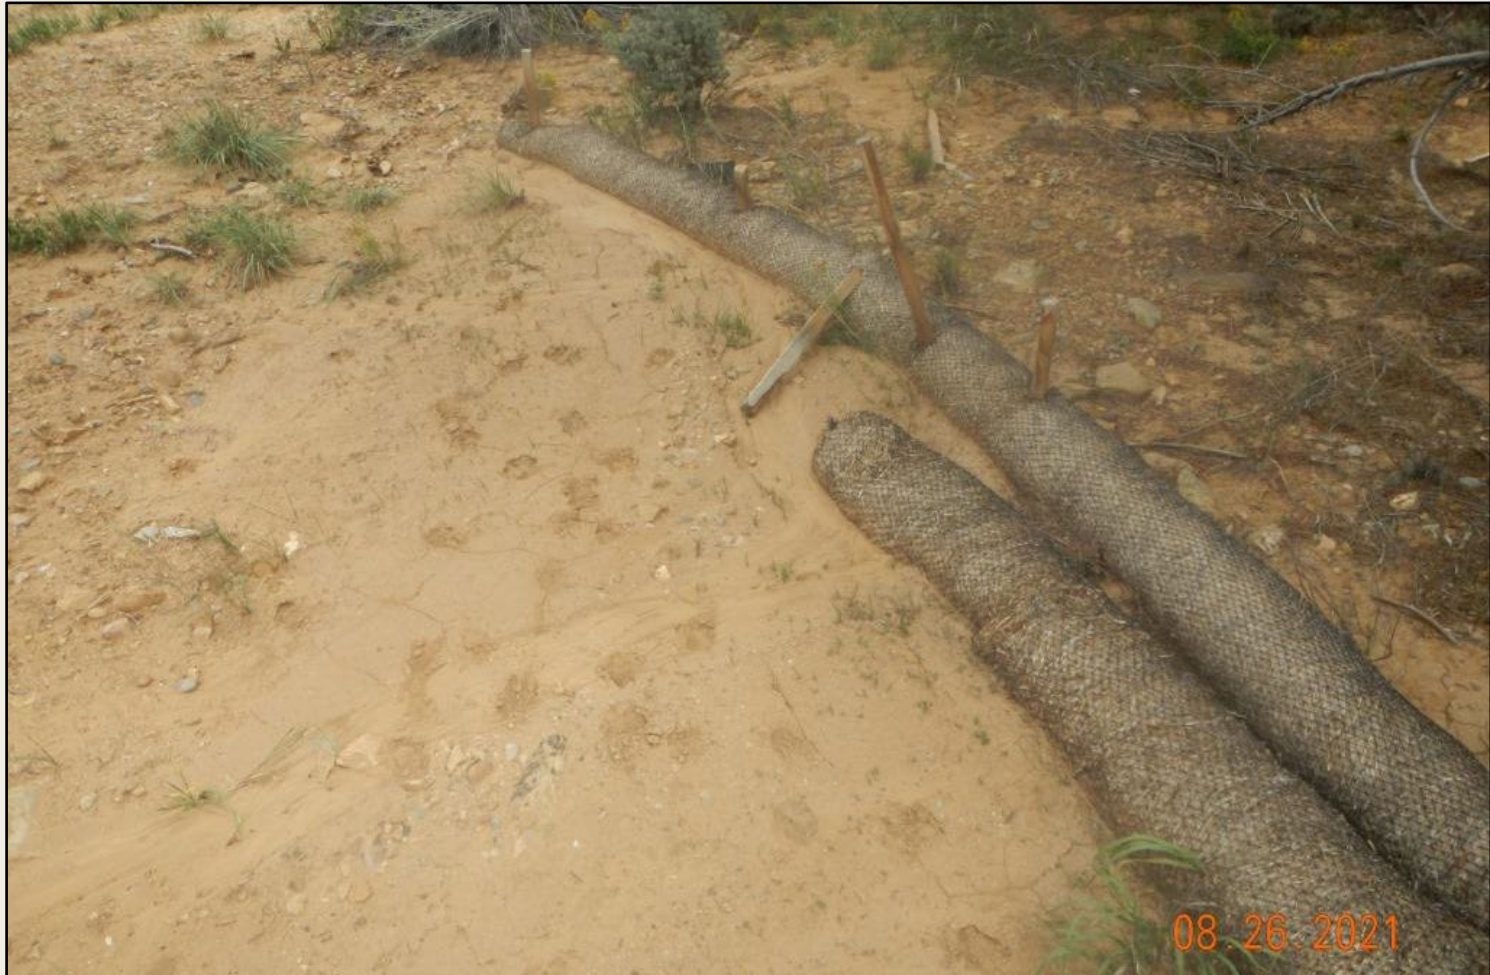
Photo 6. View of wattles in the southern project area, that are full of sediment and need stabilization. Additional seeding is needed here for long-term stabilization.
