Inspection Photos
Operator: Williford
API: 067-05446
Date: 8/25/2021

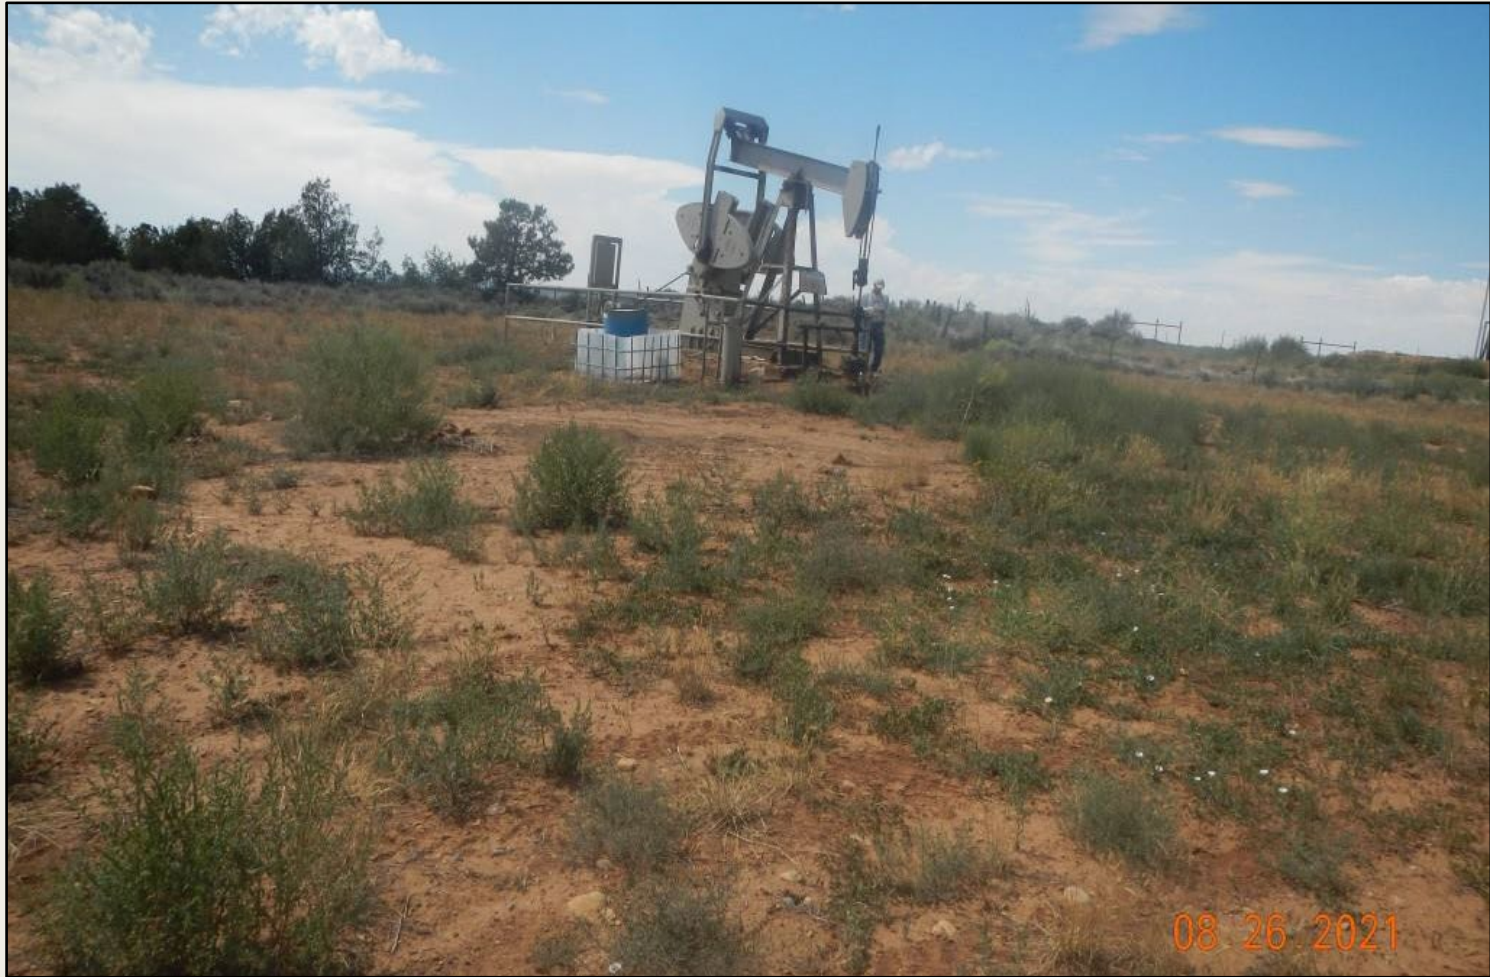
Photo 1. View of the project area from the northeastern corner facing center.

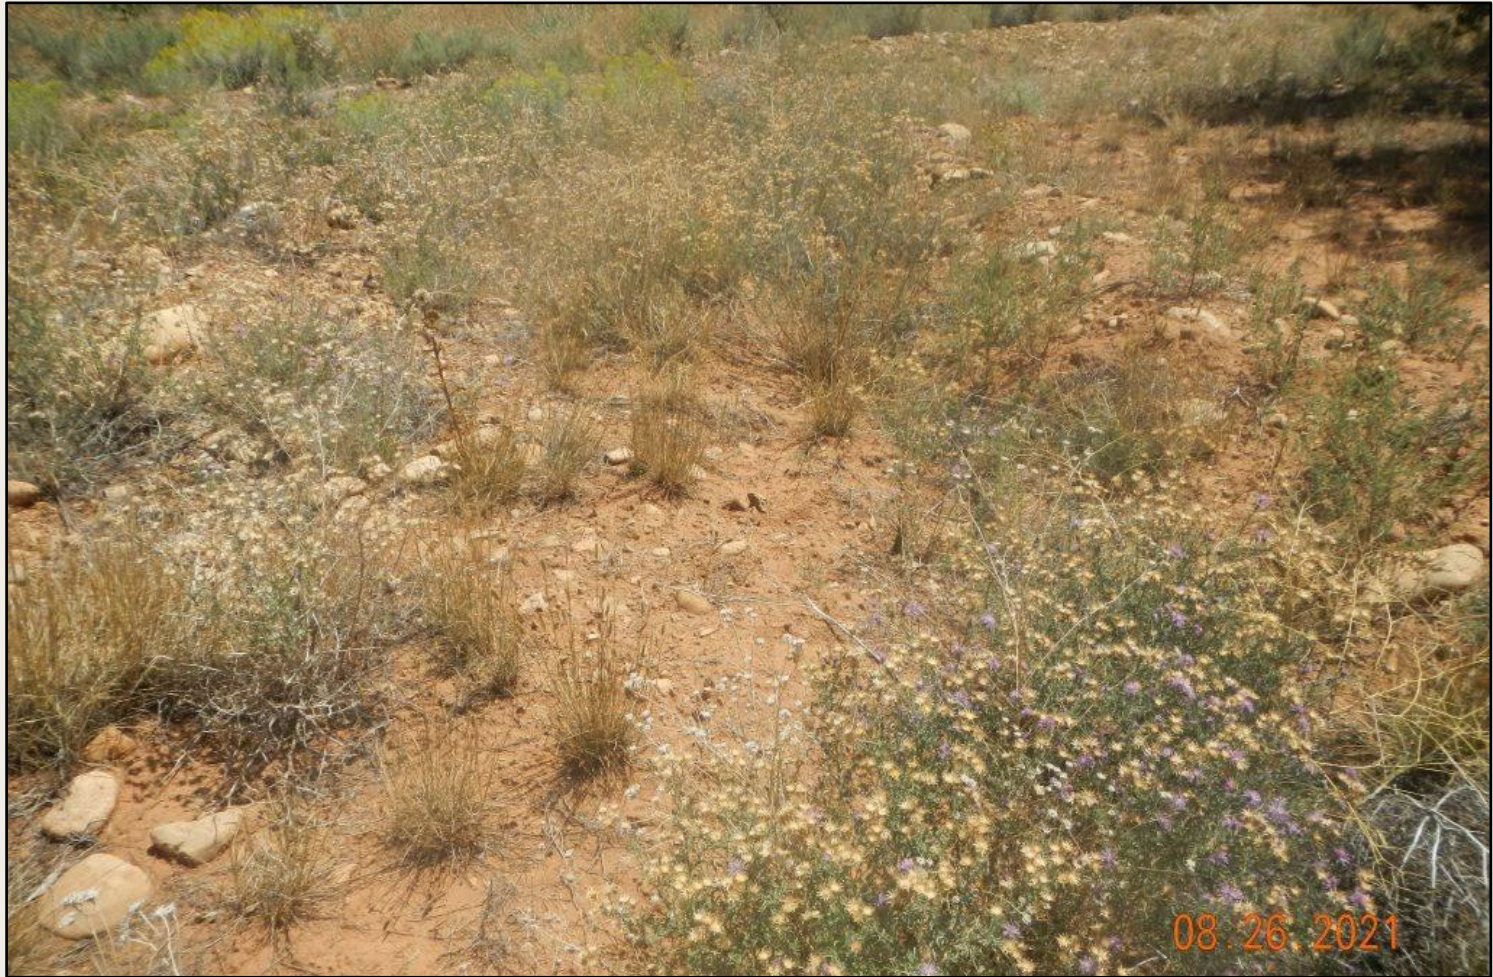
Photo 2. View of spotted knapweed observed on the eastern fill lope drainage. Approximately 200 individuals observed.

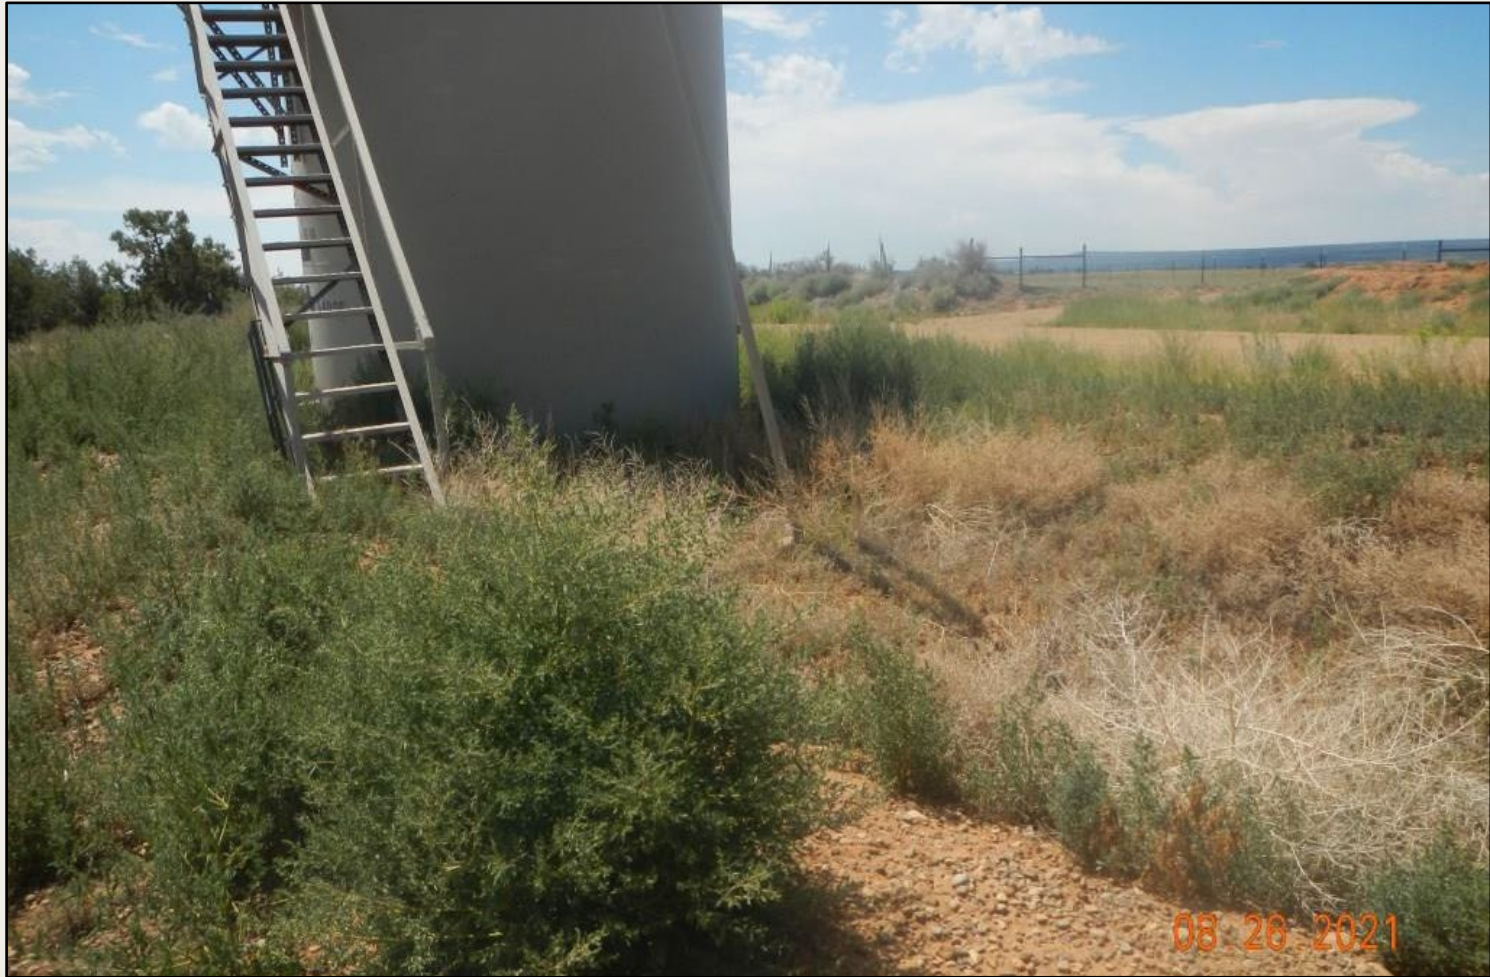
Photo 3. View of dense weedy vegetation (kochia and Russian thistle) growing in the tank battery berm and containment.
