# Inspection Photos

API: 071-06902

Operator: EVERGREEN NATURAL RESOURCES

Inspection Date: 8/27/2021

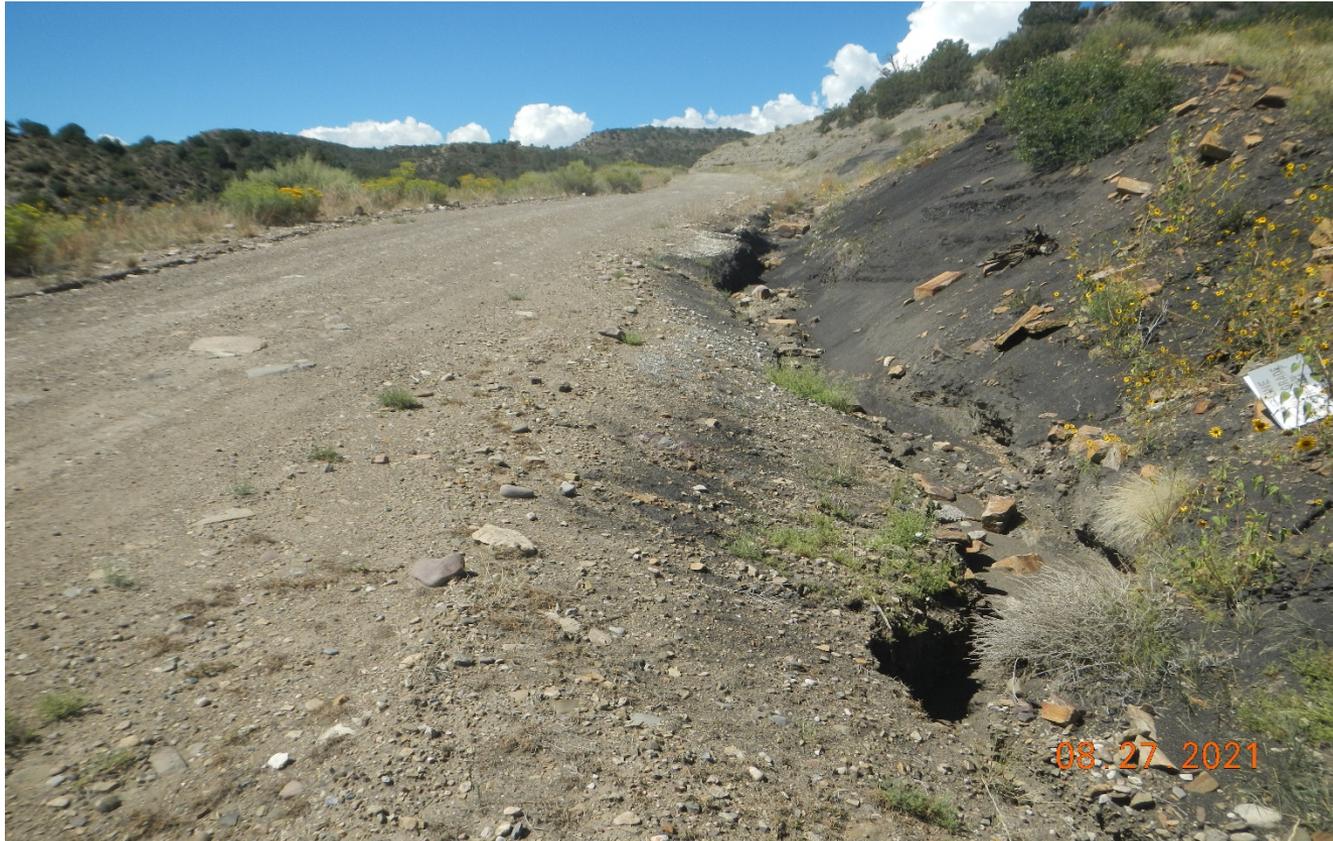
**Photo 1.** Facing southwest along the main road to the well site. There is erosion along the road which is causing sediment accumulation at the culvert and at the main road in Lorencito Canyon.

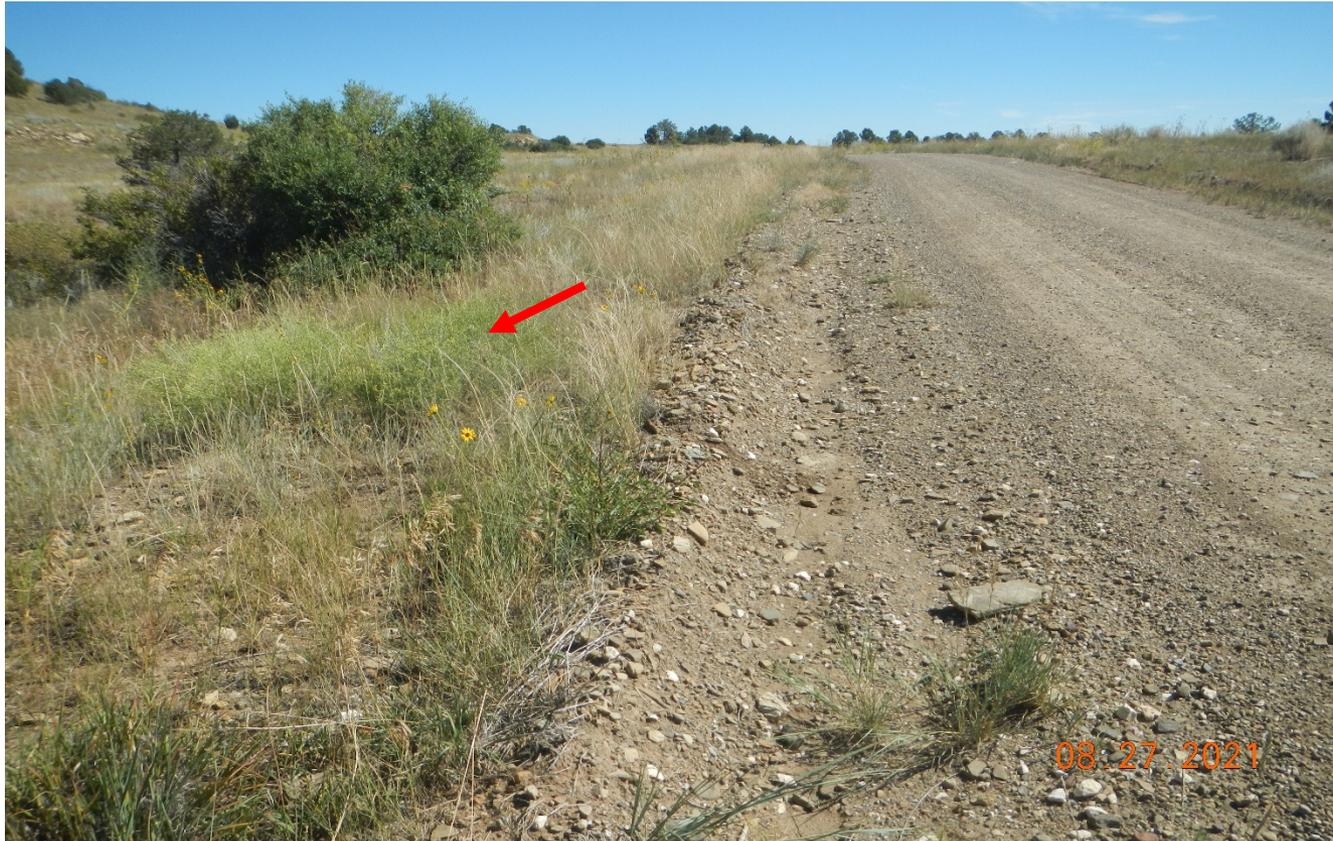
**Photo 2.** Facing northeast along the main road to the well site. There are noxious weeds (Diffuse knapweed) along the road that needs to be controlled. Some of the noxious weeds are beginning to disperse seed.

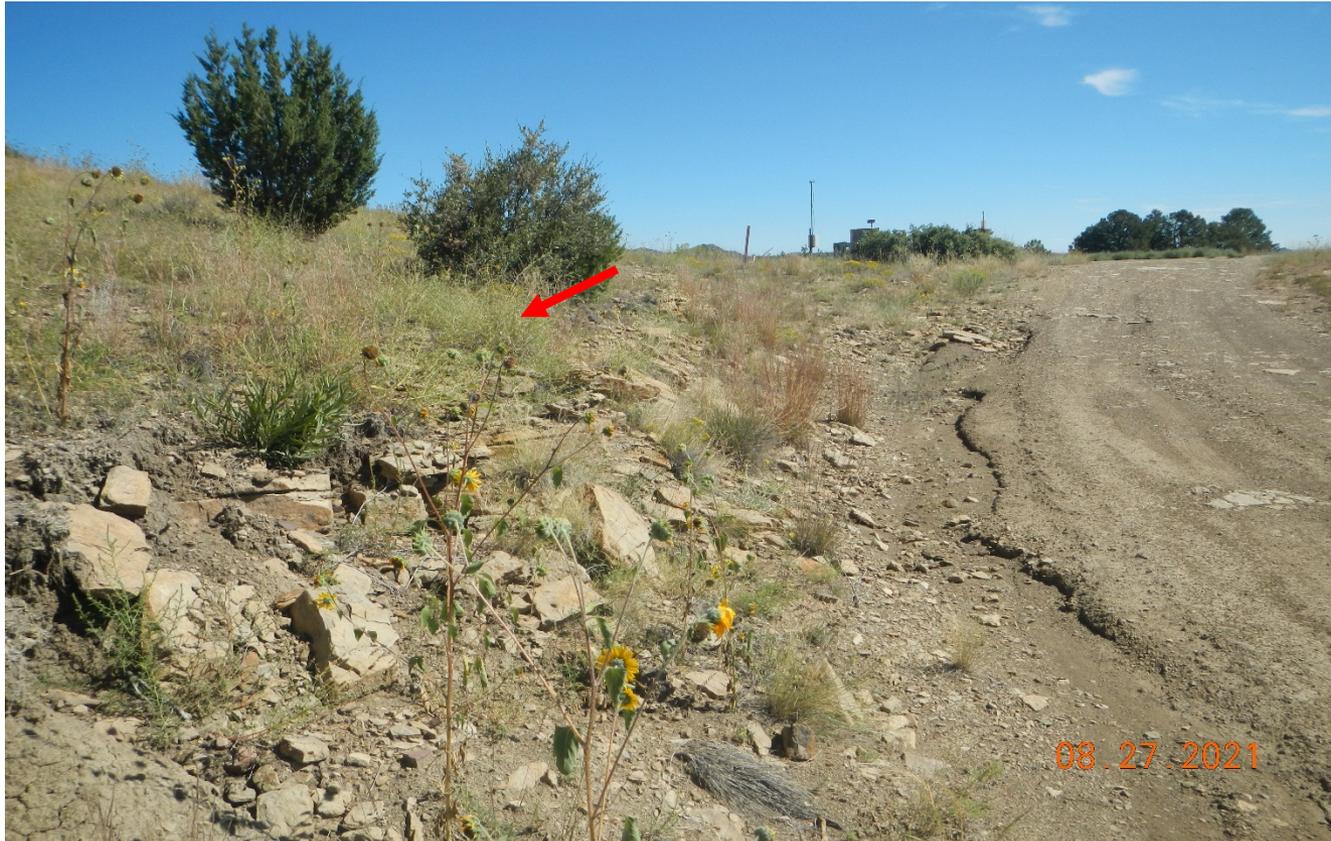
**Photo 3.** Facing northeast along the access road to the well site. There are noxious weeds (Diffuse knapweed) along the road that needs to be controlled. Some of the noxious weeds are beginning to disperse seed.
