**Inspection Photos**  
**Location Name: HLADKY O'GORMAN #3**  
**Location ID: 332971**

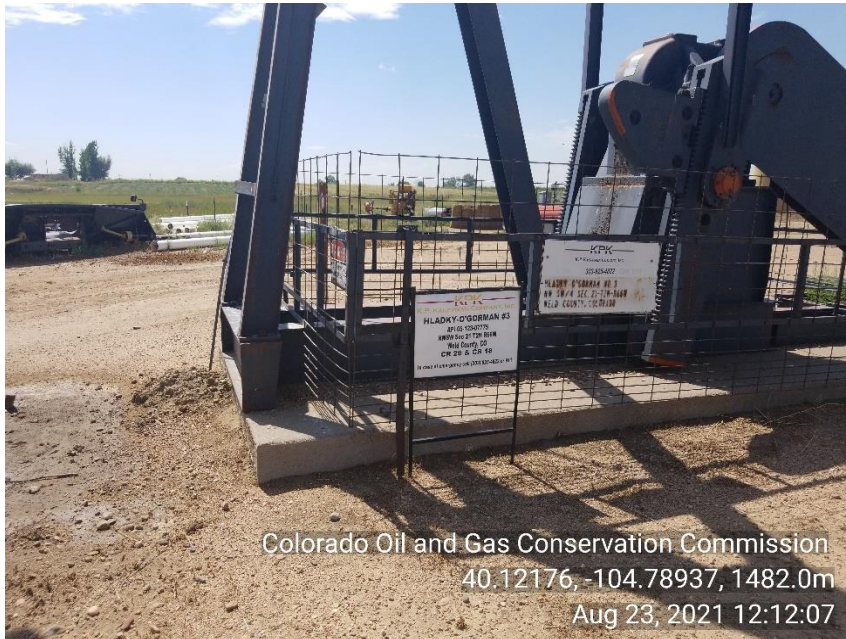
**Photo 3 WH sign**

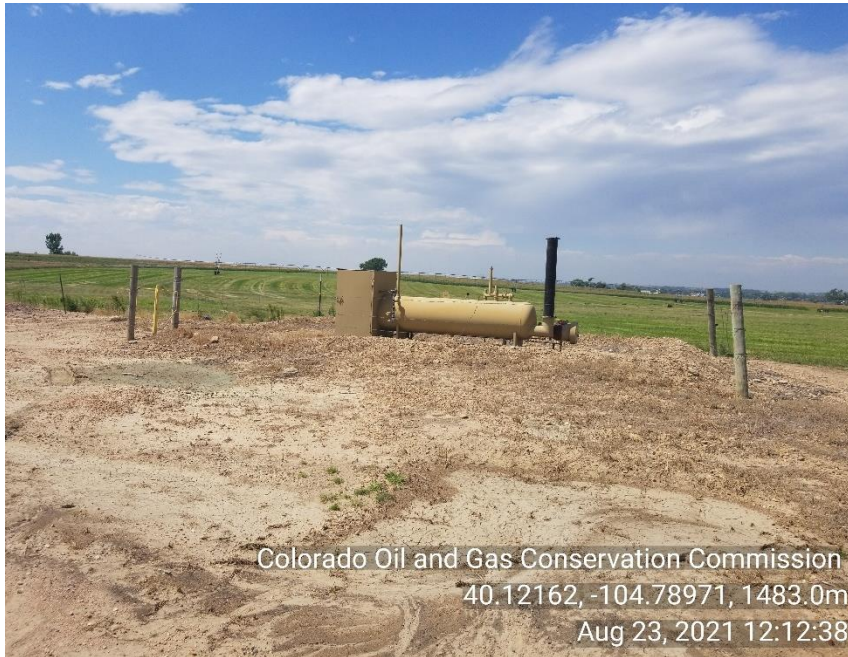
**Photo 5 Hoz separator**

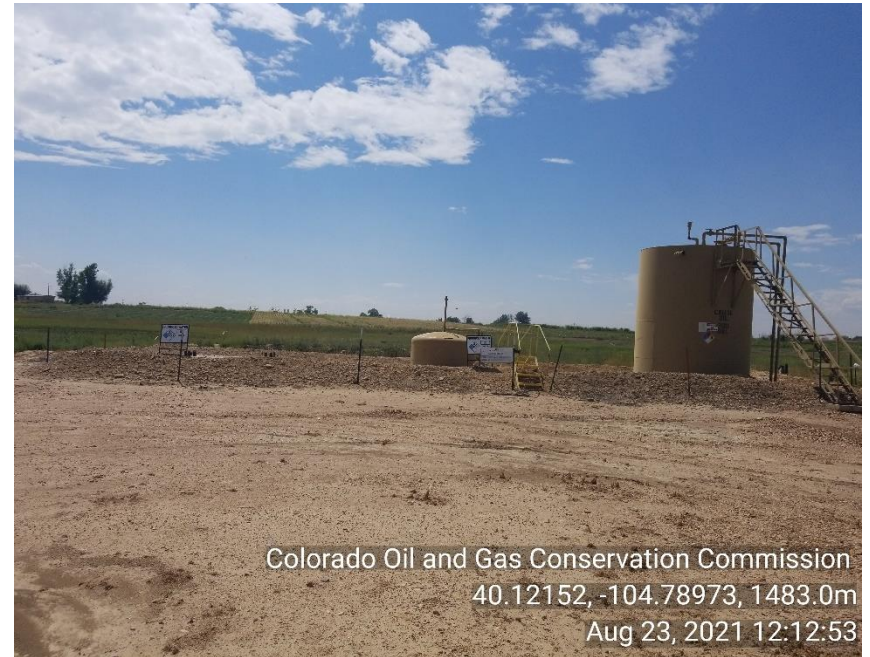
**Photo 6 TNK BTRY**

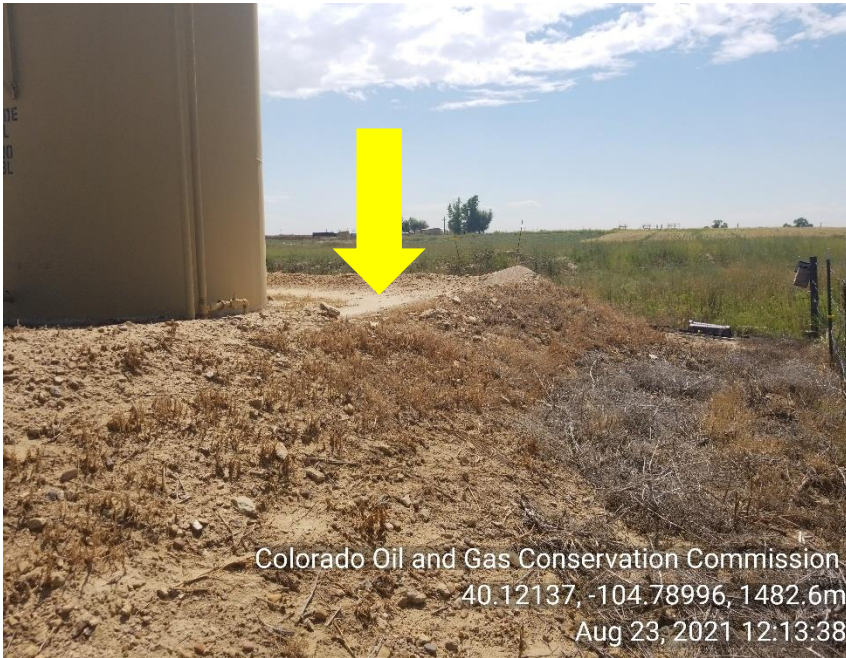
**Photo 7 breach in secondary containment berm.**

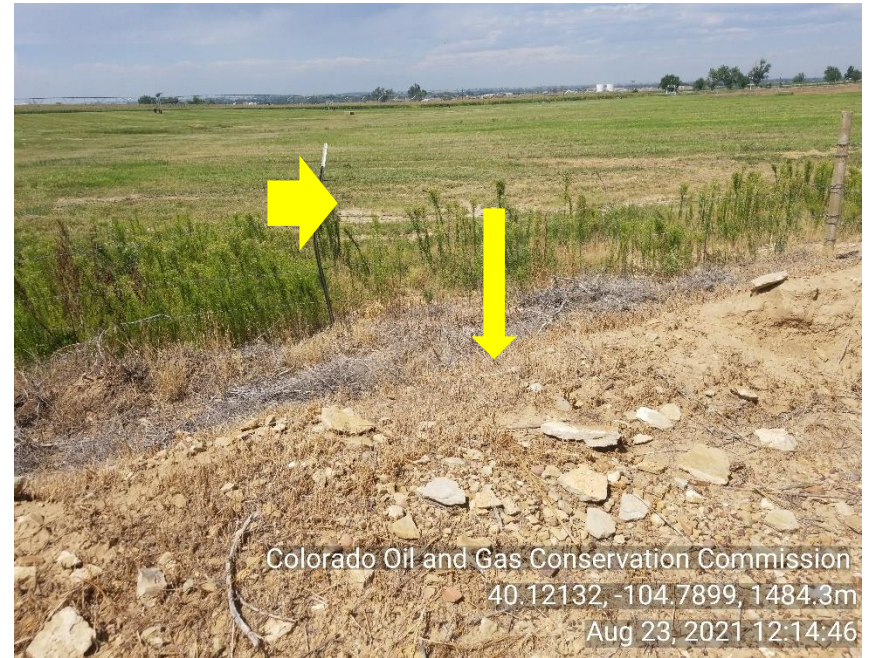
**Photo 8 Sediment from breach in containment berm carrying sediment off location into field.**

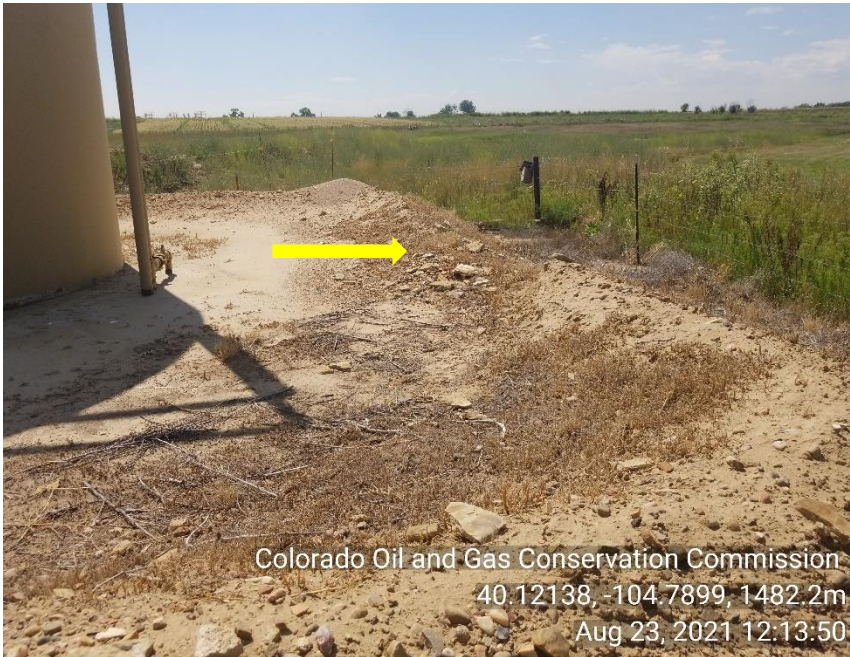
**Photo 9 Breach in secondary containment berm.**

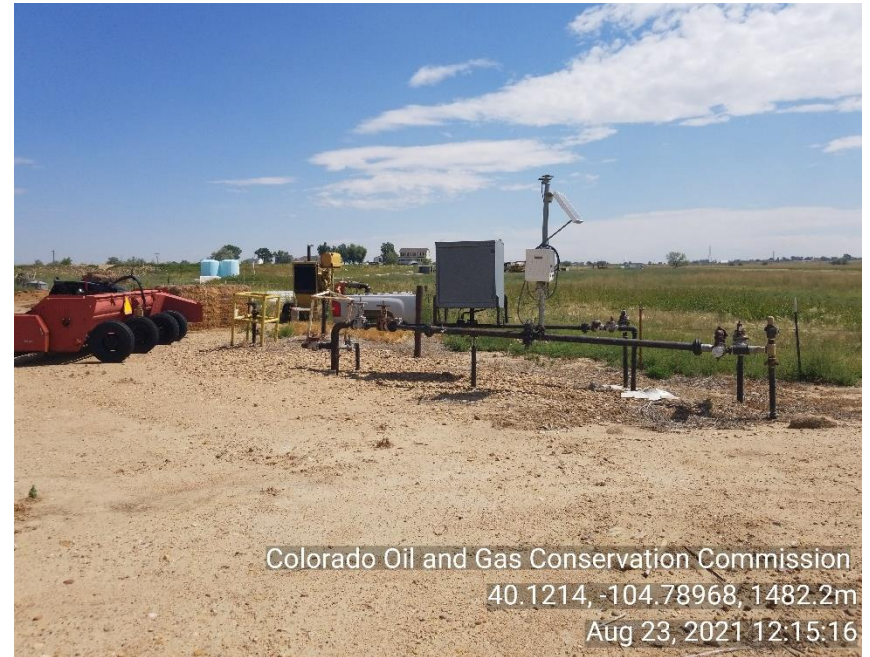
**Photo 10 Meter run**

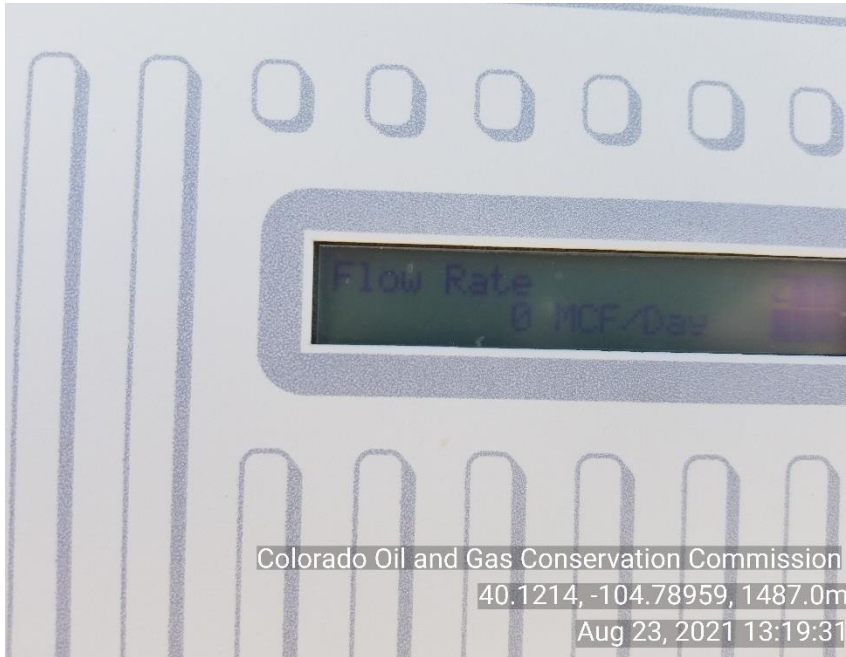
**Photo 11 flow rate on meter run.**
