Inspection Photos
Operator: Hubbs III
API: 067-07171
Date: 8/26/2021

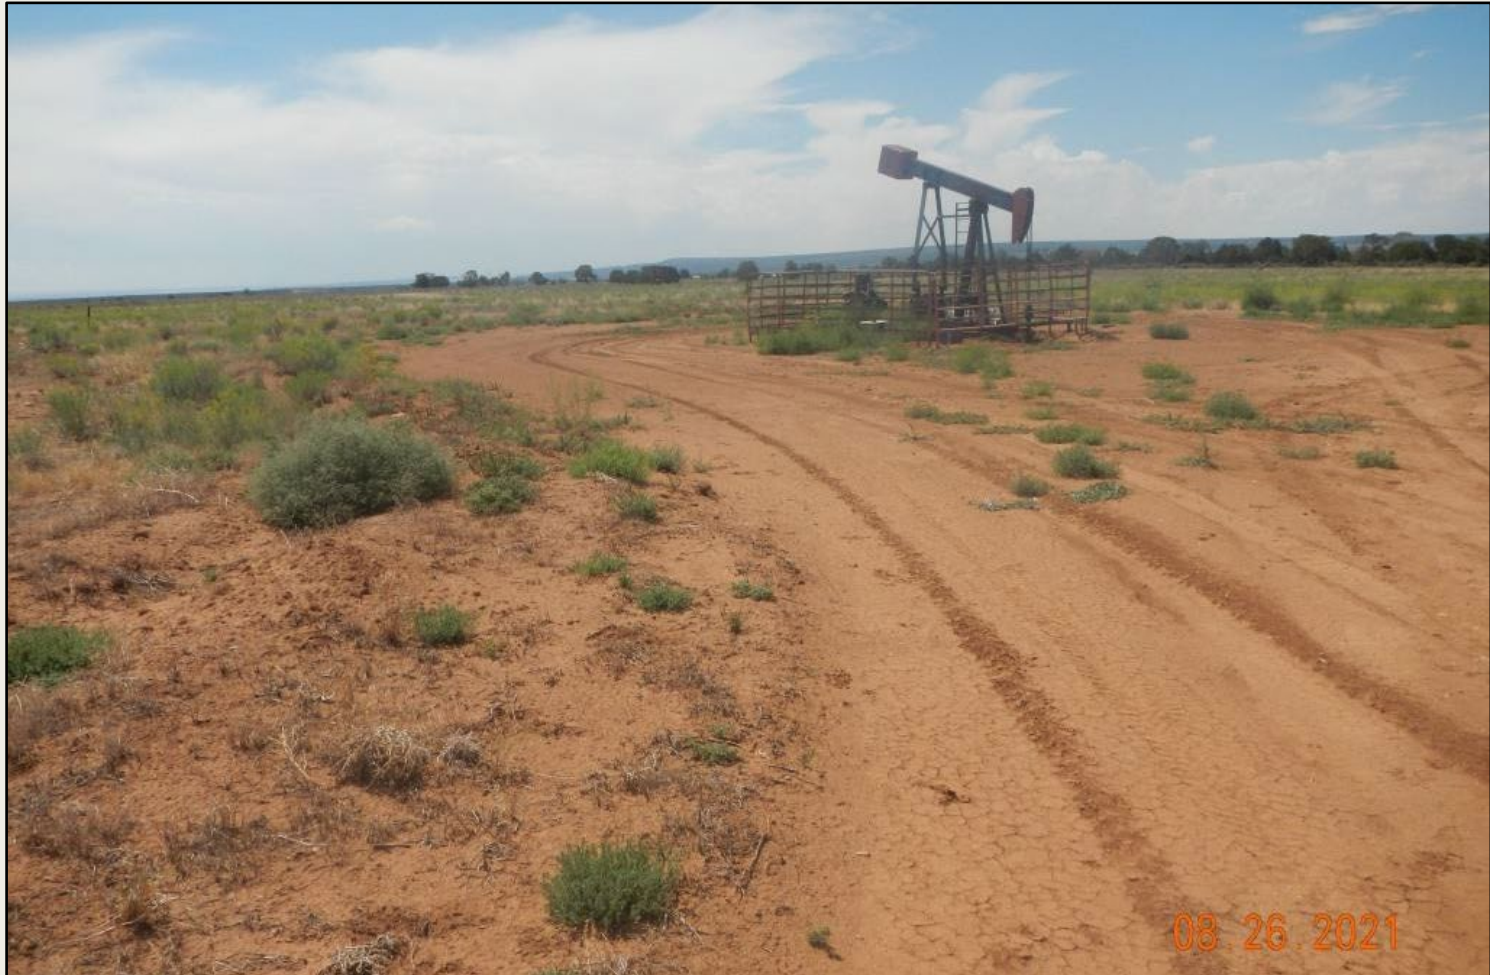
Photo 1. View of the project area from the well pad entrance facing center.

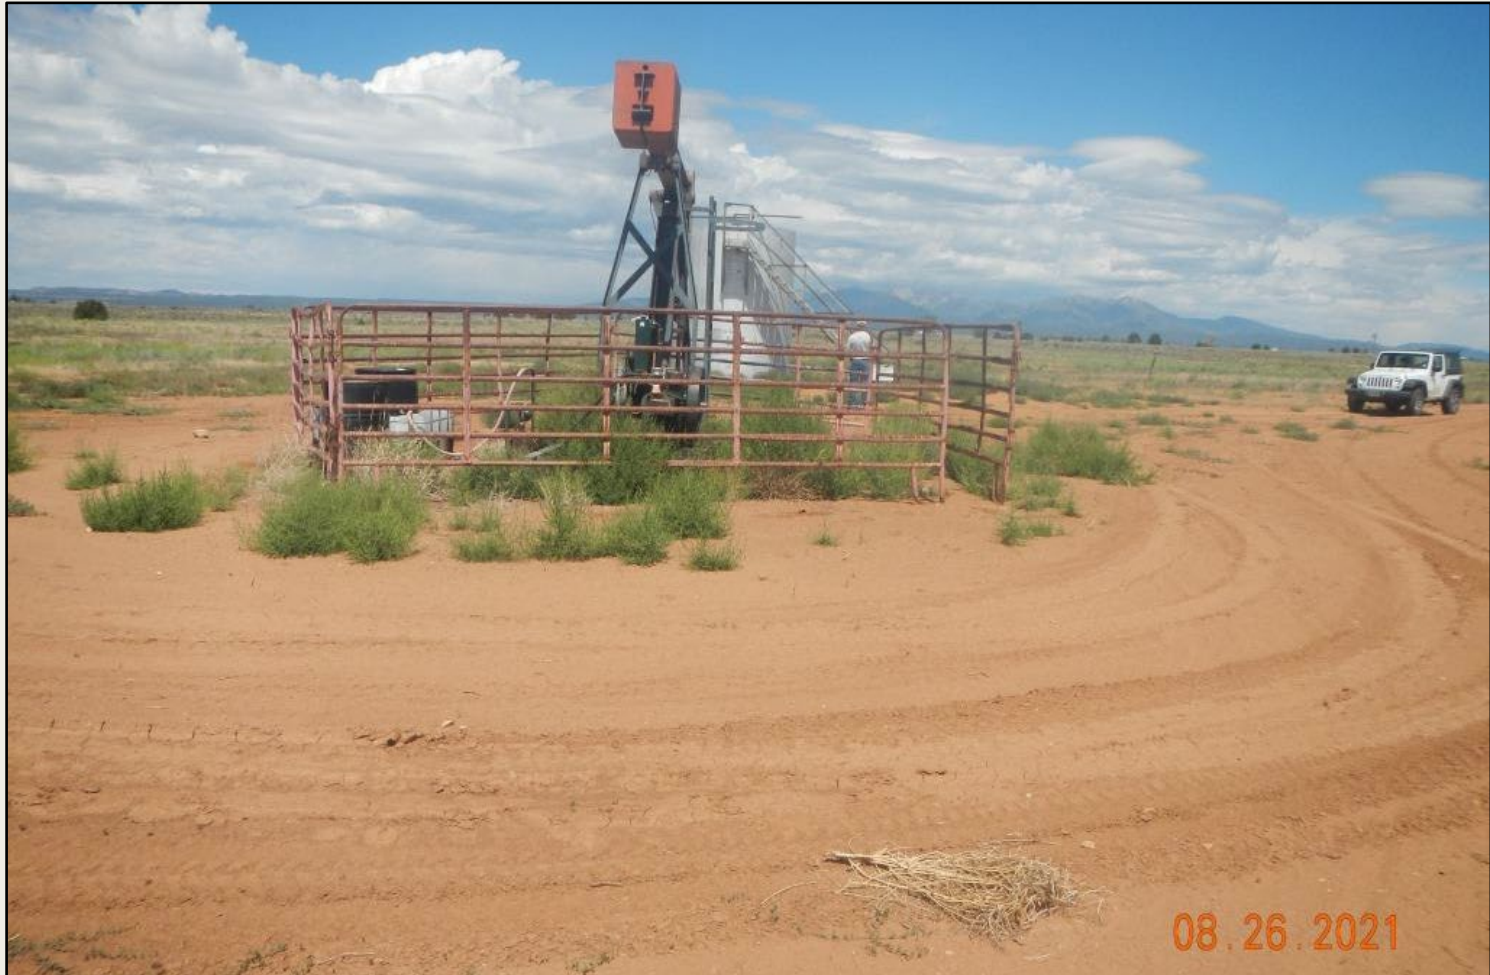
Photo 2. View of weeds growing around well, needing management.

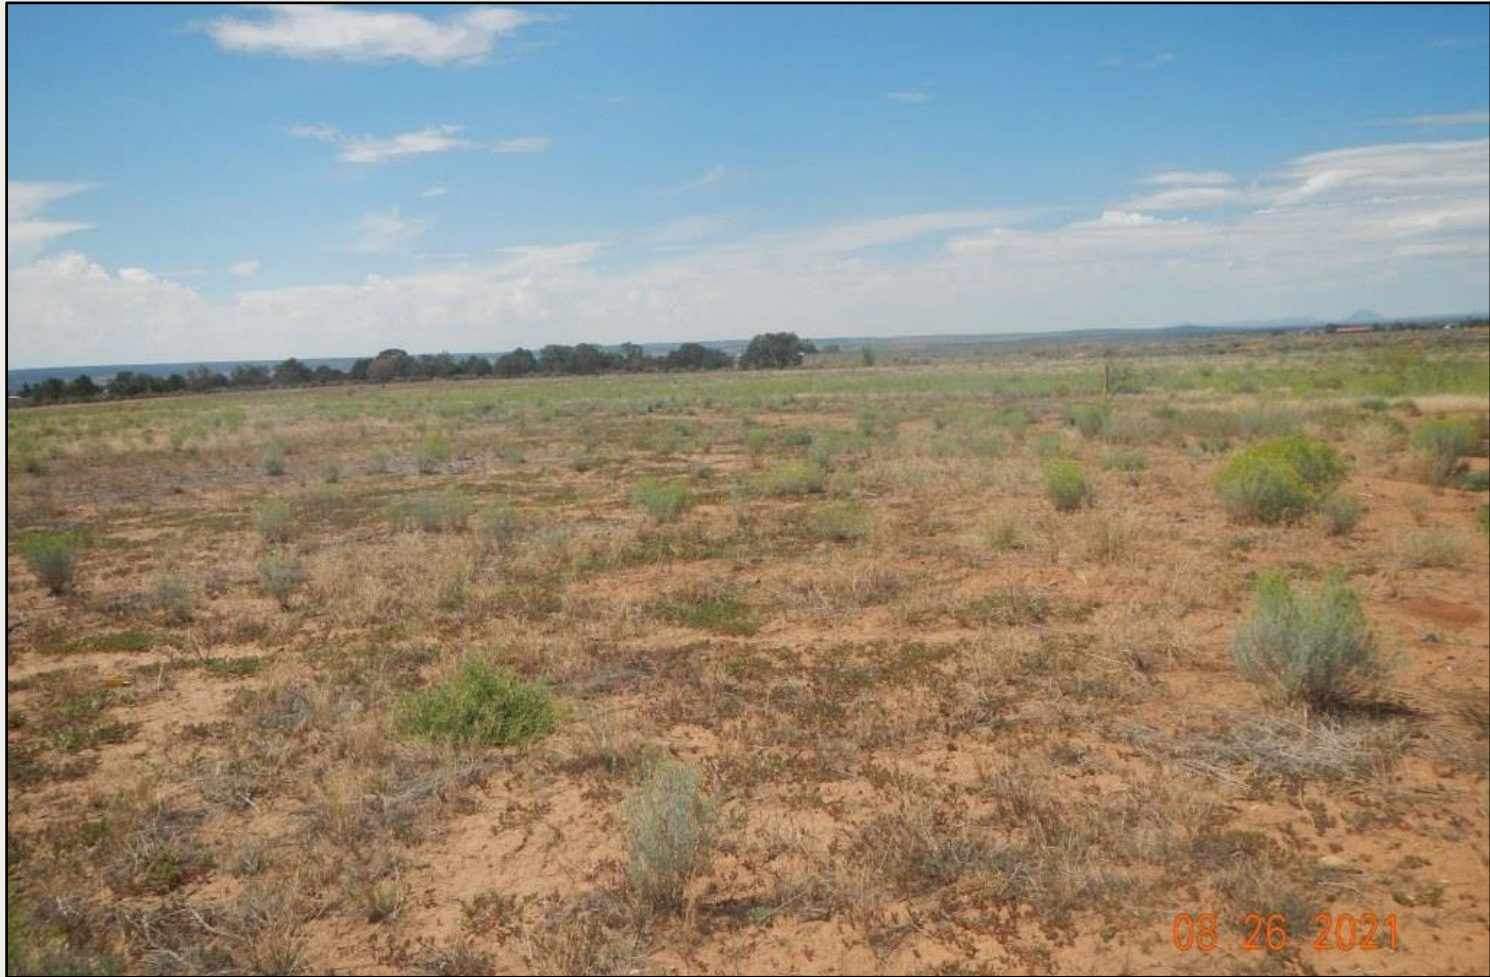
Photo 3. View of the southern project area from the southeastern corner facing westward. Revegetation is progressing similar to surrounding field with rubber rabbitbrush, Indian ricegrass, and weeds such as cheatgrass.

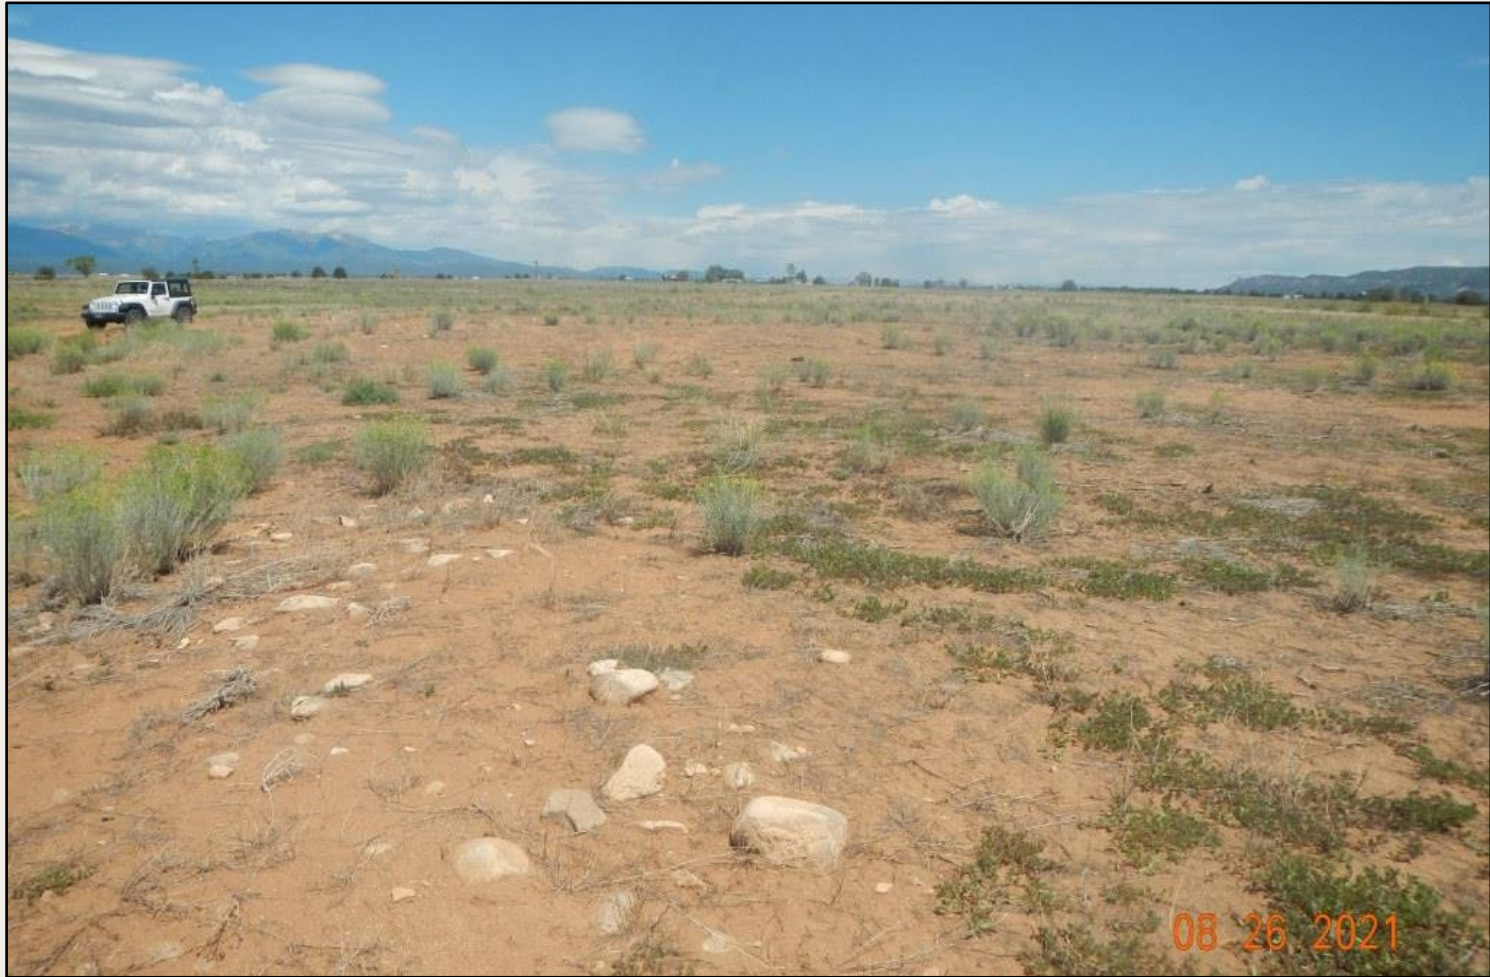
Photo 4. View of the eastern project area from the southeastern corner facing northward.

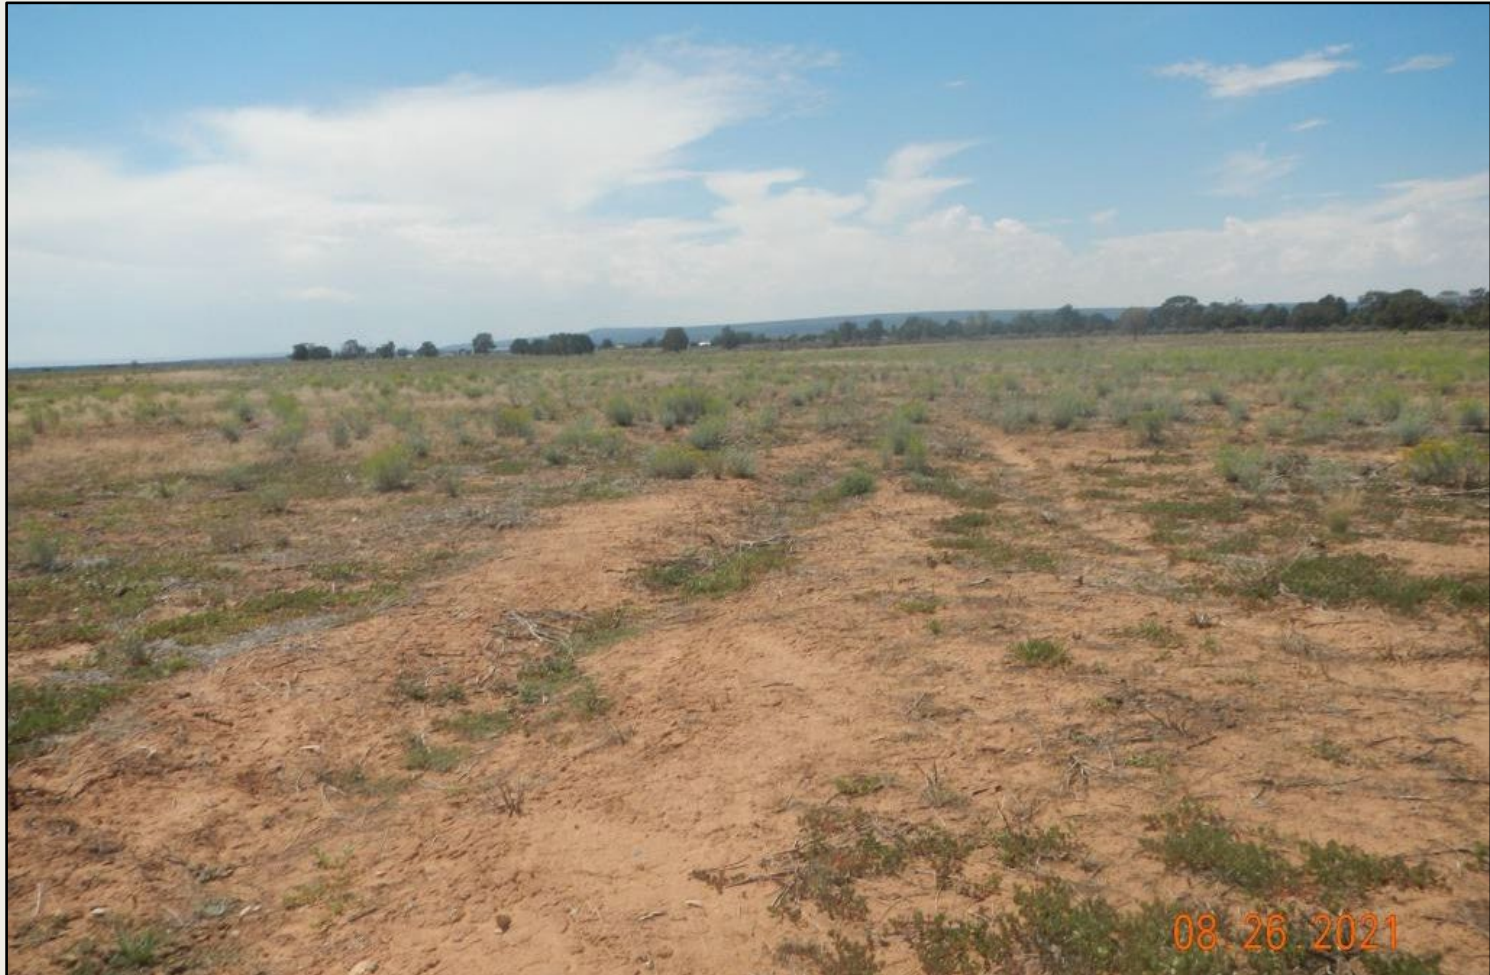
Photo 5. View of reference area comprised of open grass and shrub field with rubber rabbitbrush, Indian ricegrass, and weeds such as portulaca and cheatgrass.
