Inspection Photos
Location Name: Dungan 32-5 #5-4
API: 05-007-06222

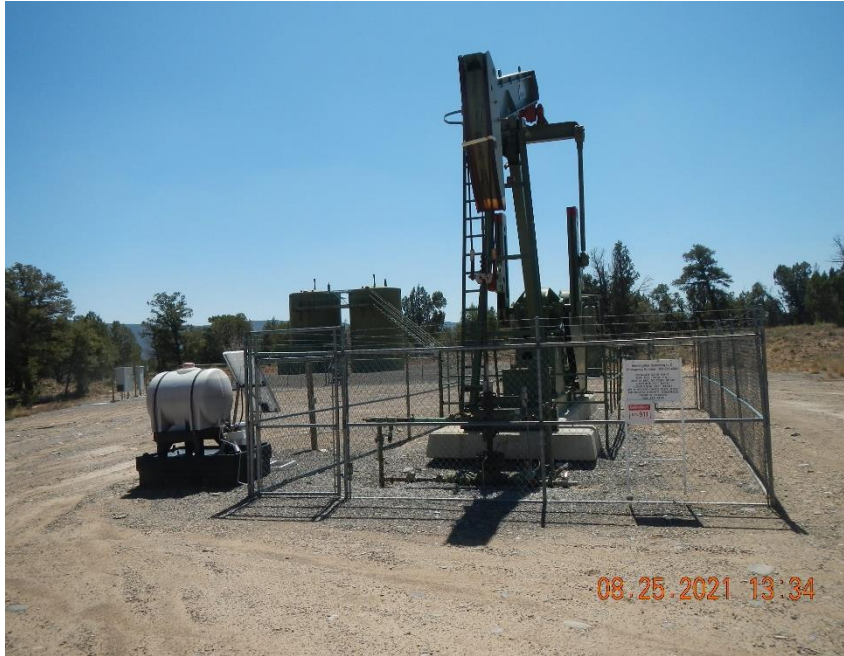
Dungan 32-5 #5-4 pump jack and well head.

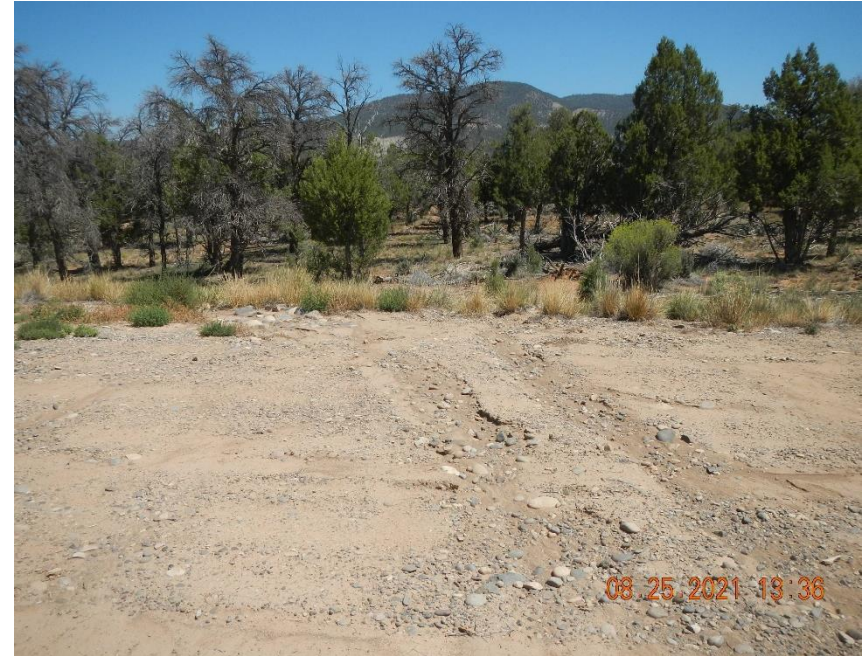
Erosional channel forming along eastern edge of location.

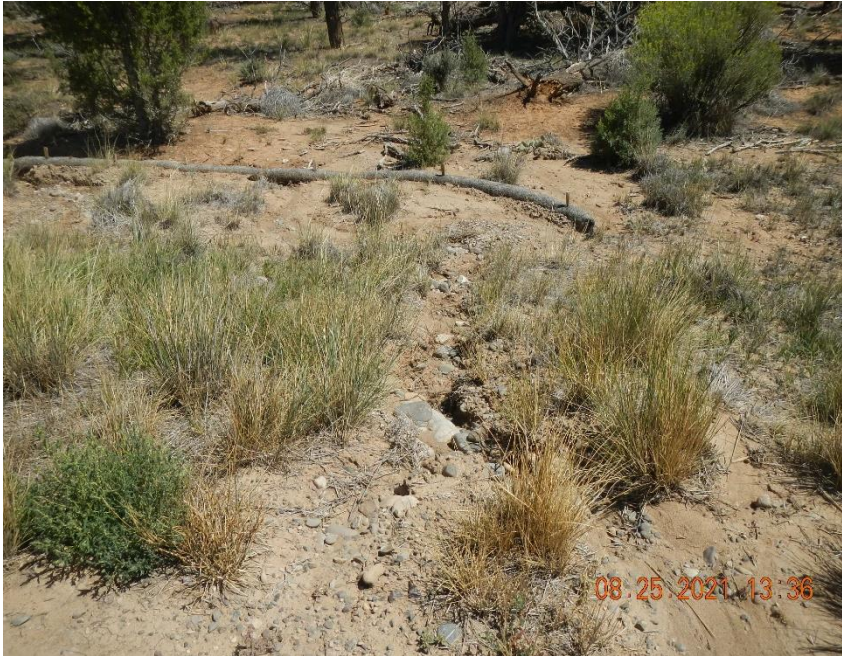
Wattles along eastern edge of location require maintenance.

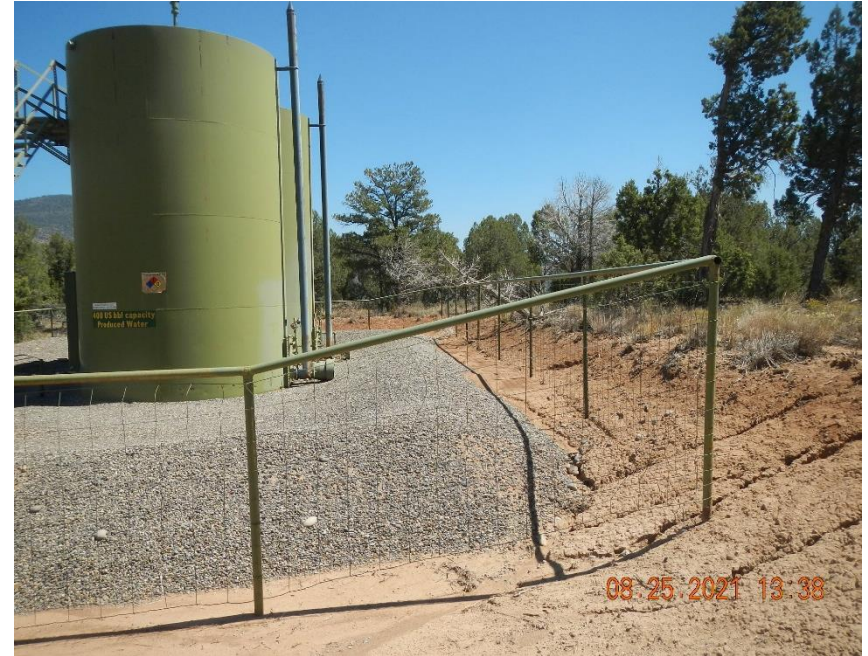
Sediment deposited on location from cut slope on southern edge of location.
