Inspection Photos
Operator: Kinder Morgan
API: 083-06473
Date: 8/31/2021

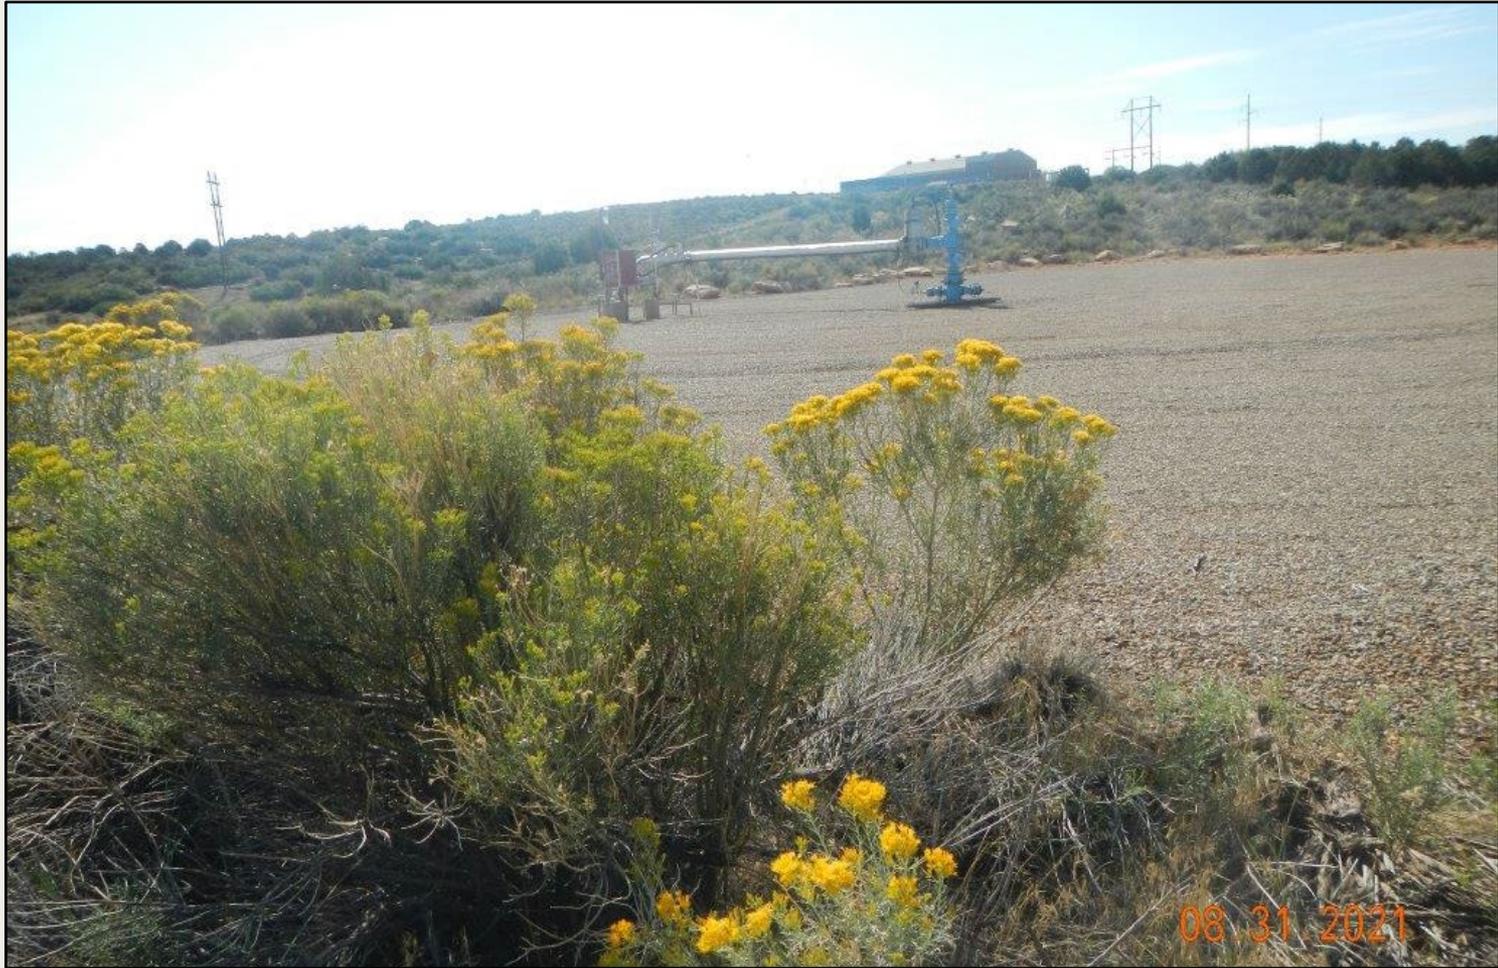
Photo 1. View of the project area from the northwestern corner facing center.

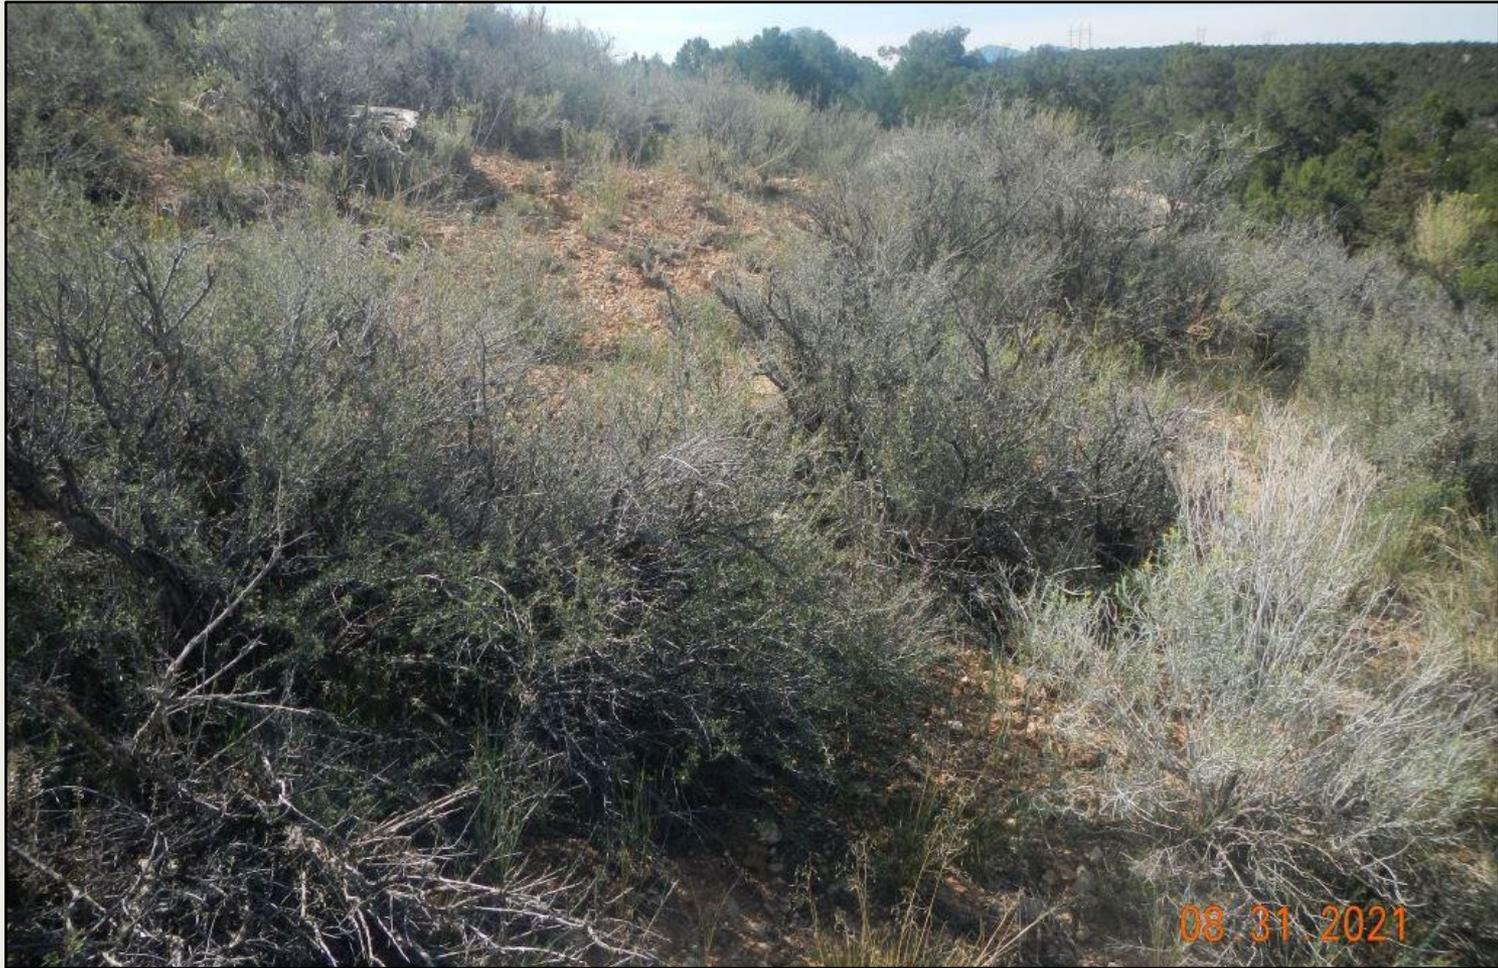
Photo 2. View of the western project area from the northwestern corner facing southward. Revegetation is progressing with antelope bitterbrush, rubber rabbitbrush, Indian ricegrass, western wheatgrass, and crested wheatgrass.

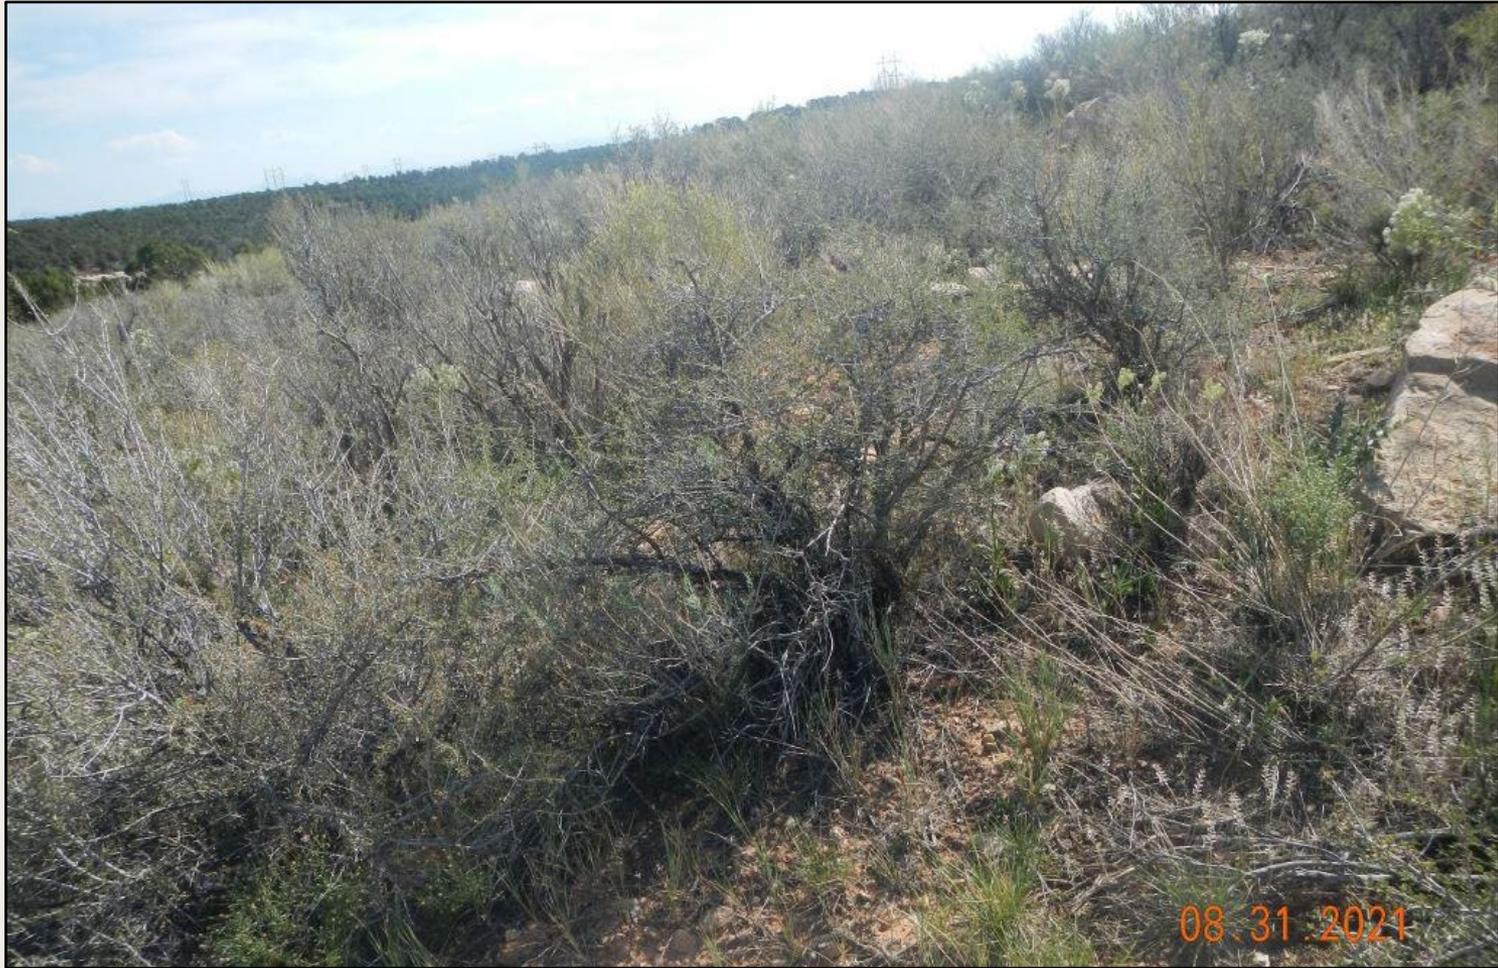
Photo 3. View of the northern project area from the northwestern corner facing eastward.

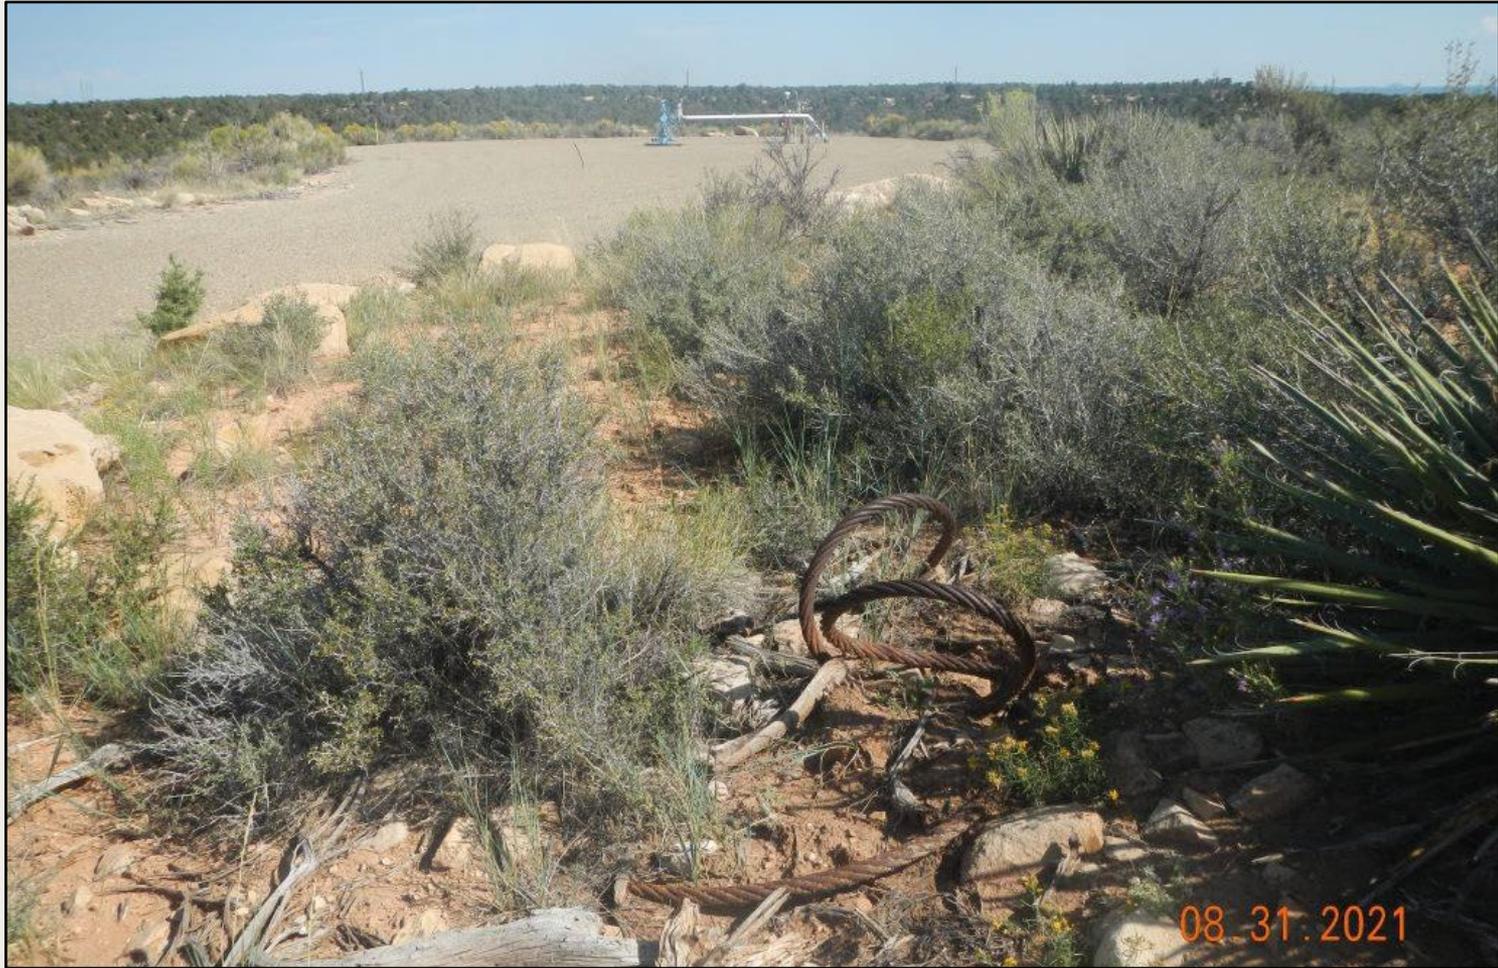
Photo 4. View of rig cable in the southern project area near the well pad entrance.

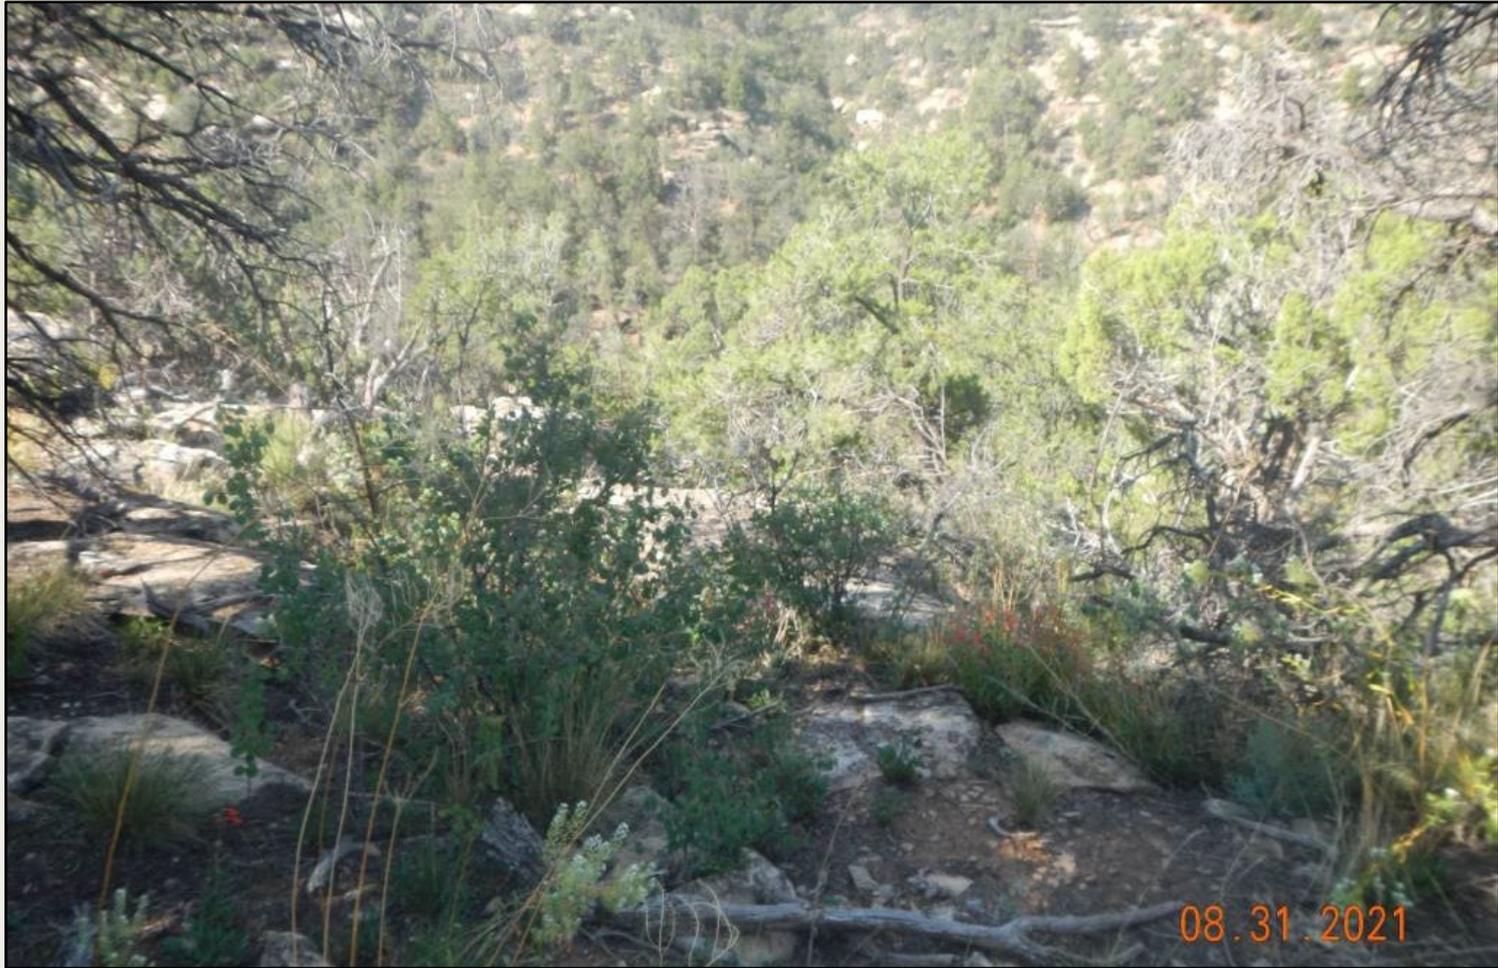
Photo 5. View of reference area comprised of pinyon and juniper woodland with serviceberry, Indian ricegrass, Eaton's penstemon, and gambel oaks.
