**Inspection Photos**  
**Location Name: Champlin 248 Amoco A3**  
**Location ID: 320030**

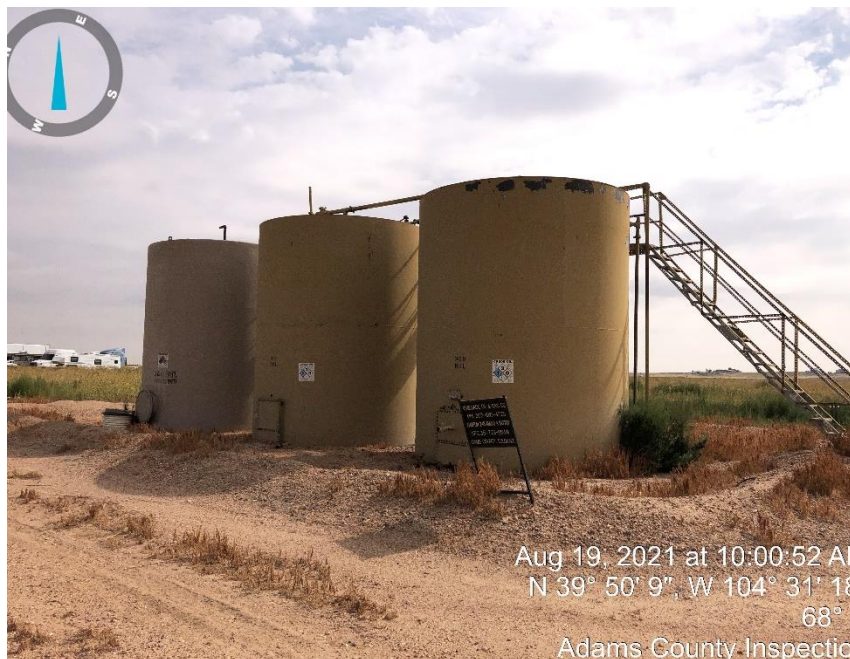
**Photo #1 tanks.**

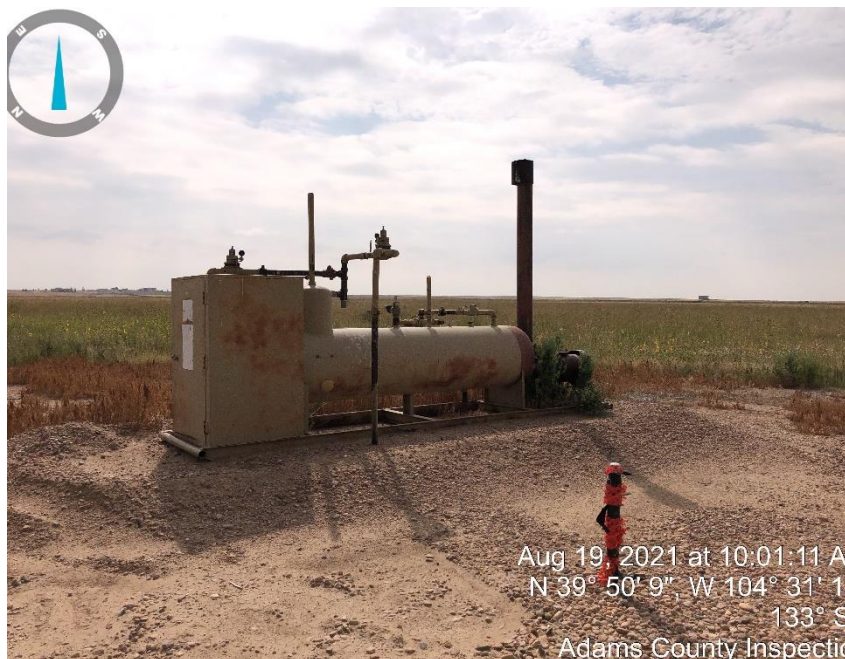
**Photo #2 Separator.**

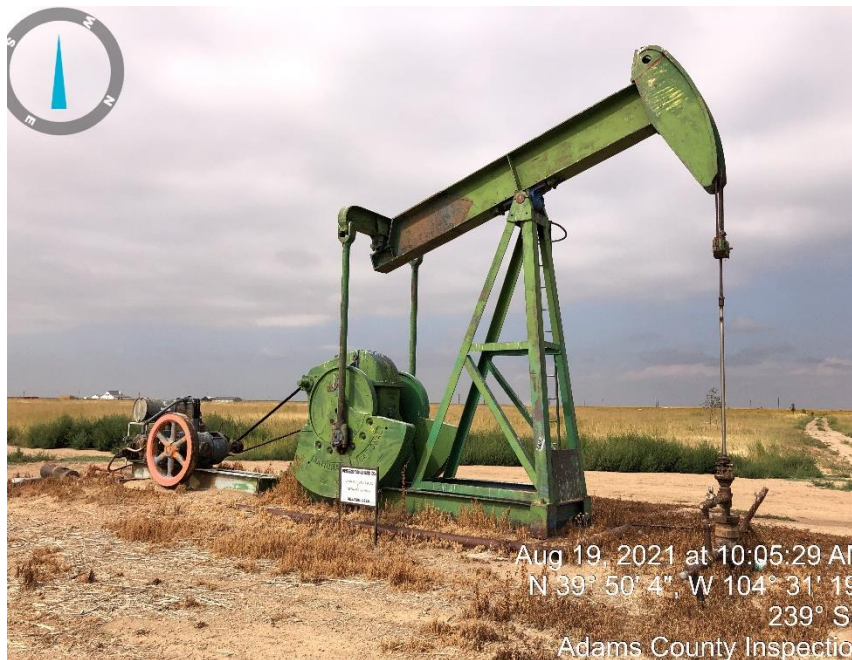
**Photo #3 Pump Jack.**

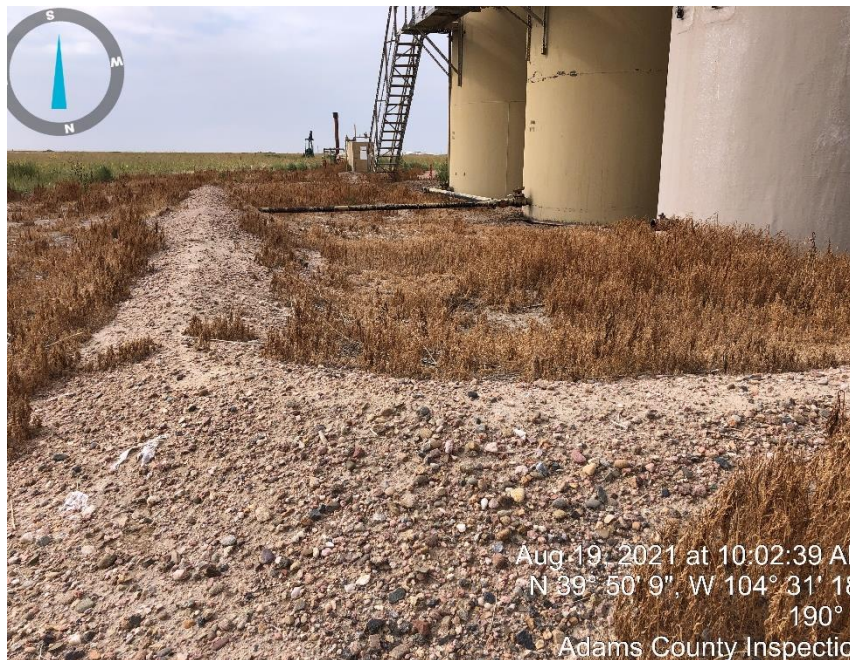
**Photo #4 unmaintained berm on east side of tanks.**

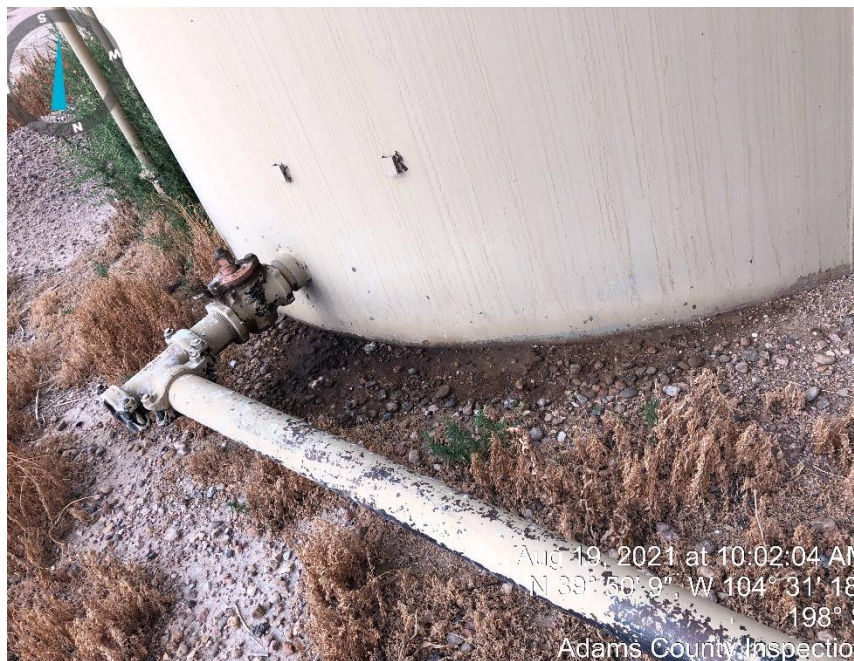
**Photo #5 stained soil on the back side of tank to the south.**

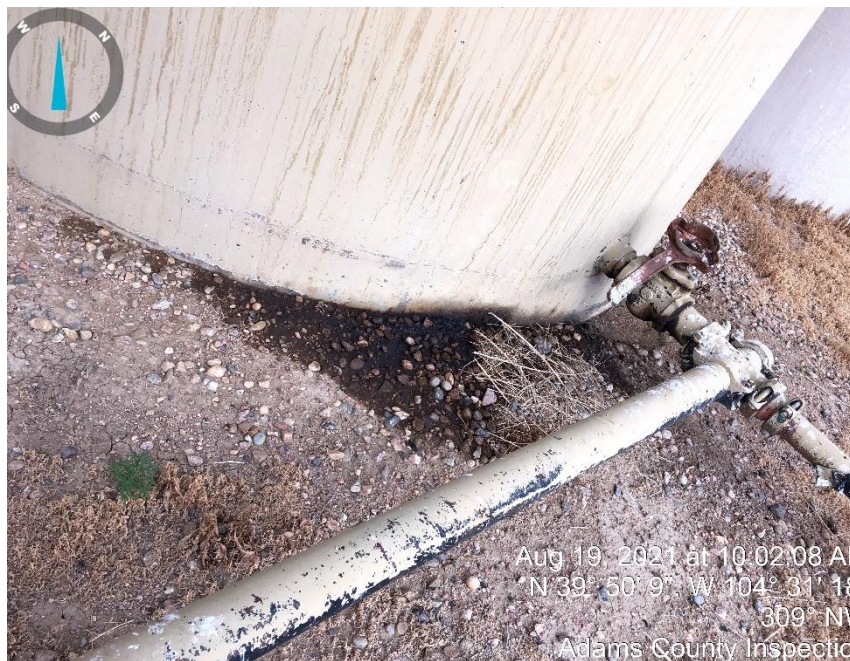
**Photo #6 Stained soil on back side of middle tank.**
