Inspection Photos
Location Name: Gladys #2
API: 05-067-09363

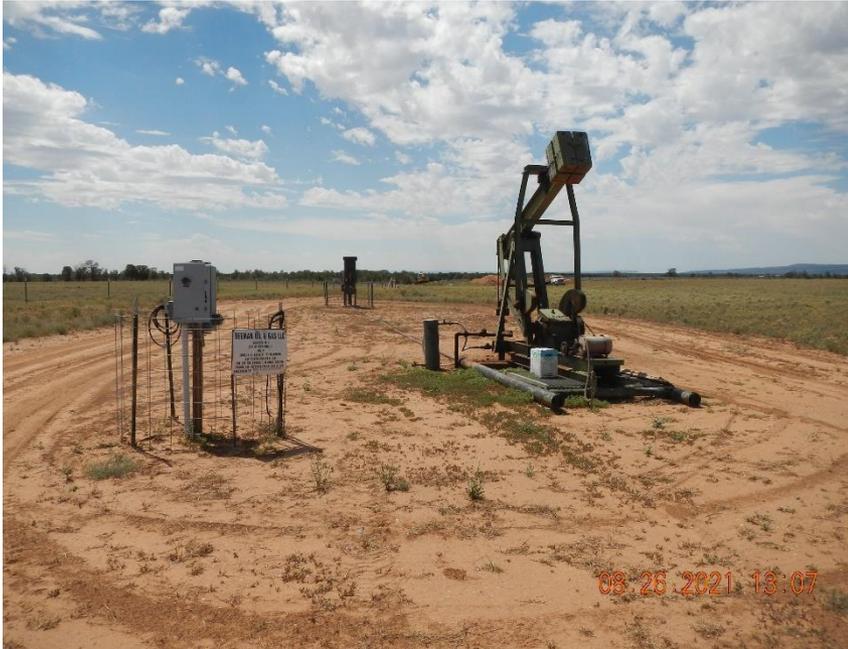
Gladys #2 location photo.

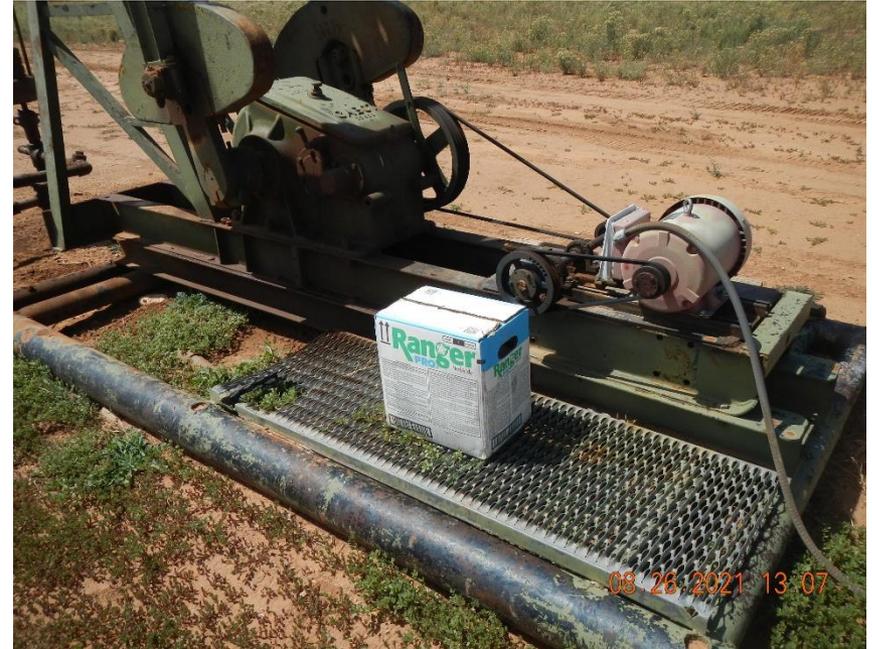
Herbicide stored on pump jack skid.

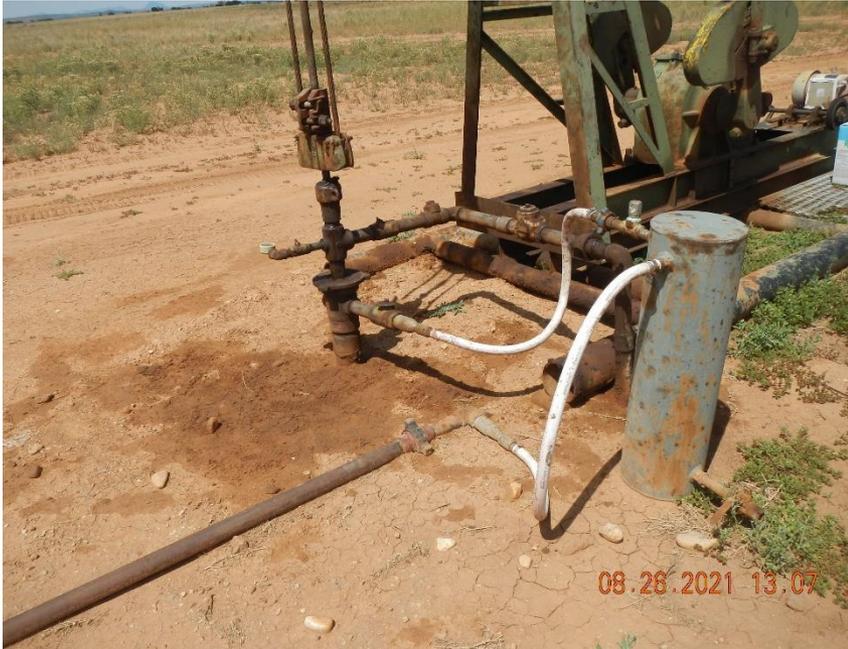
Well head and surrounding soil are stained with oil.

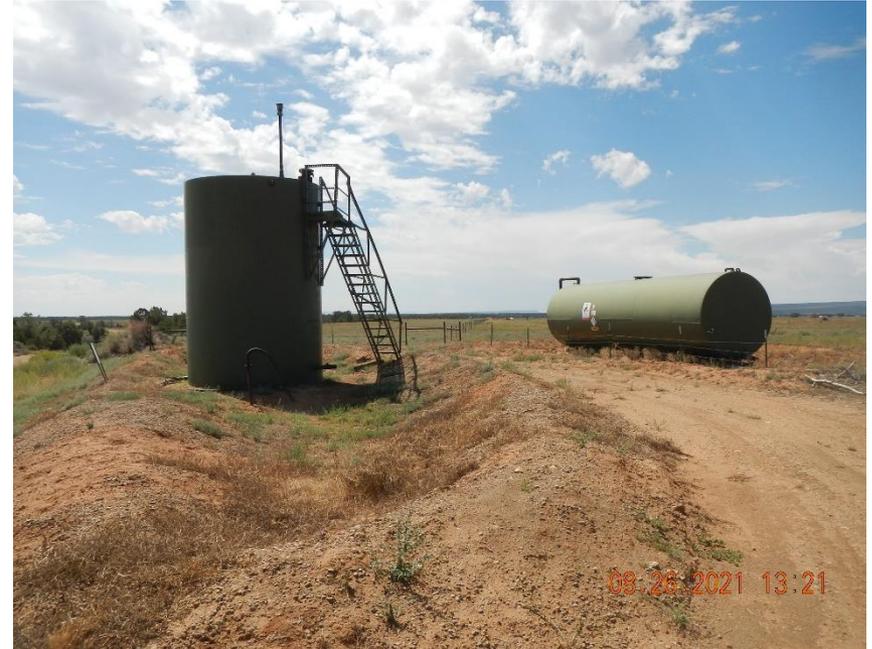
Gladys #1 and #2 tank battery.

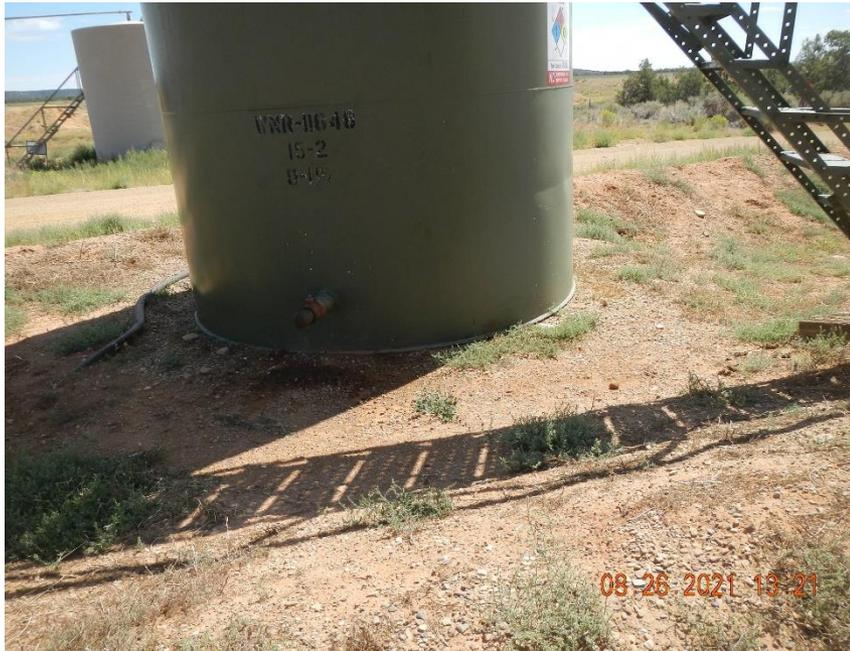
Stained soil beneath truck load out valve.

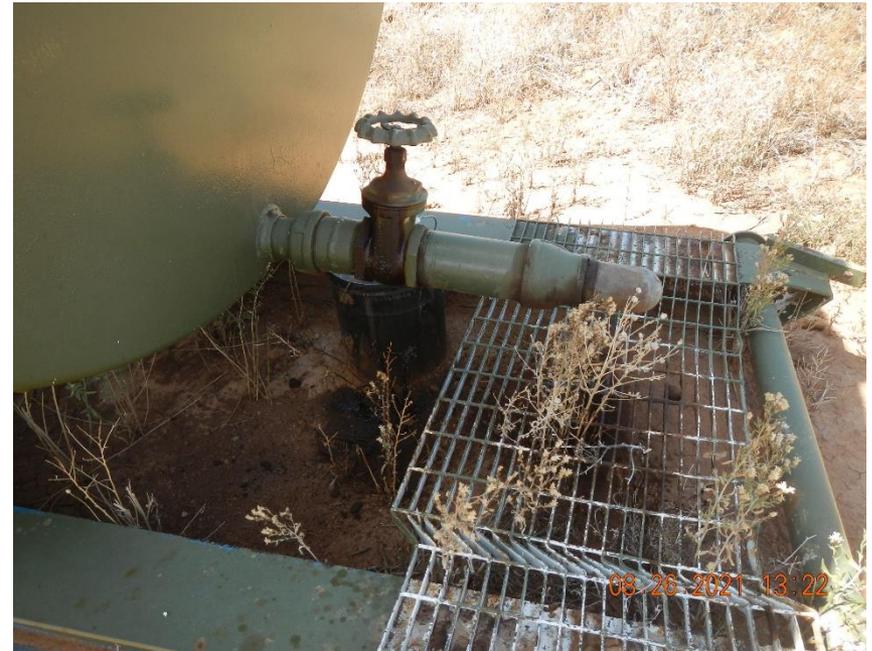
Truck load out valve on horizontal tank is wet and stained with oil. Soil beneath valve is wet and stained.
