Inspection Photos
Location Name: Gas Gathering Pipeline System
Spill/Release Point ID #480312

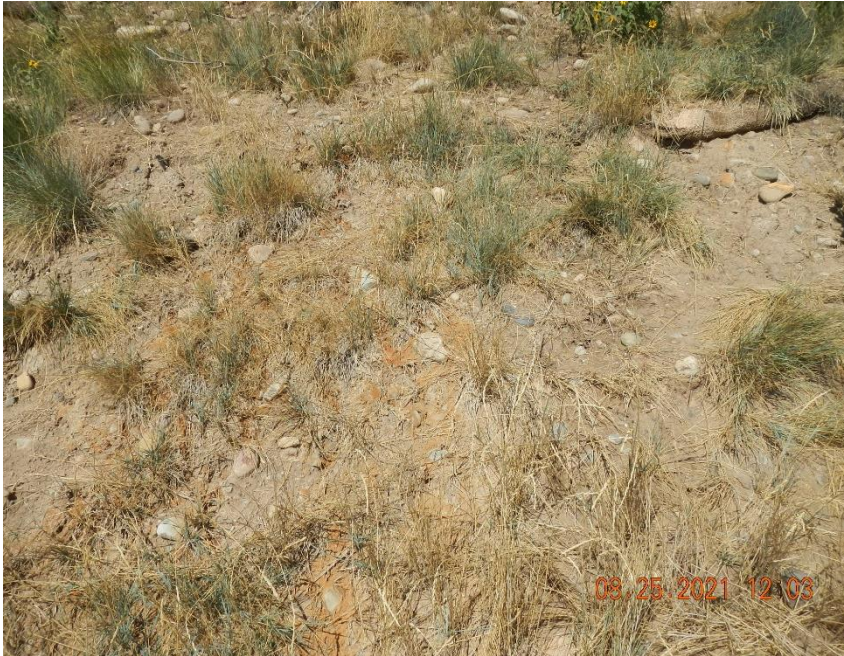
Area where fluids allegedly day lighted from Spill/Release Point ID #480312.

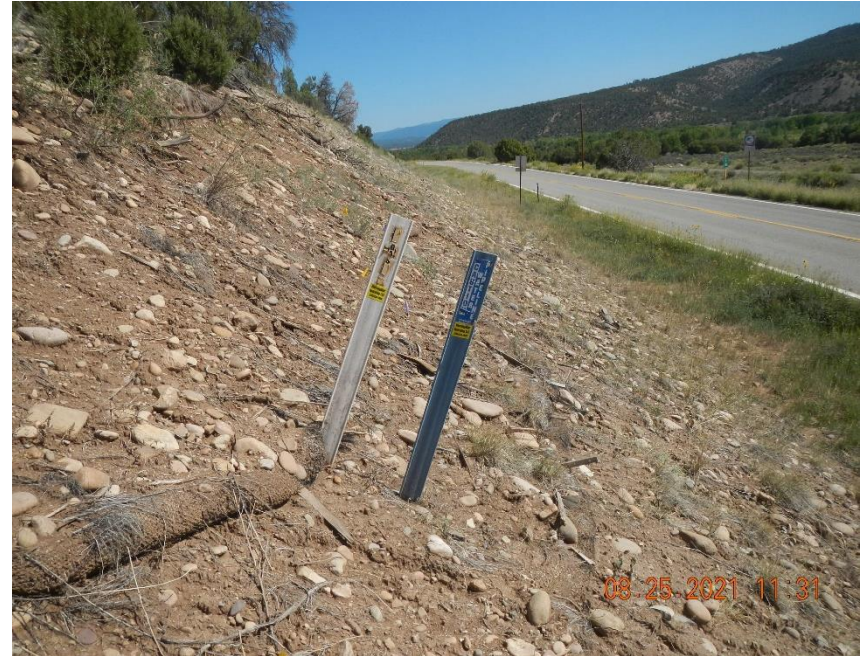
Pipeline markers near release point.

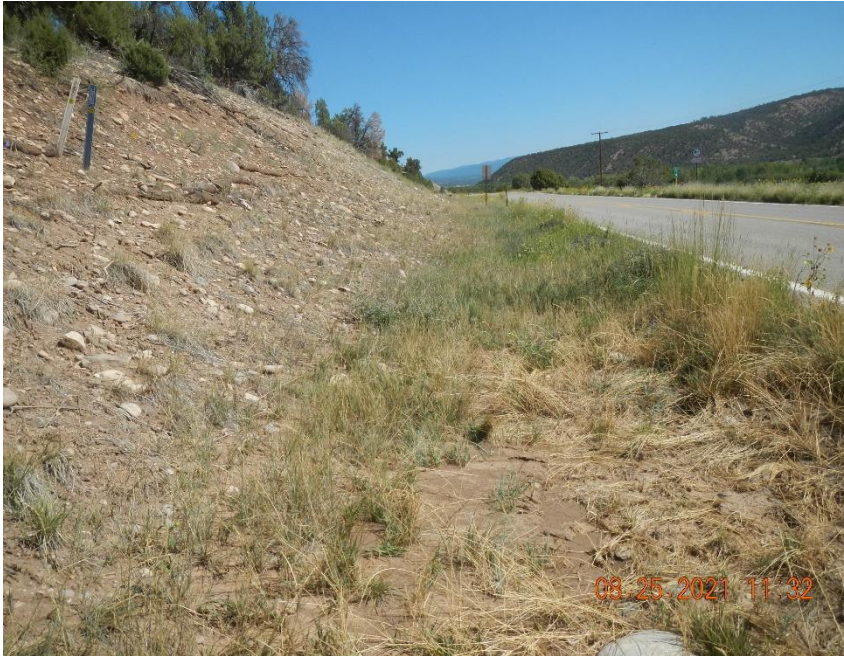
Point source of Spill/Release Point ID #480312 on hillside adjacent to Highway 151.

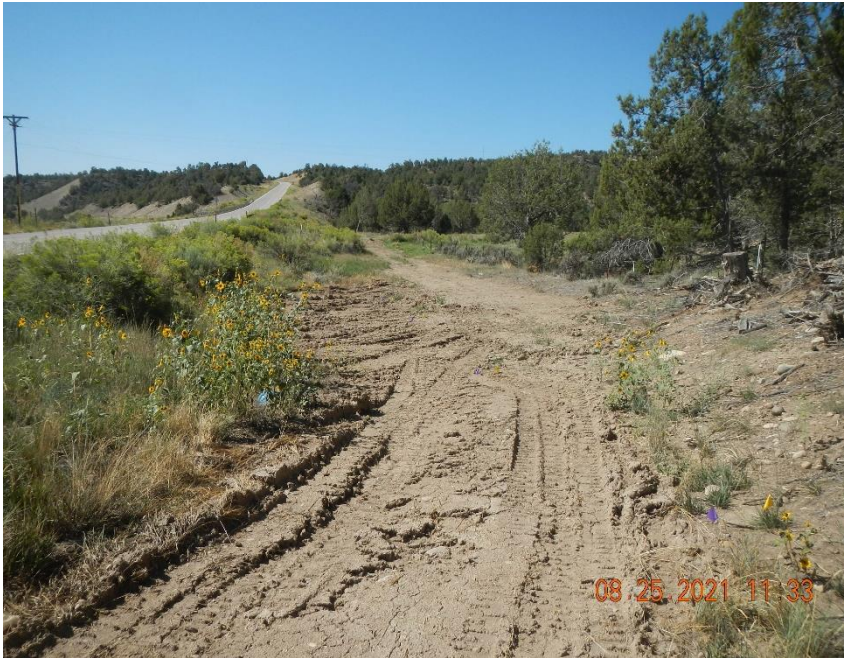
Flow path continued along Highway 151.

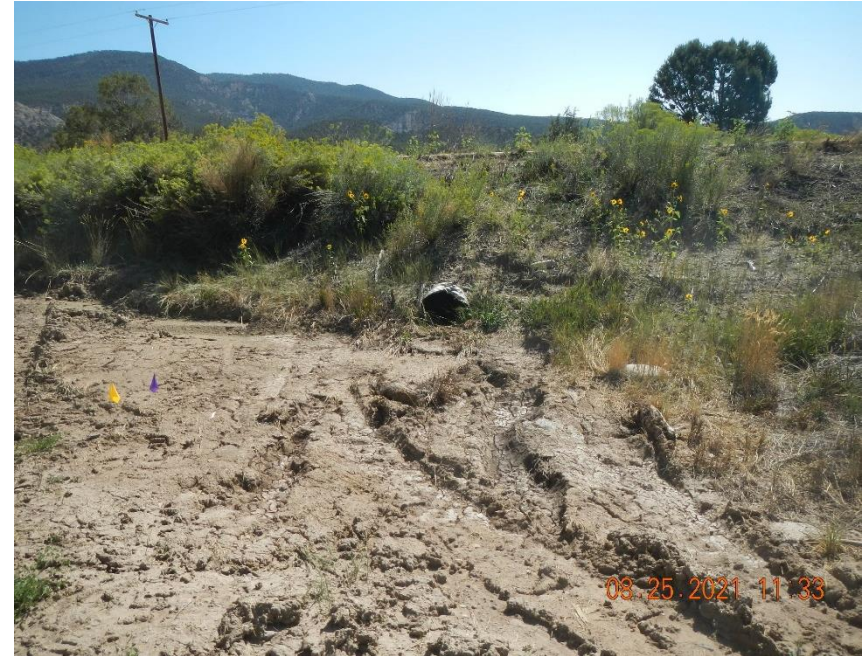
Released fluids travelled beneath Highway 151.

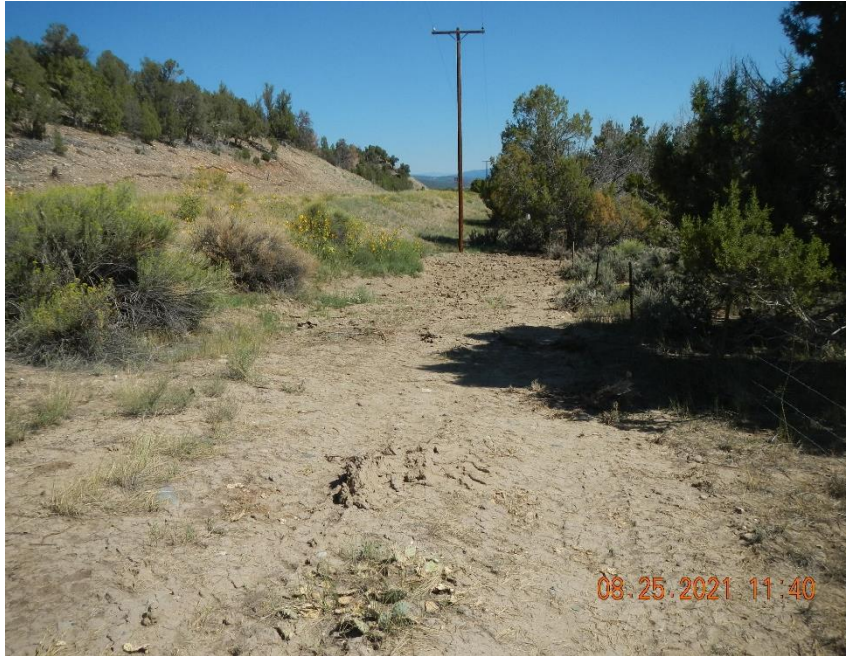
Impacted material on east side of Highway 151.

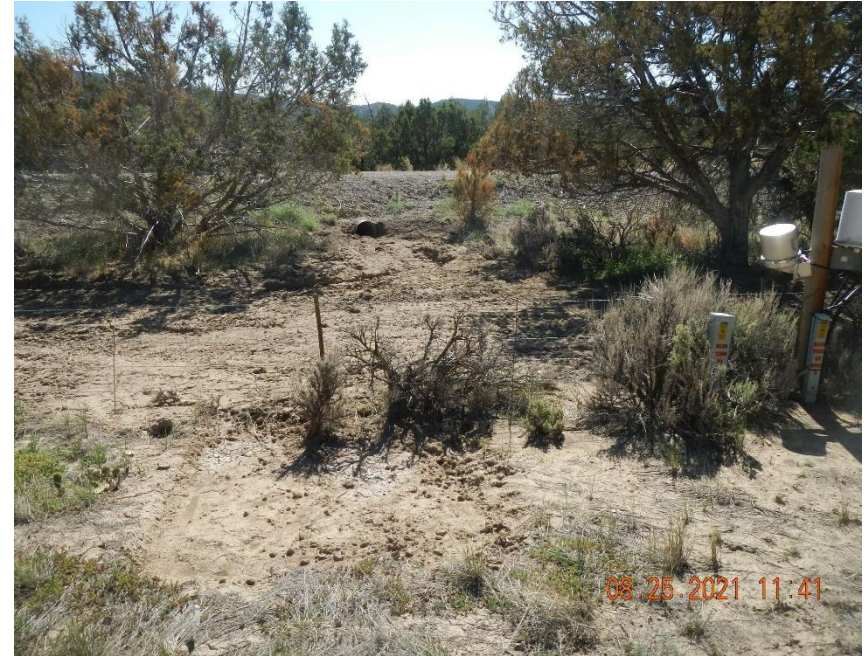
Flow path continued on east side of Highway through culvert beneath dirt road.

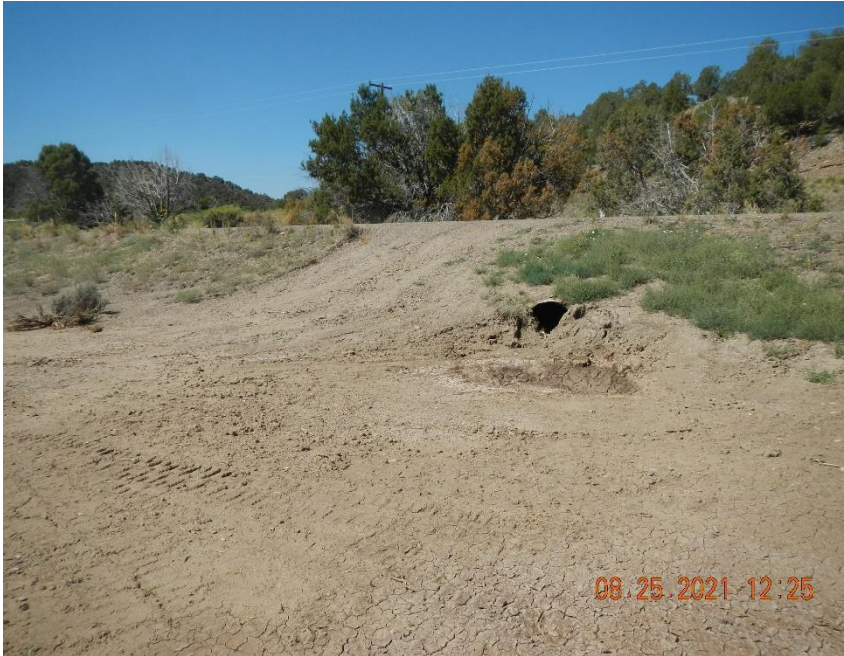
Outlet of culvert beneath dirt road.

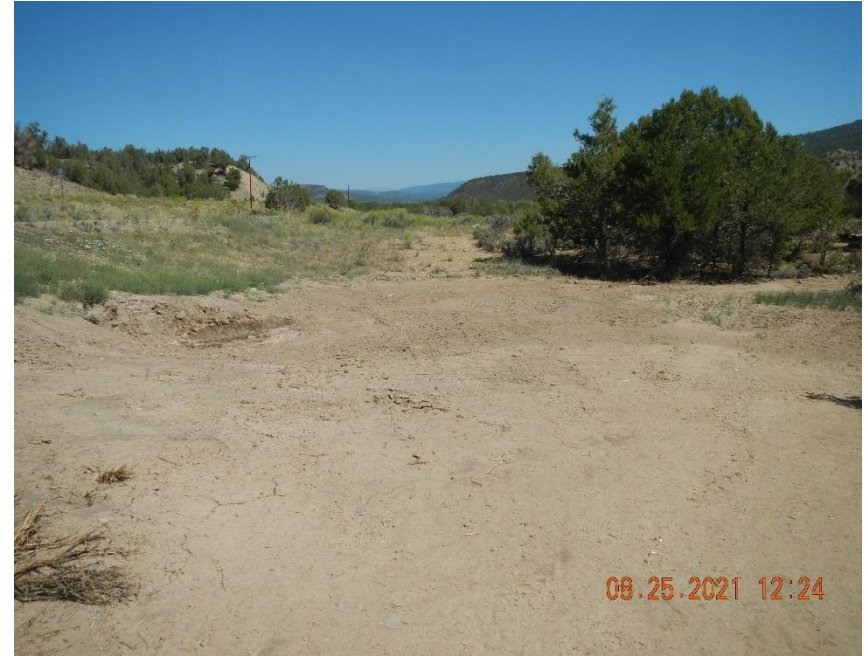
Area to the east of the dirt road. Culvert outfall is located on the left side of this picture.

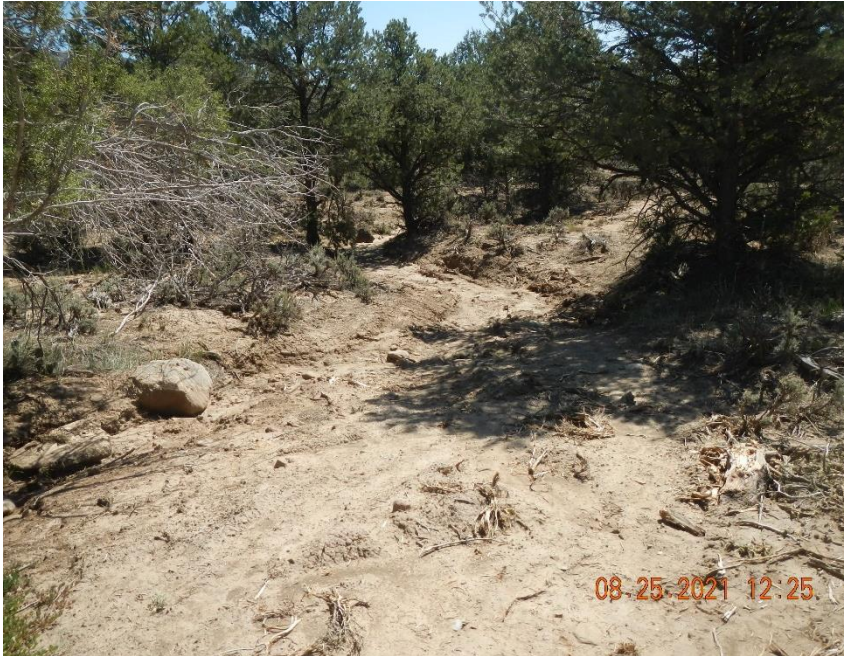
Impacted material in natural drainage.

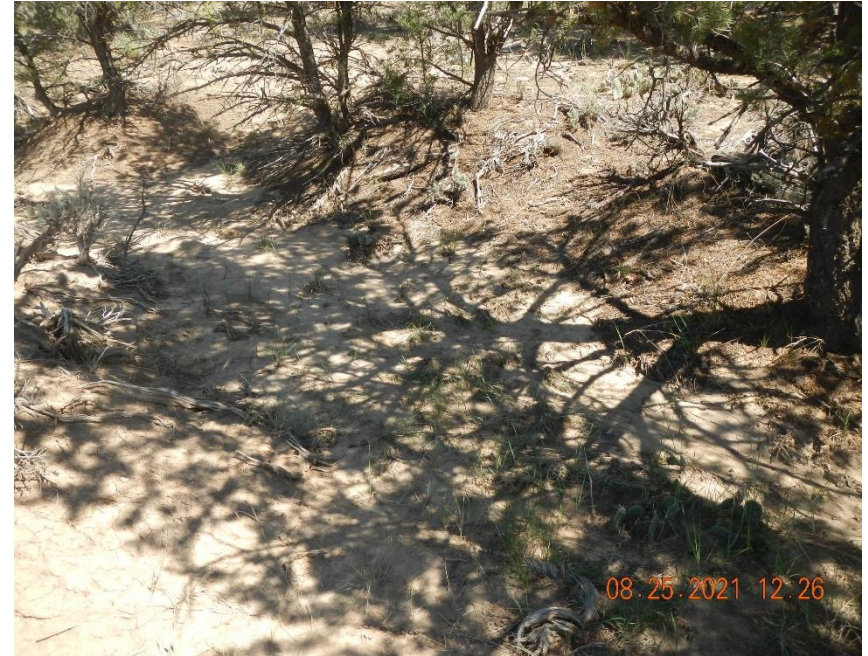
Reported terminus of released fluids in drainage.
