Inspection Photos
Location Name: Neleigh 01-07 #1
API: 05-067-06357

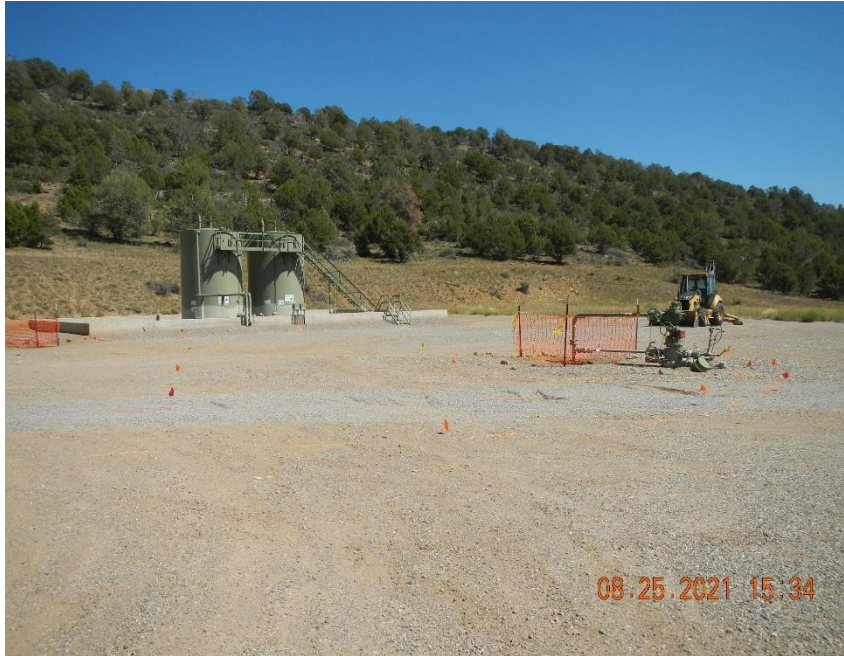
Neleigh 01-07 #1 location photo.

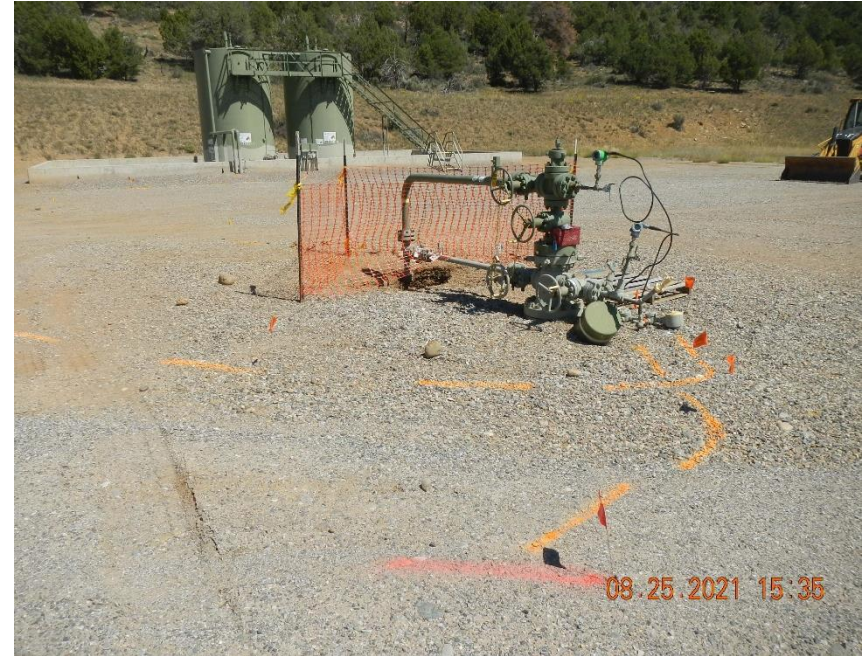
Neleigh 01-07 #1 well head and flow line.

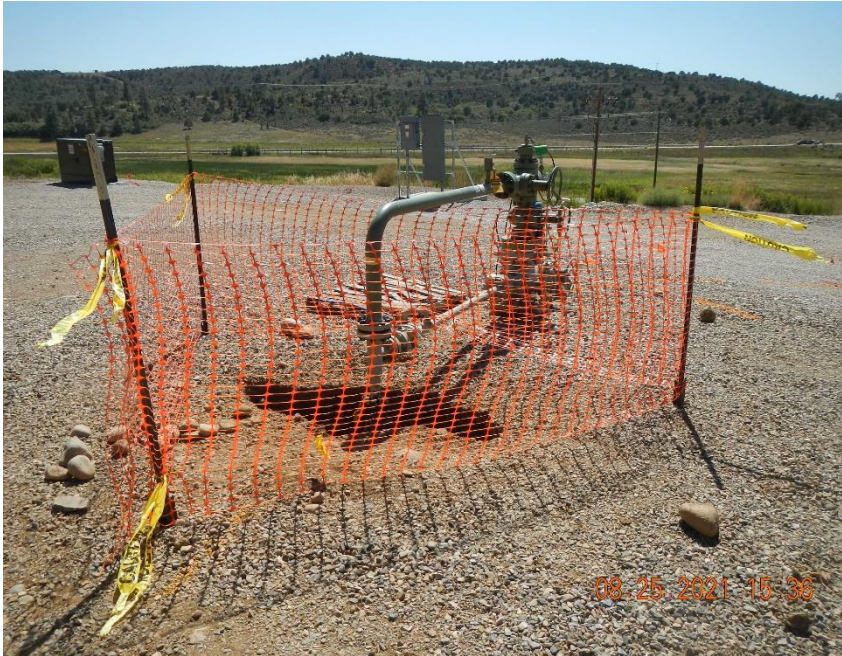
Excavation around flow line at well head.

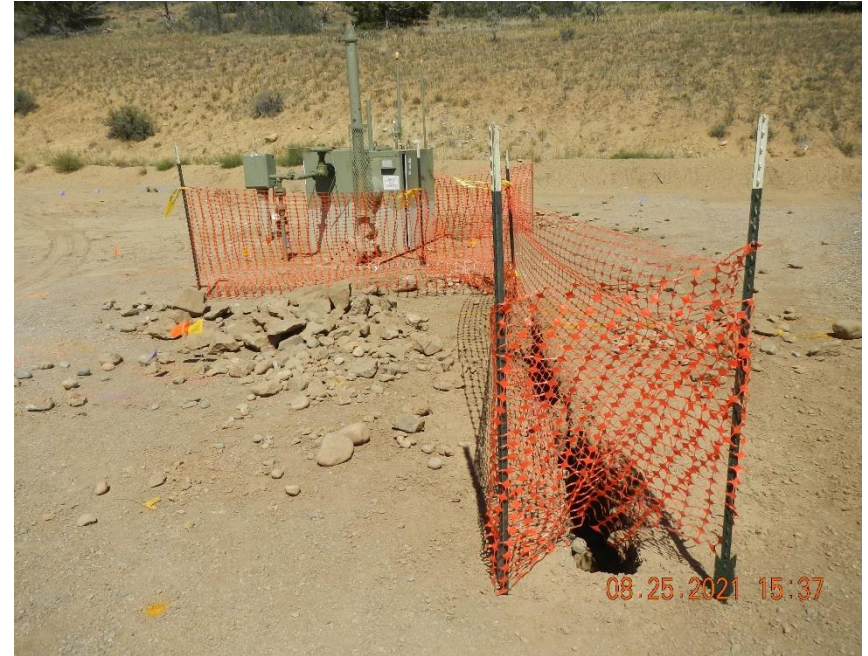
Excavation around flow line.

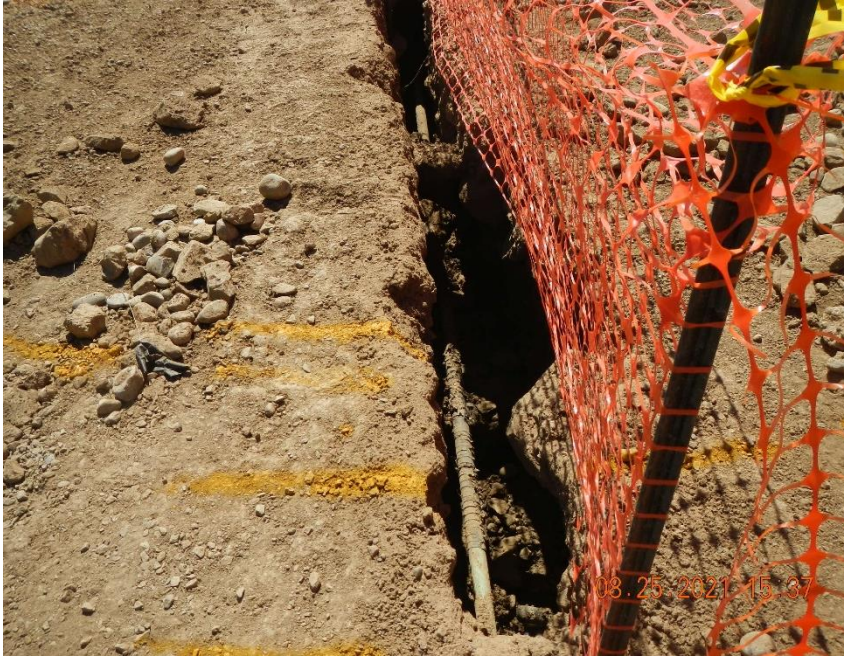
Flow line in open trench.

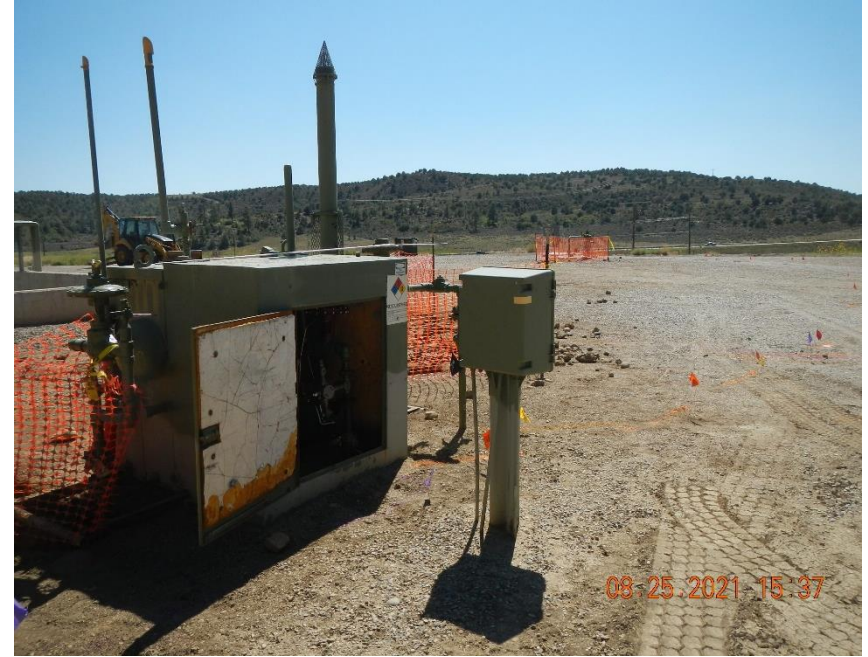
Flow line exposed up to separator.
