Inspection Photos (09-01-2021)
Location Name: Martin J Schaefer #2 Flowline
Spill/Release ID: 480698

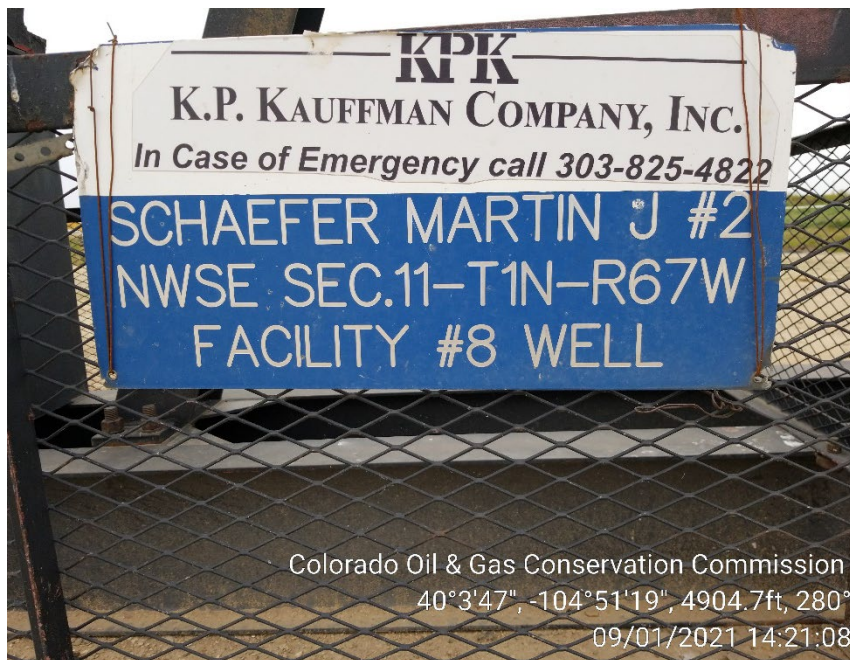
Location sign

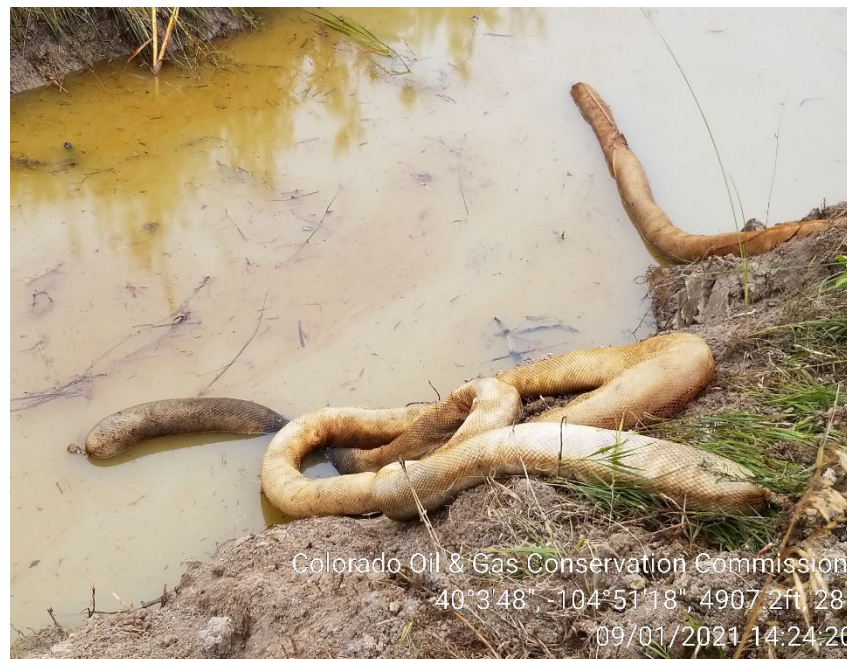
Absorbent booms deployed by the operator.

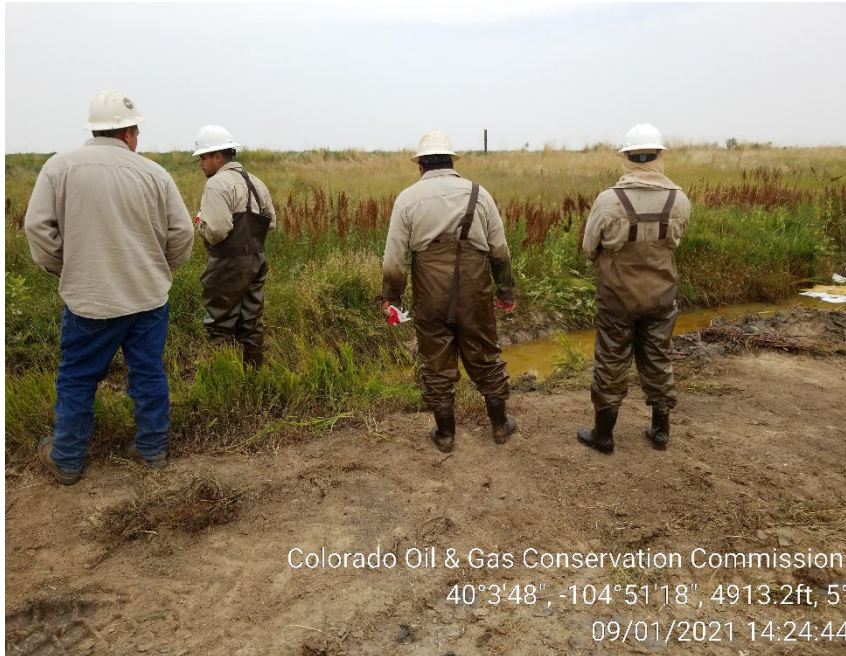
Operator's personnel working along the unnamed ditch.

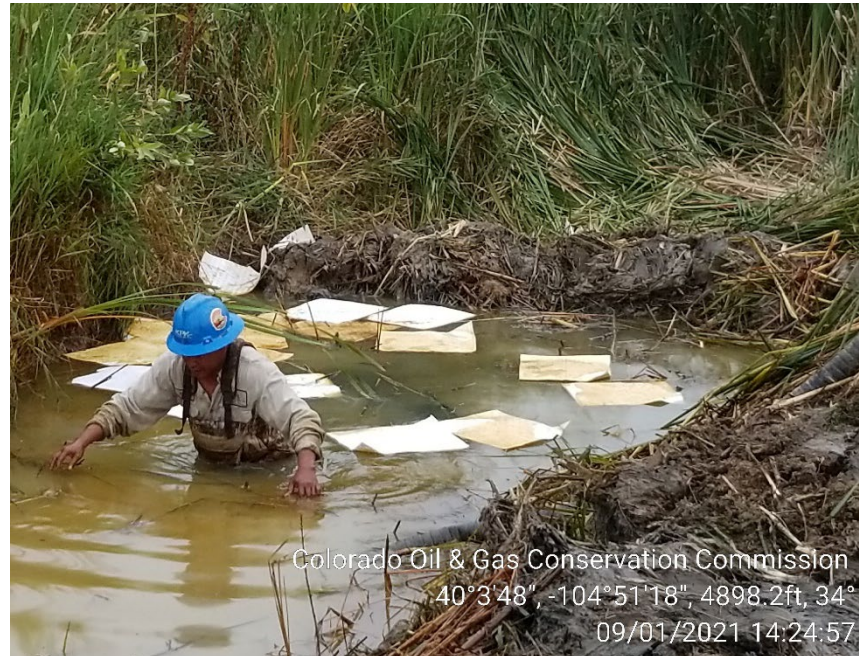
**Operator's personnel deploying absorbent pads in the ditch.
Note temporary dam behind the person.**

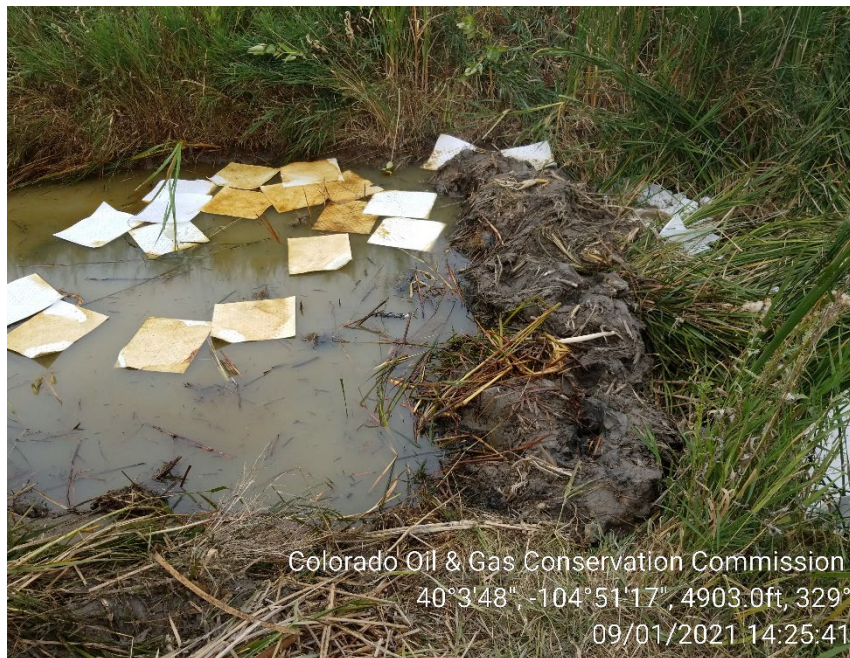
Second temporary dam constructed to restrict water from entering wetland.

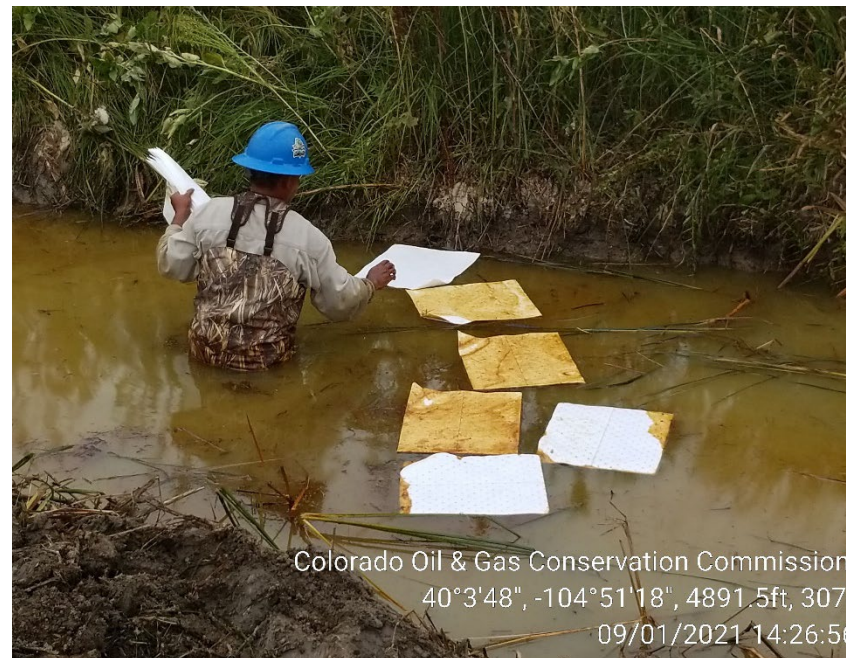
Operator's personnel deploying absorbent pads in the ditch.

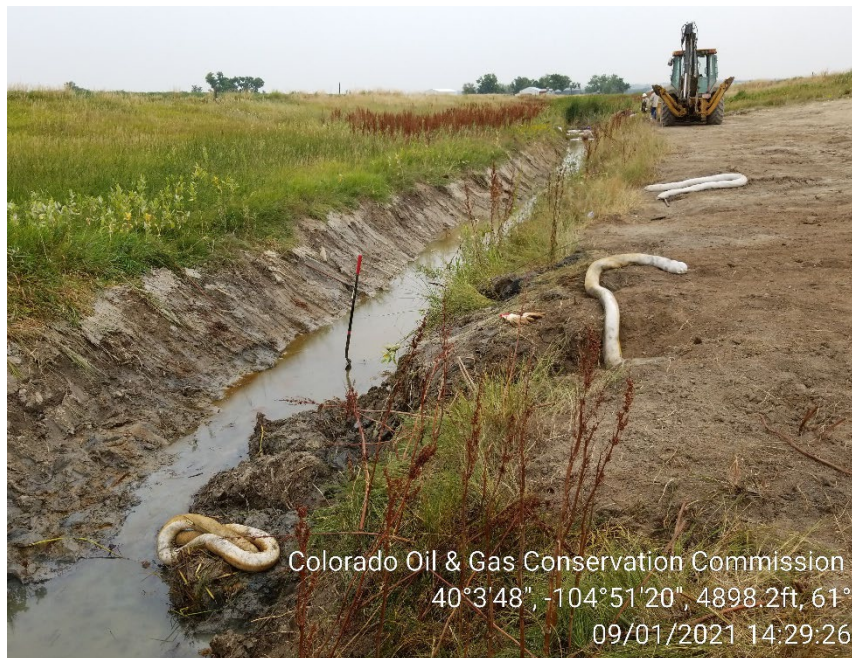
Partial view of the impacted reach of the ditch.

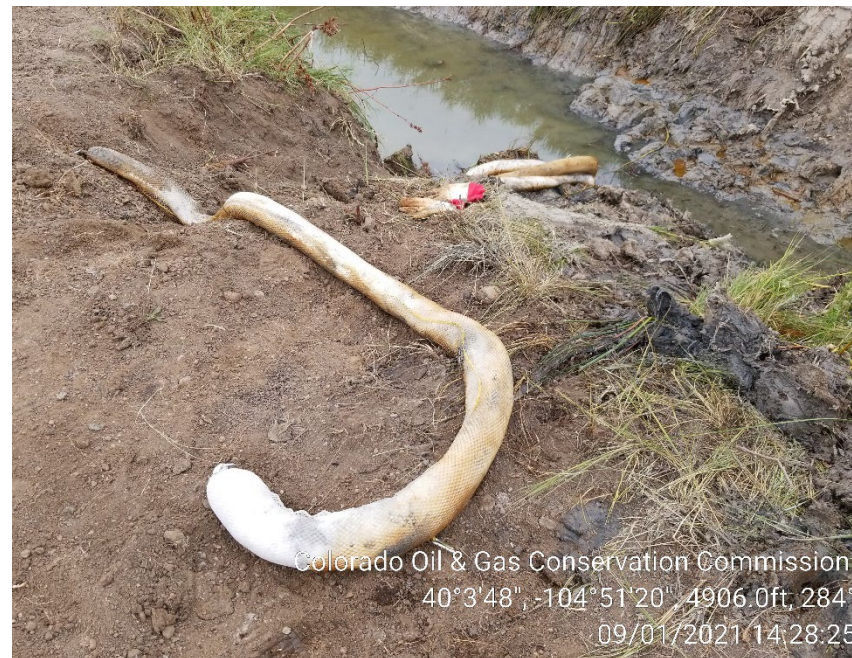
"Spent" absorbent booms.

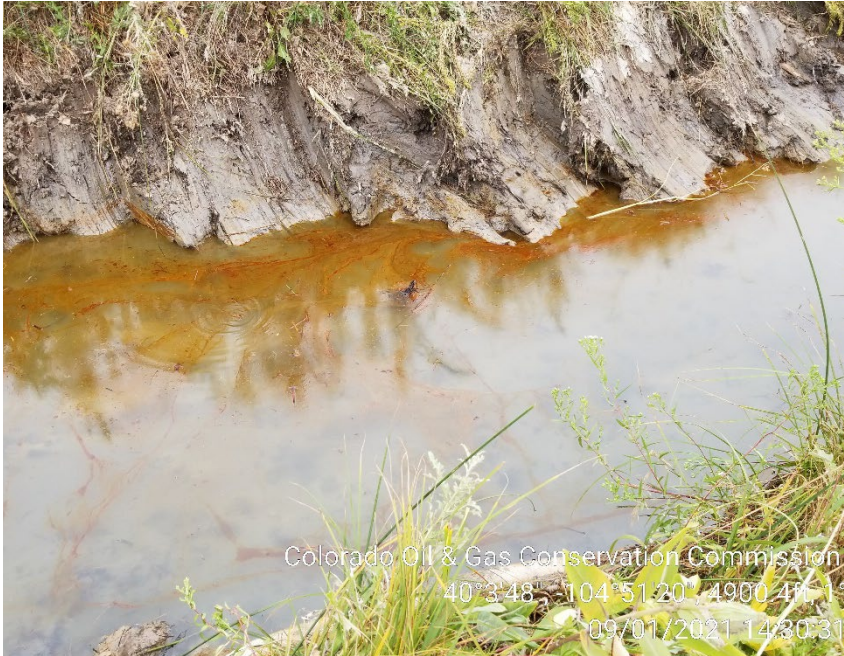
Oil (orange) floating on water in the ditch.

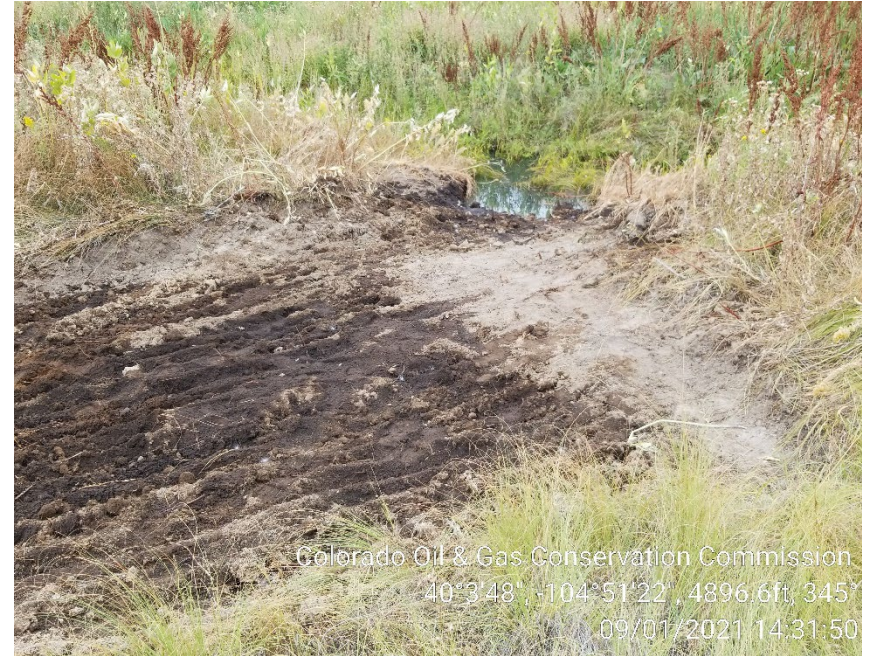
Small excavation in background filled with blue opaque water.

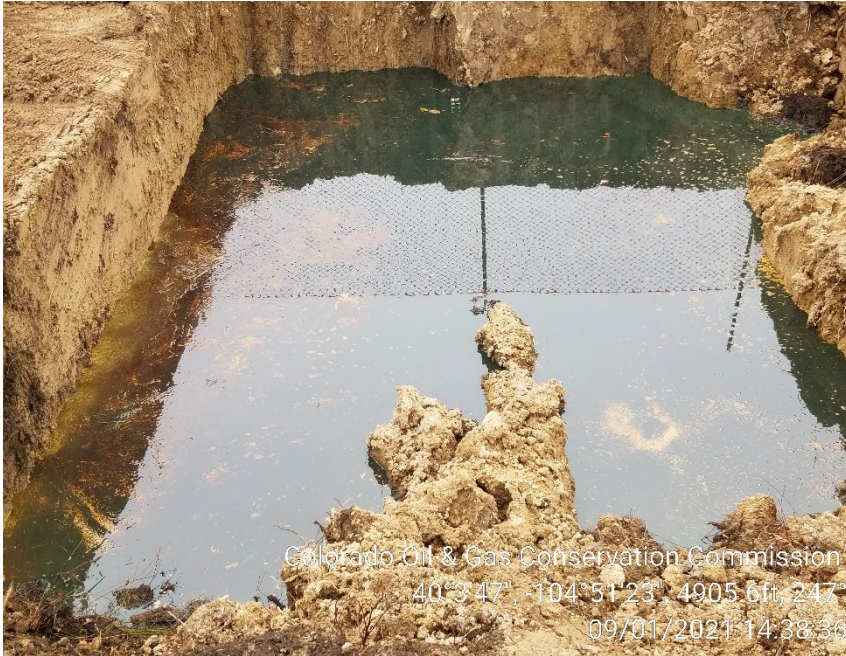
Excavation opened to expose the release point.

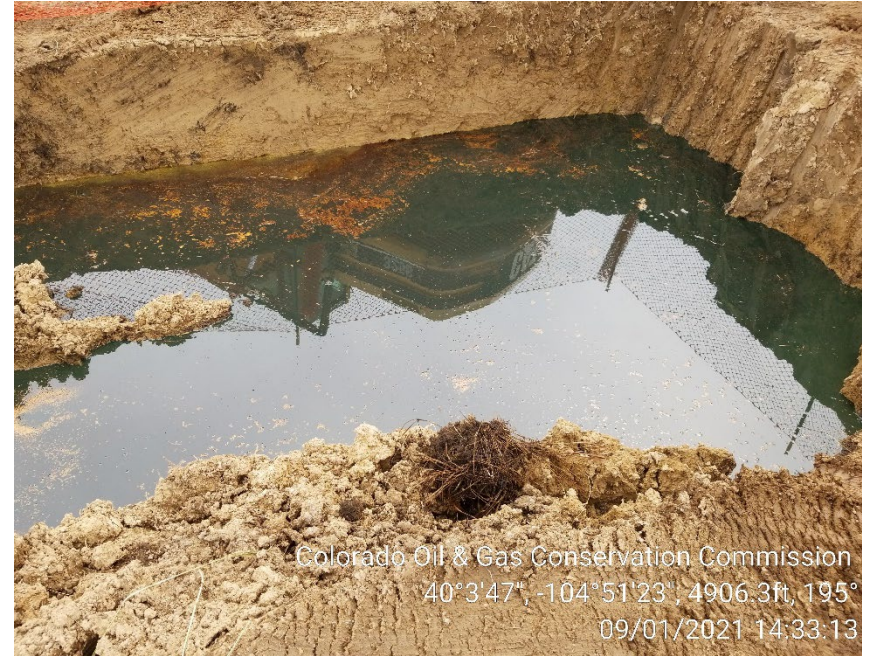
Excavation opened to expose the release point.

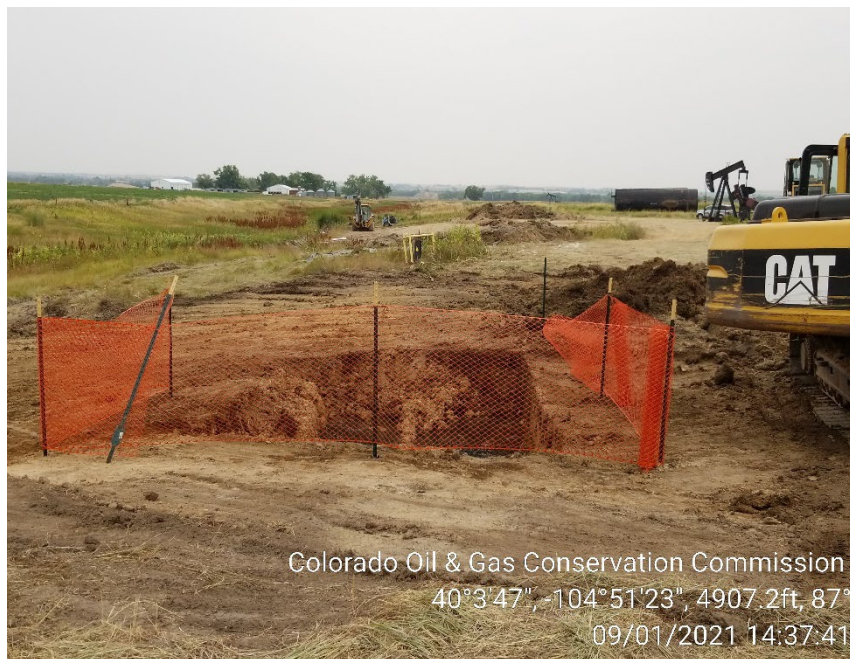
Orange safety fencing delineating the open excavation.

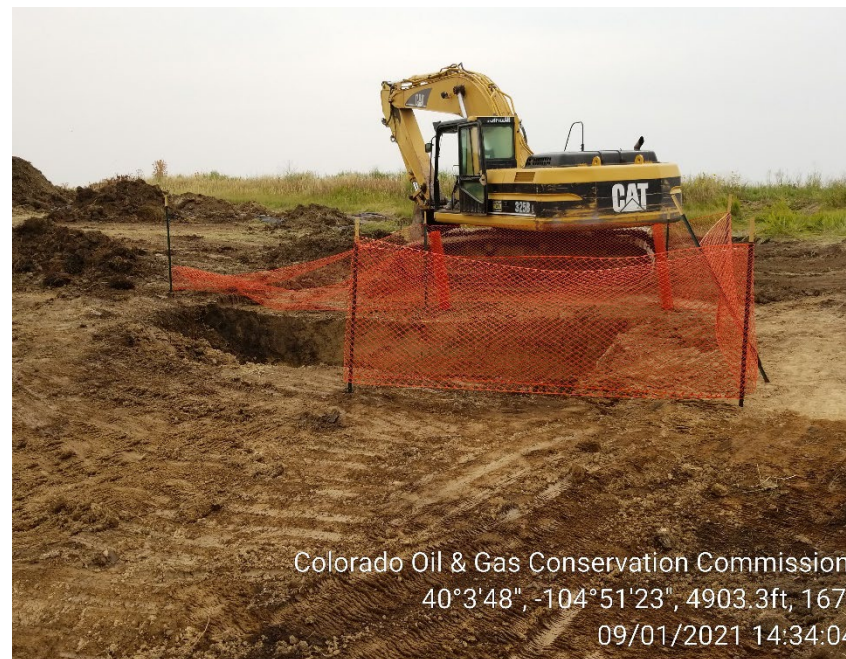
Orange safety fencing delineating the open excavation.

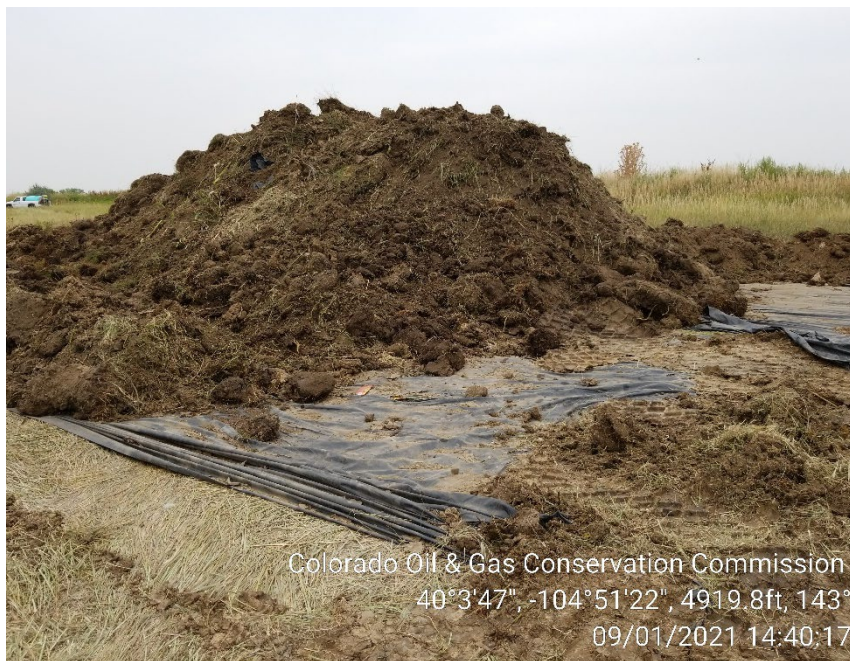
Spoil pile on top of a liner.

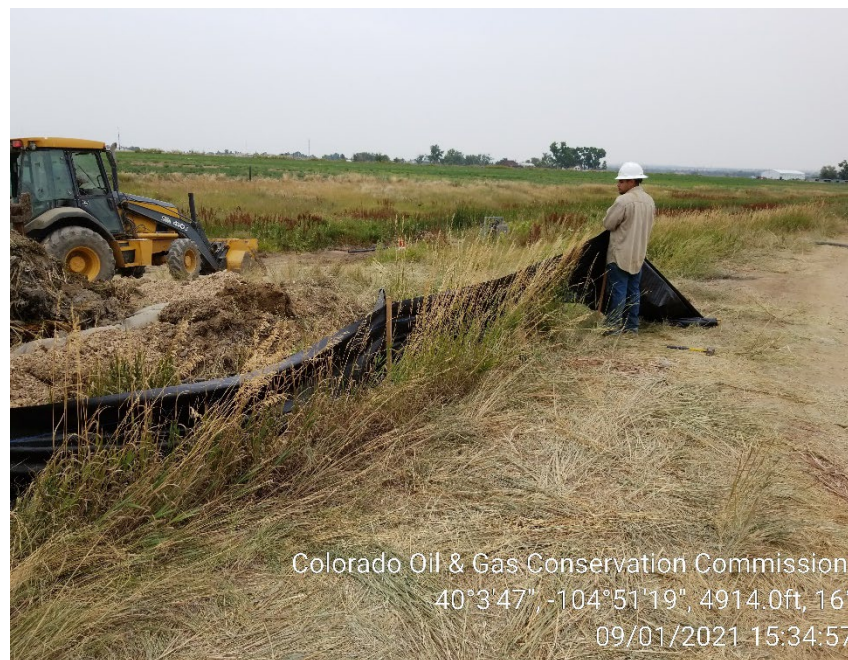
Operator's personnel deploying silt fence as a storm water BMP.

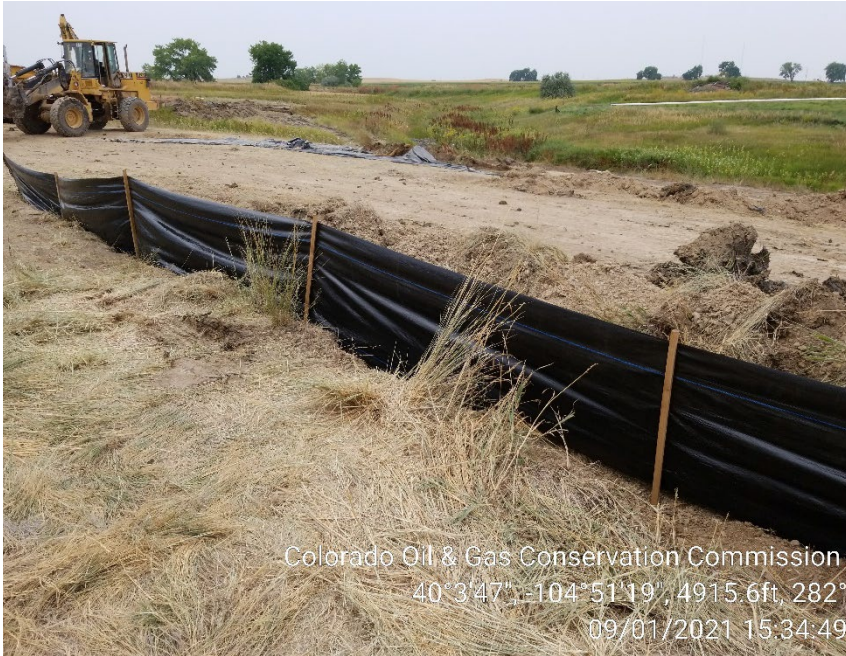
Silt fence being used as a storm water BMP.
