Inspection Photos
Martin J Schaefer #2 Flowline
Spill ID 480698 (AC)

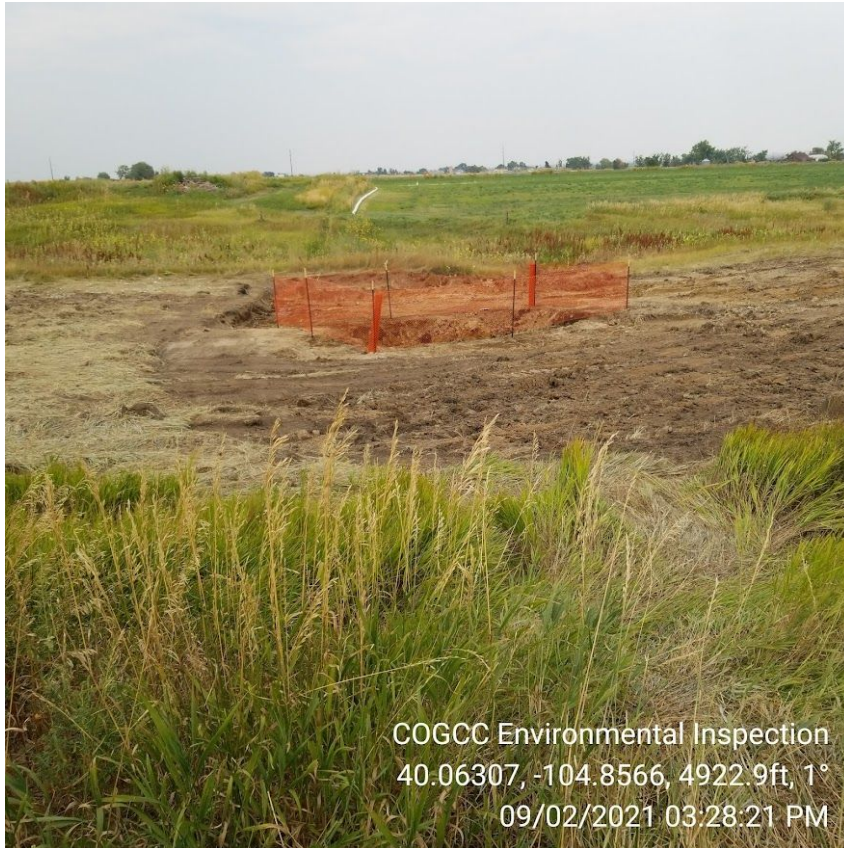
Photo 1 – Spill source location

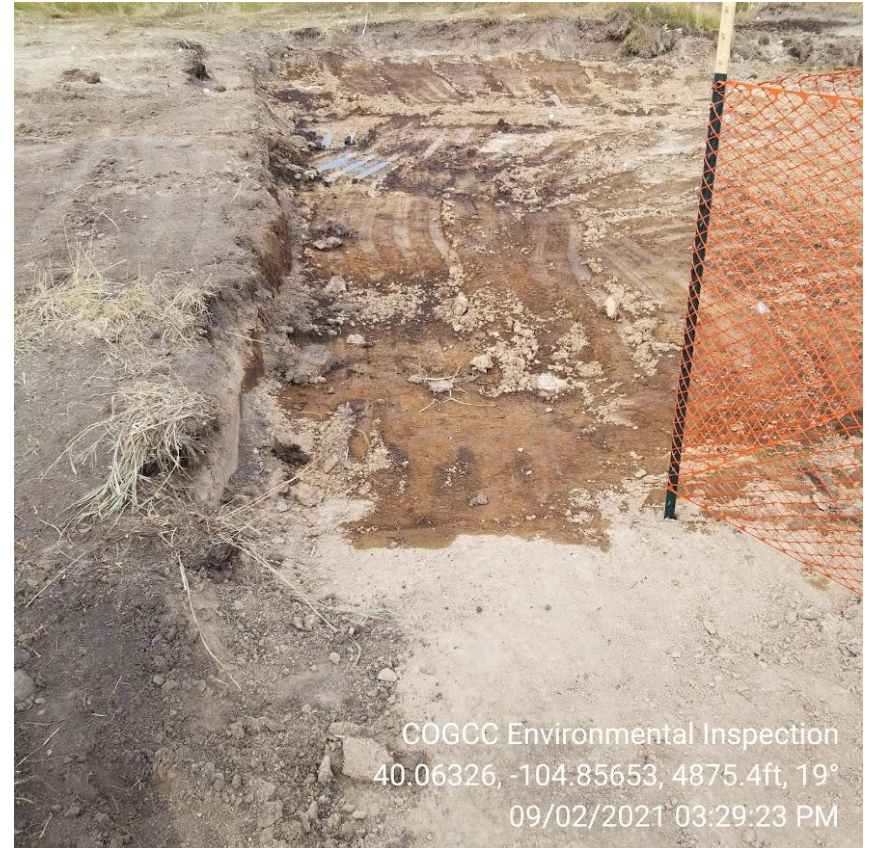
**Photo 2 – Free product remains on surface at
scraped spill area.**

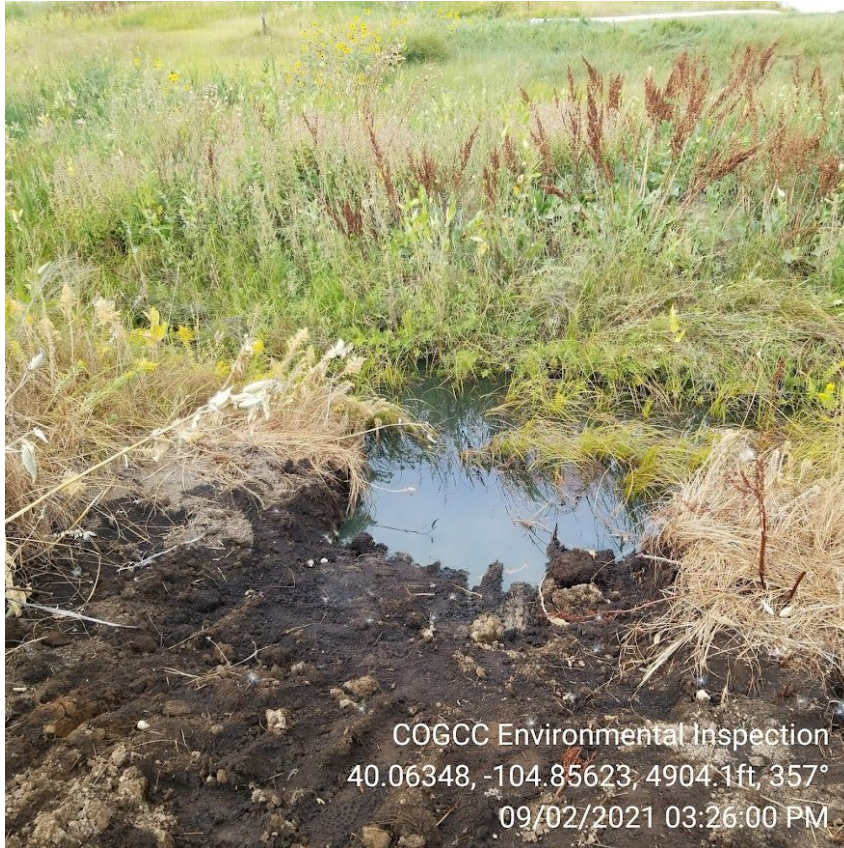
**Photo 3 – Entrance point of spill into stream/ wetland.
Measurable free product present on groundwater.**

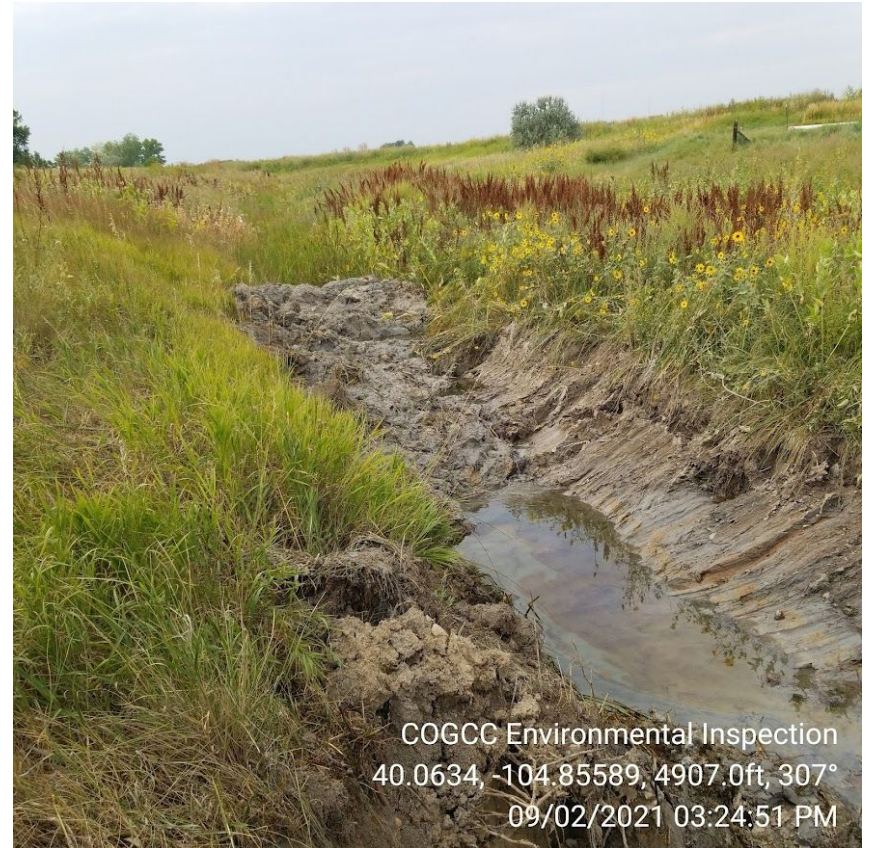
**Photo 4 – Soils dam constructed downstream of spill.
Hydrocarbons observed on groundwater on both sides of
the dam and on water running down the dam surface.**

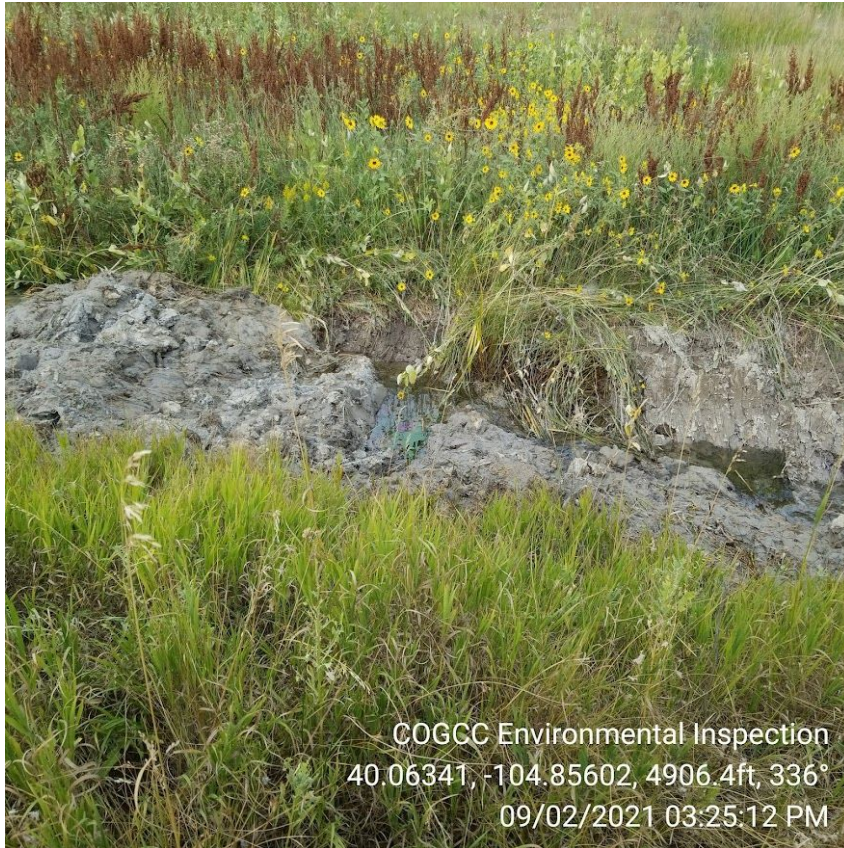
Photo 5 – Soil dam. Running water with hydrocarbons observed on dam.

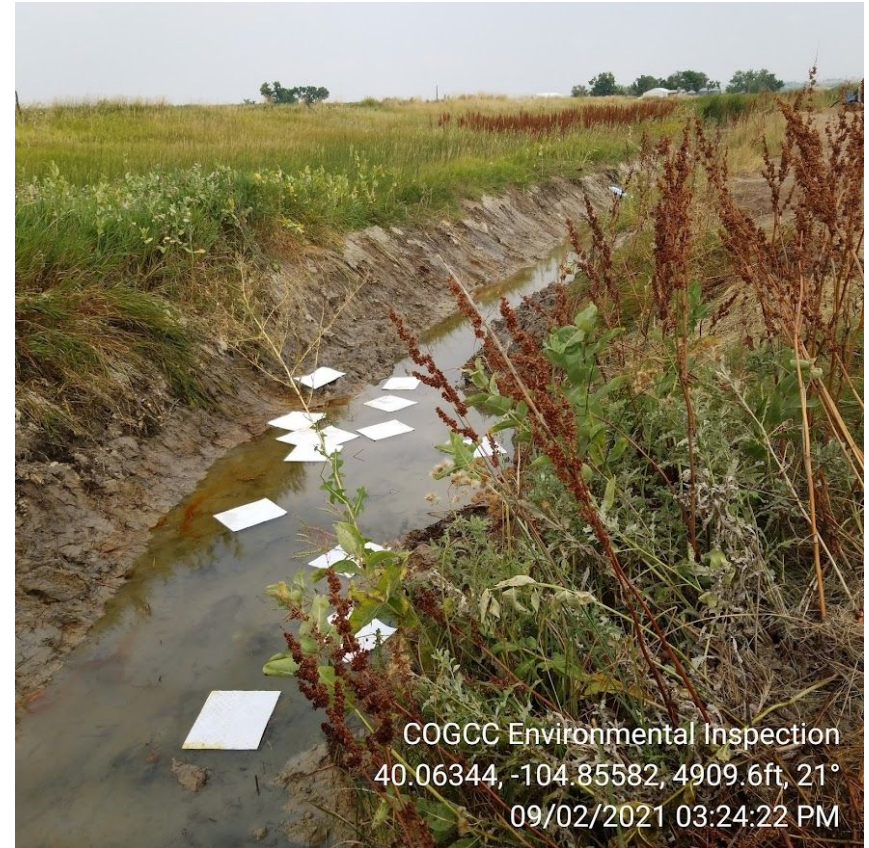
Photo 6 – View looking downstream. Absorbent pads placed in stream. Free product visible on surface water. Impacts to soil and vegetation visible along the stream. Wetlands dredged.

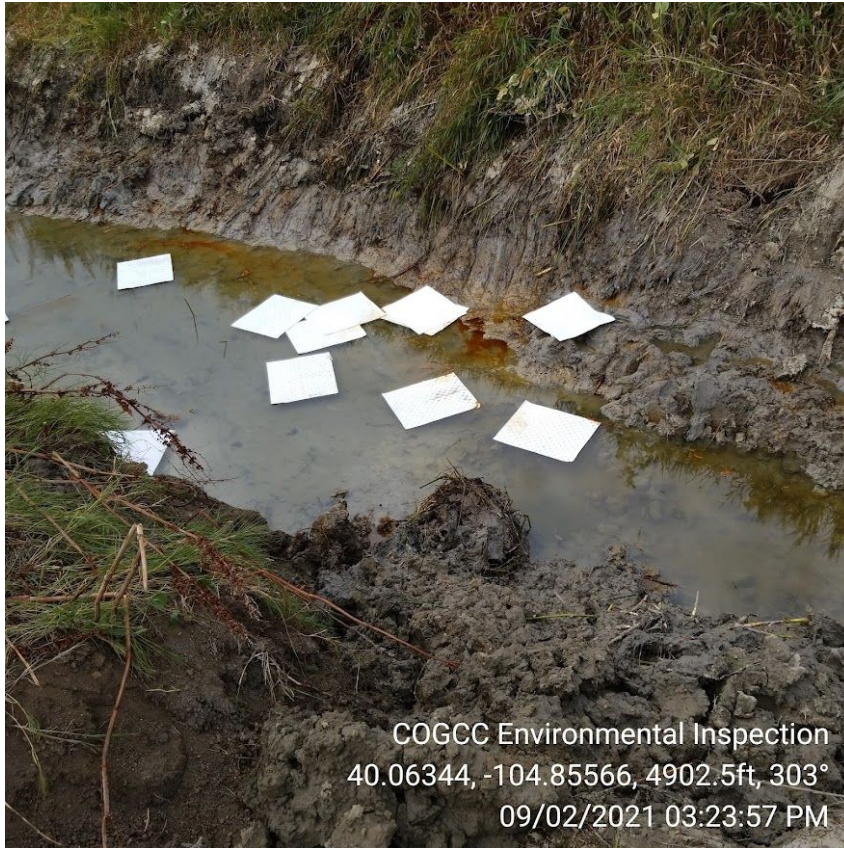
Photo 7 – Impacts to soils and surface water. Free product visible. Wetlands dredged.

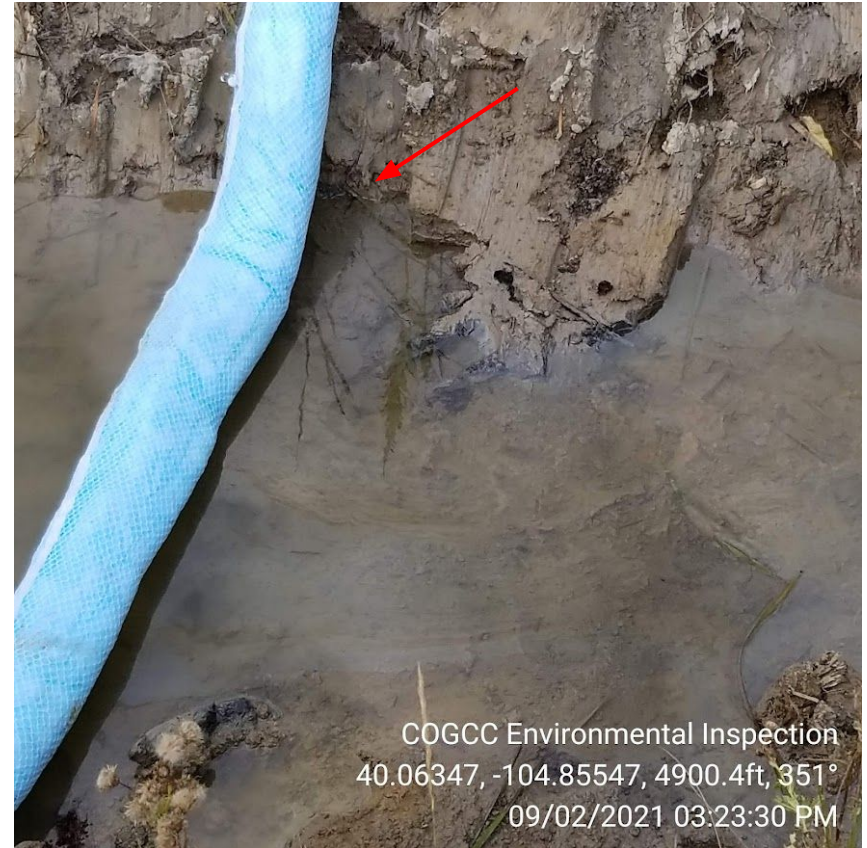
Photo 8 – Improperly installed boom allowing hydrocarbons to flow downstream through gap.

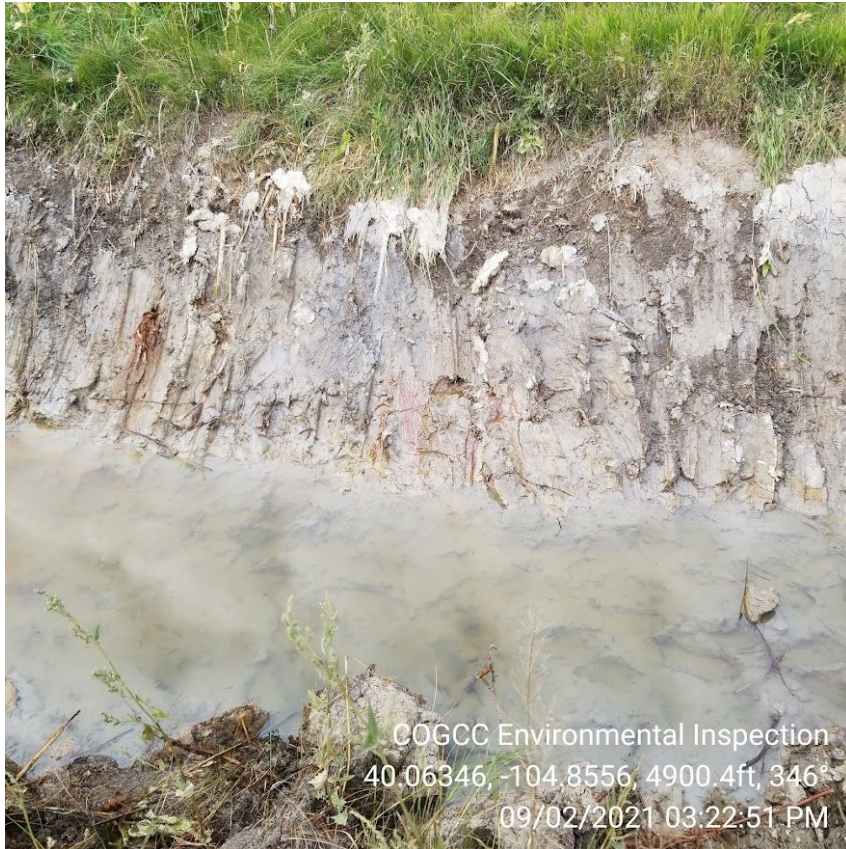
Photo 9 – Impacted soils along stream bank.

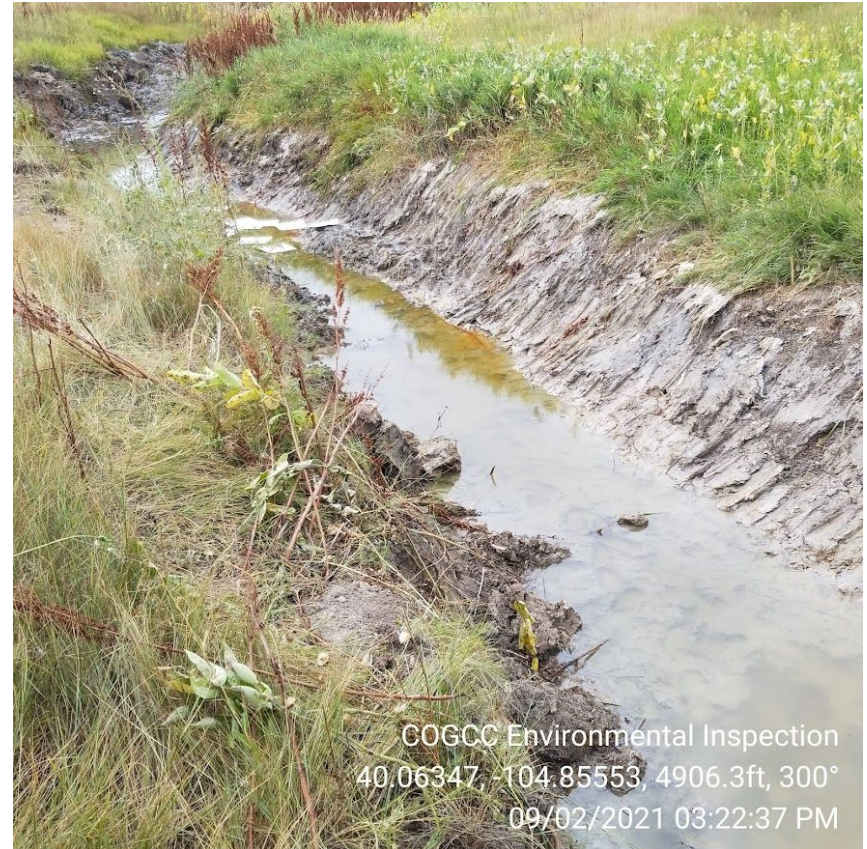
Photo 10 – Impacted soils and surface water. Wetlands dredged.

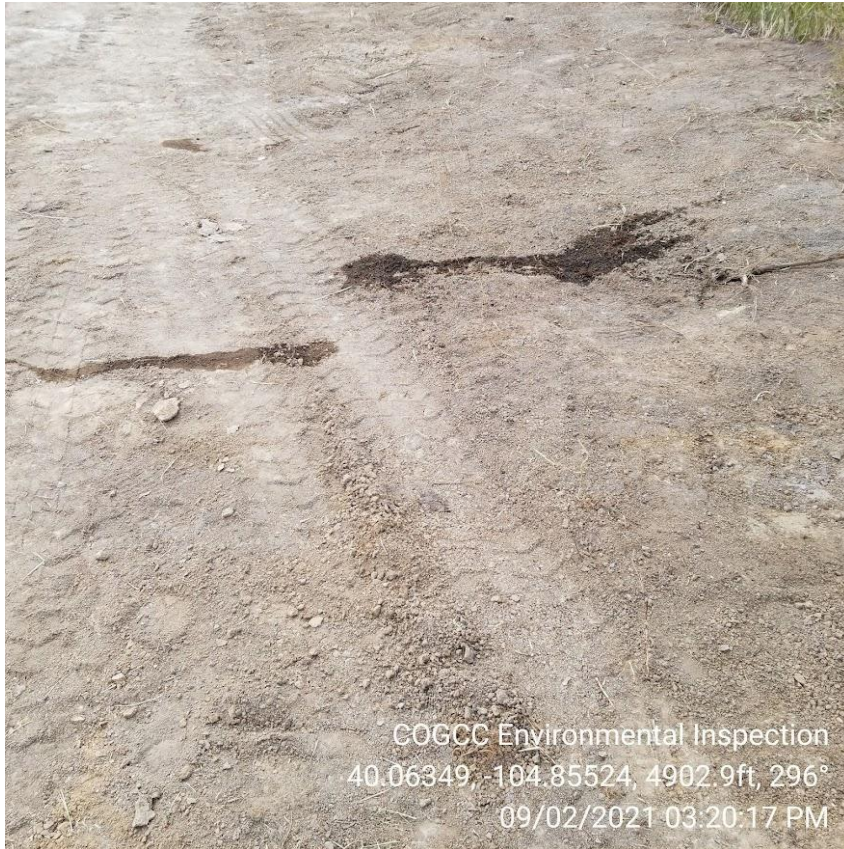
Photo 11 – Impacted soils in remediation footprint.

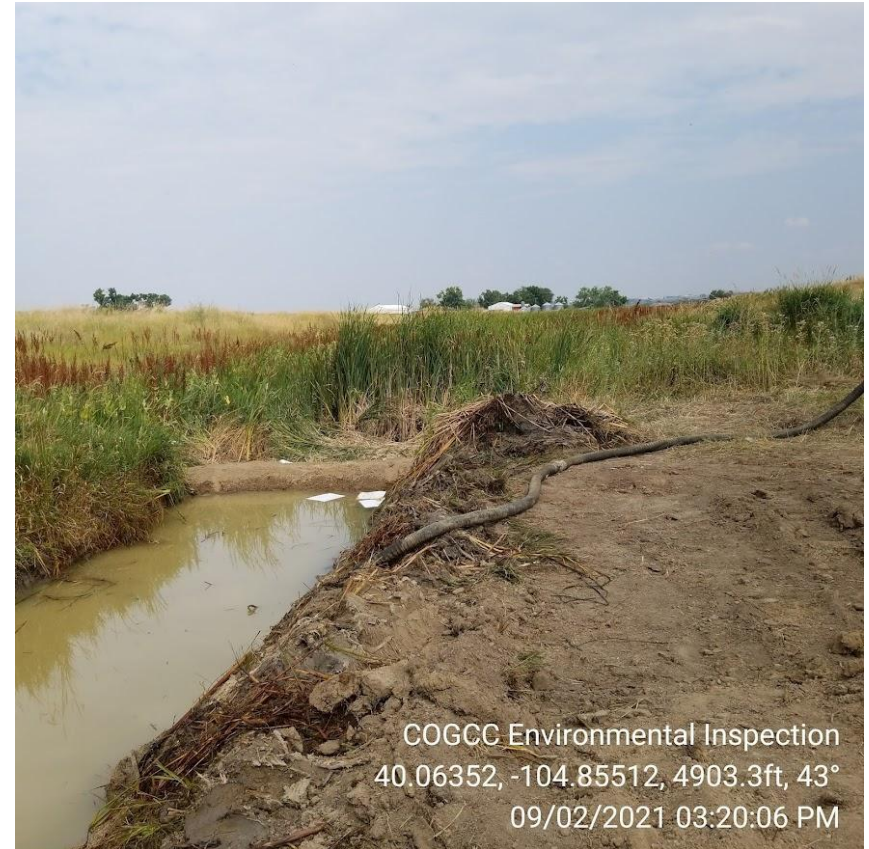
Photo 12 – Earthen berm and absorbent booms within dredged area.

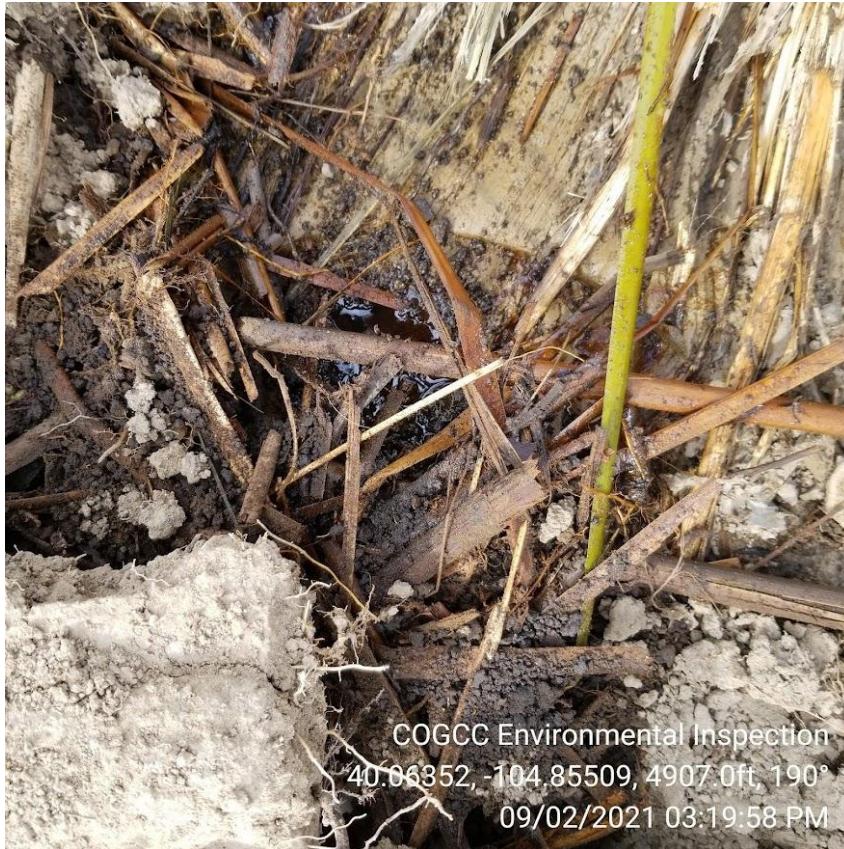
Photo 13 – Free Product observed in wetland in dredged area.

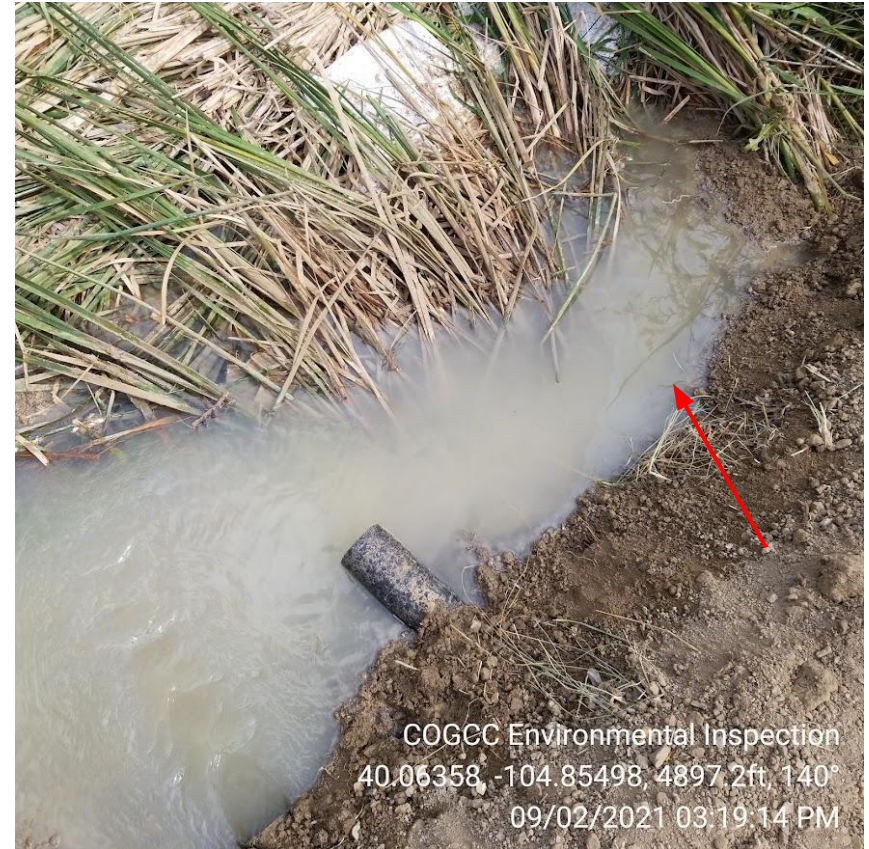
Photo 14 – Hydrocarbon sheen observed downstream from earthen dam below dredged area.

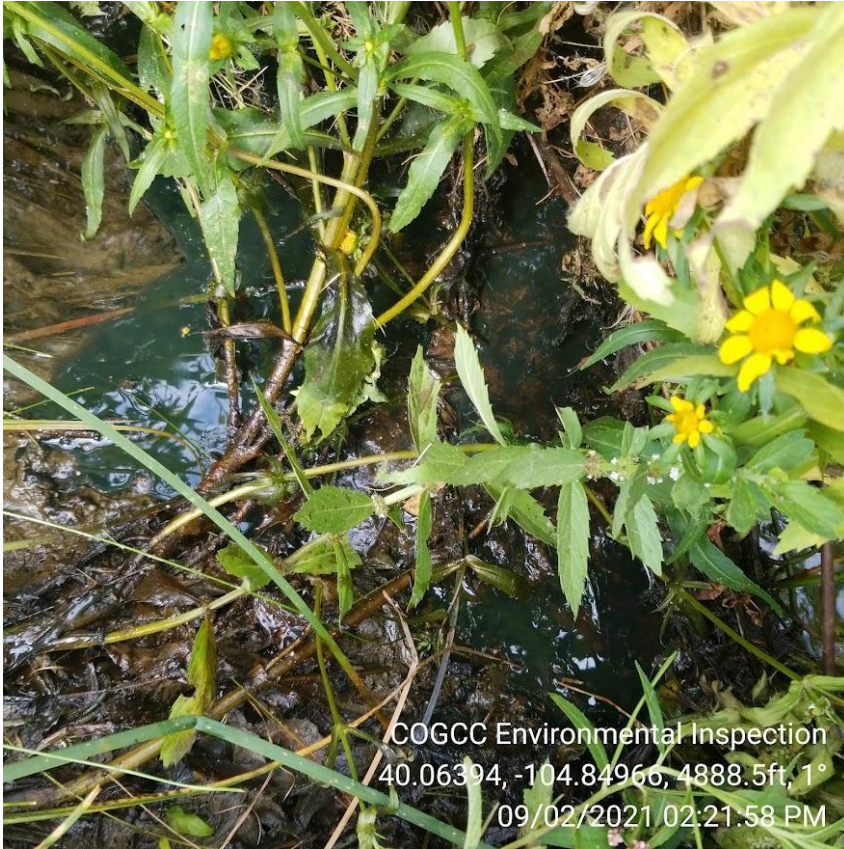
**Photo 15 – Measurable product on wetlands
approximately 1600' downstream of spill area.**

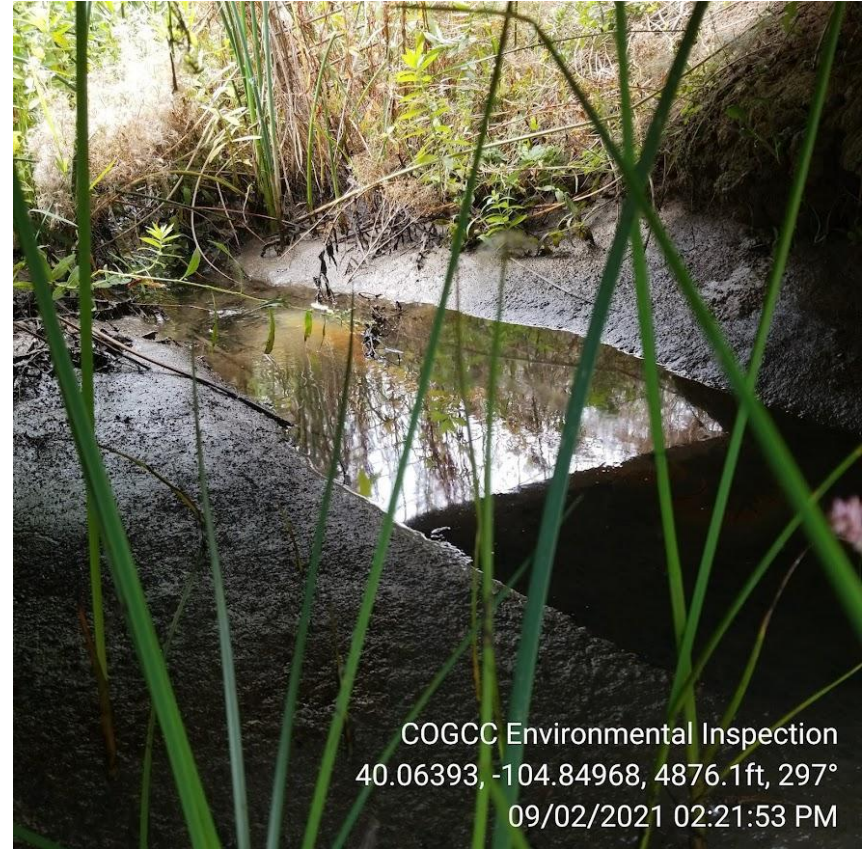
**Photo 16 – Sheen and product on wetlands approximately
1600' downstream of spill area.**

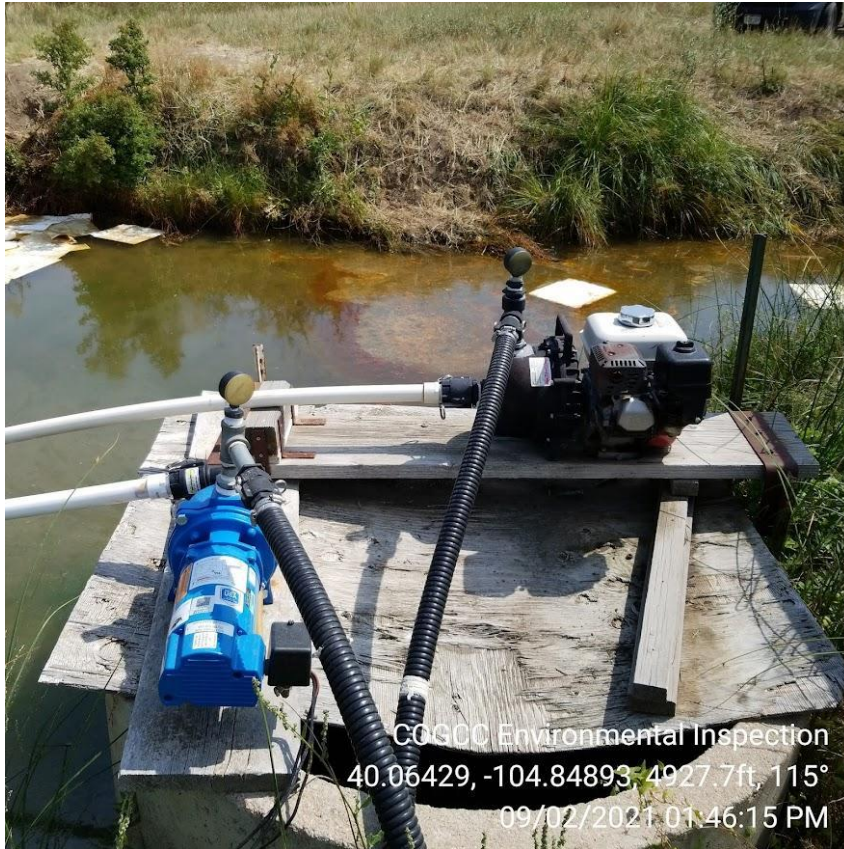
**Photo 21 – Irrigation source of residence to north.
Free product in background.**

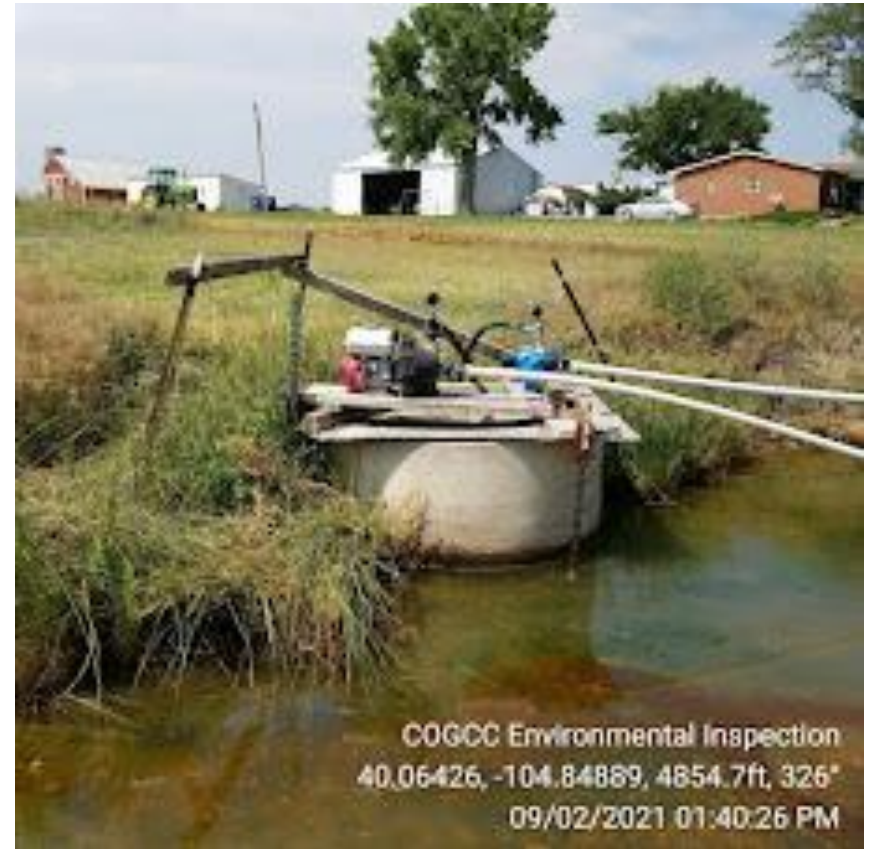
**Photo 22 – Irrigation source of residence to north. Free
product in foreground, staining observed on concrete
vault.**

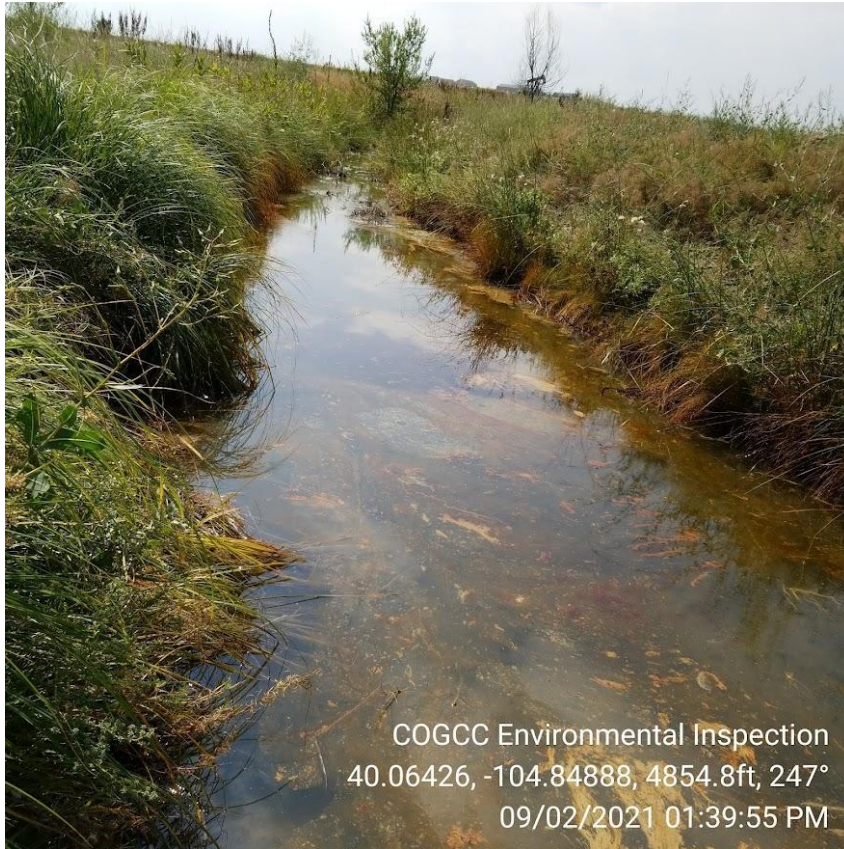
Photo 23 – Product on water looking upstream of pond.

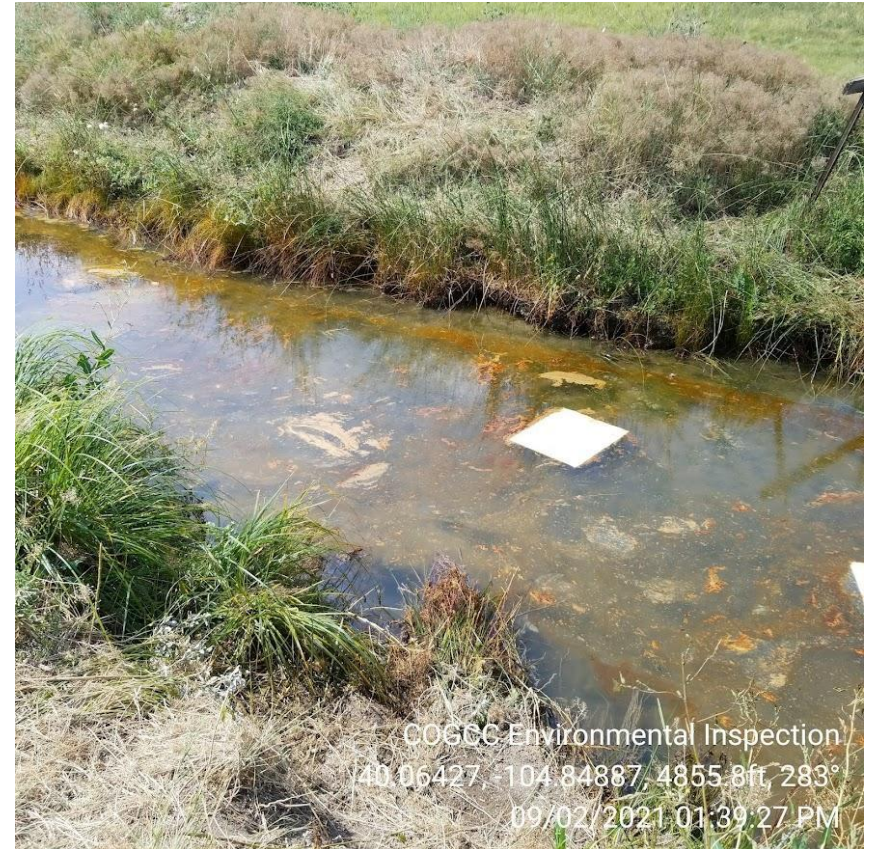
Photo 24 – Product on water upstream of pond.

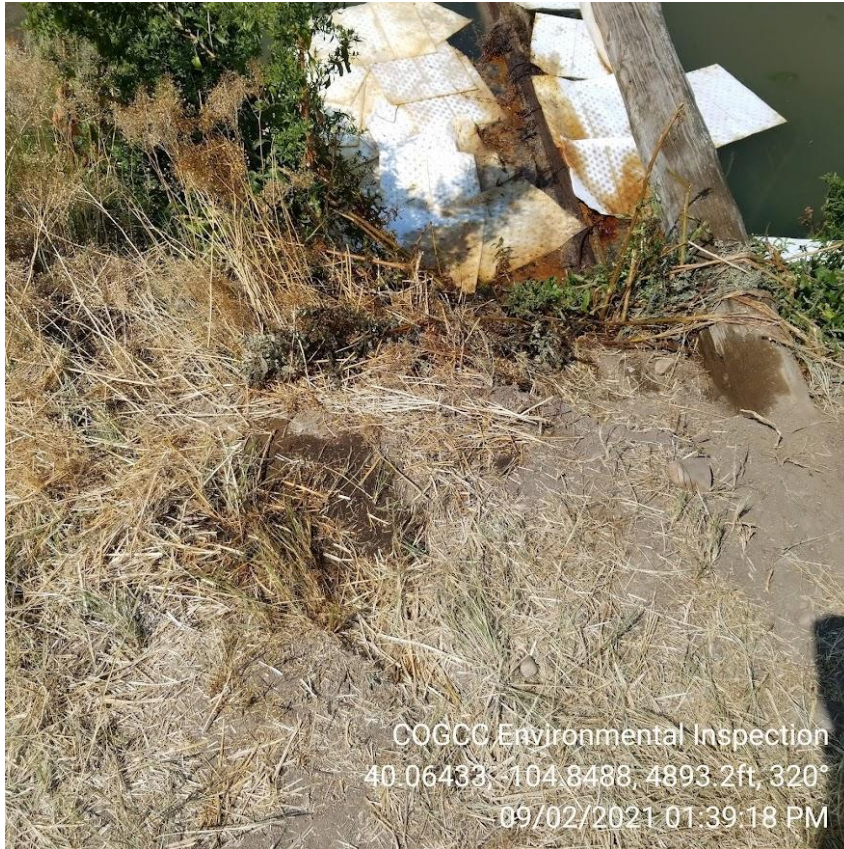
Photo 25 – Soil staining in area adjacent where booms were placed.

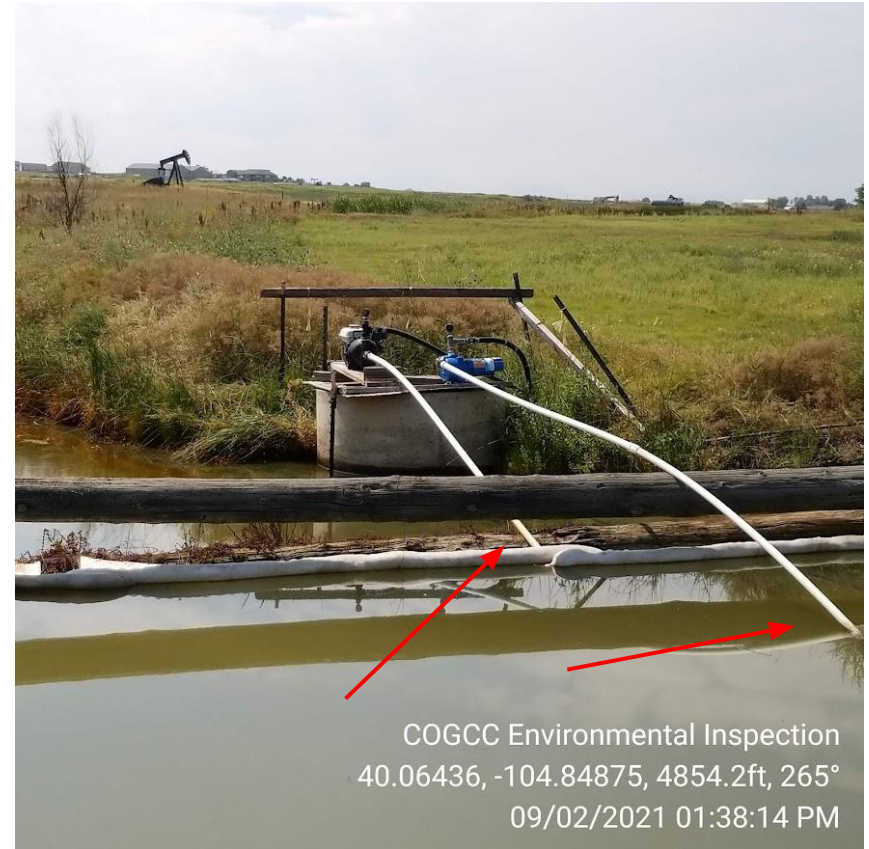
Photo 26 – Irrigation source for residence showing source pipes within pond with area of visible impacts.

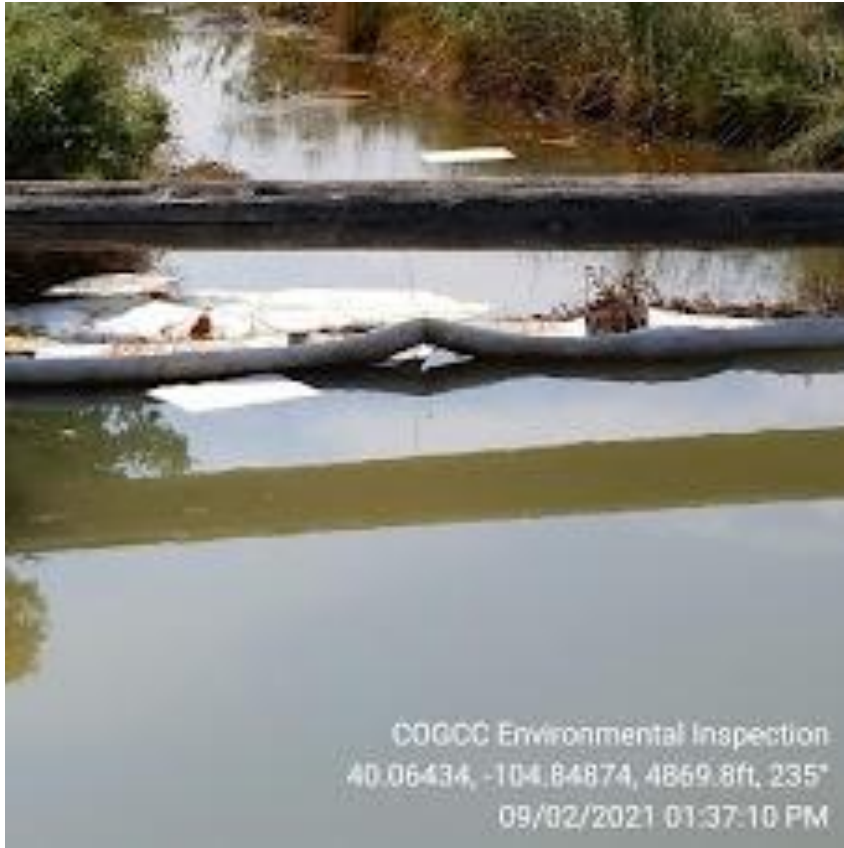
Photo 27 – Incorrectly installed booms allowing impacts to migrate under wire hanger.

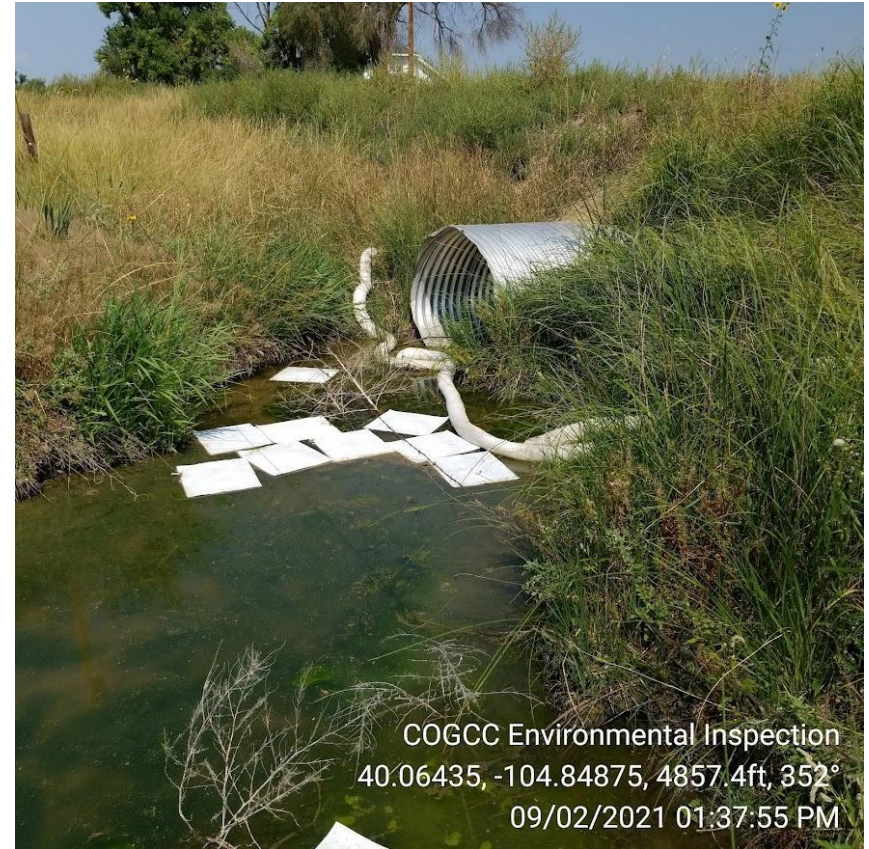
Photo 30 – Impacts and absorbent booms upstream of culvert running under County Road 23.

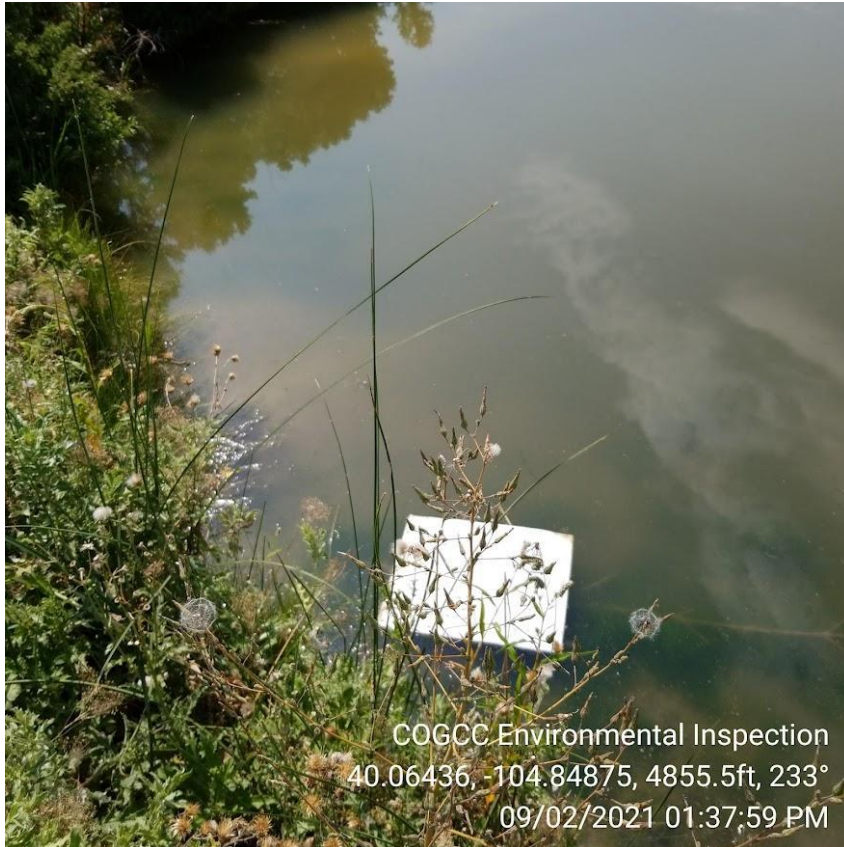
Photo 31 – Hydrocarbon sheen visible on surface water

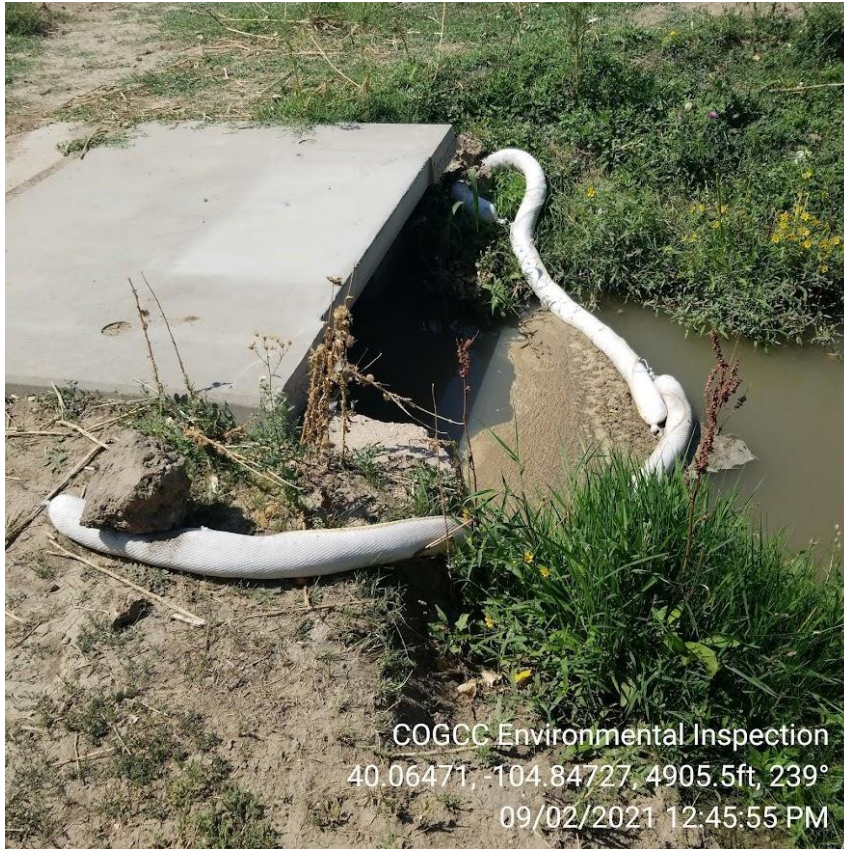
Photo 35 – Boom downstream of where unnamed stream meets Brighton ditch. Booms are improperly secured by dirt clod.

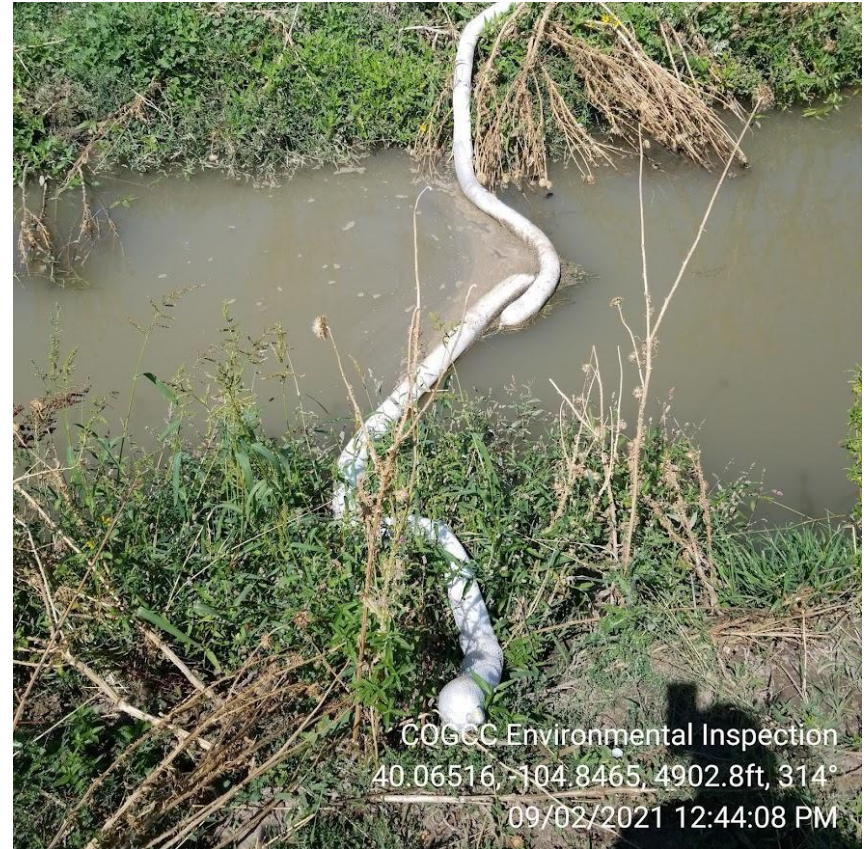
Photo 36 – Furthest downstream boom (3,000' from source). Boom is not secured.

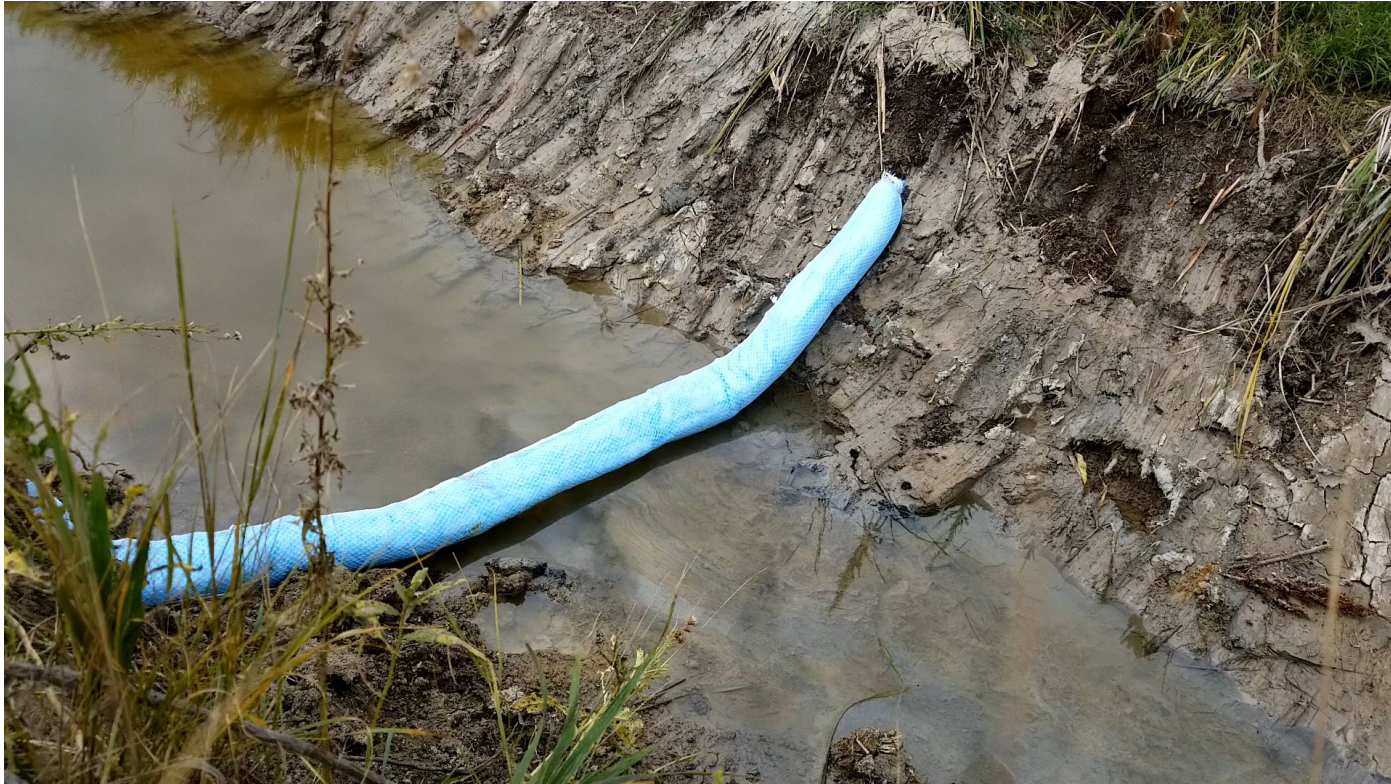
Video 1 – Hydrocarbon sheen on groundwater observed moving around improperly installed boom and downstream. Video is from the source area.
