Stormwater Inspection Report

Operator:	Laramie Energy, LLC
Project:	Cascade Creek
Location:	Cascade Creek 697-09-61
Date:	Wednesday, September 1, 2021
Weather:	Cloudy & Rain, Windy, Hi 79°, Lo 55°

Operator:	Laramie Energy, LLC
Project:	Cascade Creek
Location:	Cascade Creek 697-09-61
Date:	Thursday, September 2, 2021
Weather:	Partly Cloudy, Light Wind, Hi 77°, Lo 53°

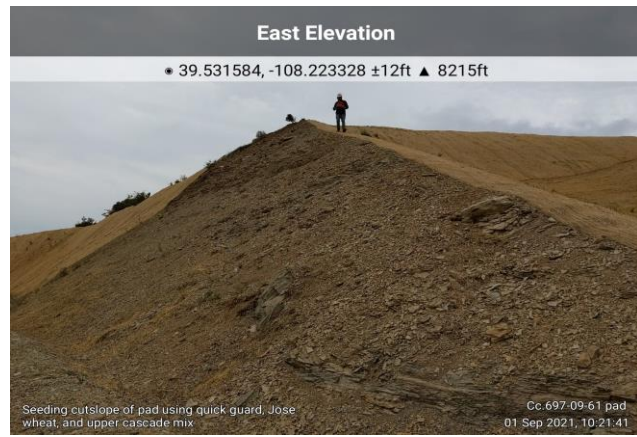
Photo 1

Broadcast Seeding over Steep Cut Slope on the CC 697-09-61 Pad

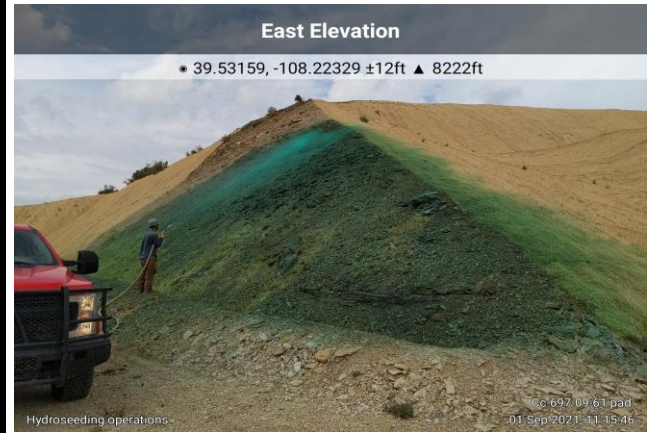
Photo 2

Applying Liquid Nutrients to Steep Cut Slope on the CC 697-09-61 Pad

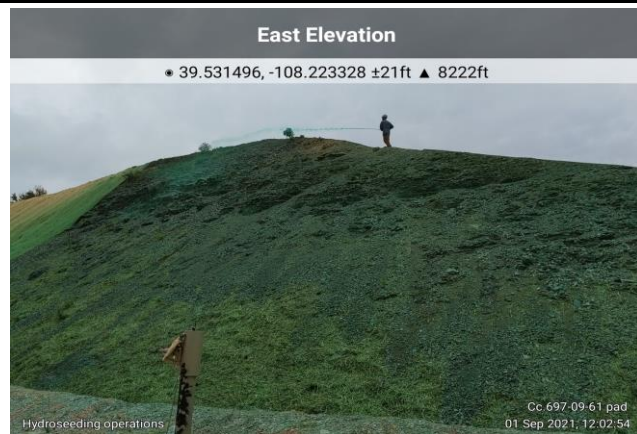
Photo 3

Applying Liquid Nutrients to Steep Cut Slope on the CC 697-09-61 Pad

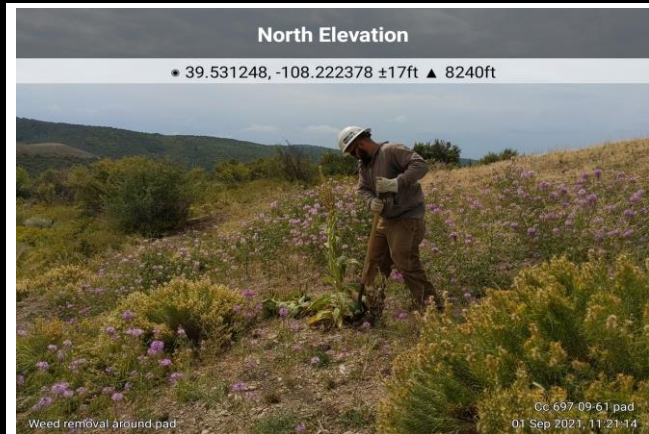
Photo 4

Removing Common Mullein from the CC 697-09-61 Pad

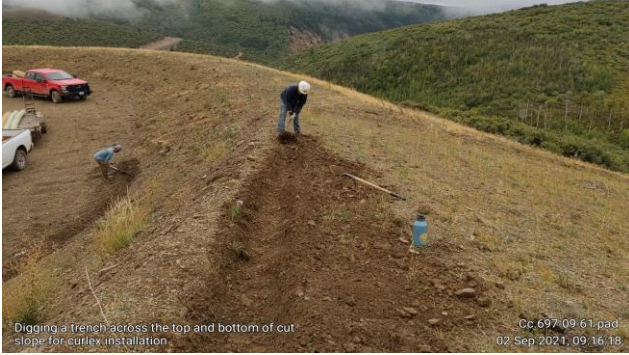
Photo 1

Installing Trenches to Anchor Upper and Lower Ends of Erosion Control Blanket Installations

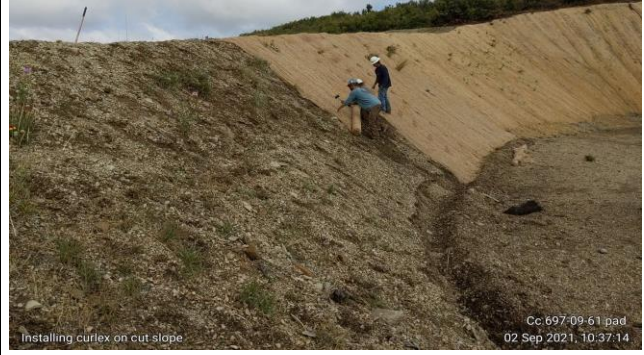
Photo 2

Installing Erosion Control Blanket on the Cascade Creek 697-09-61 Pad

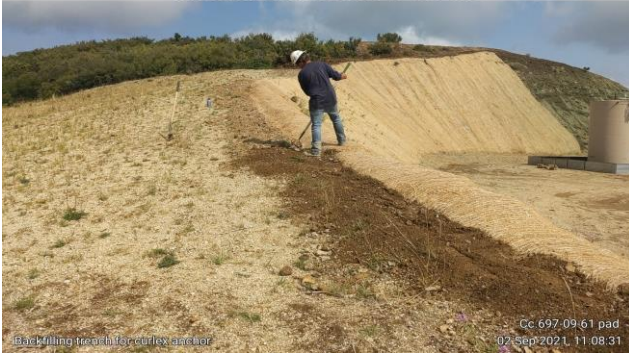
Photo 3

Backfilling Trench on CC 697-09-61 Pad

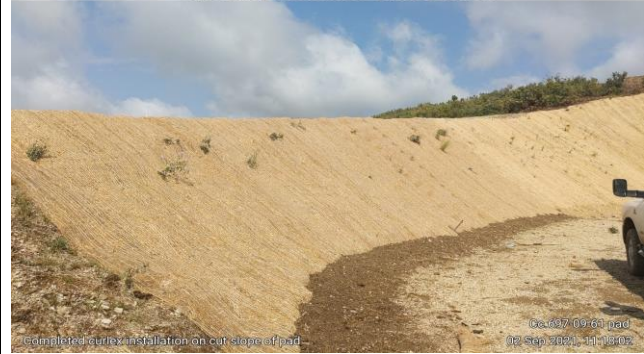
Photo 4

Erosion Control Blankets Installed on the CC 697-09-61
