# Inspection Photos

API: 071-08482

Operator: OGRIS OPERATING LLC

Inspection Date: 9/3/2021

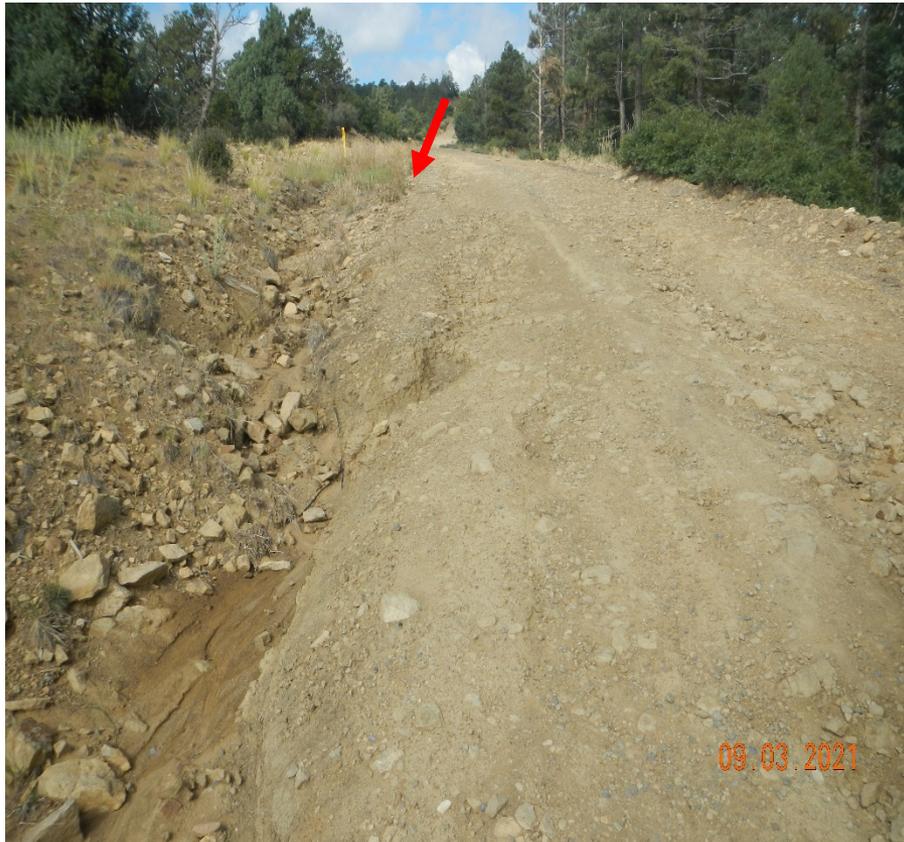
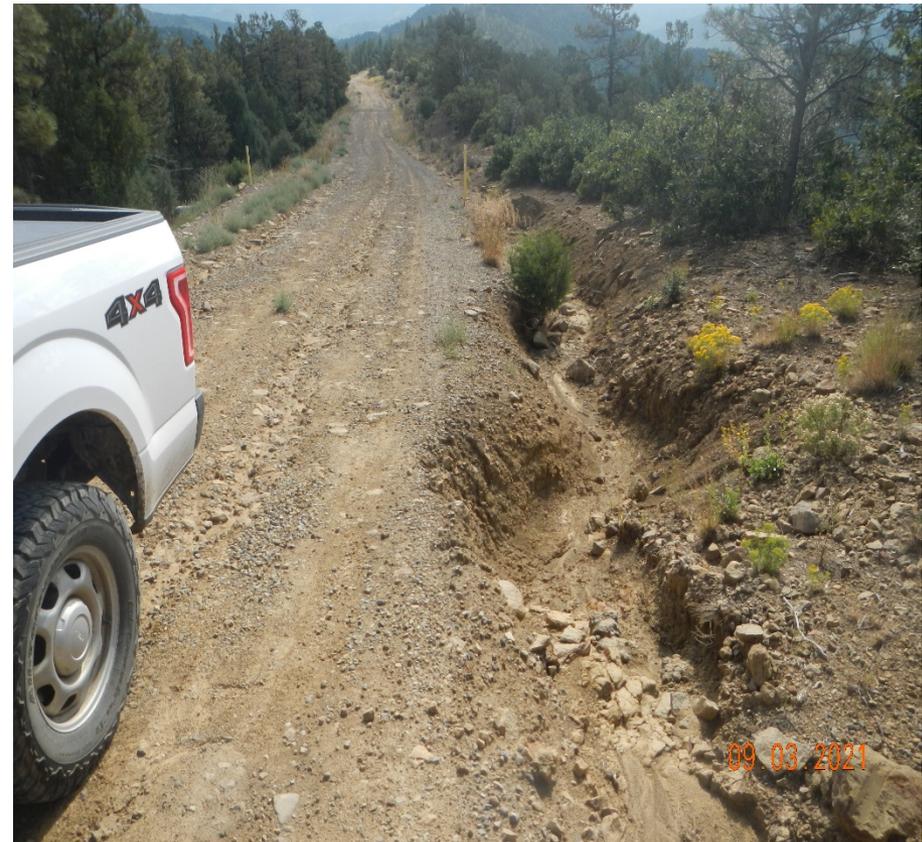
**Photo 1.** Facing west along the access road. There is insufficient BMP's along the road causing stormwater to flow down a long portion of the road which is causing erosion. Previous corrective action was not performed.

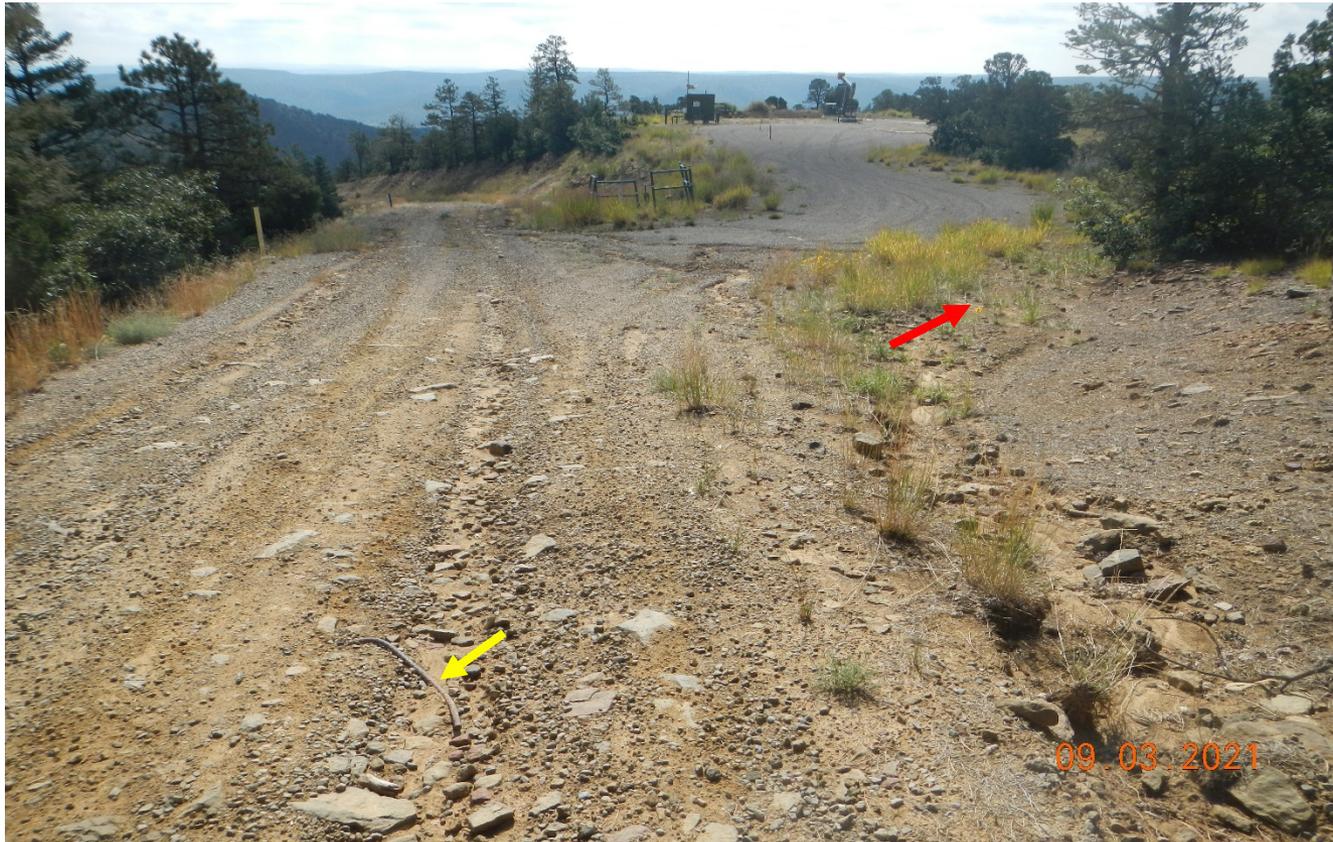
**Photo 2.** Stormwater is directed down the road causing erosion shown in previous photos. Stormwater should be diverted off the road shown at red arrow, The yellow arrow points to a piece of rebar stuck in the road which could puncture a tire.

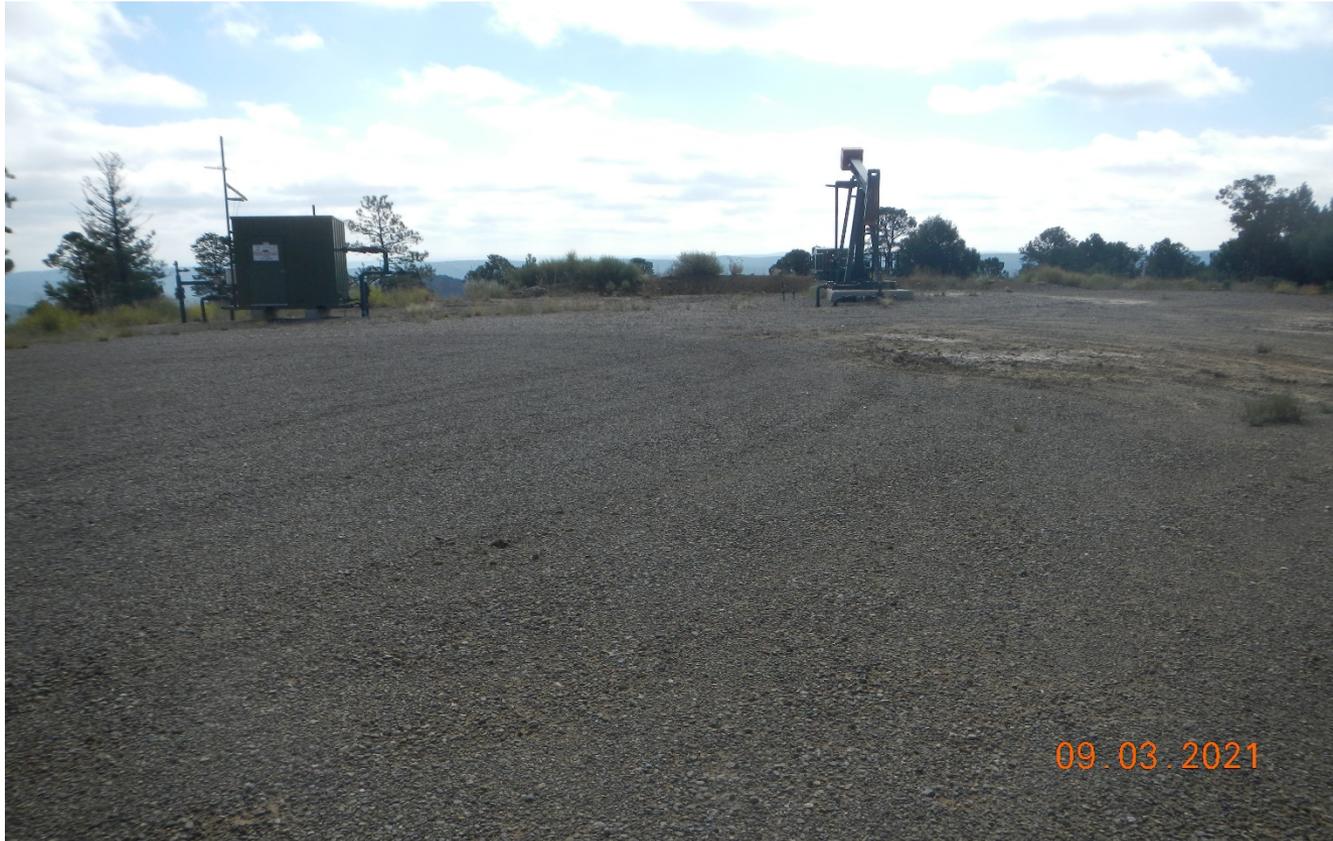
**Photo 3.** Facing toward the location.
