Inspection Photos

API: 071-07560

Operator: OGRIS OPERATING LLC

Inspection Date: 9/3/2021

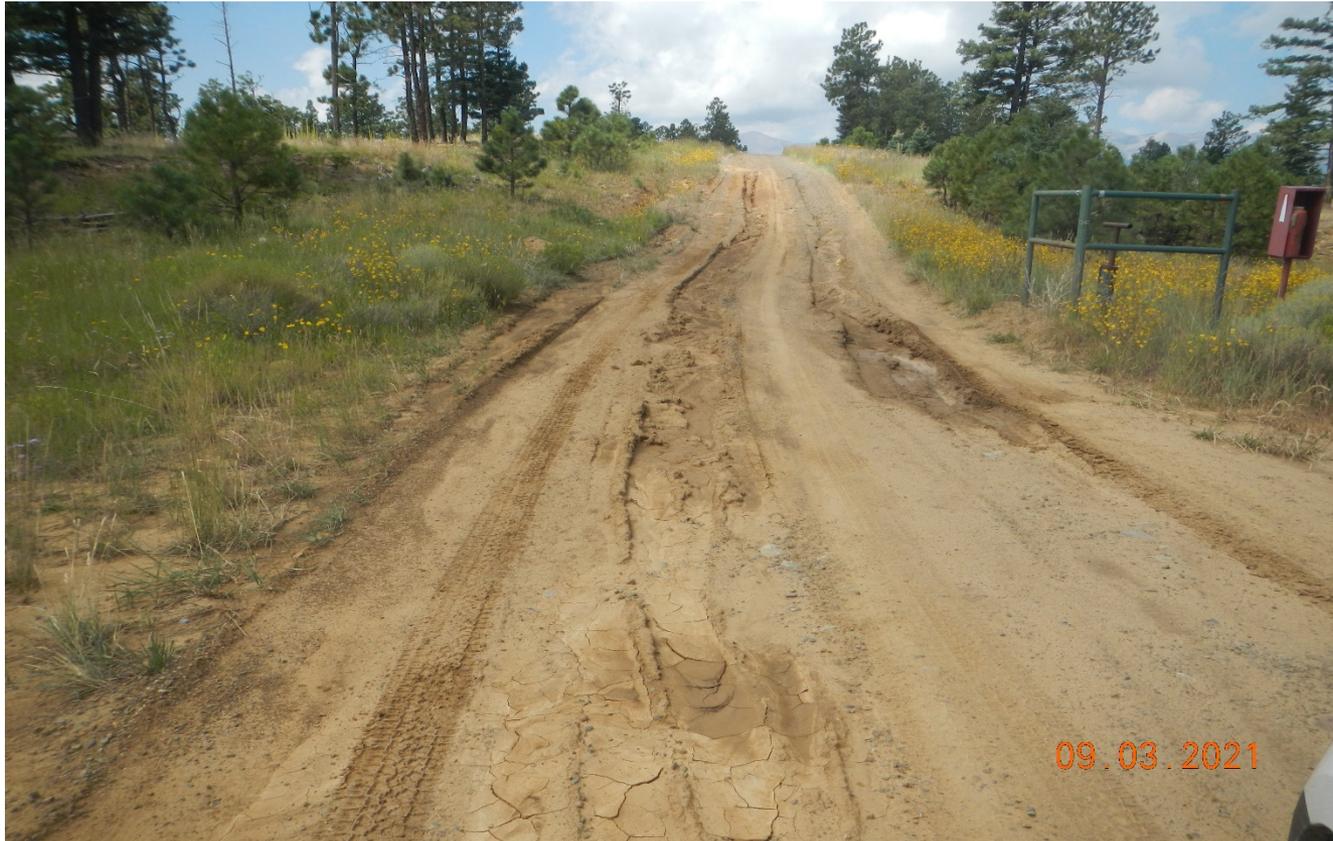
Photo 1. There is vehicle rutting along the road traveling to the location. The road needs to be maintained. Previous corrective action has not been completed.

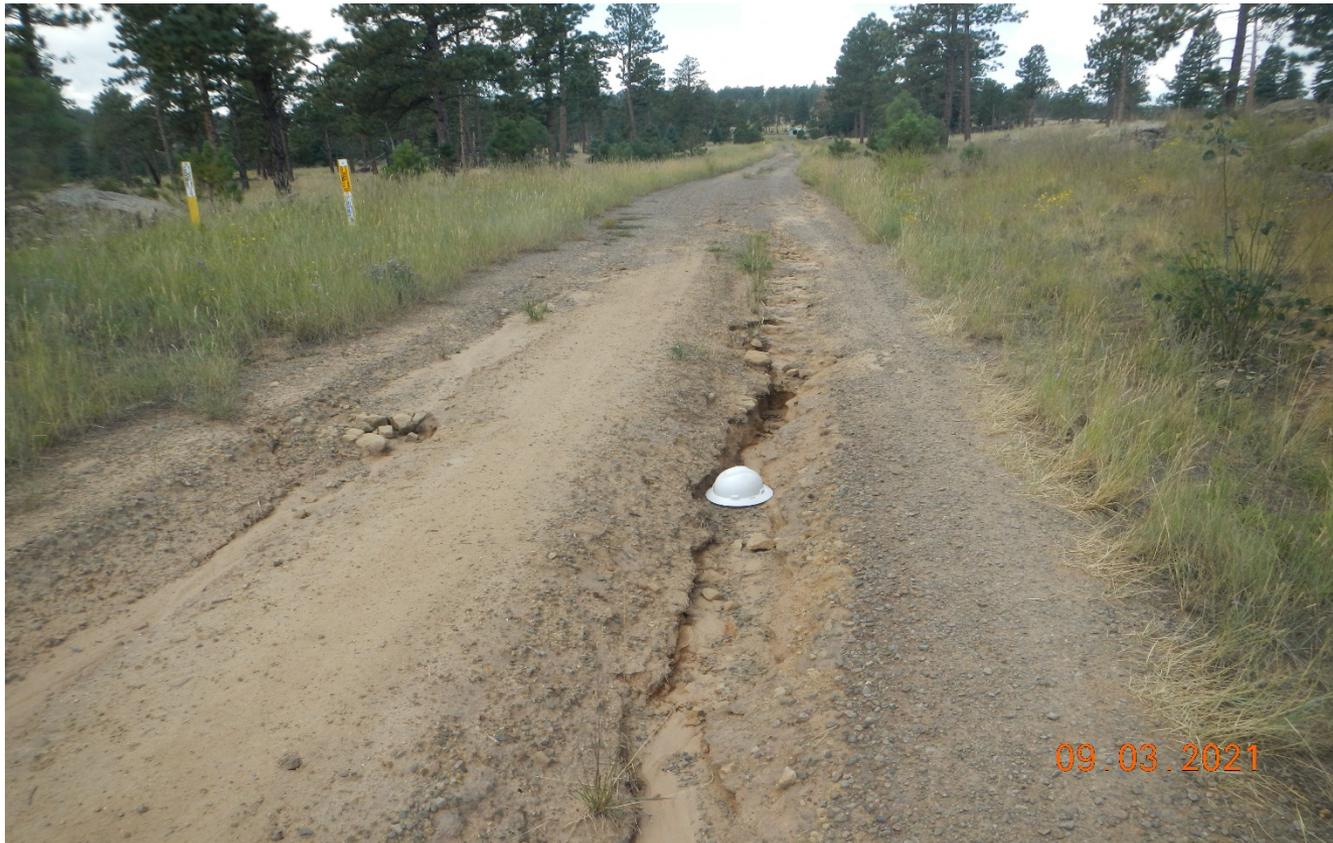
Photo 2. Facing southwest along the access road. There are areas of erosion along the road. A hard hat was placed in the erosion channel for scale.

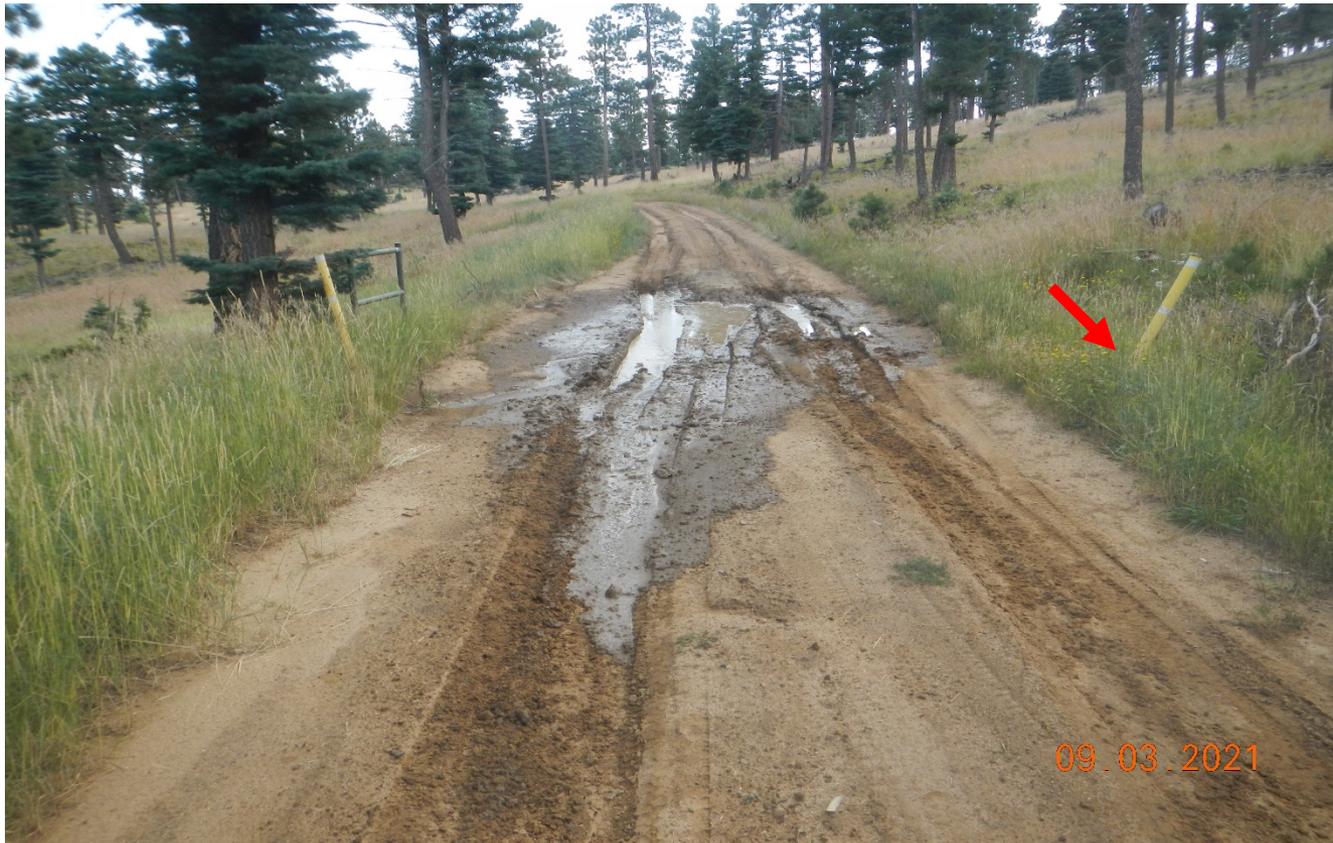
Photo 3. Facing southeast along the access road. There is a low spot in the road where stormwater accumulates. This area needs to be repaired to allow proper drainage. Red arrow points to culverts that are not maintained to allow proper drainage.

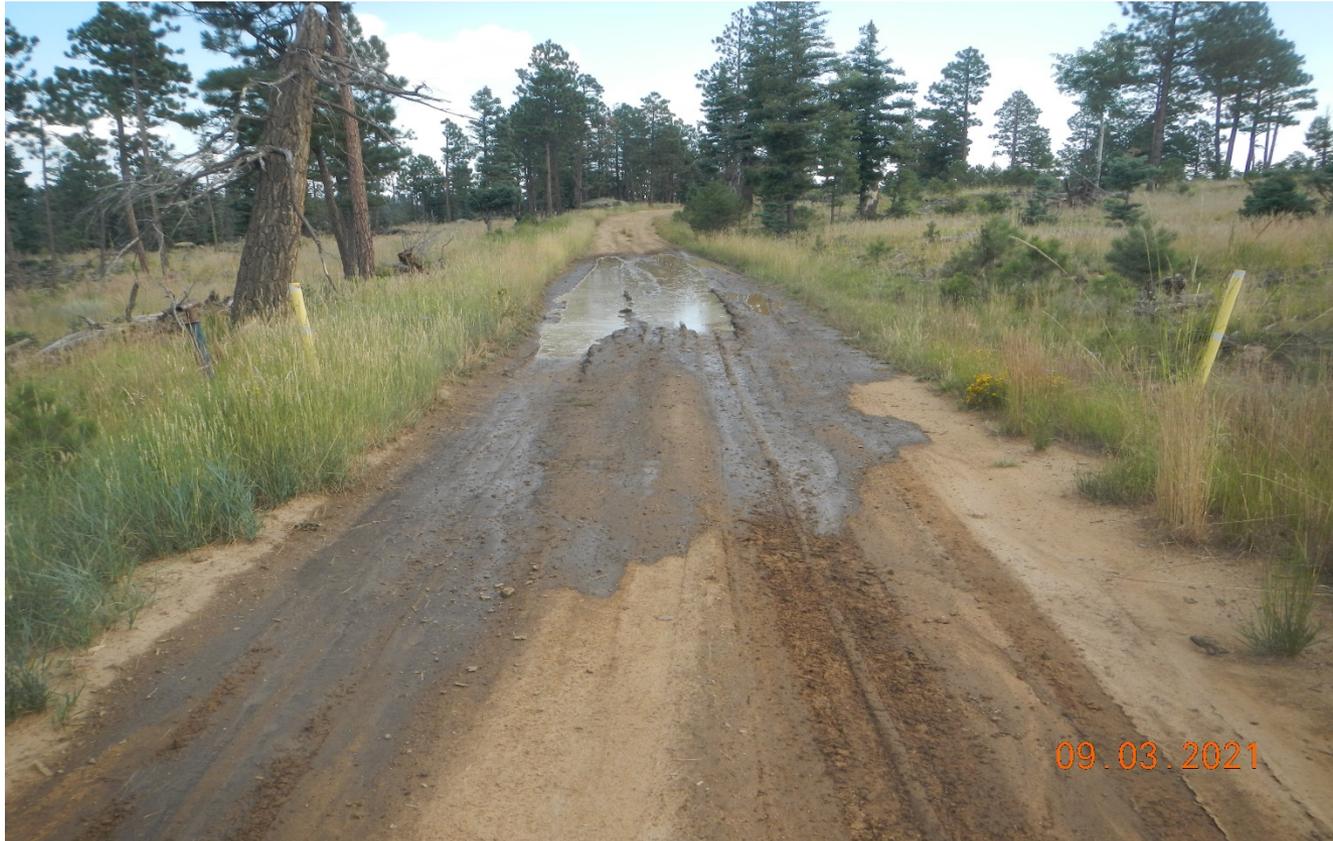
Photo 4. Likewise to previous photo. There is a low spot in the road where stormwater accumulates and vehicles are widening the road to avoid this area. This area needs to be repaired to allow proper drainage.

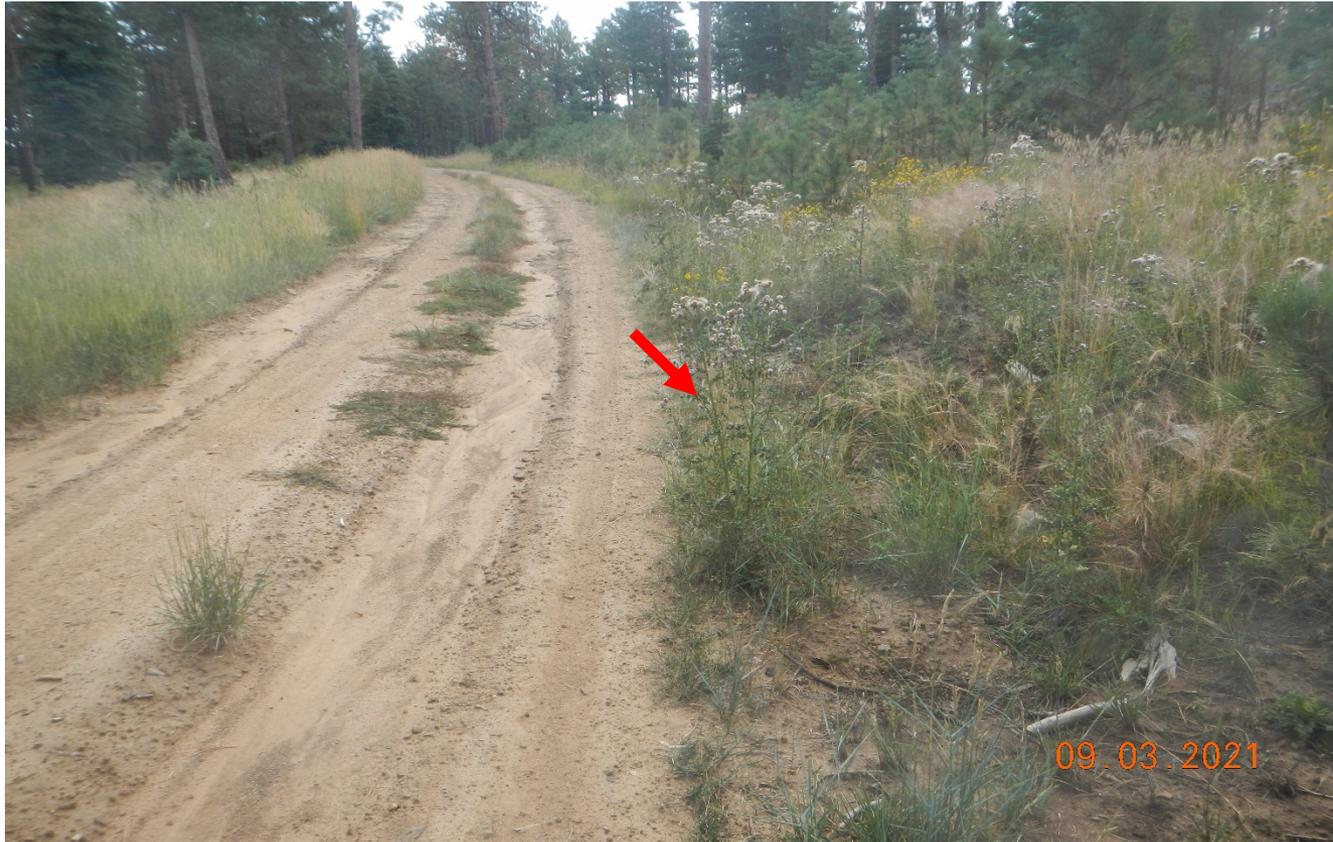
Photo 5. There are noxious weeds along the roadside that need to be controlled. Red arrow points to Canada thistle.

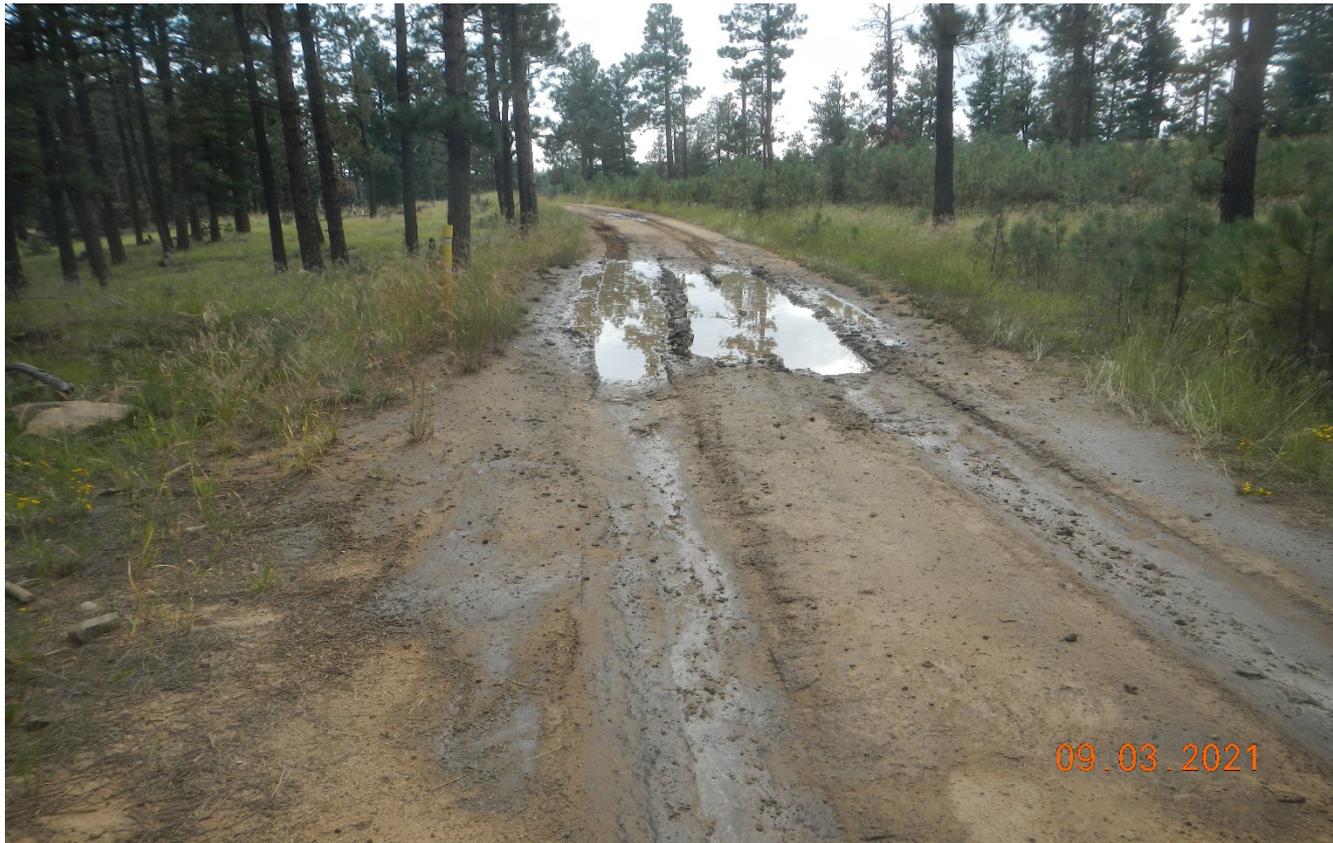
Photo 6. There is vehicle rutting along the road traveling to the location. The road needs to be maintained.

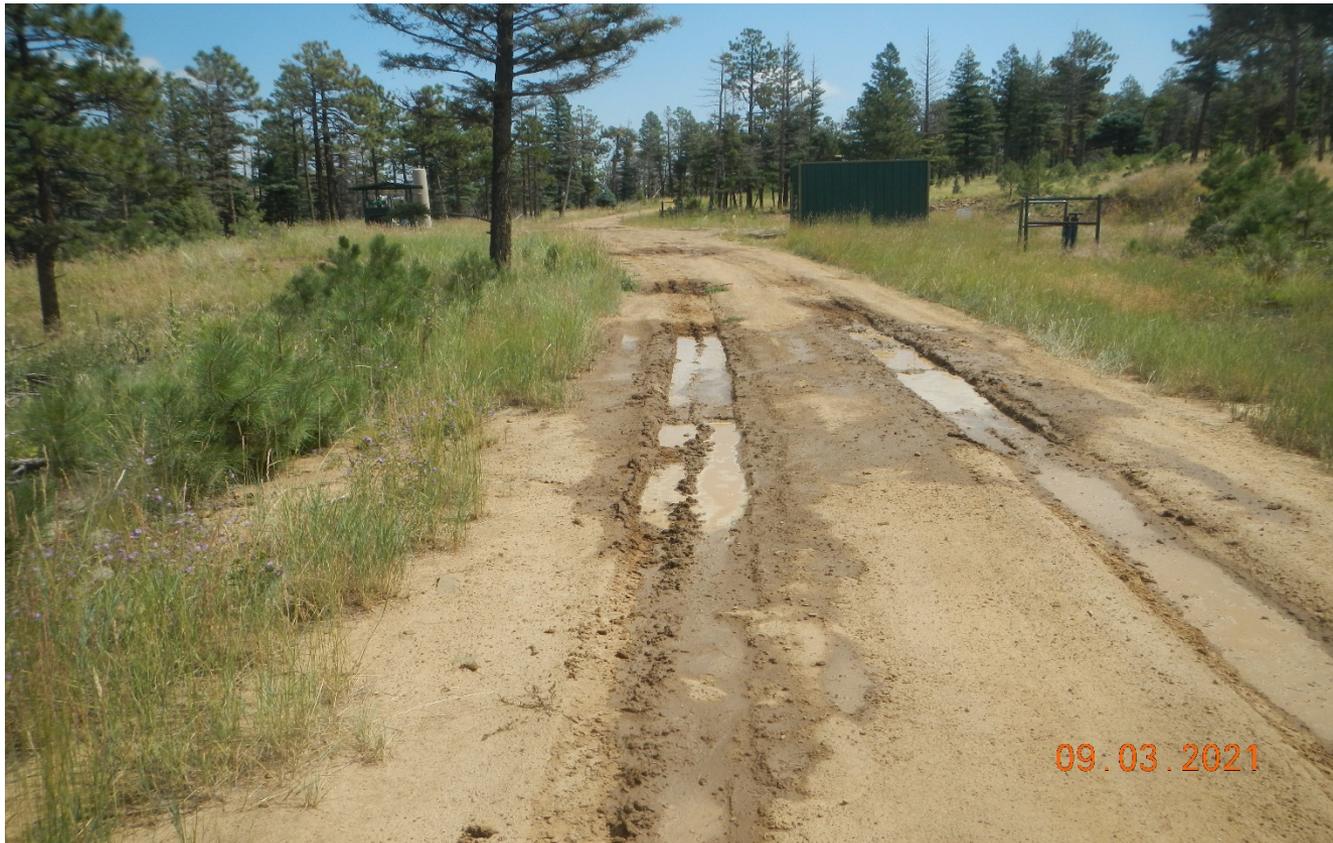
Photo 7. Facing east toward the location.

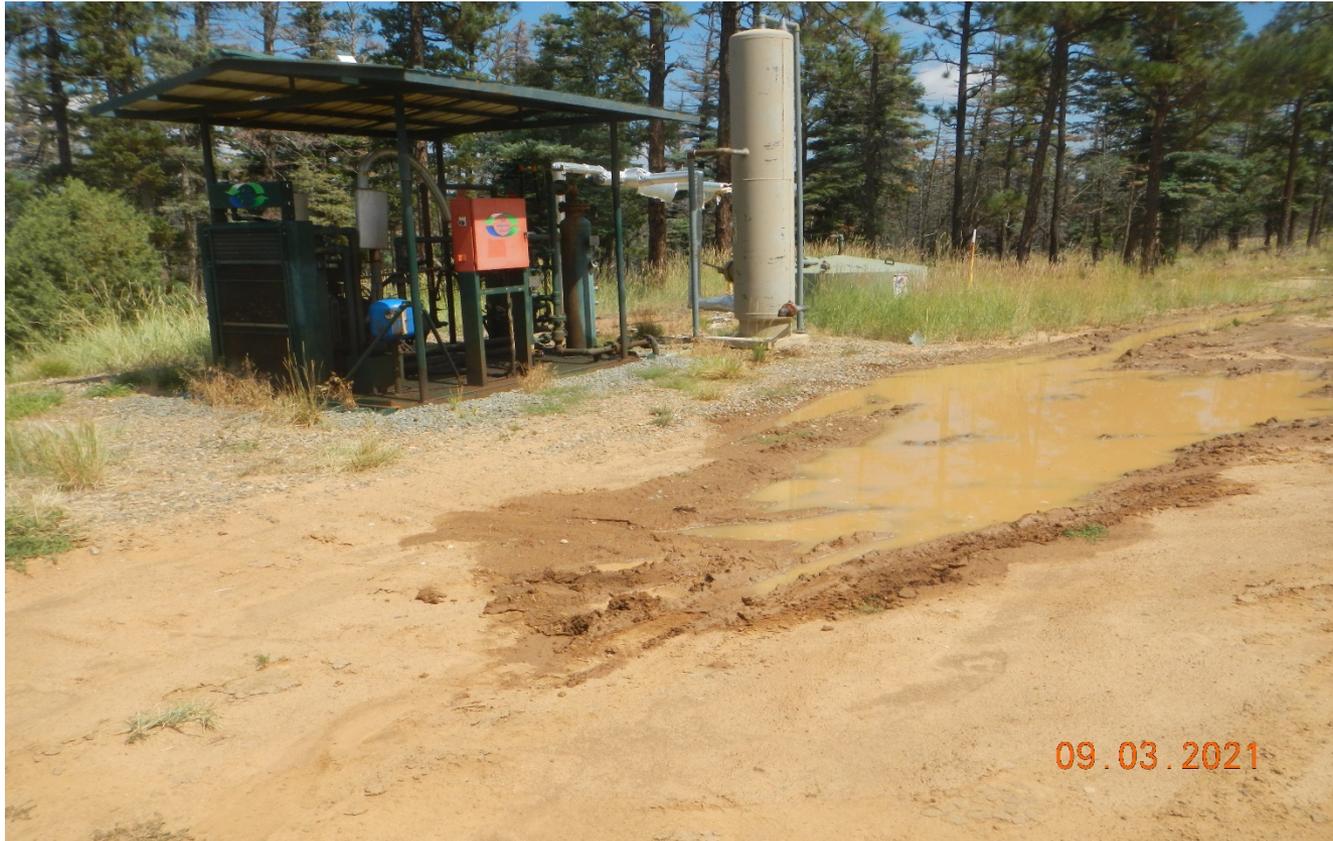
Photo 8. Facing toward the location. Areas of rutting at the location need to be repaired and stabilized. Production areas are not stabilized.

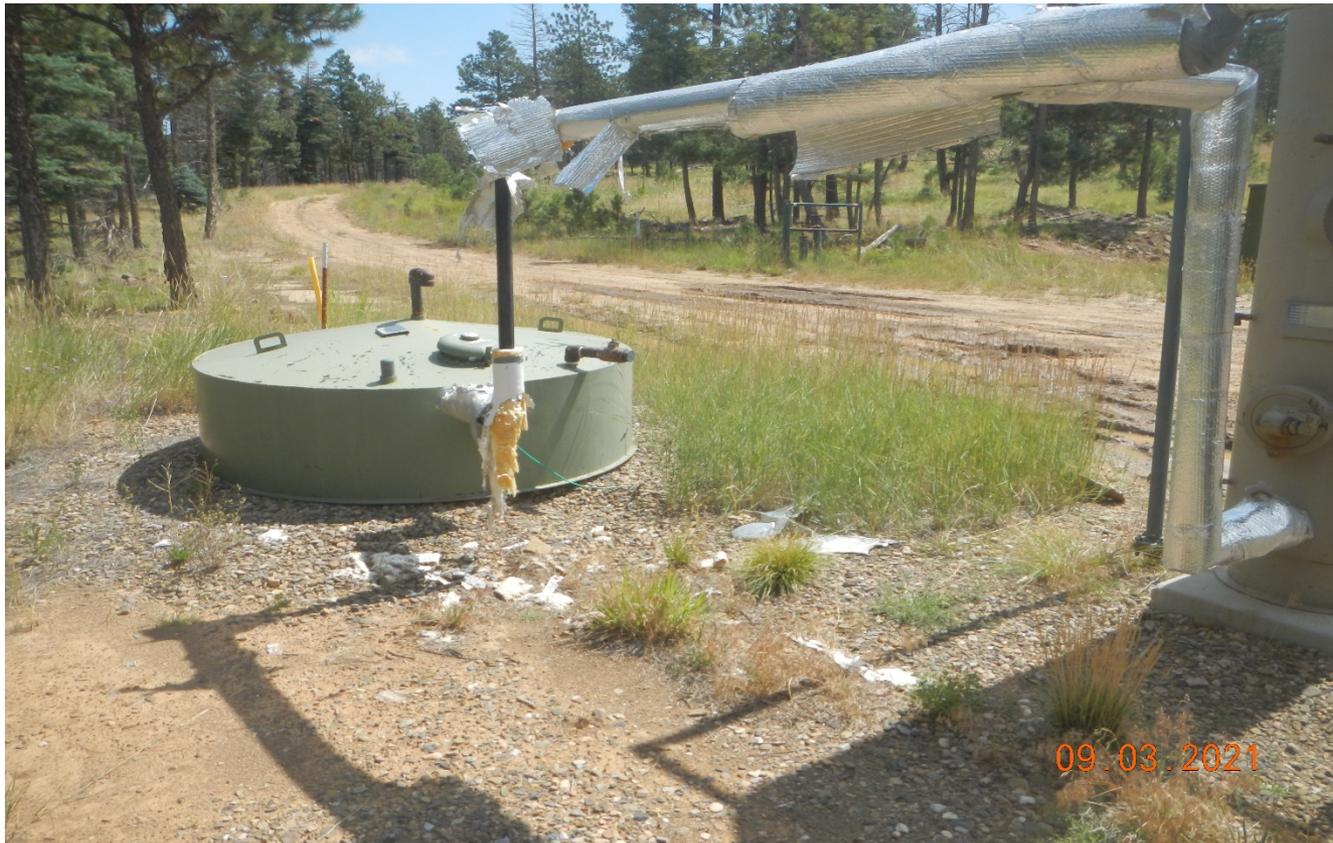
Photo 9. The insulation around the piping is degraded. The insulation debris needs to be cleaned up and removed.
