Well Name : Price 13-25

API # : 115-06056

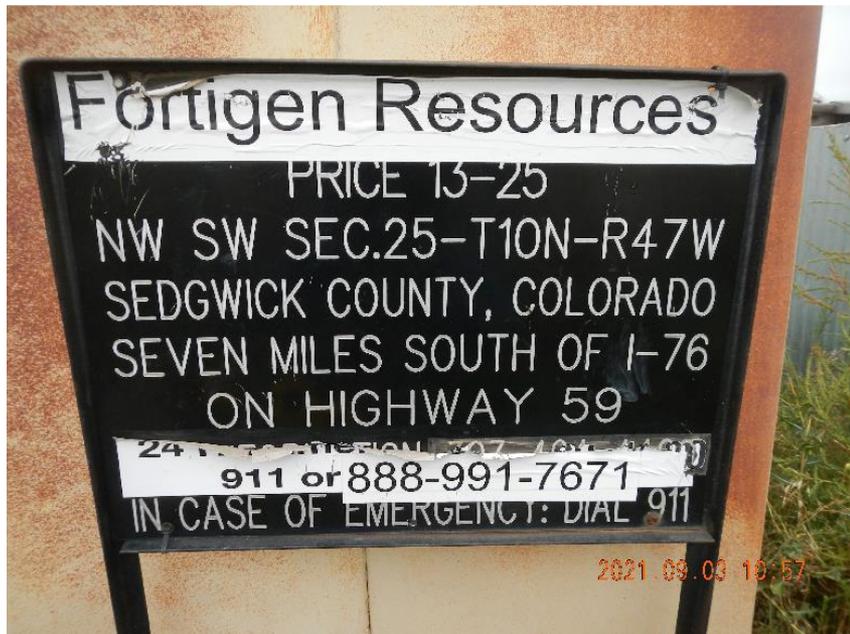
Photo 1: View of sign at the separator.

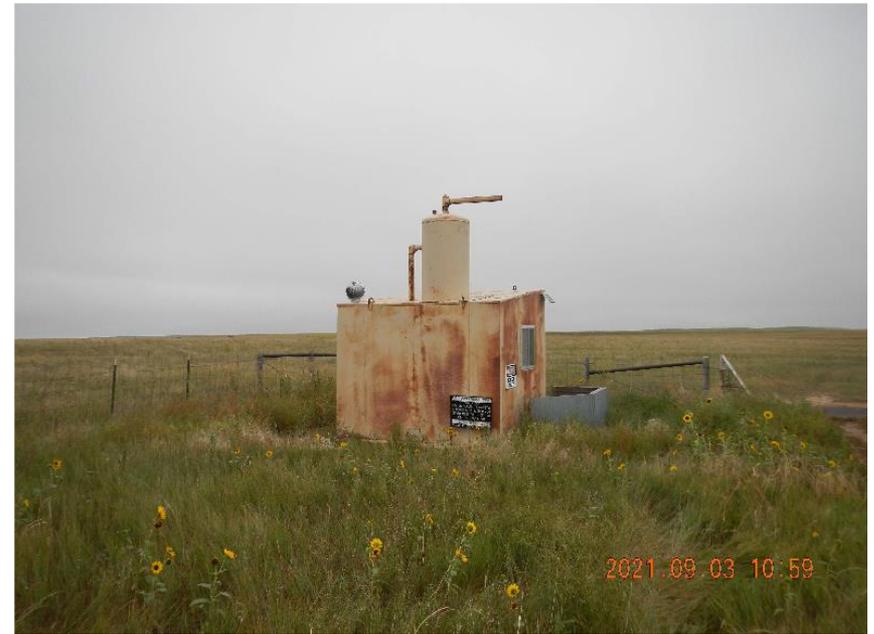
Photo 2: View of separator and vegetation around it.

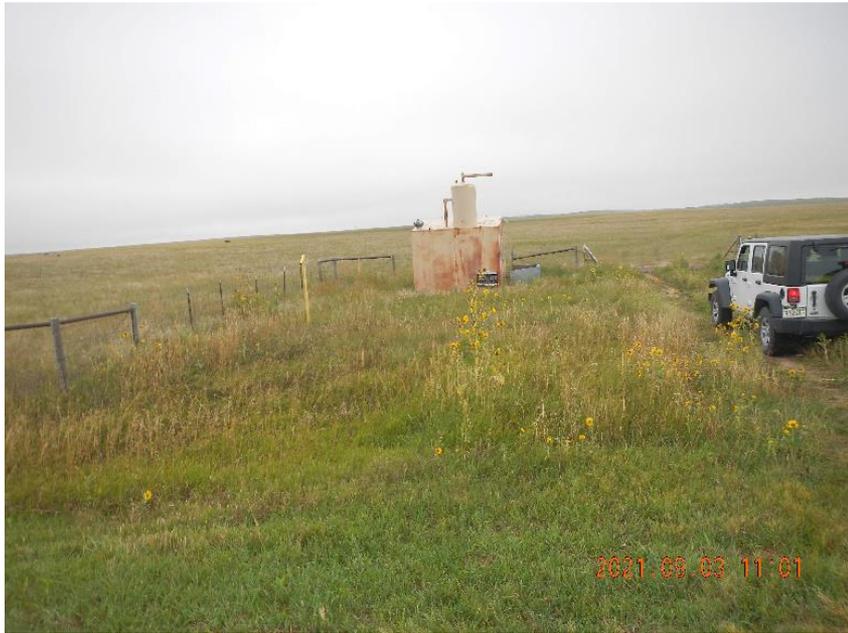
Photo 3: View of location entrance from CR with separator and vegetation around it.

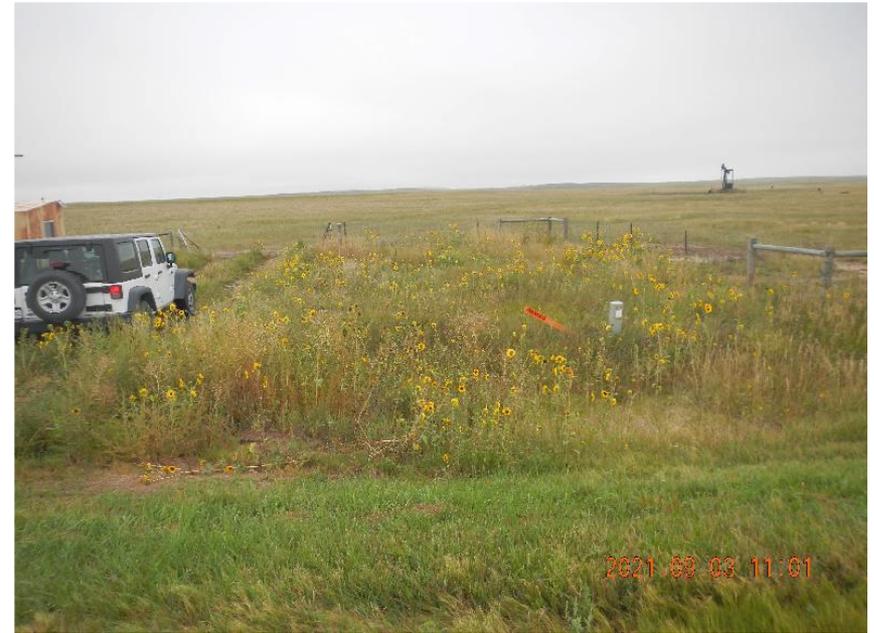
Photo 4: Additional view of location entrance from CR with separator, vegetation, and pumping unit in background.

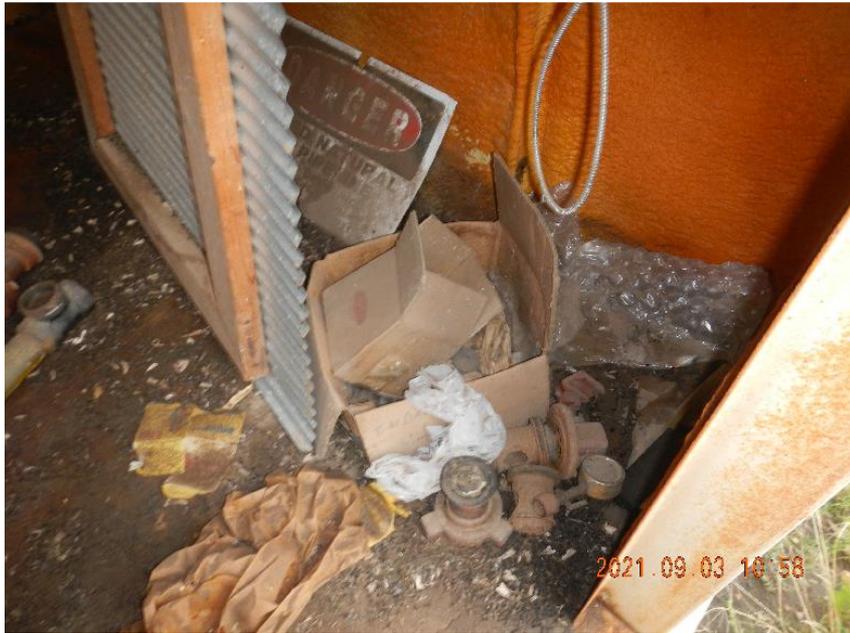
Photo 5: View of trash and rubbish inside separator house.

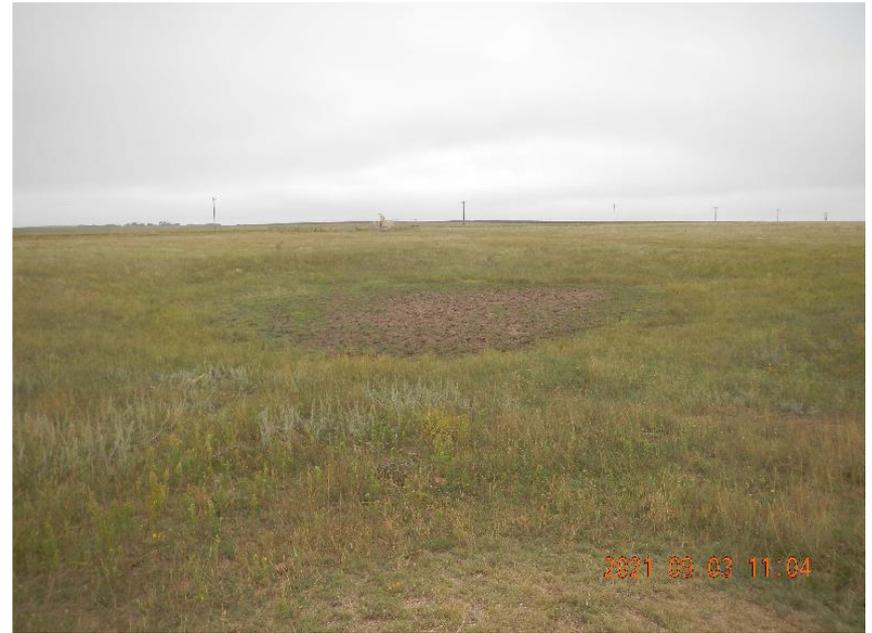
Photo 6: View of what appears to be old pit site in pasture between well site and separator facility.

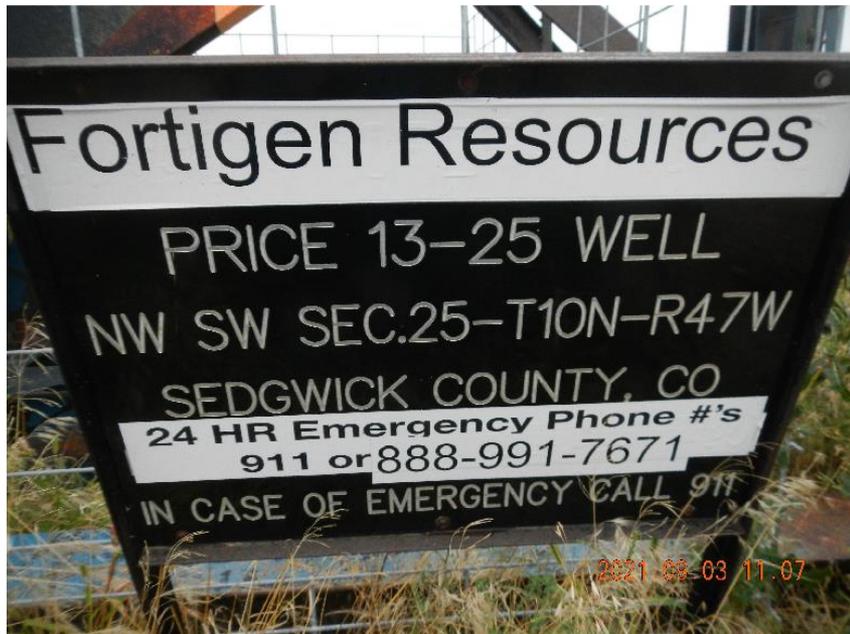
Photo 7: View of wellhead sign at well site.

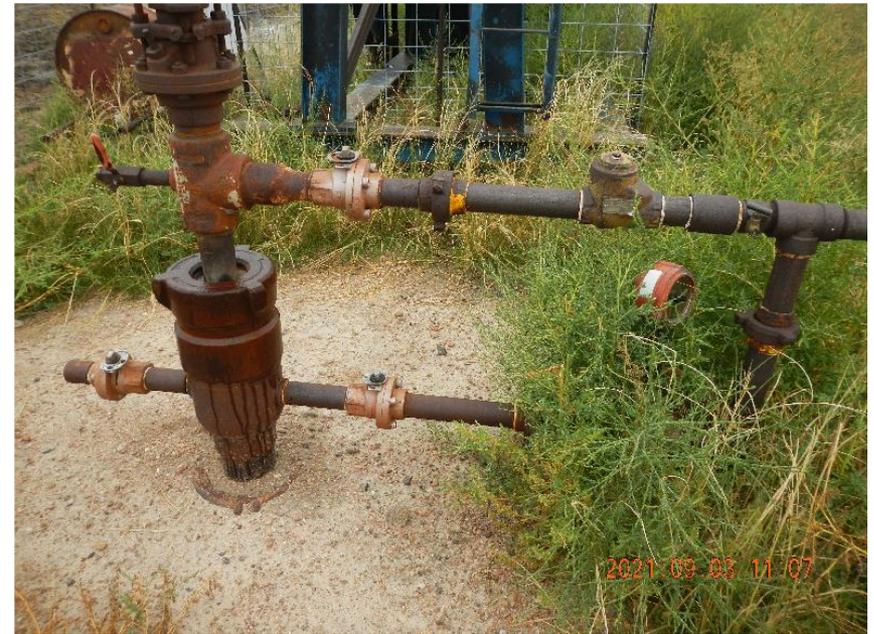
Photo 8: View of wellhead and tree. Well actively venting at packing/cap. Valves were found closed at time of inspection.

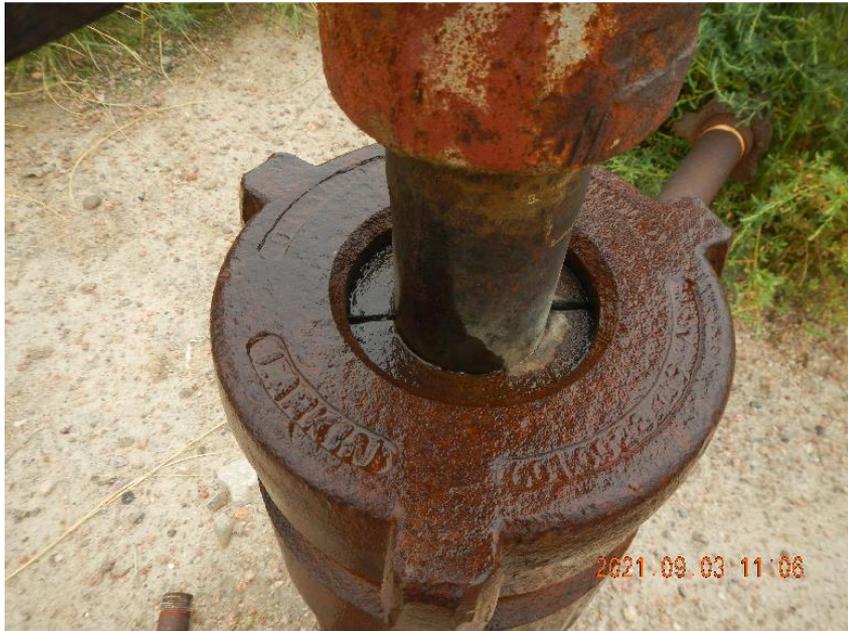
Photo 9: View of packing and cap.

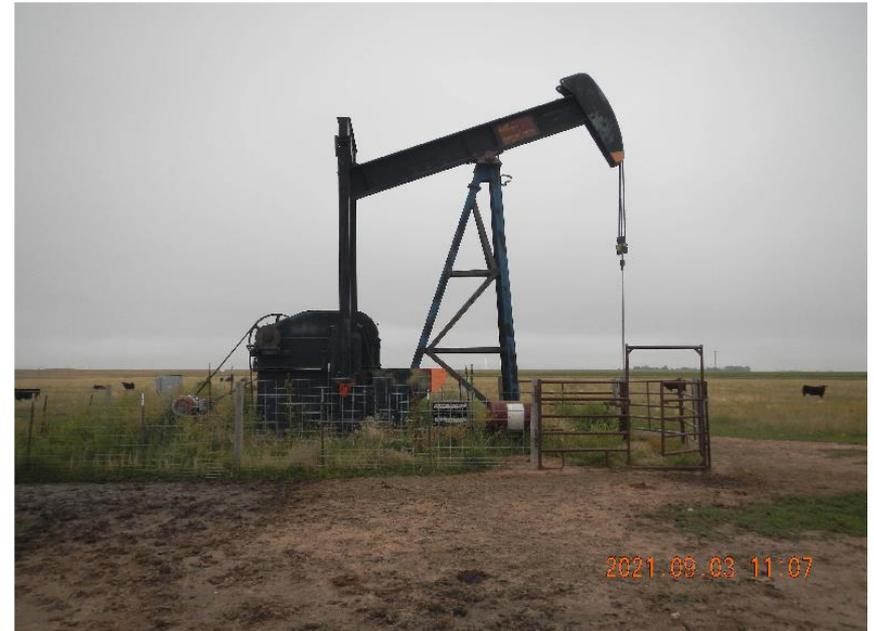
Photo 10: View of pumping unit and vegetation inside the fencing. Polish rod is attached to the bridge.

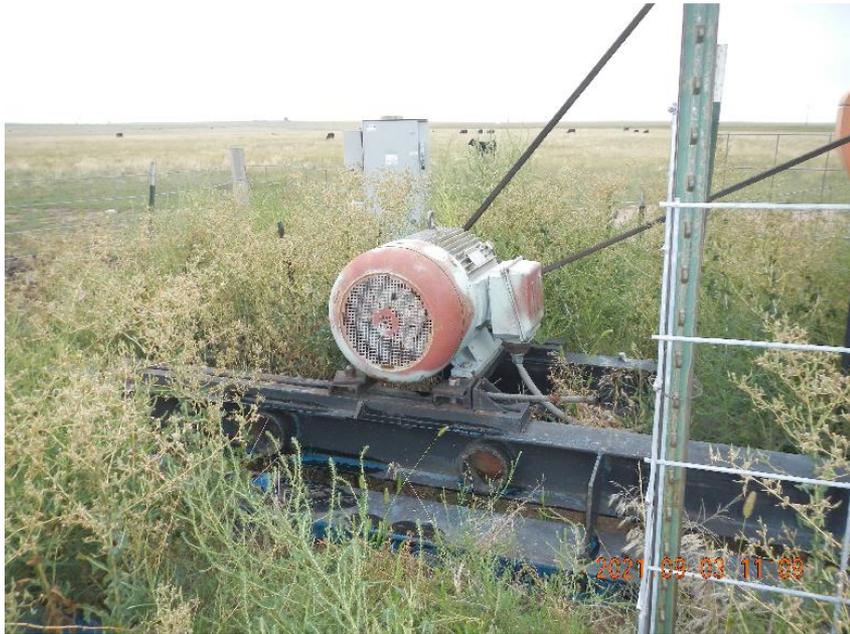
Photo 11: View of electric prime mover and vegetation inside fencing.

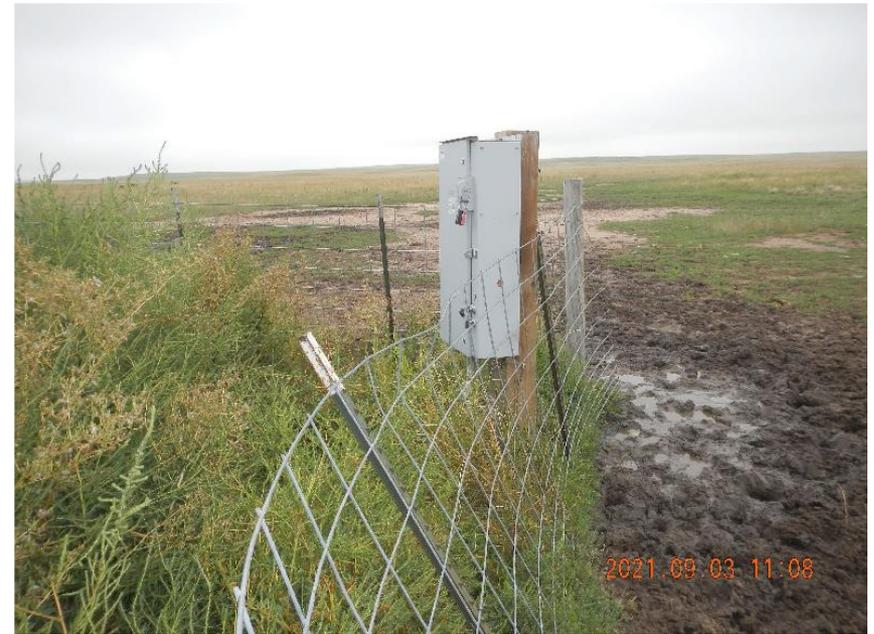
Photo 12: View of control box and vegetation inside fencing.

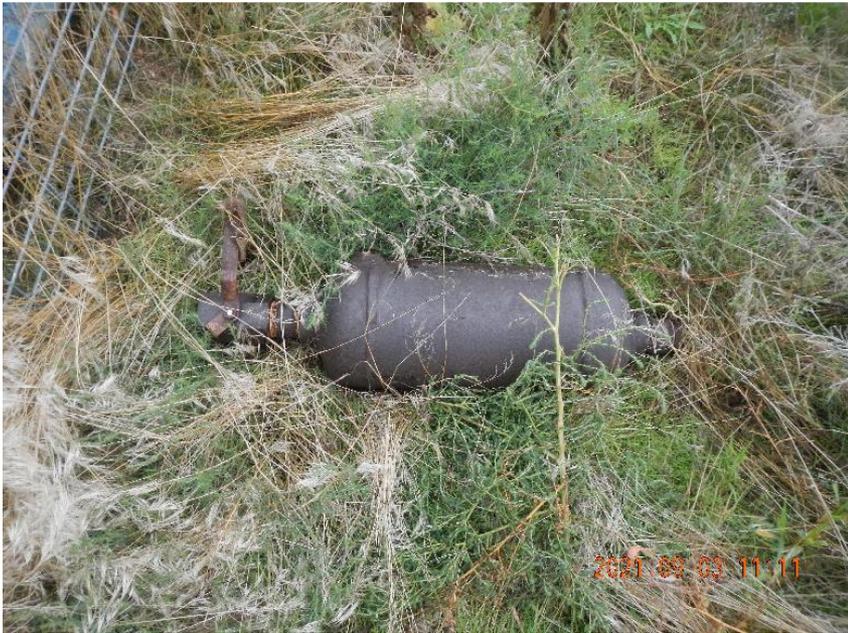
Photo 13: View of disconnected dryer vessel laying inside pumping unit fencing.

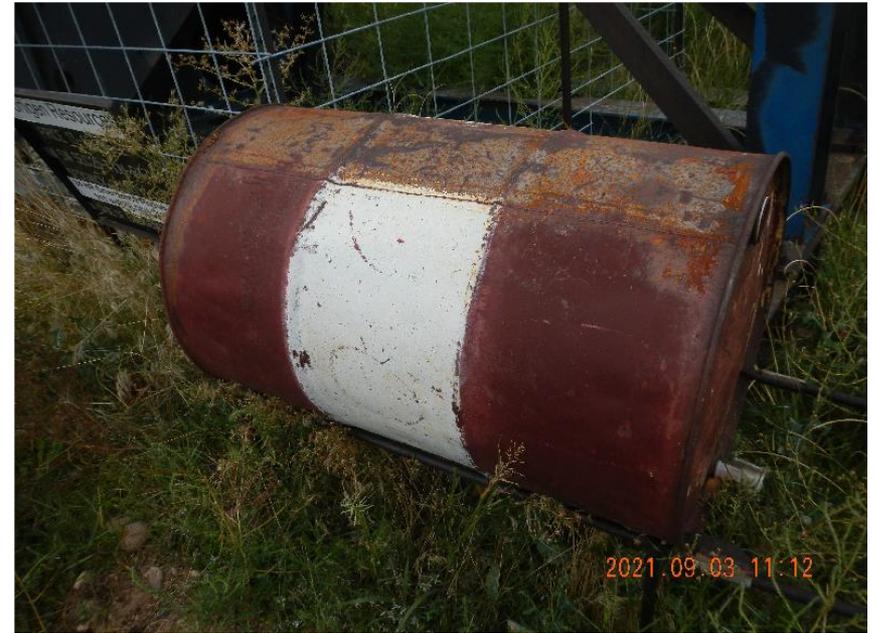
Photo 14: View of disconnected/empty 55 gallon drum on skid mount inside pumping unit fencing.

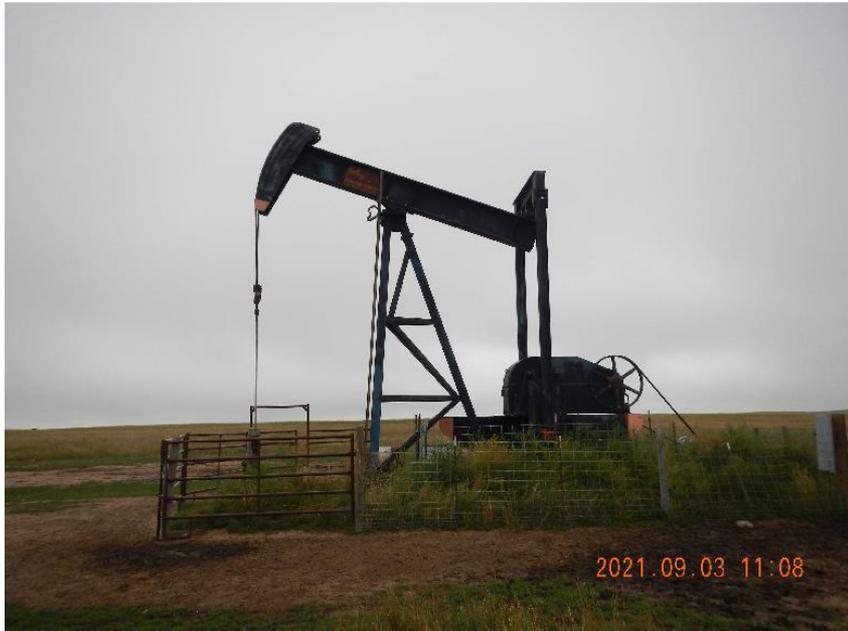
Photo 15: View of Pumping unit, polish rod, and bridle. Note vegetation inside fencing.

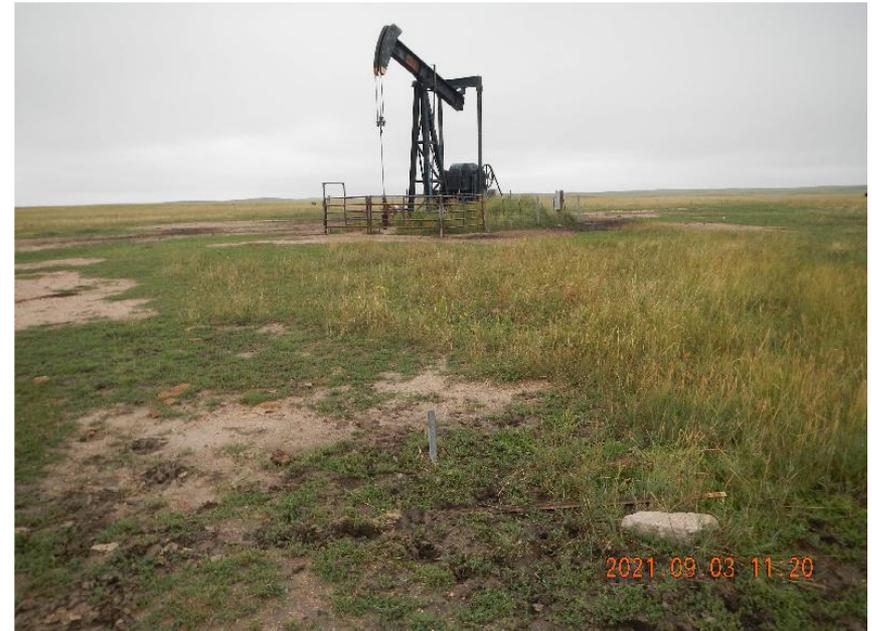
Photo 16: View of well site. One of four located anchors with markers down at time of inspection.
