Inspection Photos
Operator: Simcoe
API: 067-08689
Date: 9/7/2021

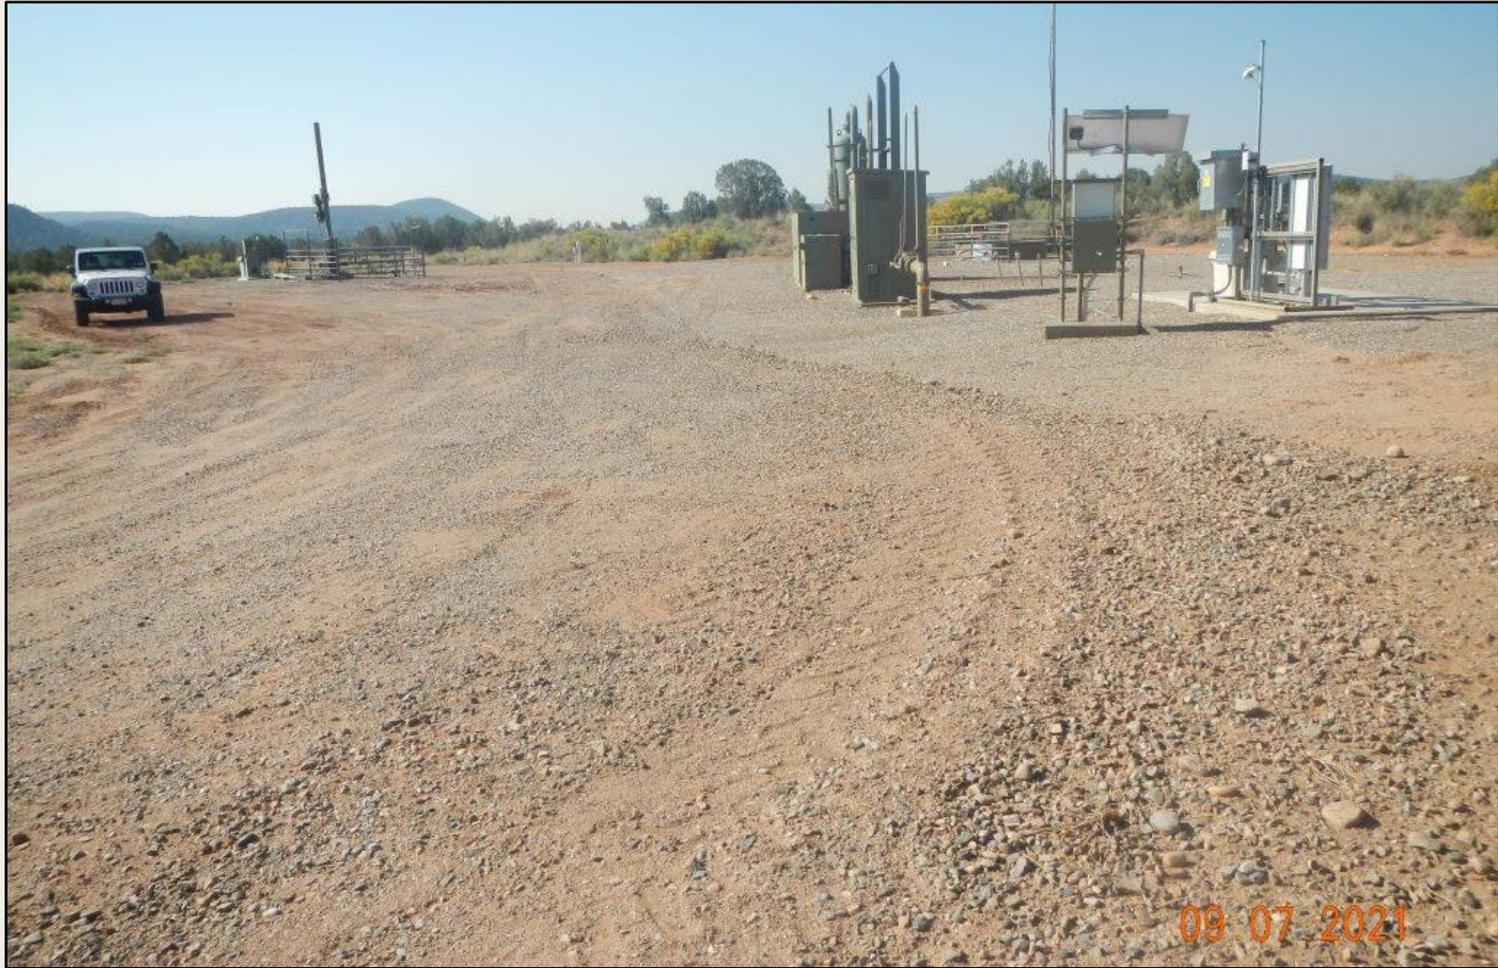
Photo 1. View of the project area from the well pad entrance facing center.

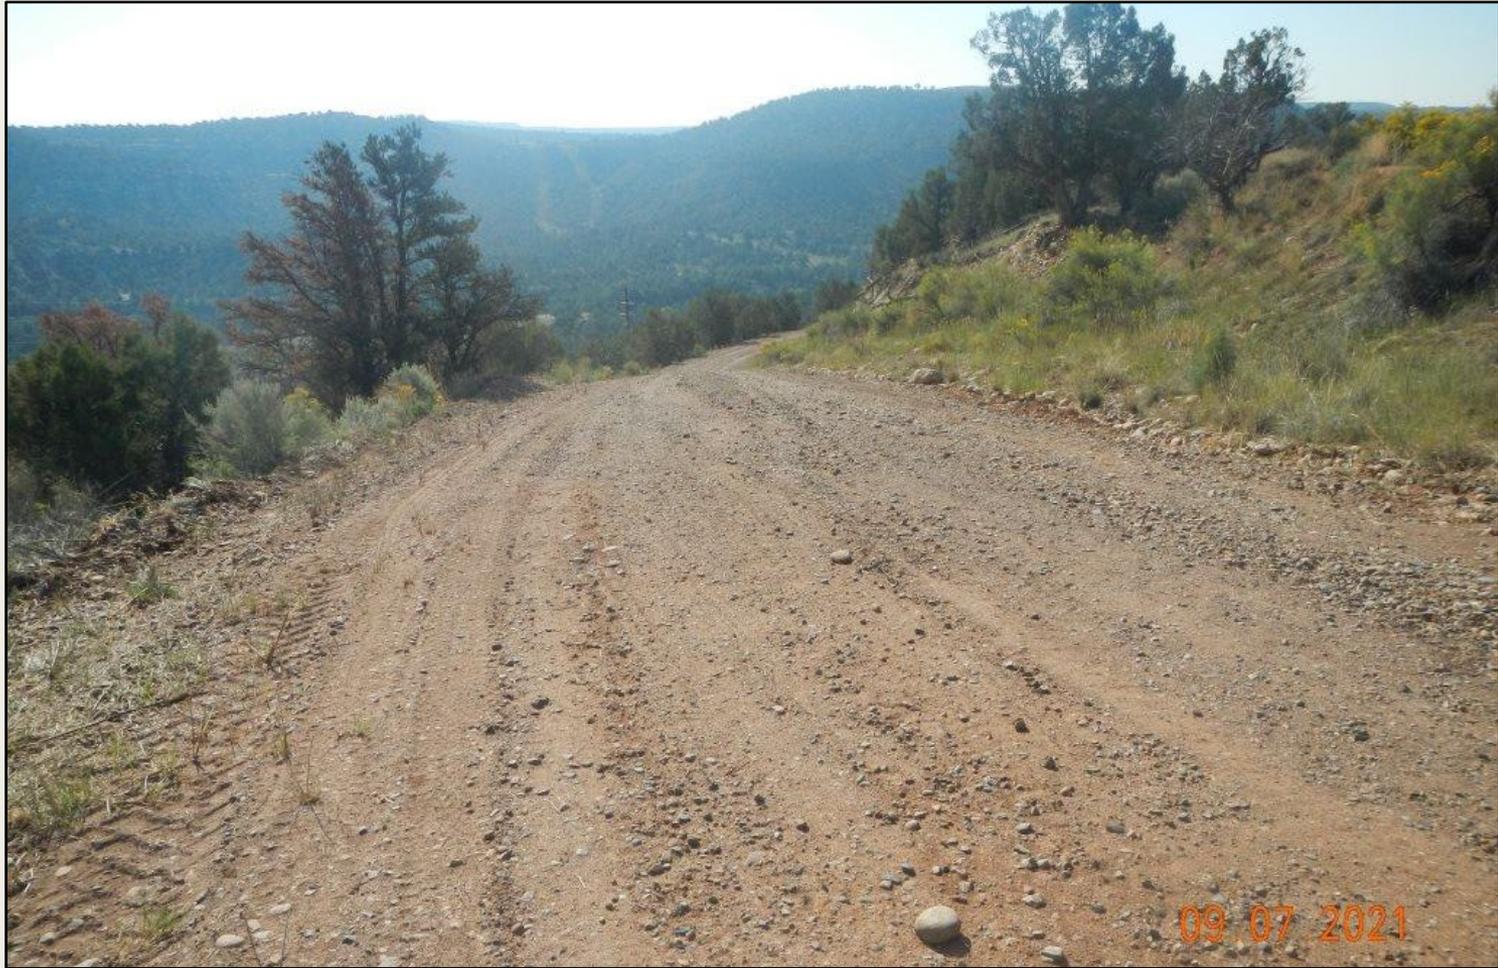
Photo 2. View of the access road, surface is recently graded, culverts and ditches are maintained.

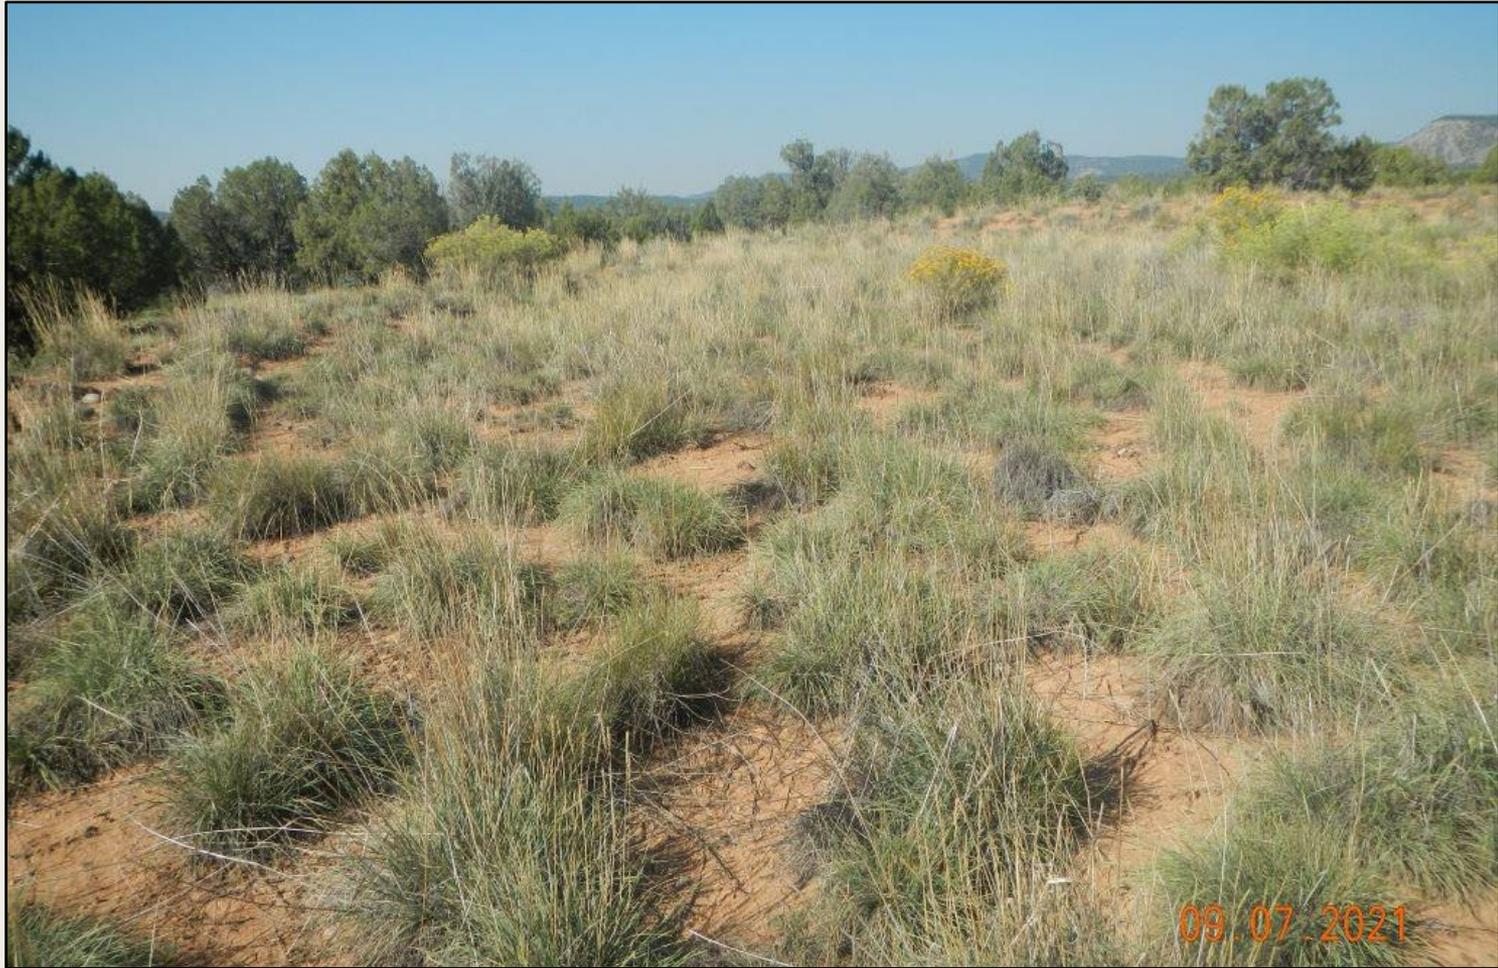
Photo 3. View of the southern project area from the southeastern corner facing westward. Revegetation is progressing with crested wheatgrass, rubber rabbitbrush, and fourwing saltbush.

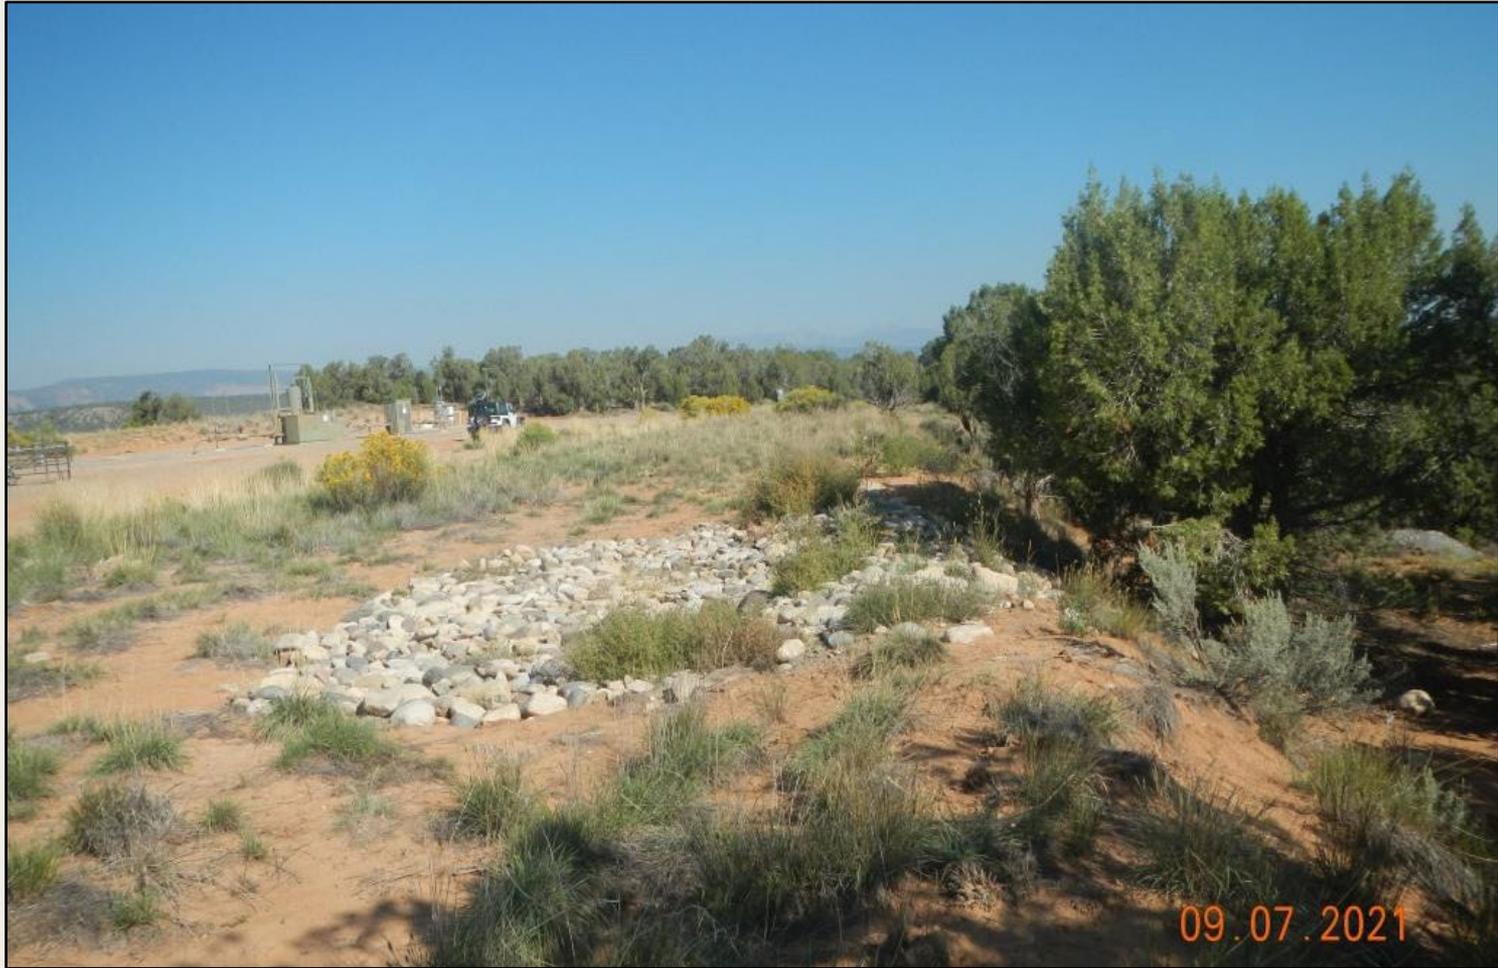
Photo 4. View of the eastern project area from the southeastern corner facing northward.

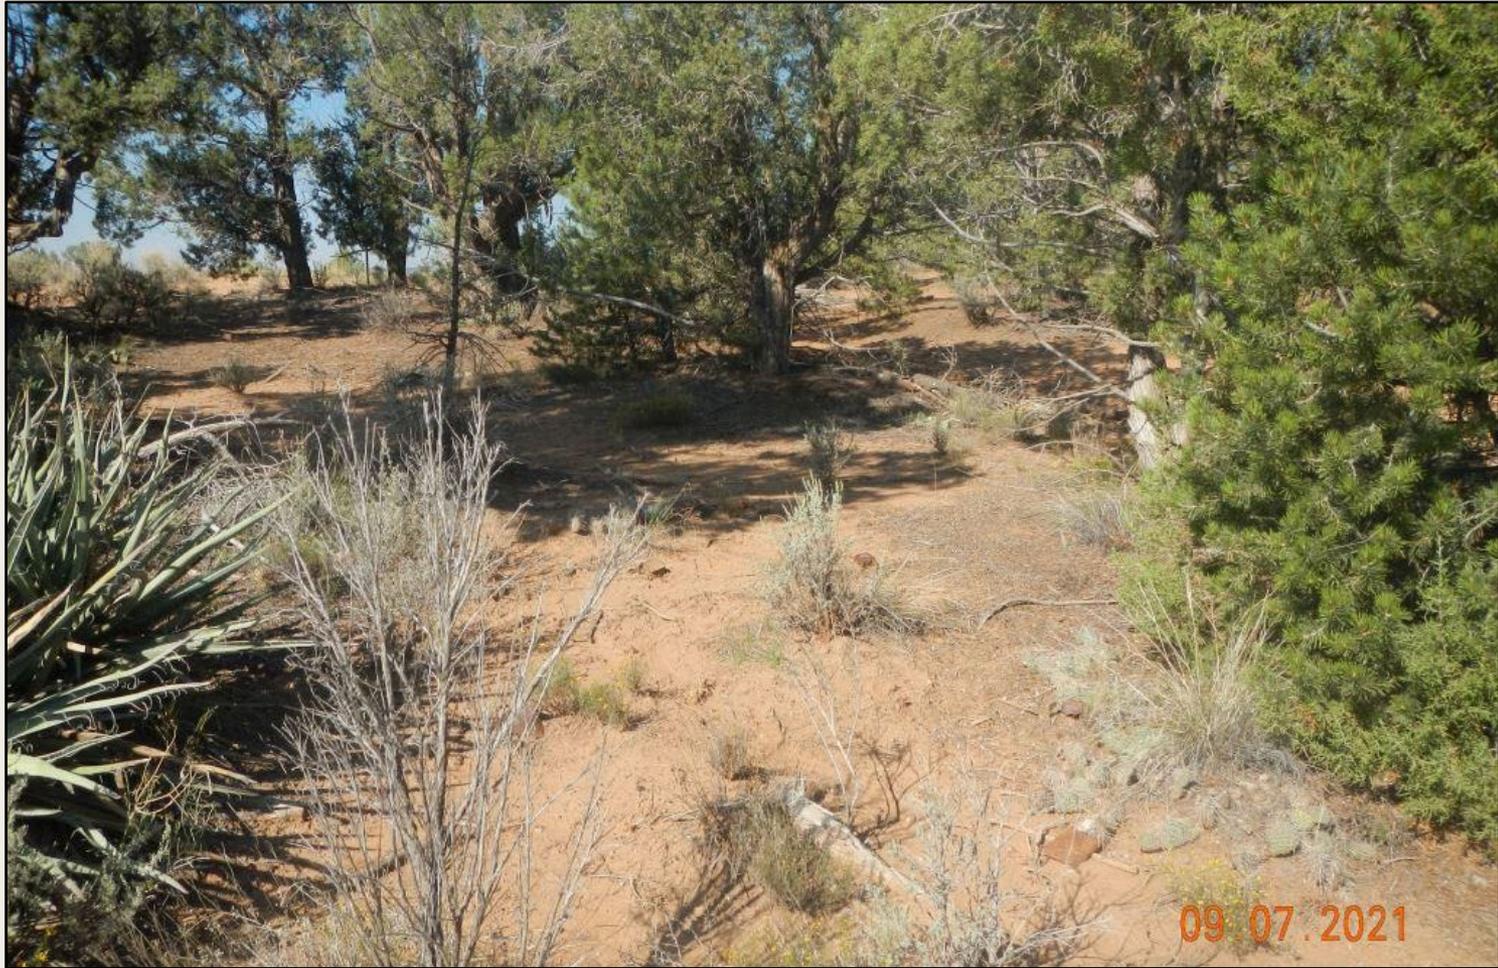
Photo 5. View of reference area comprised of pinyon and juniper woodland with yucca, sagebrush, prickly pear, and Indian ricegrass.
