Inspection Photos
Operator: Maralex
API: 067-09350
Date: 9/7/2021

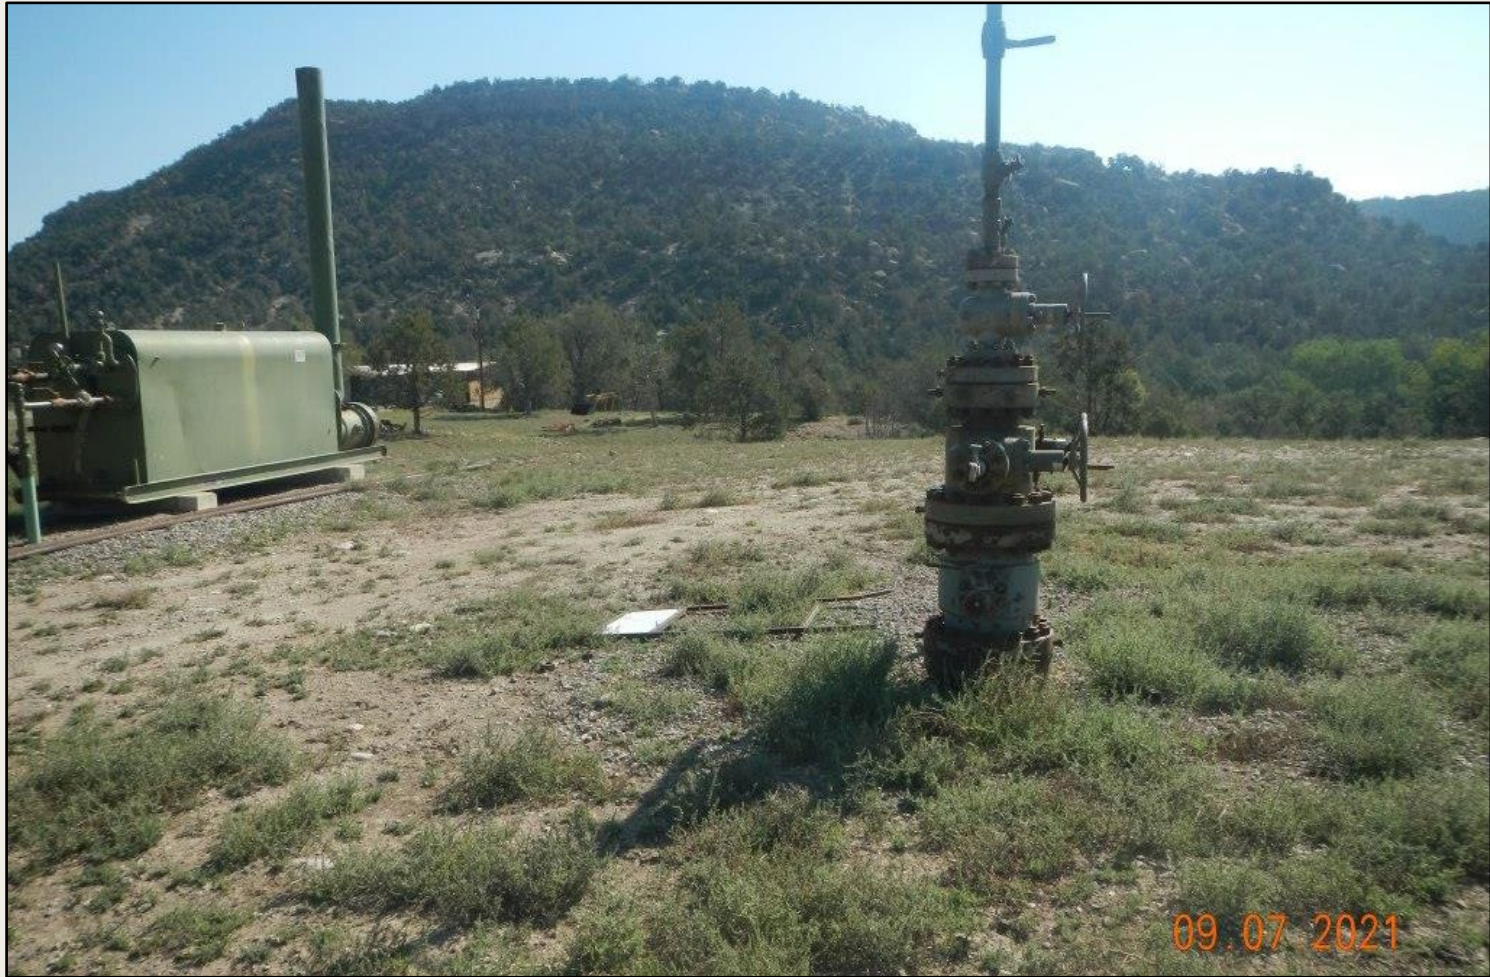
Photo 1. View of the project area from the well pad entrance facing center. Sign needs to be repaired.

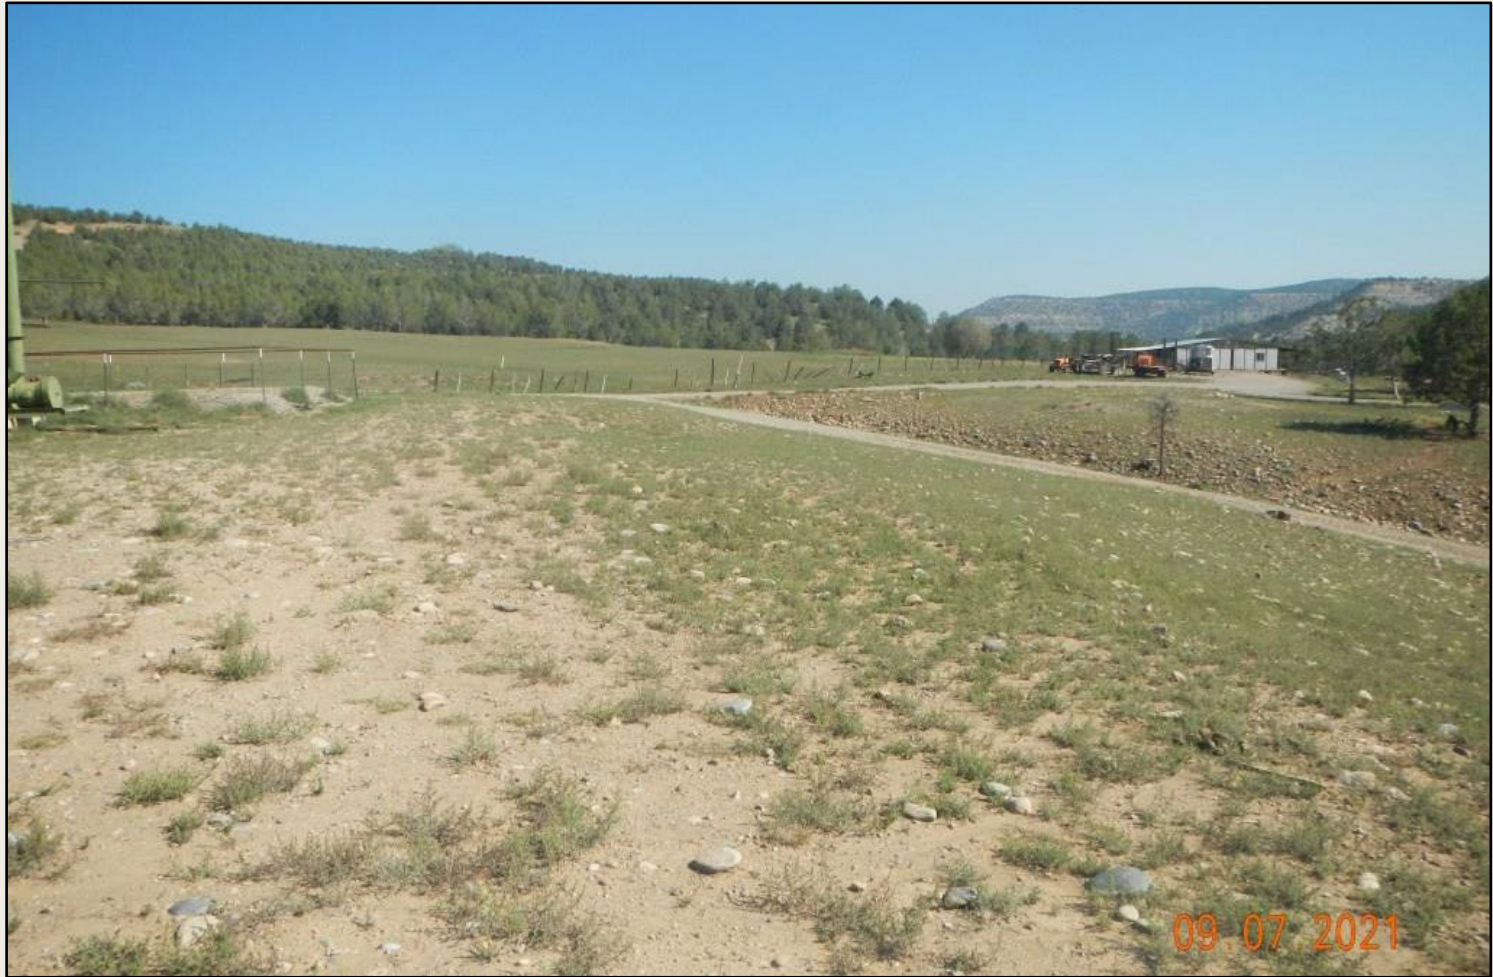
Photo 2. View of the eastern project area from the southeastern corner facing northward. Vegetation is largely kochia, similar to surrounding grazed pasture.

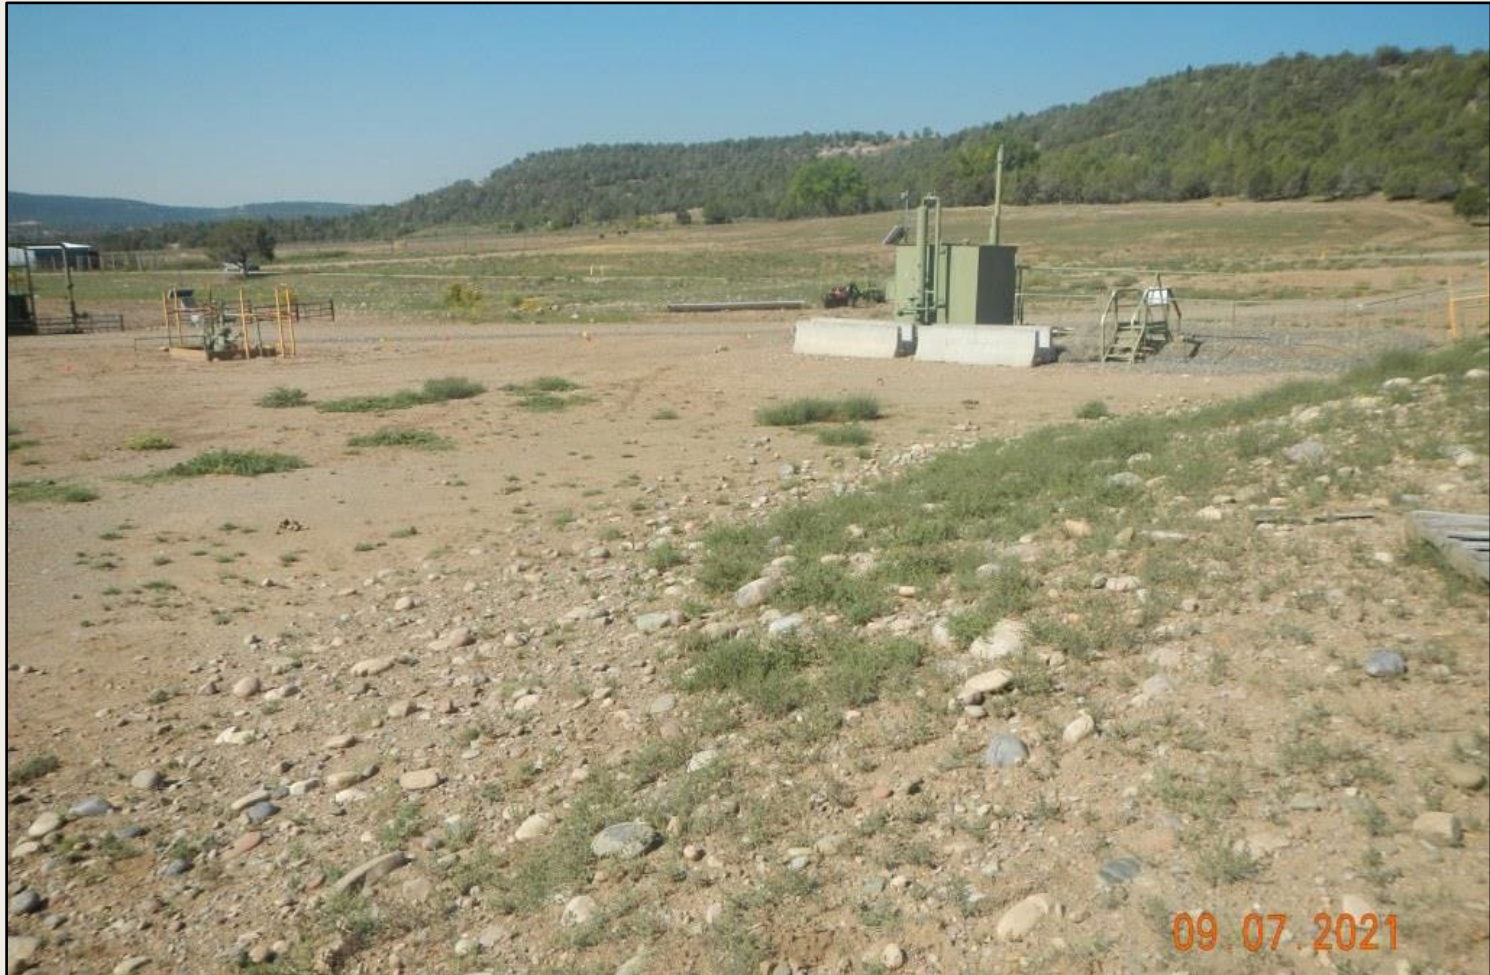
Photo 3. View of the southern project area from the southeastern corner facing westward. Adjacent well pad visible.

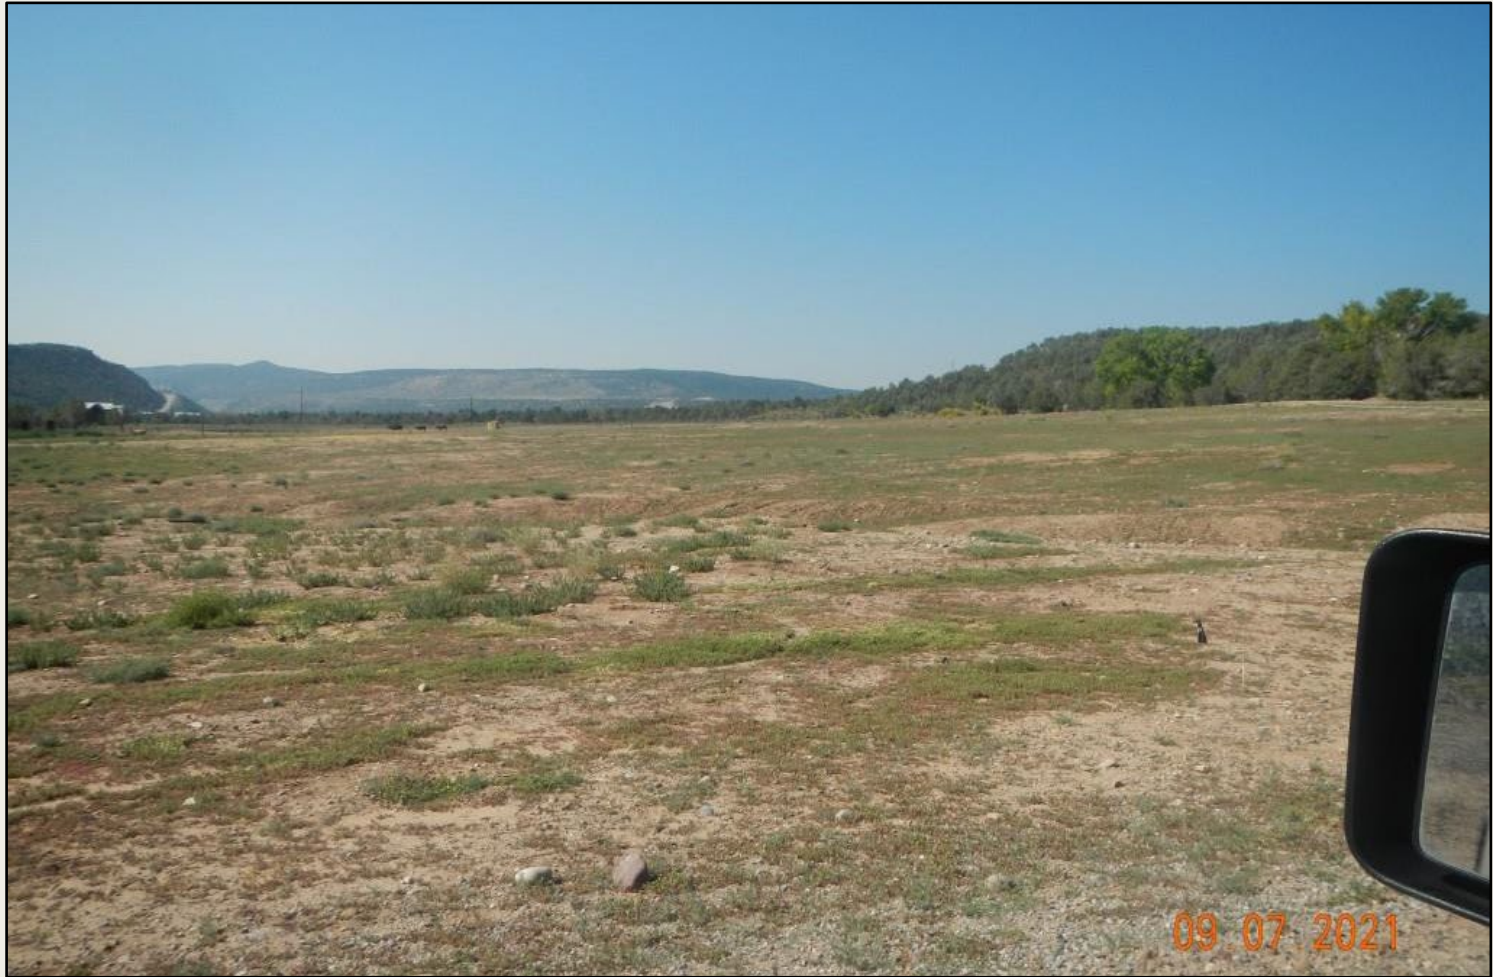
Photo 5. View of reference area comprised of grazed pasture.
