Inspection Photos  
Operator: Simcoe  
API: 067-07589  
Date: 9/7/2021

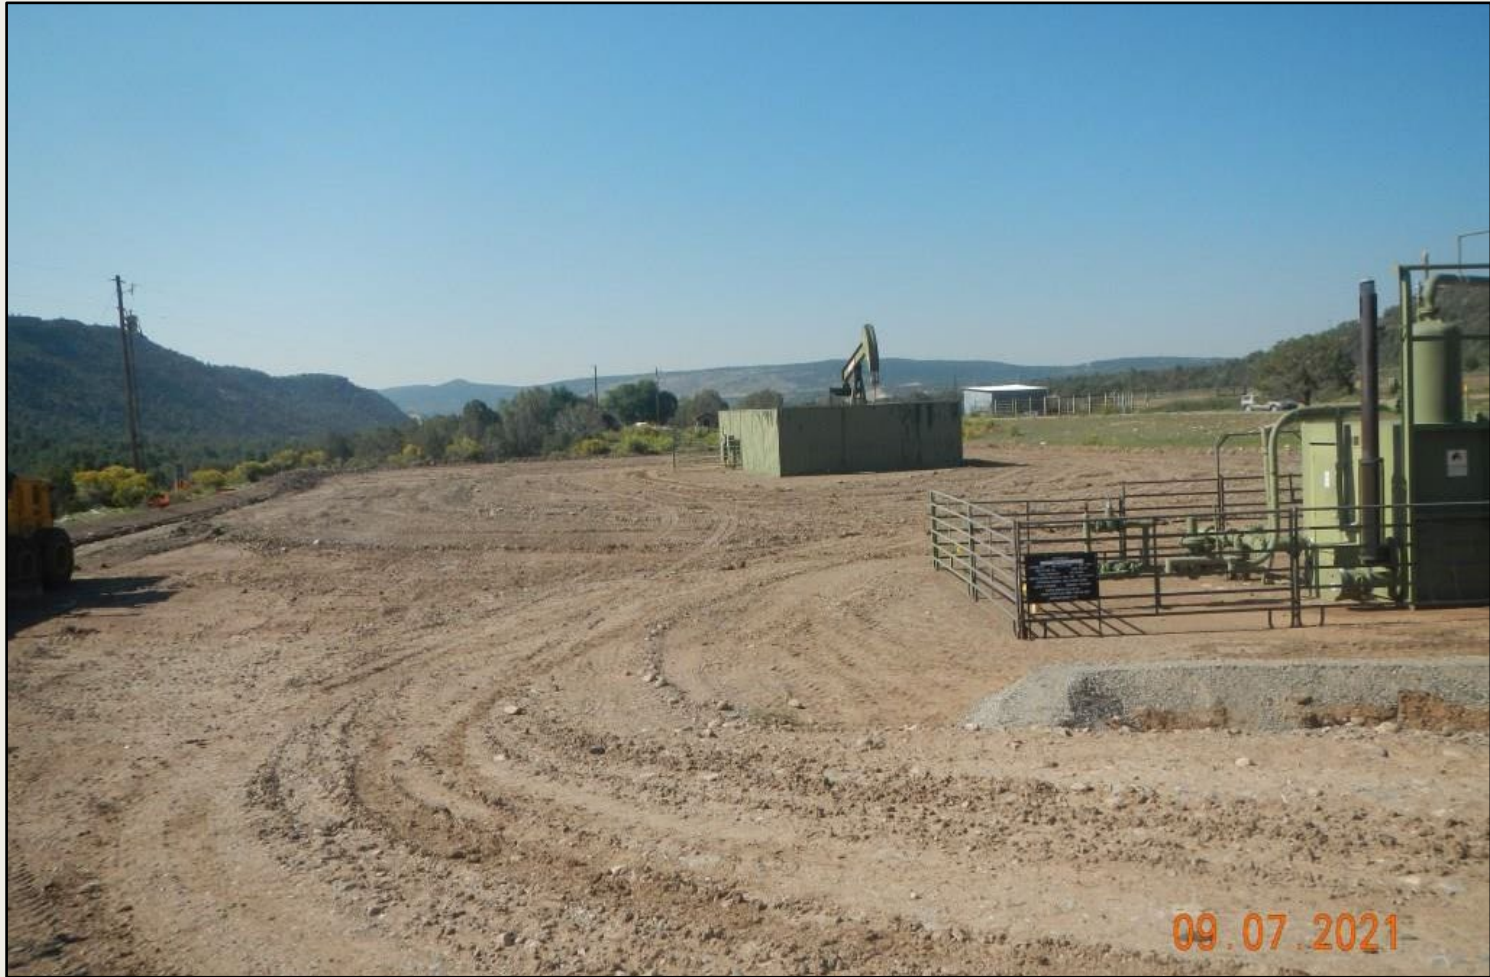
Photo 1. View of the project area from the northeastern corner facing center.

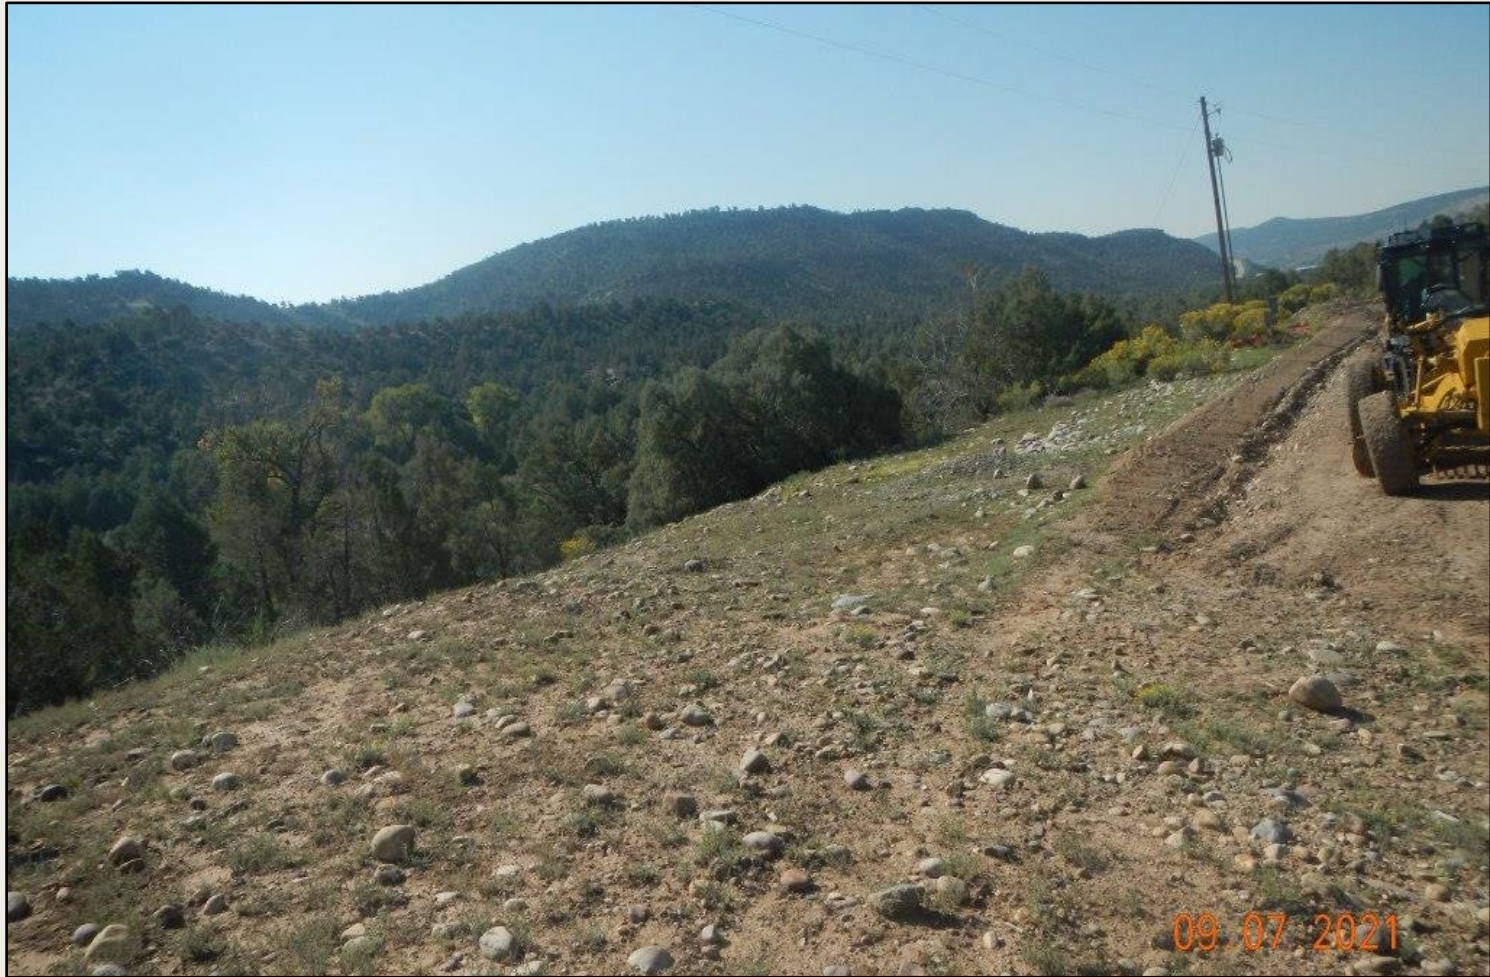
Photo 2. View of the eastern project area from the northeastern corner facing southward. Revegetation is comprised of grazed grasses such as western wheatgrass and kochia.

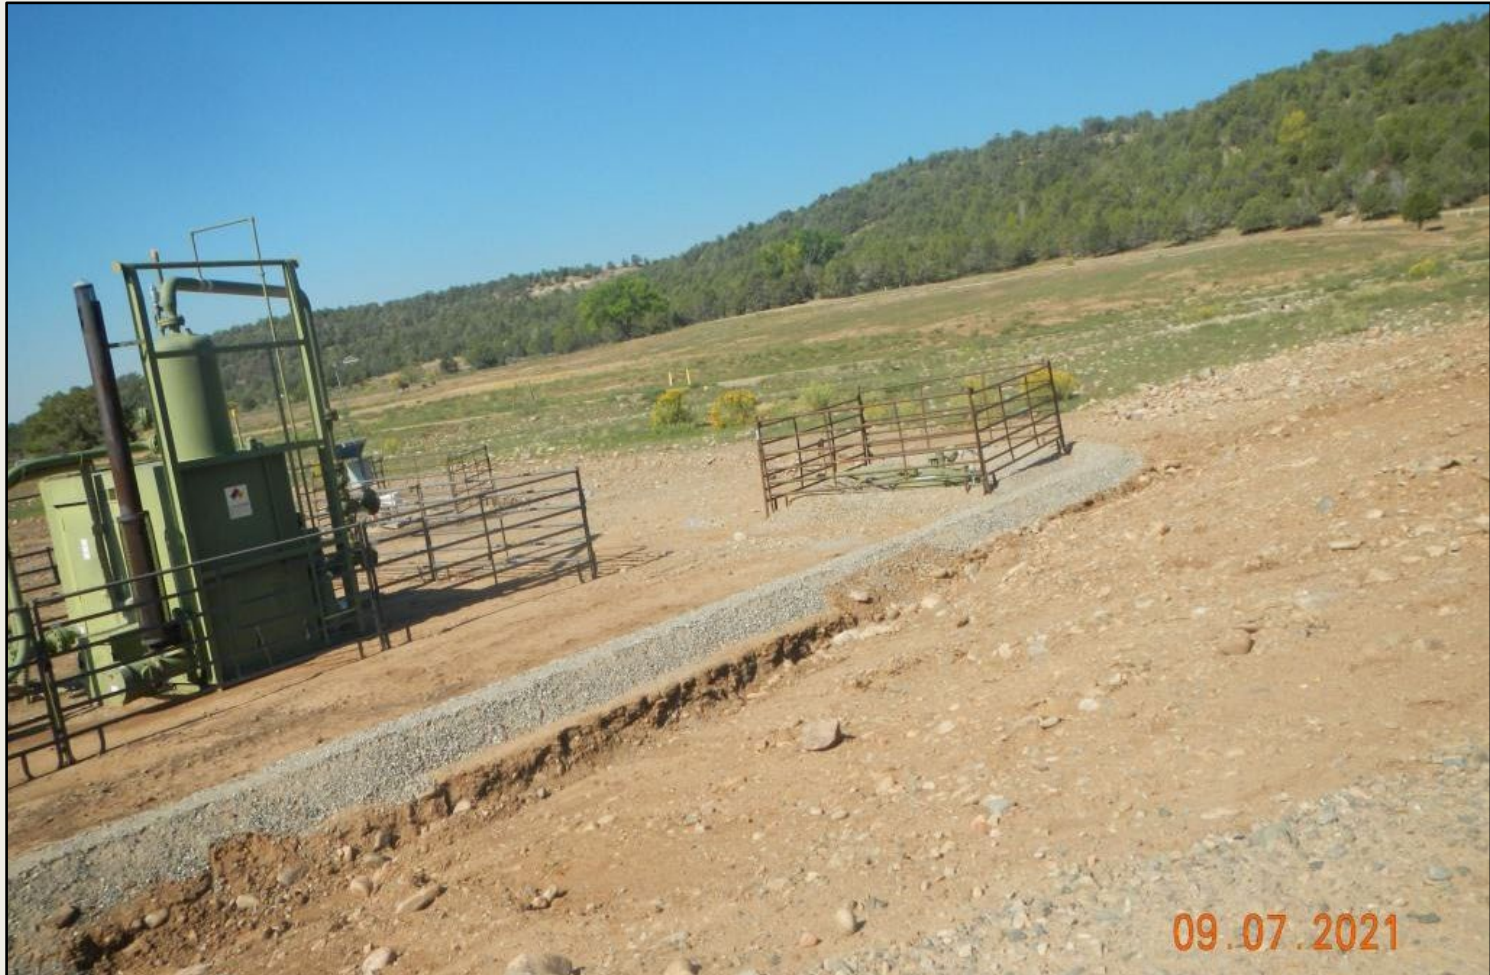
Photo 3. View of the northern project area facing westward. Well pad grading and berm construction is in process. Disturbed soils outside of the working area need seeding after work is completed.
