Inspection Photos
Operator: Simcoe
API: 067-08507
Date: 9/7/2021

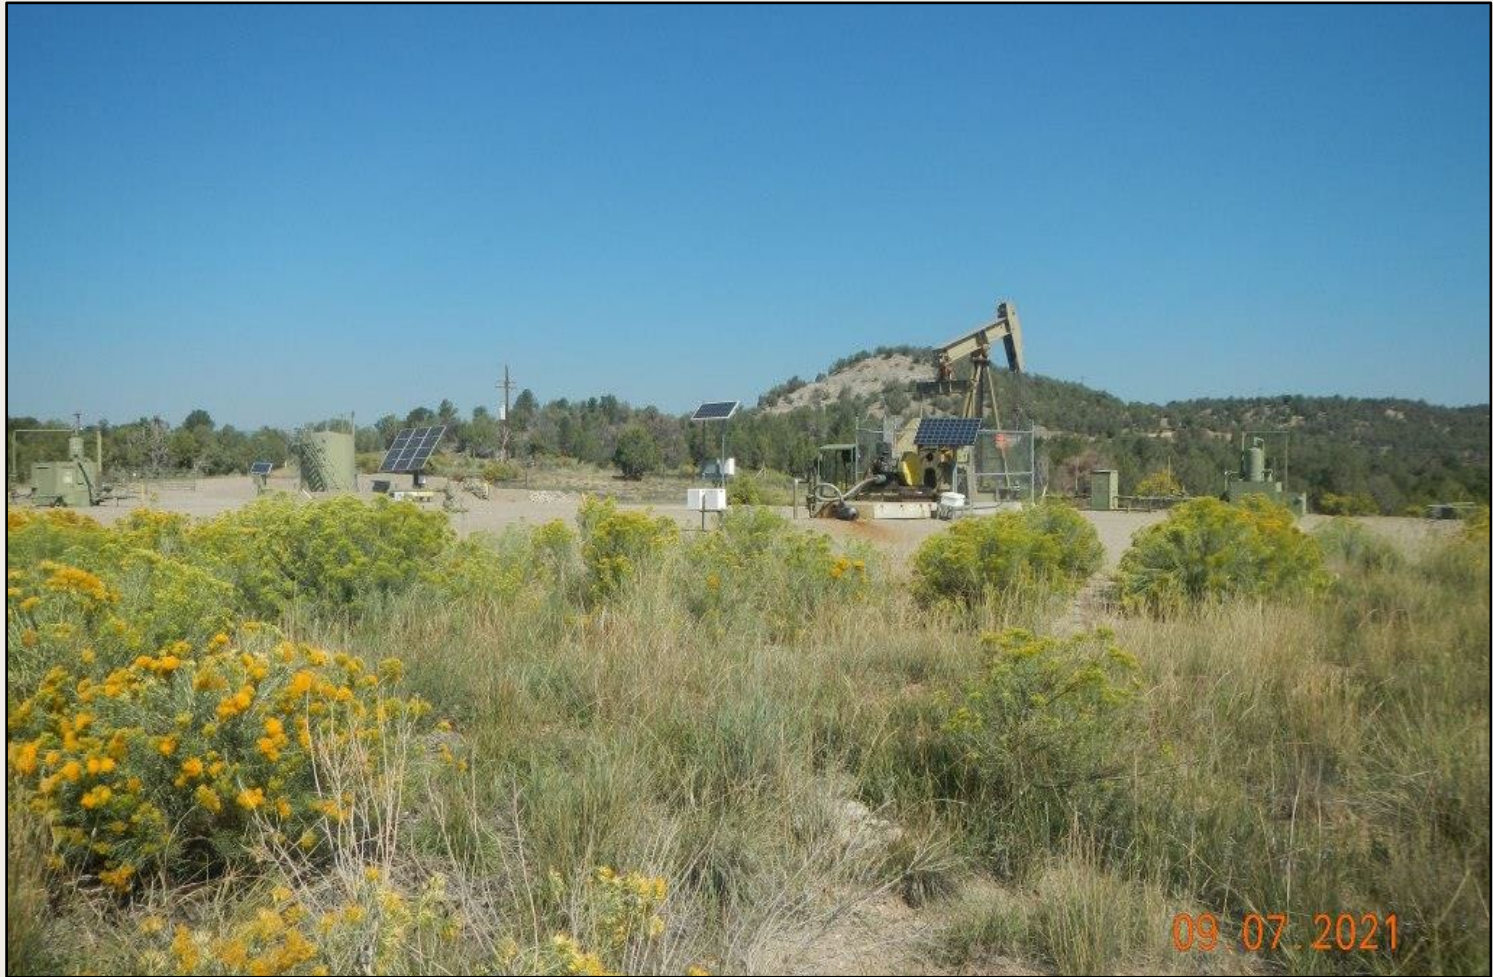
Photo 1. View of the project area from the southeastern corner facing center.

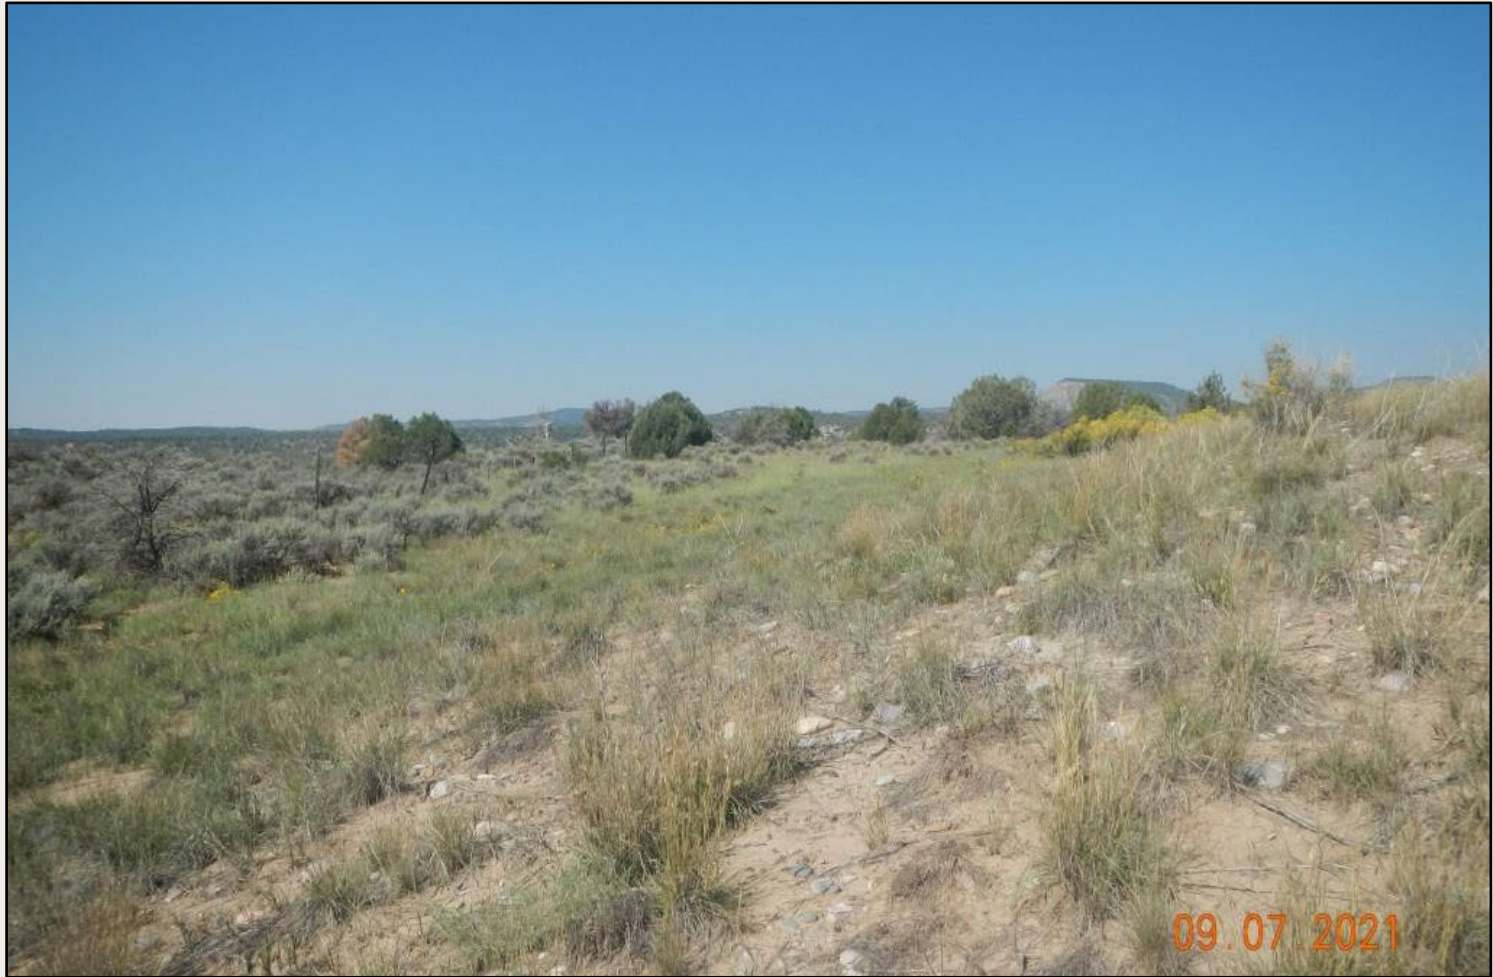
Photo 2. View of the southern project area from the southeastern corner facing westward. Revegetation is comprised of blue grama, western wheatgrass, crested wheatgrass, and rubber rabbitbrush.

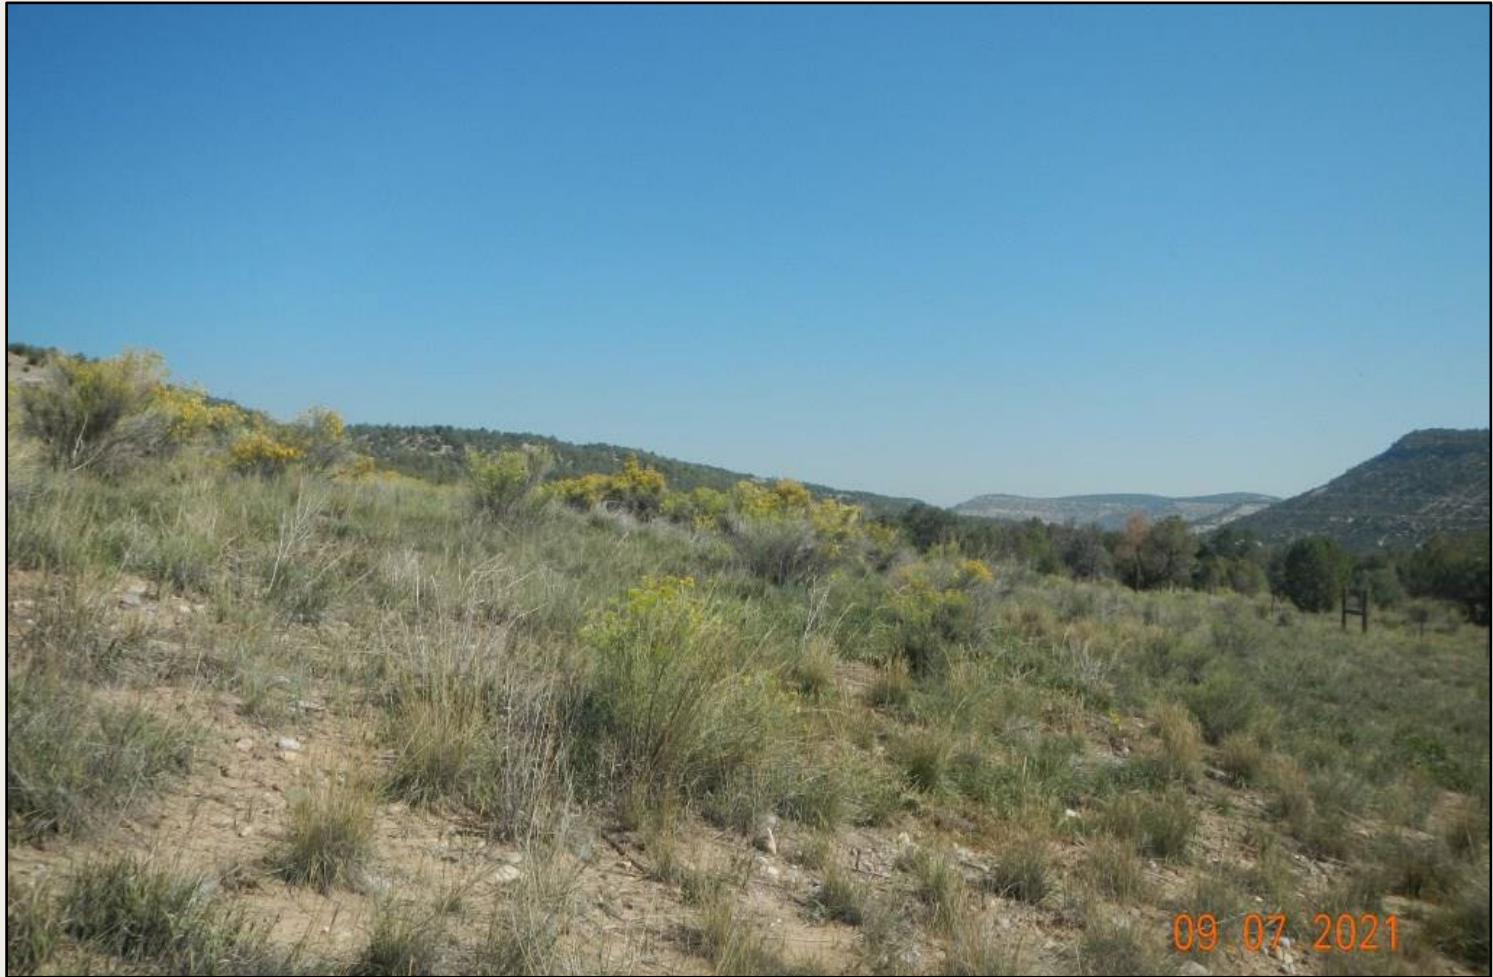
Photo 3. View of the eastern project area from the southeastern corner facing northward.

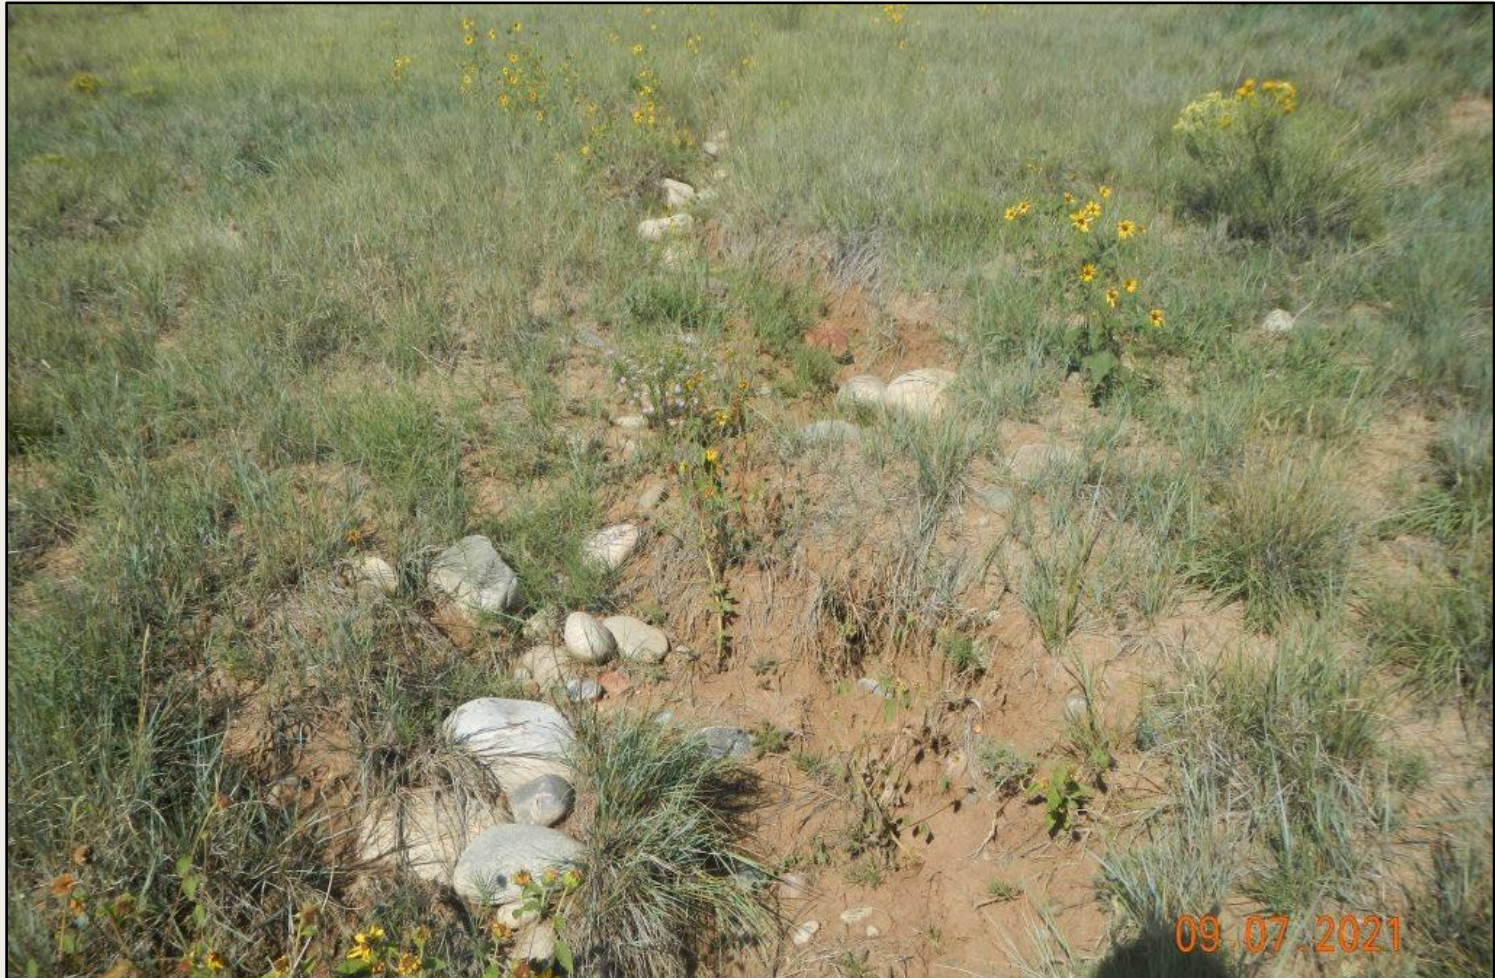
Photo 4. View of erosional channel in the southern project area where stormwater flows around cobbles and continues to erode channel.

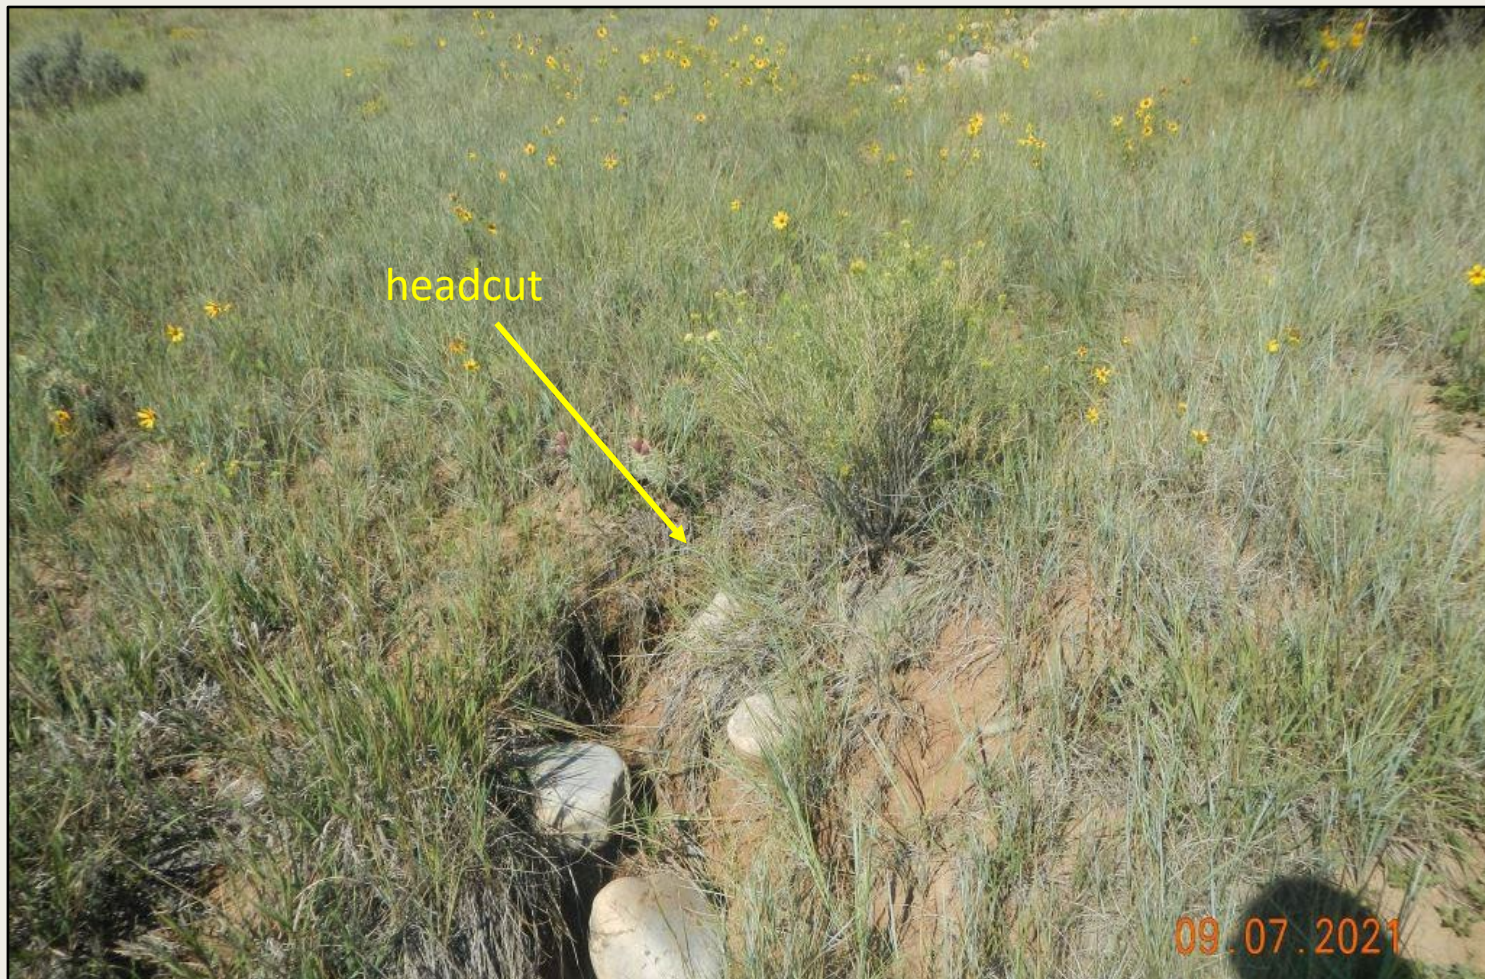
Photo 5. View of headcut where erosional channel begins to erode in the southern project area. Headcut needs long-term stabilization.

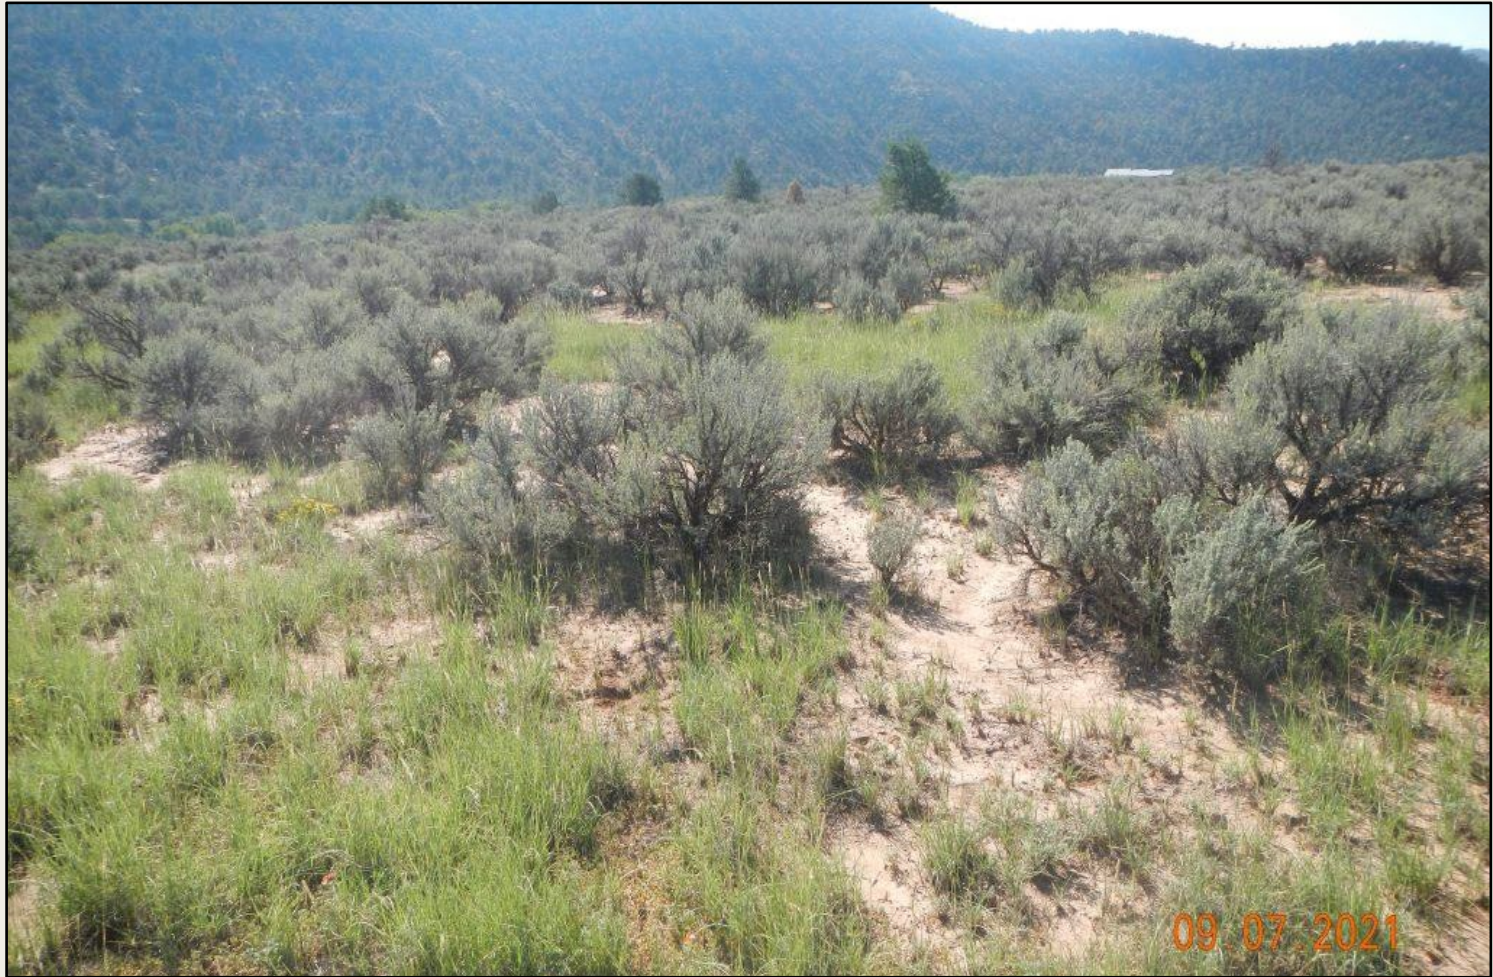
Photo 6. View of reference area comprised of sagebrush shrubland with understory of James galleta, blue grama, and snakeweed.
