Inspection Photos

Operator: Dixie Mclane Trust
API: 067-06049
Date: 9/7/2021

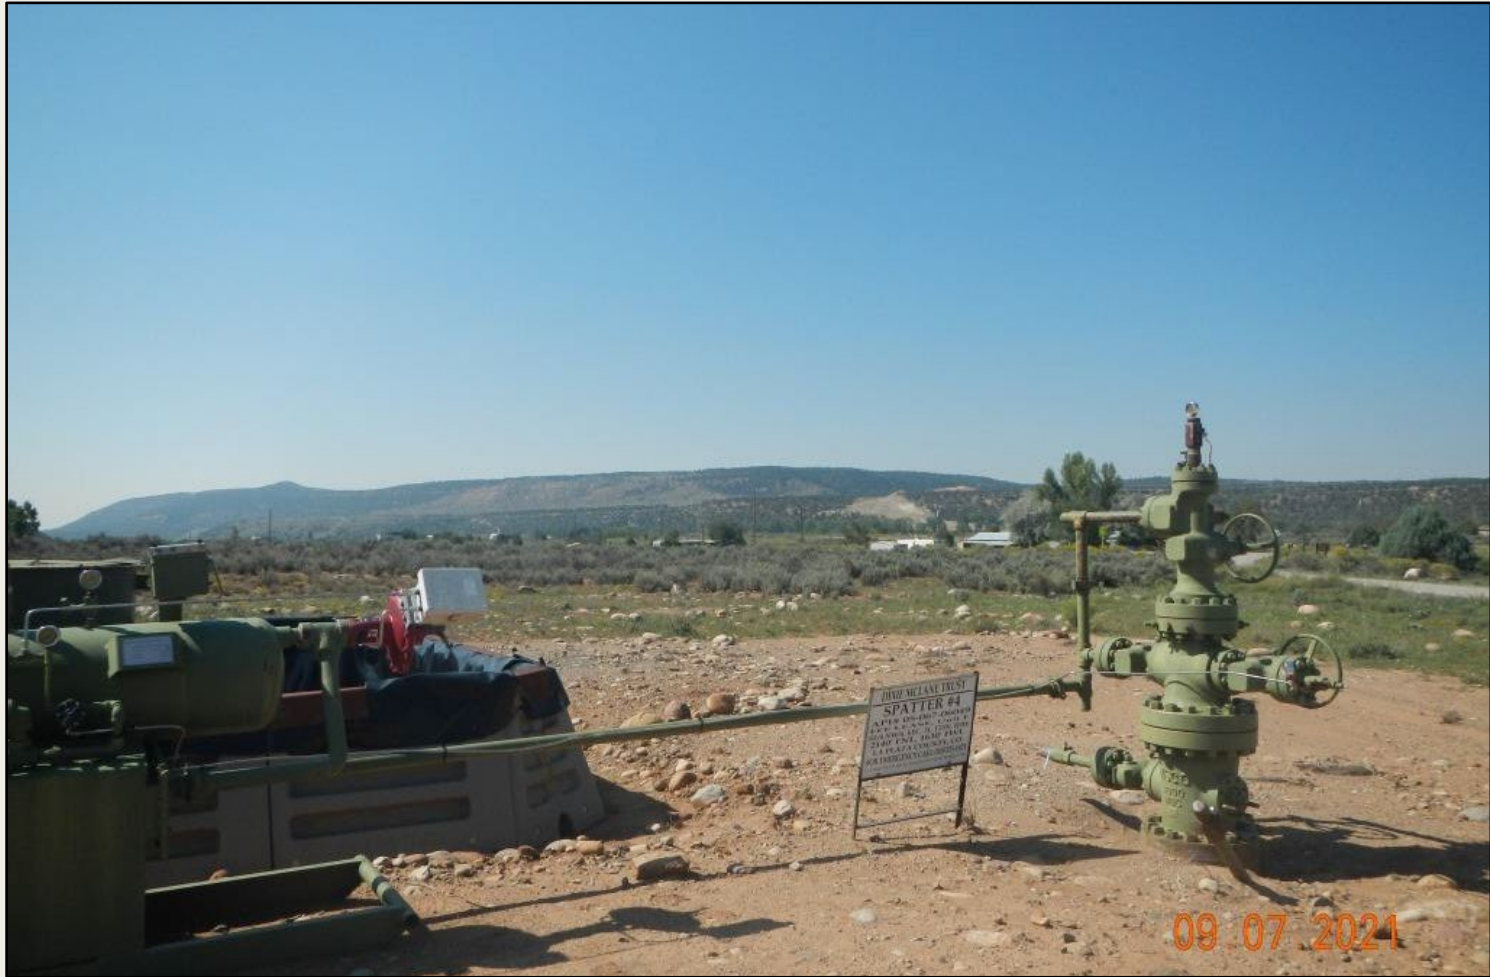
Photo 1. View of the well head and well sign facing southward.

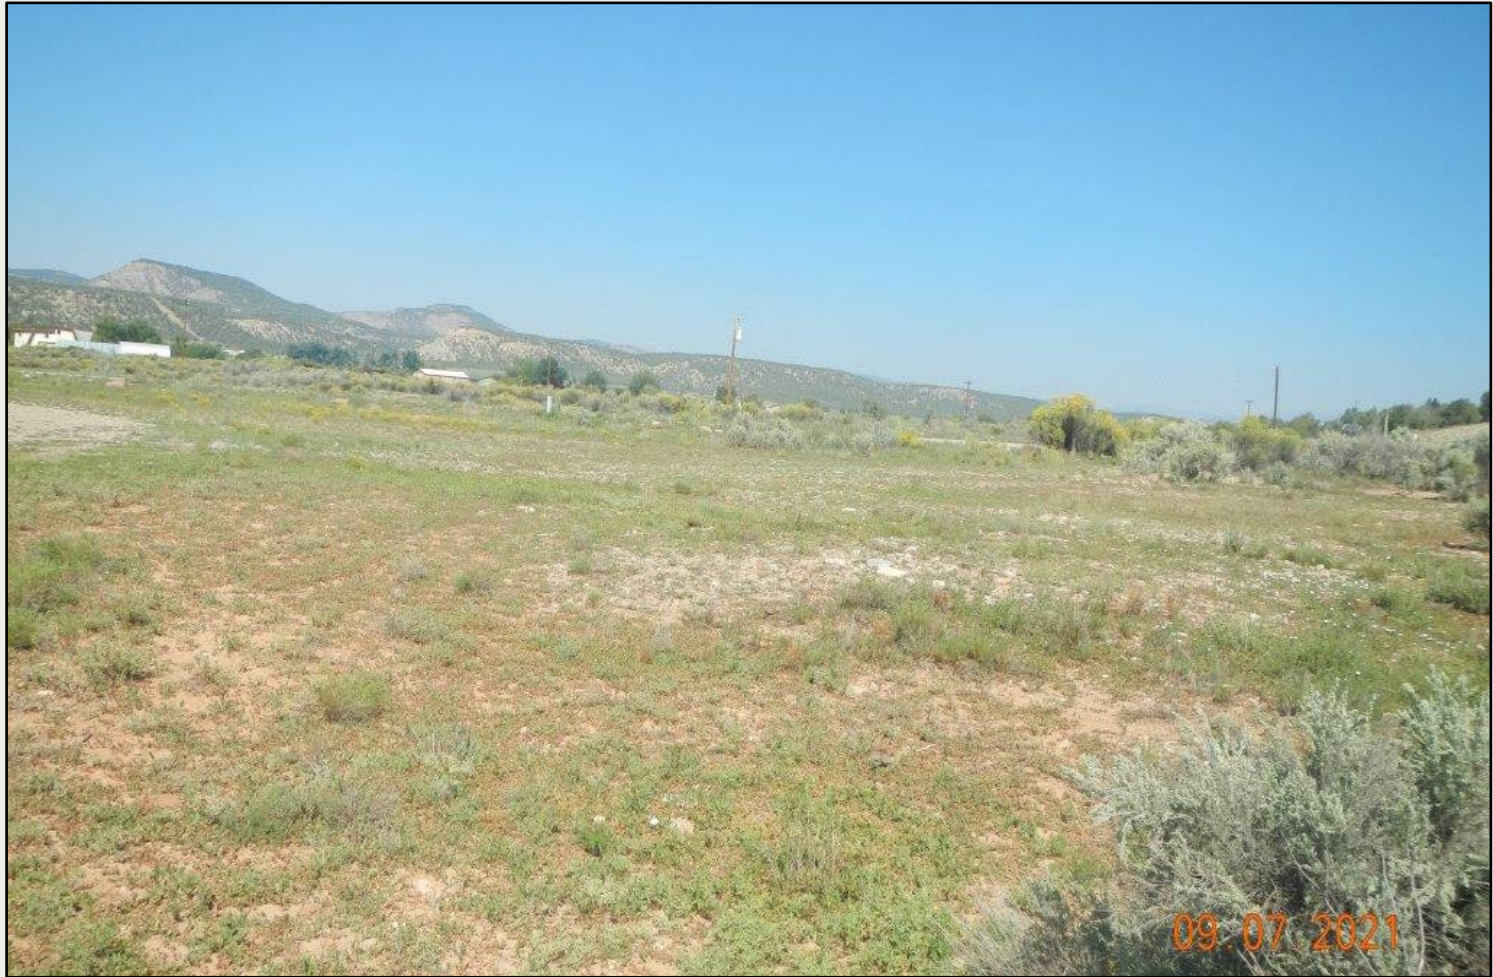
Photo 2. View of the northern project area from the northeastern corner facing westward. Revegetation is progressing with western wheatgrass, rubber rabbitbrush, and James galleta.

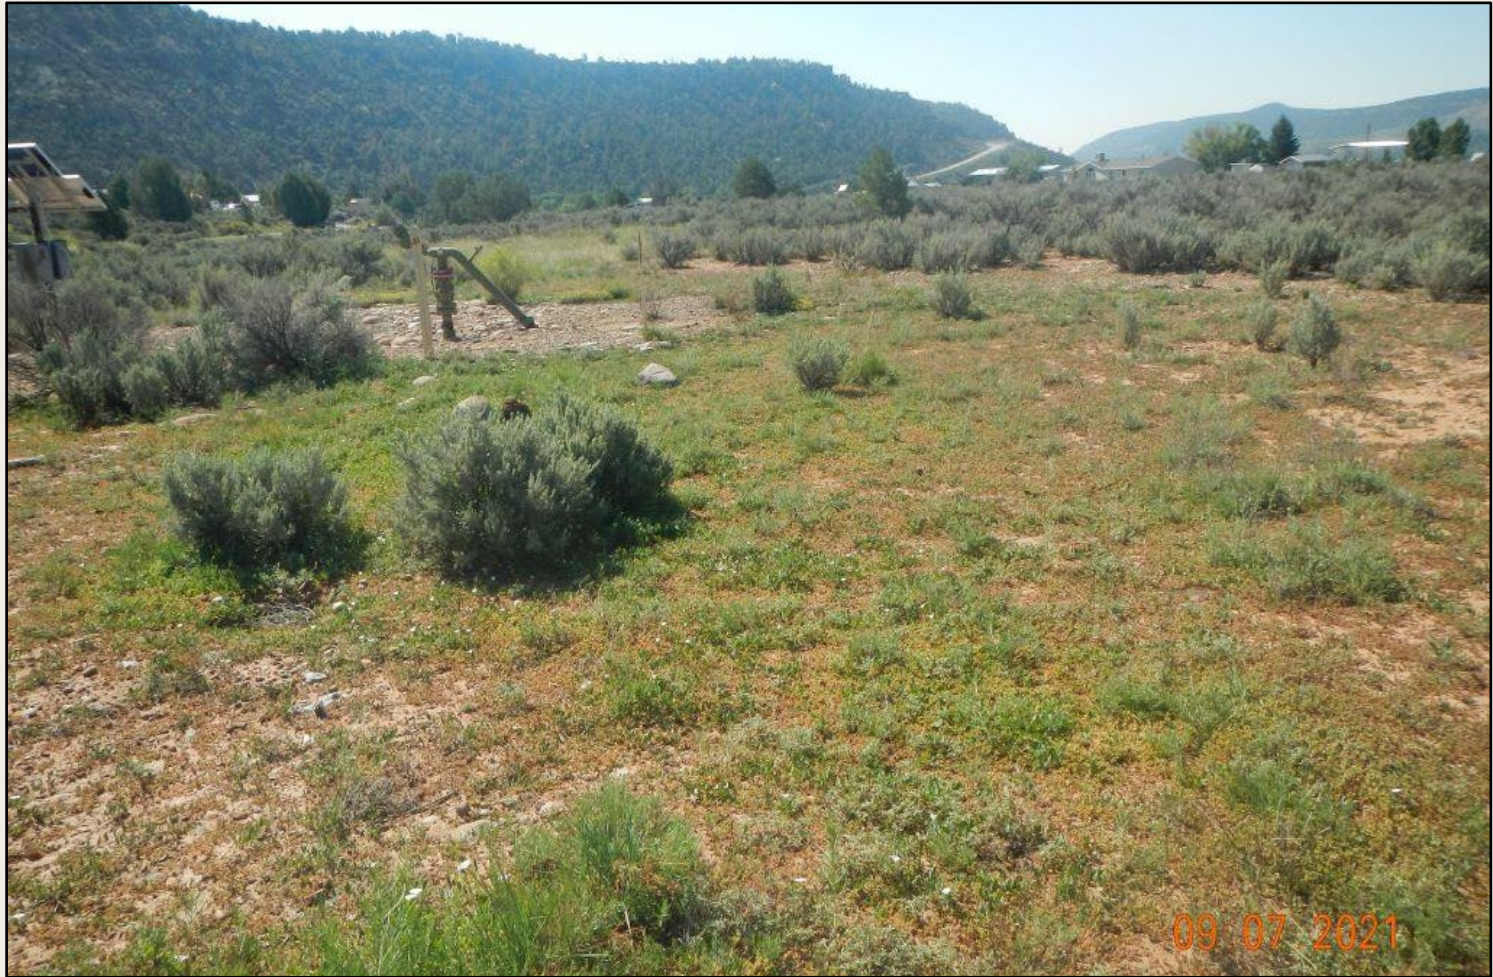
Photo 3. View of the eastern project area from the northeastern corner facing southward.
