Inspection Photos

API: 055-06012

Operator: OXY USA INC

Inspection Date: 9/9/2021

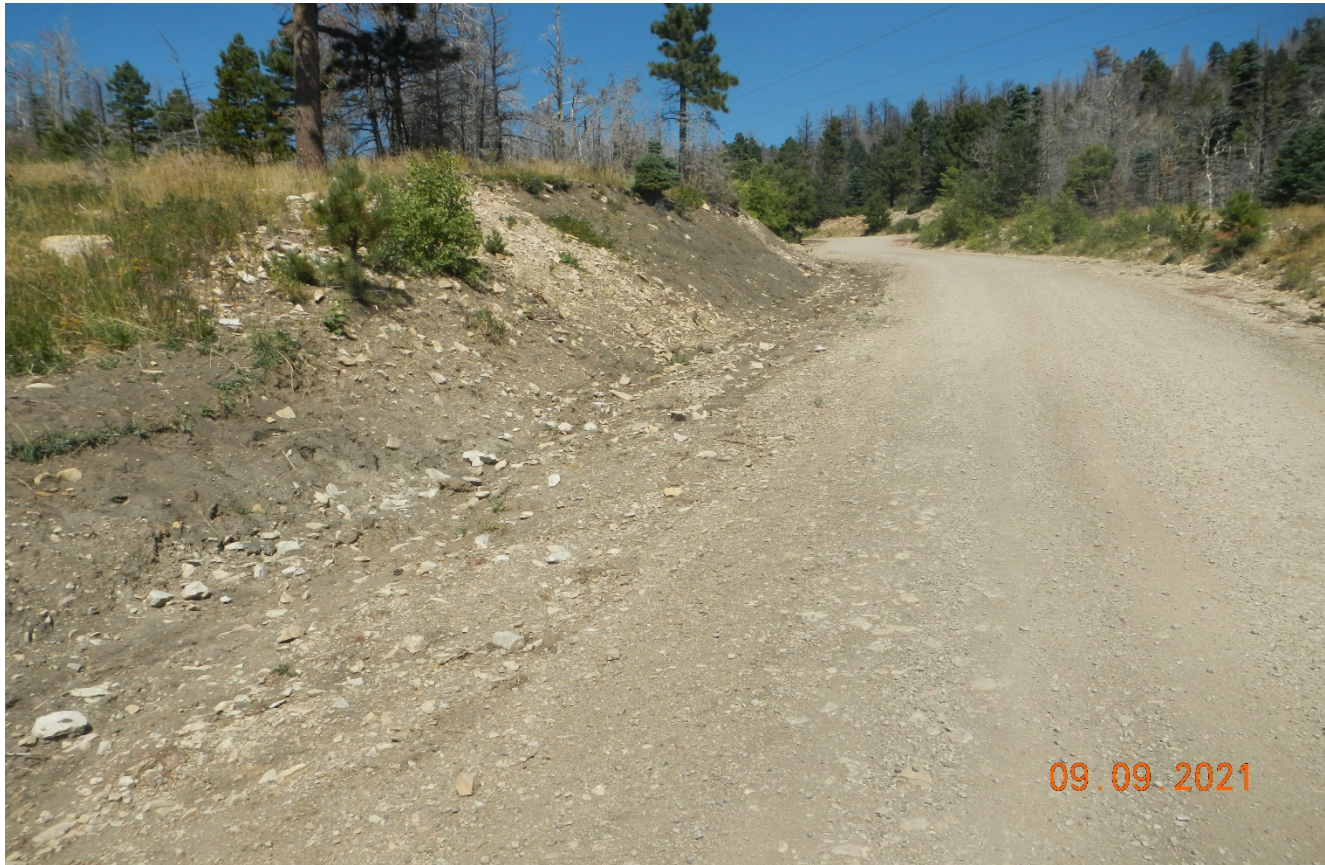
Photo 1. The area of erosion has been repaired at Lat/Long:37.66008, -105.18761. This area also needs to be stabilized.

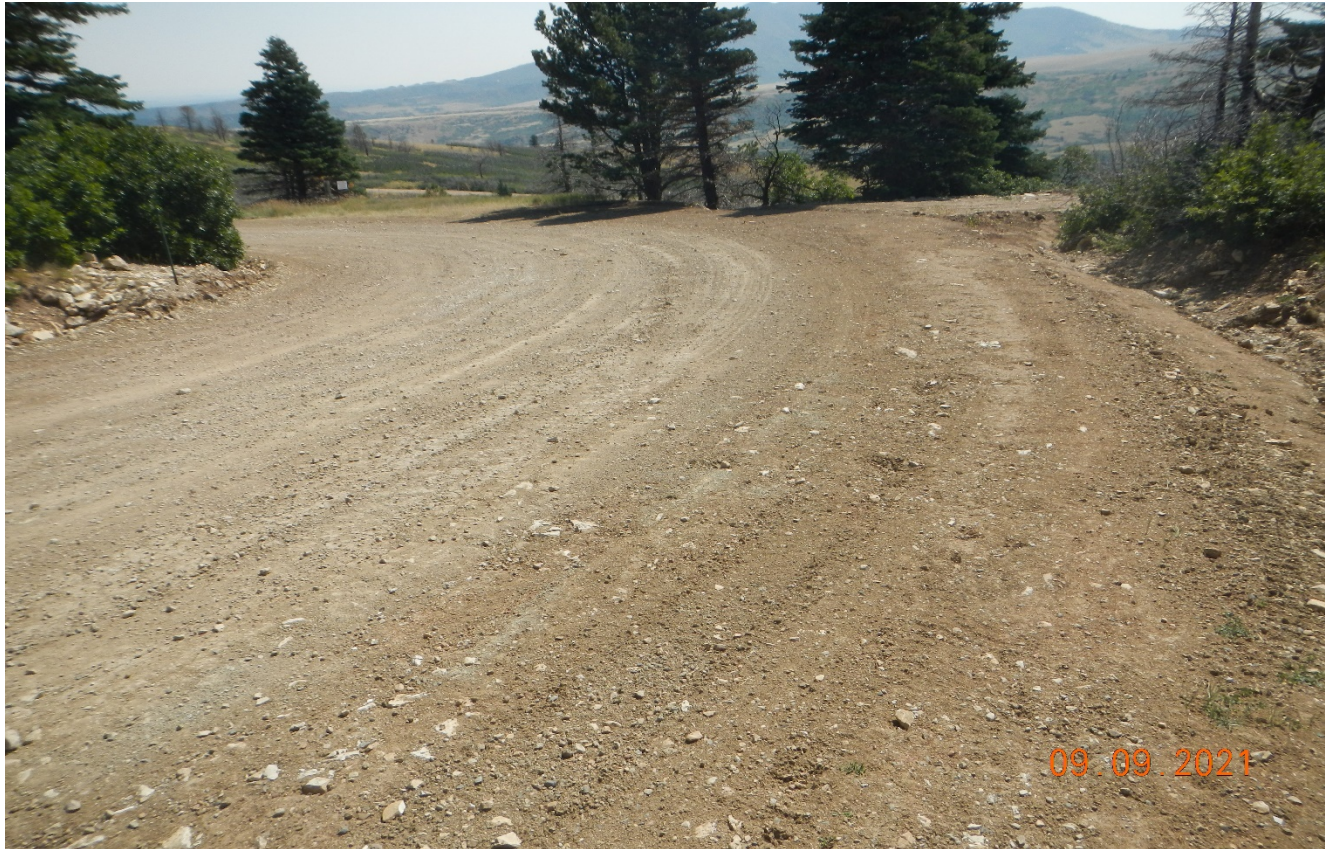
Photo 2. The road had been regraded traveling to the location.

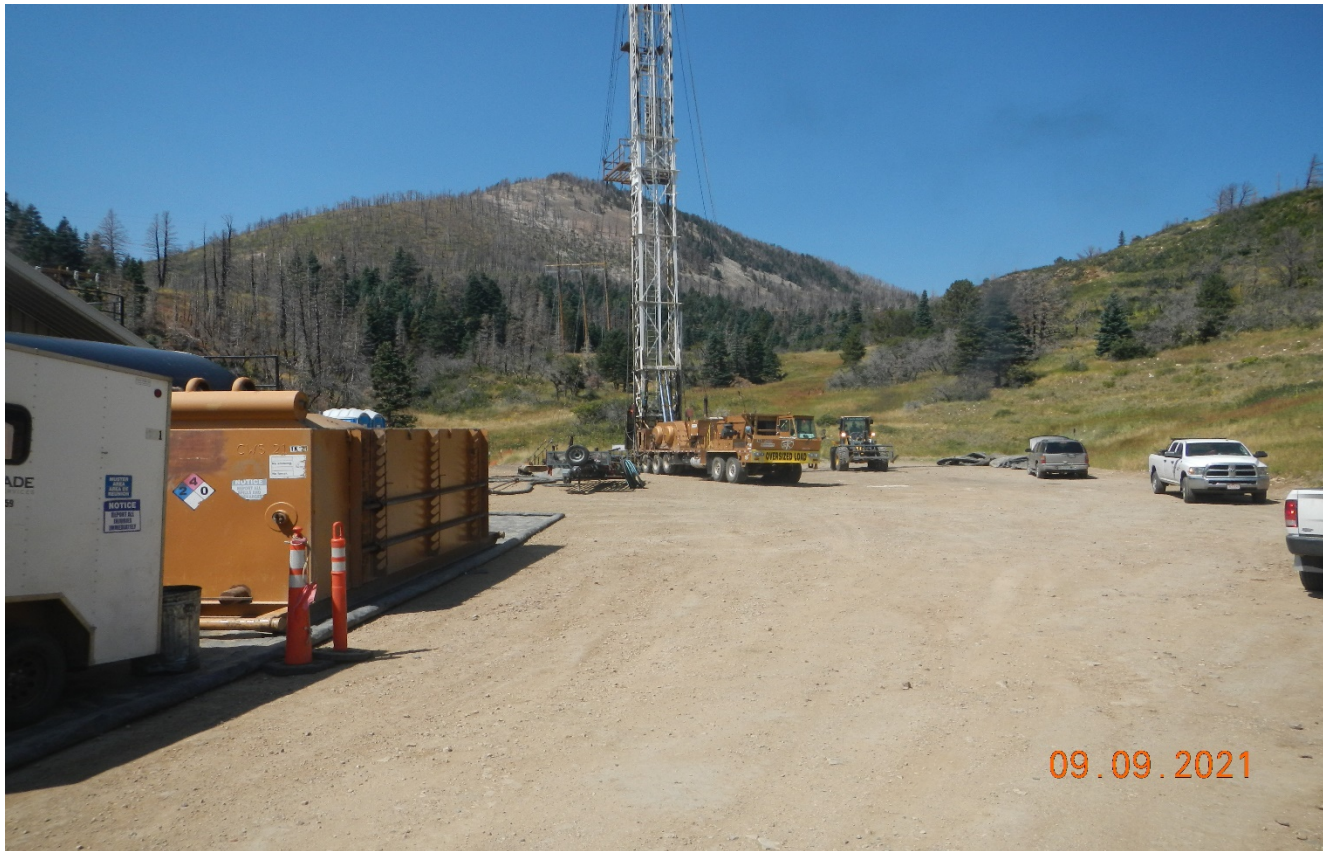
Photo 3. Facing northwest toward the location. A drill rig was on location.

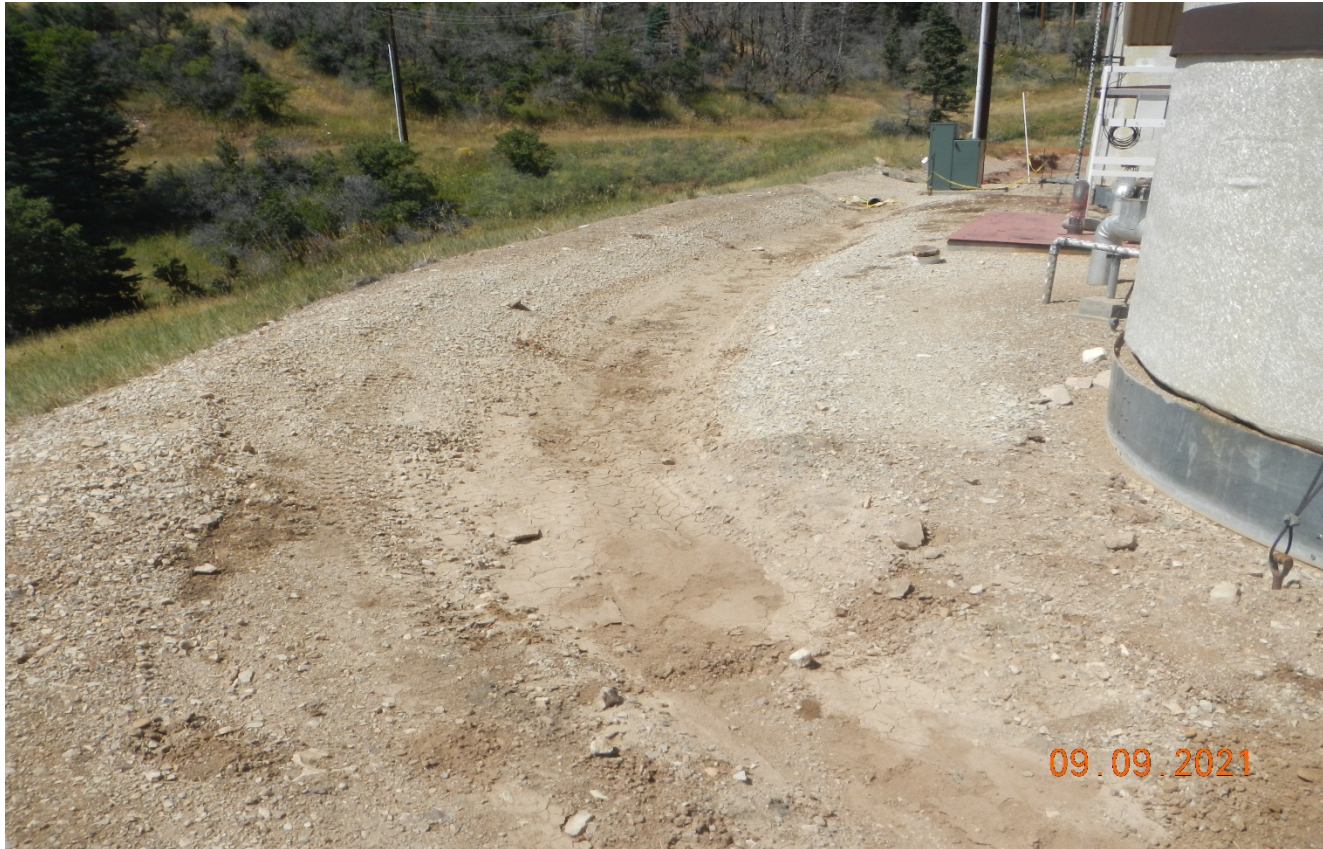
Photo 4. Facing toward the bermed area around the tank where stained soil was observed. There is still stained soils observed in this area.

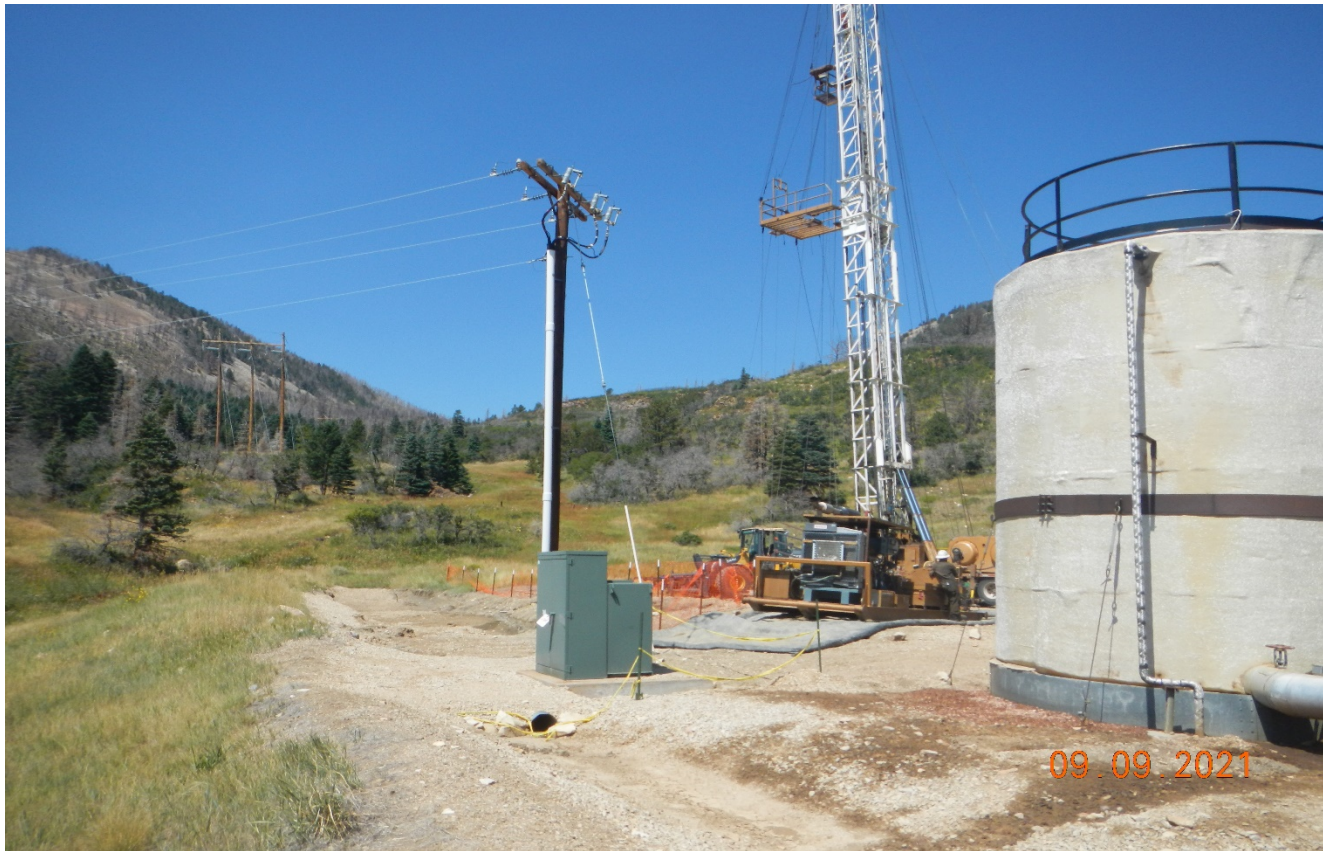
Photo 5. Facing northwest at the south side of the location.

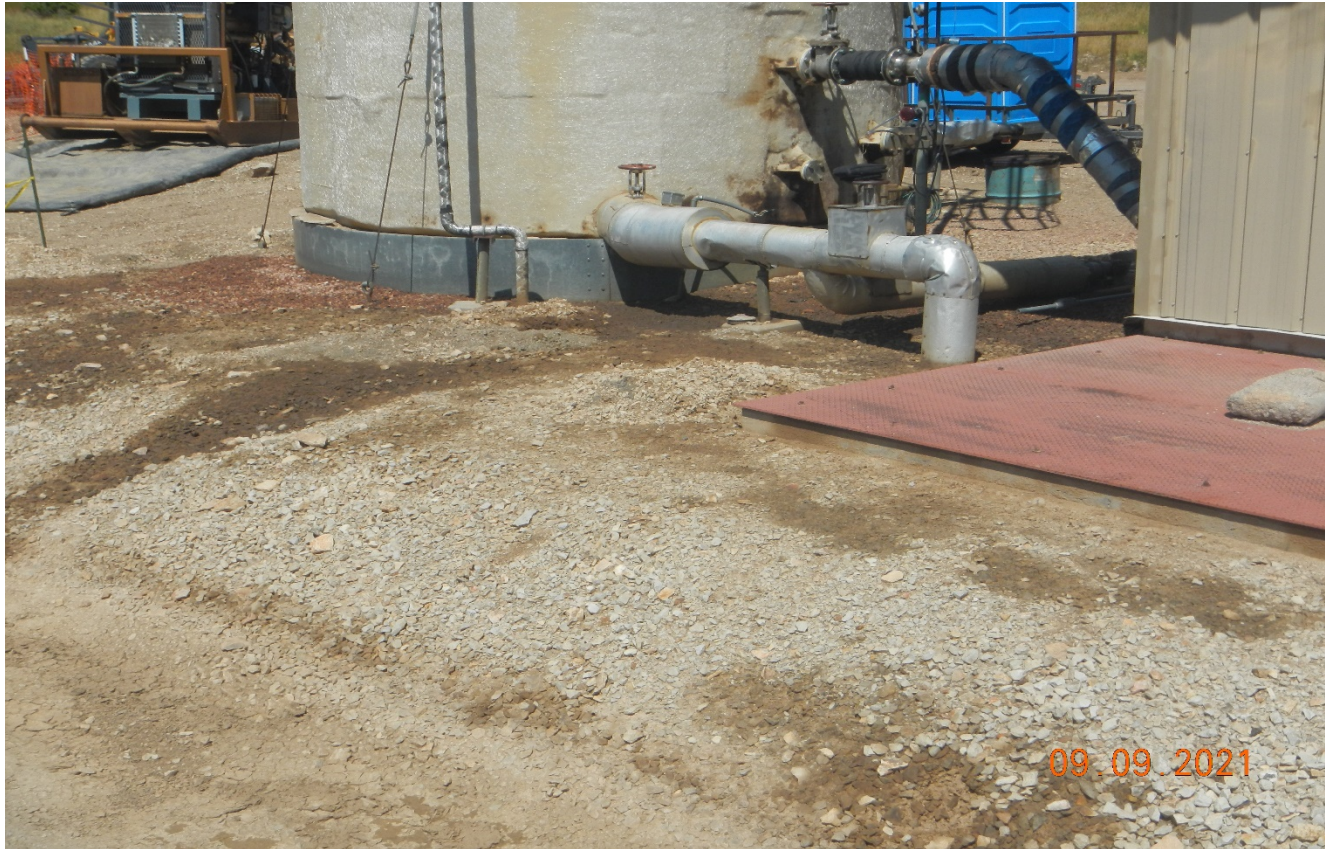
Photo 6. The oil staining near the tanks has not been cleaned up since previous inspection.
