Inspection Photos

API: 055-06105

Operator: OXY USA INC

Inspection Date: 9/9/2021

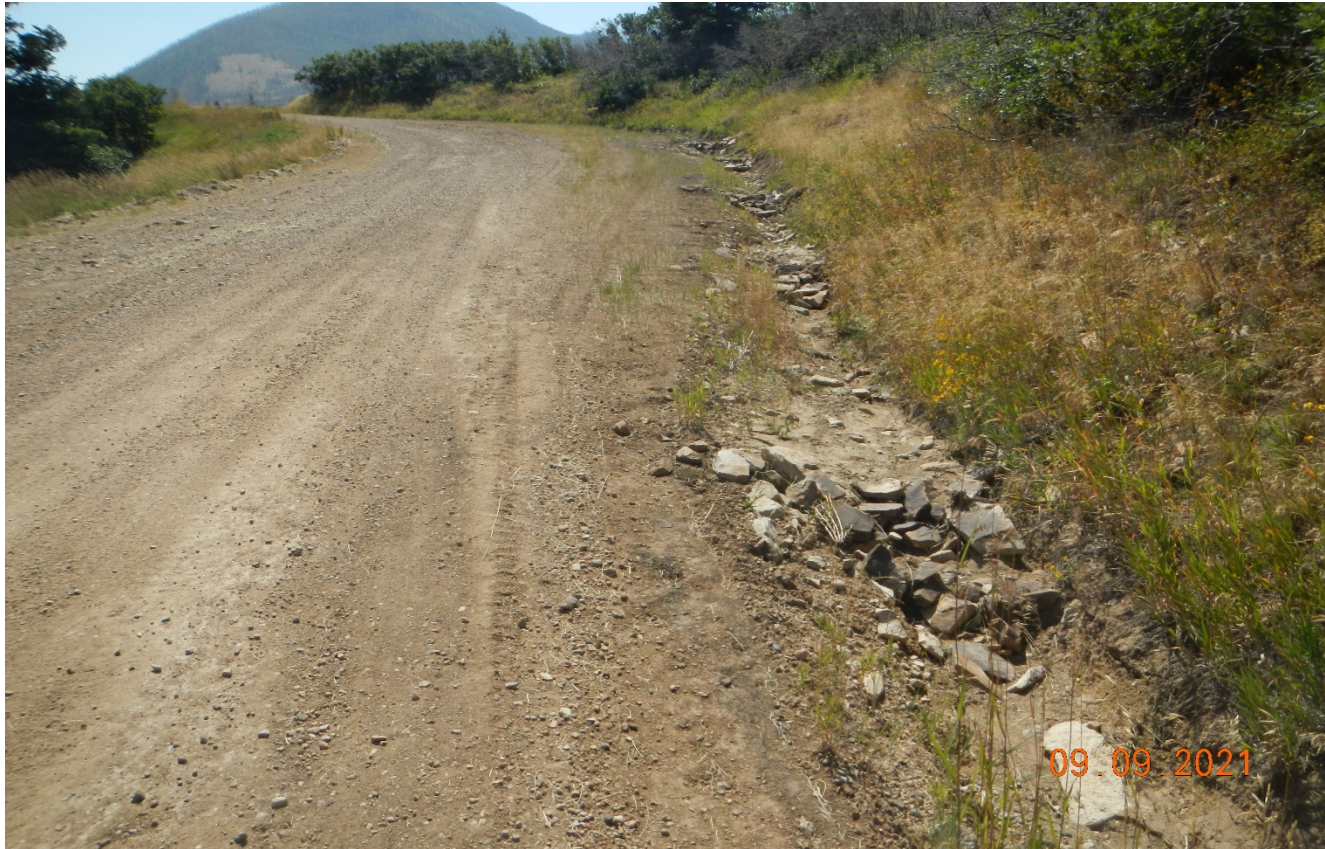
Photo 1. Facing southeast ascending the hill toward the location. There are rock check dams installed along the roadside. Some of the check dams will need maintenance.

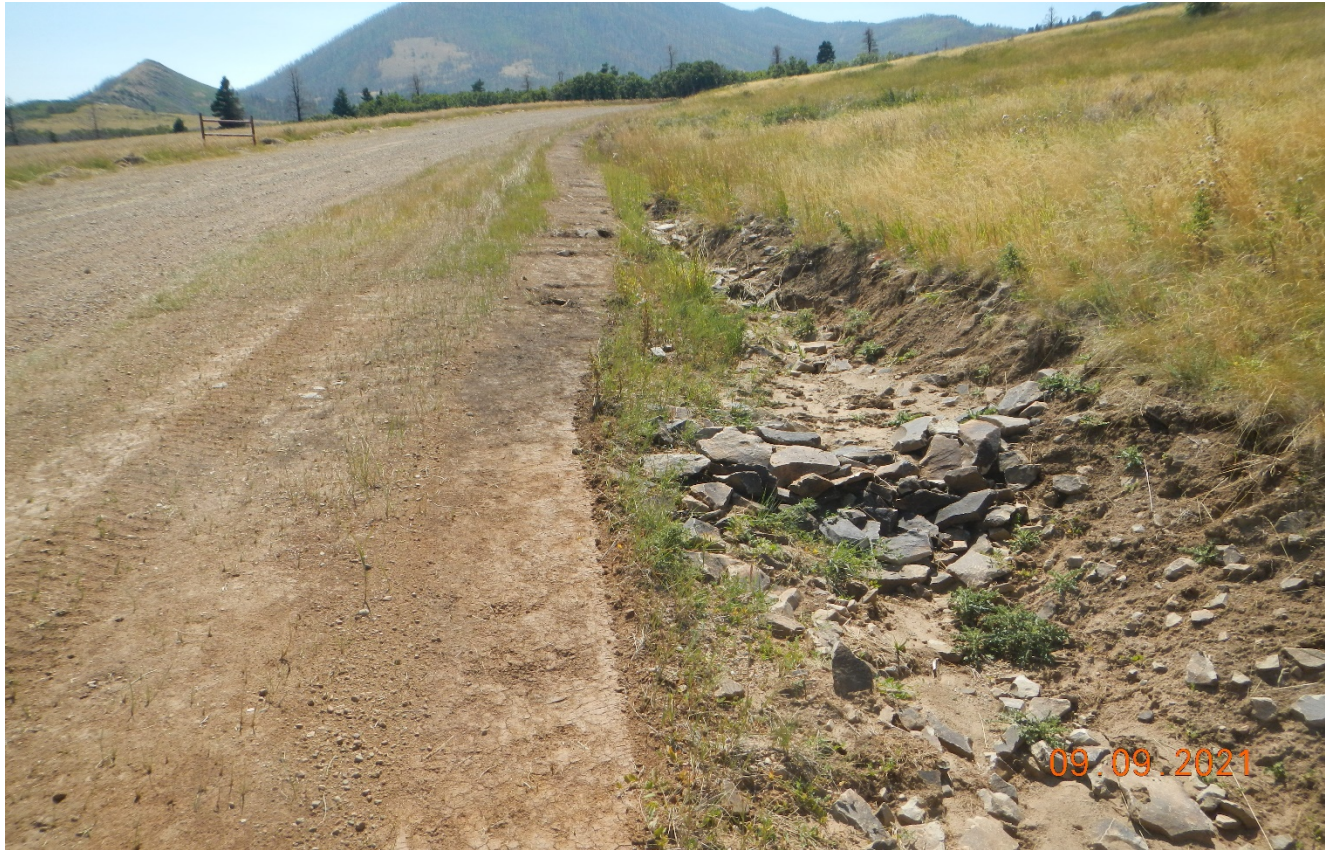
Photo 2. Facing southeast ascending the hill toward the location. There are rock check dams installed along the roadside.

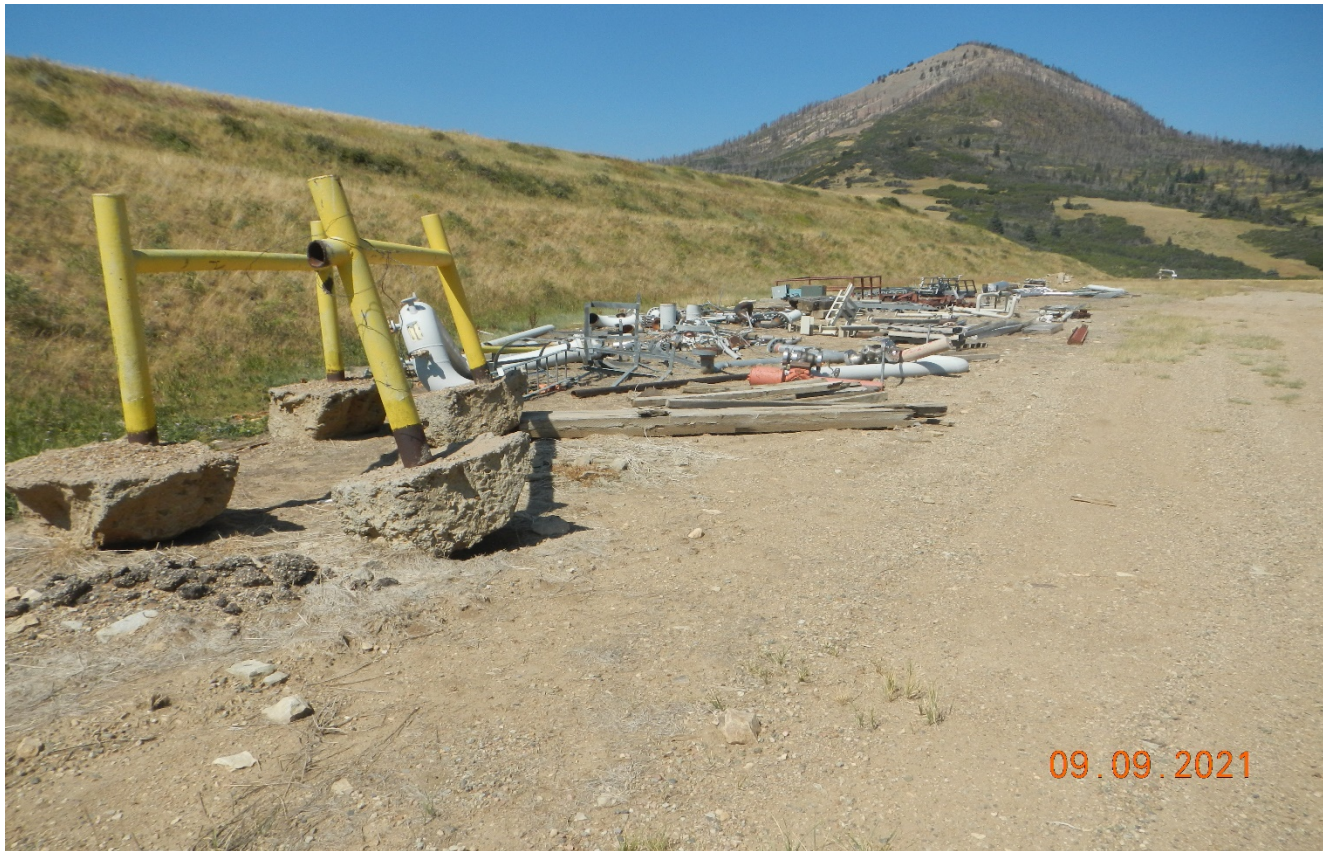
Photo 3. Facing northwest at the location. There is various unused equipment stored in this area which has not been removed.

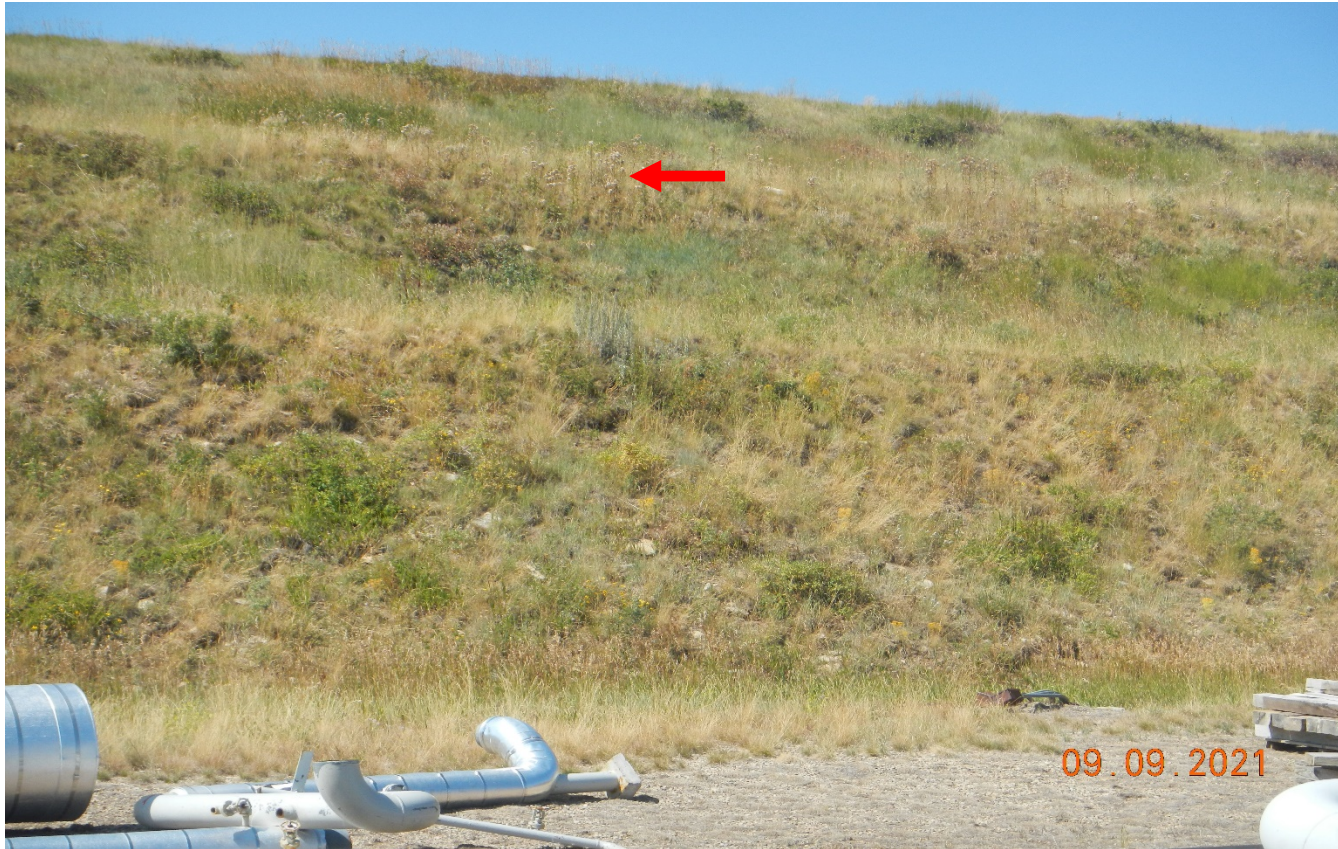
Photo 4. There were noxious weeds observed in areas of the location. There is weeds along the cut slope shown and red arrow.
