Inspection Photos

Operator: LARAMIE ENERGY LLC # 10433

Location ID: 324288

Garfield County, CO

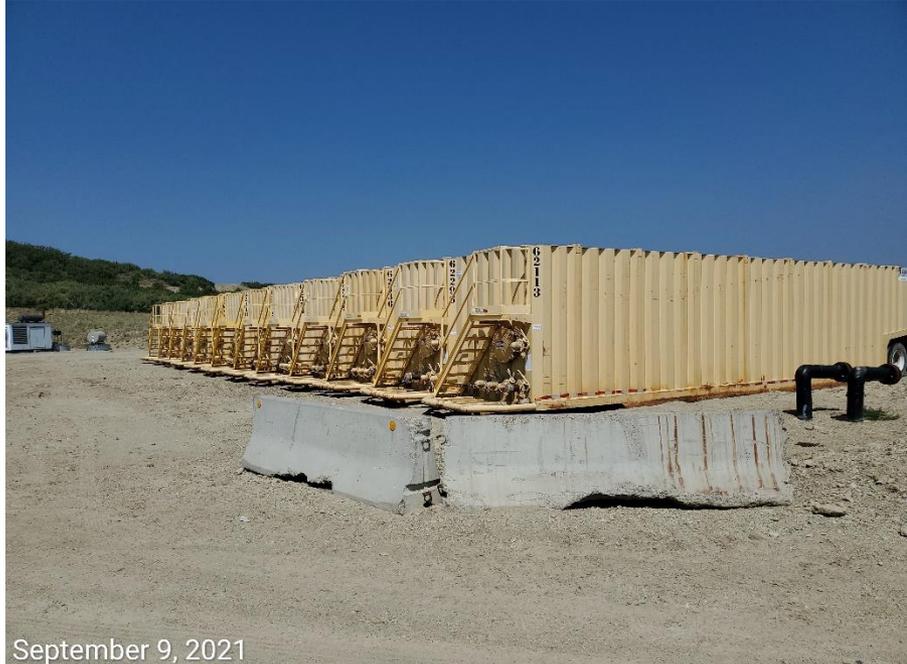
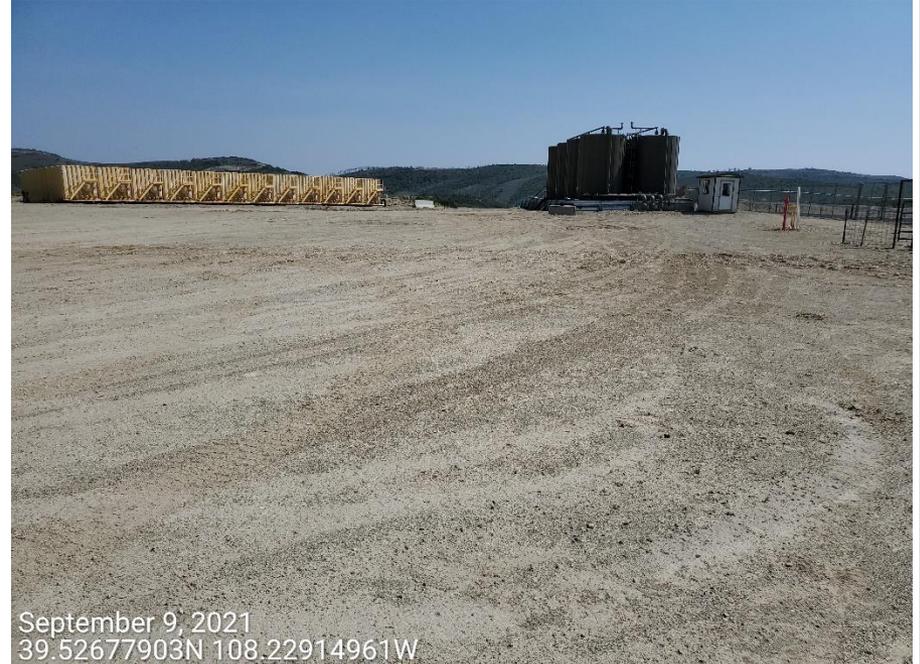
Photo 1: Photos show frac tanks being stored on the northeast end of the Location. Equipment is not needed for production and requires removal.

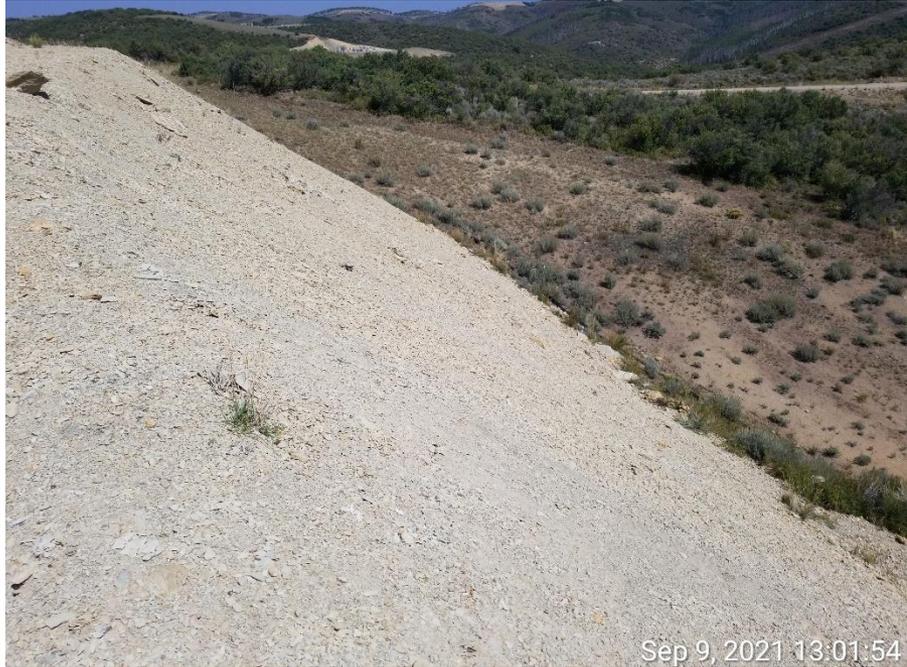
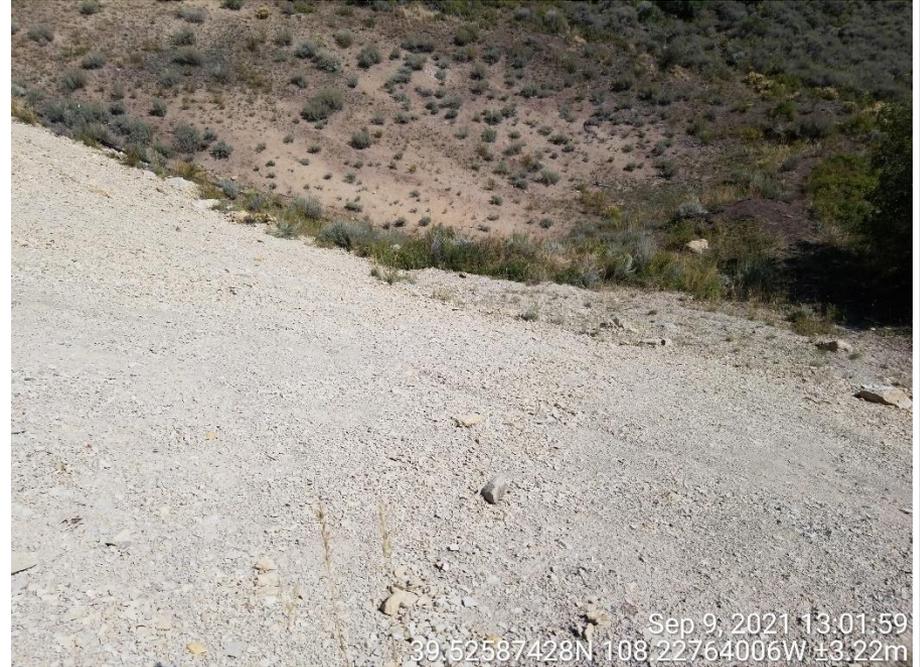
Photo 2: Photos taken from the fill slopes on the west end of the Location. Photos show BMPs to protect and stabilize the slopes, and manage runoff are missing or insufficient.

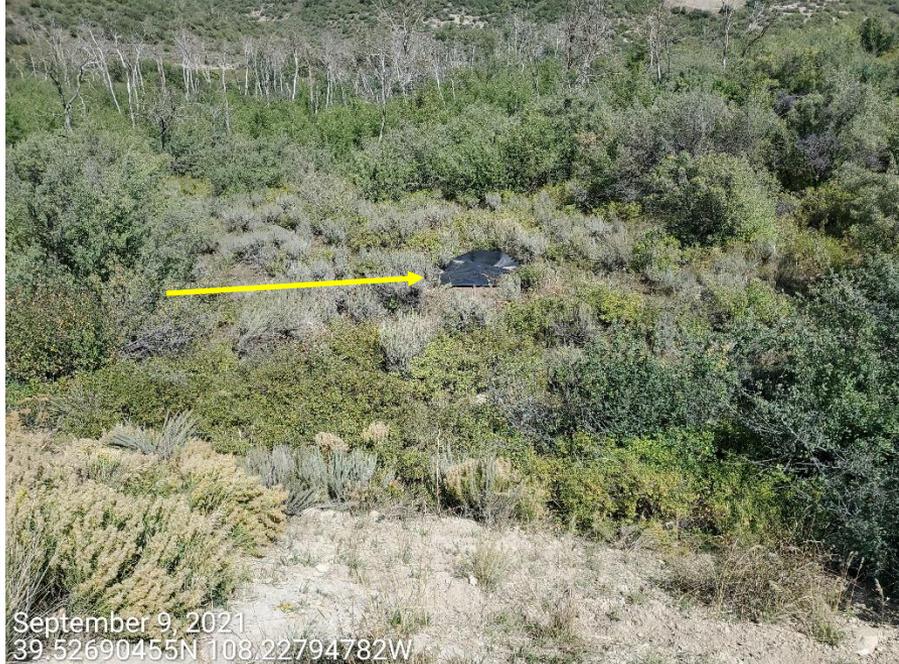
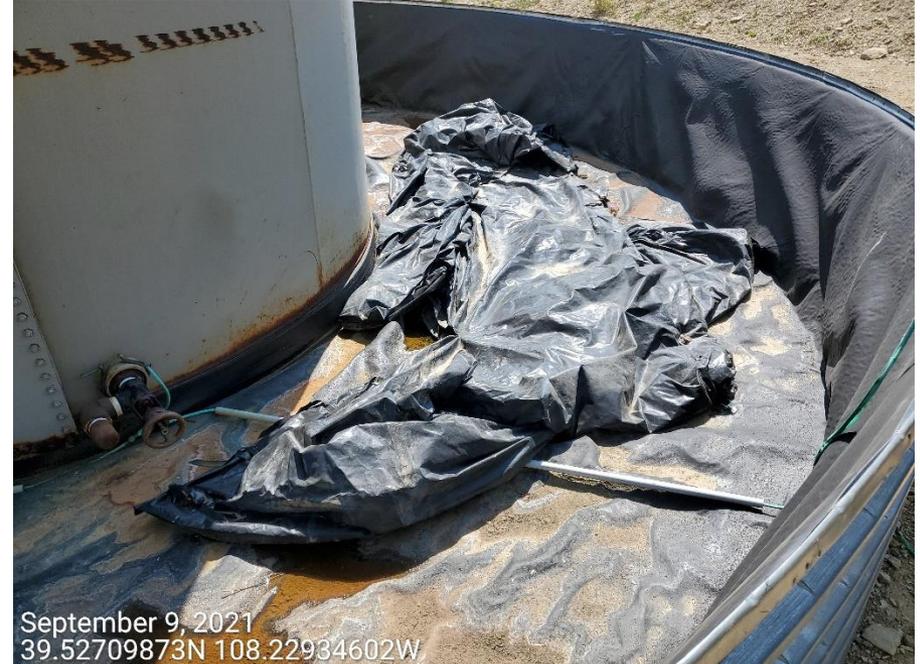
Photo 3: Photos provide example of various trash debris observed on areas north of the Location (photo left), and improperly stored within the secondary containment.

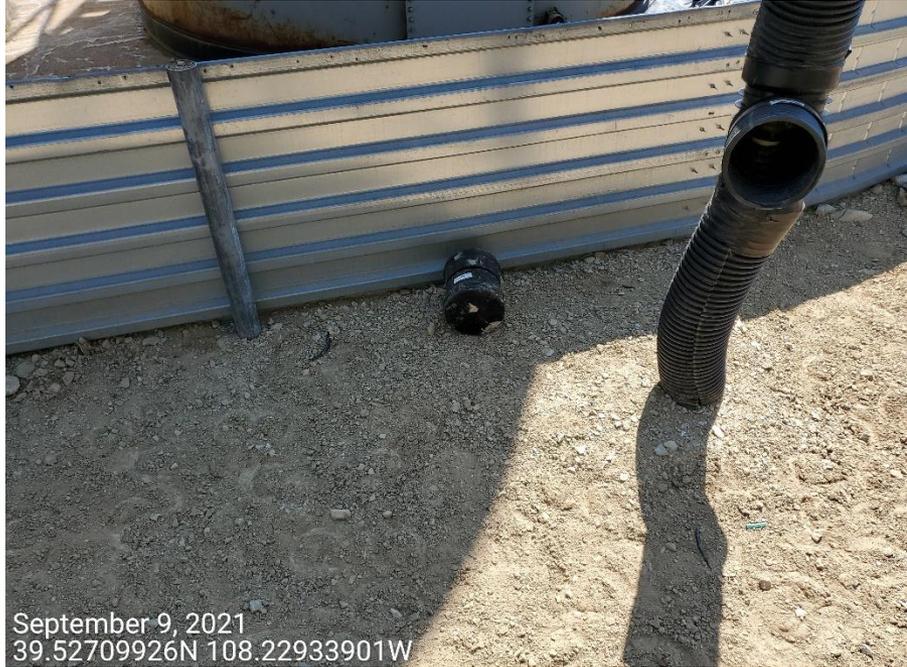
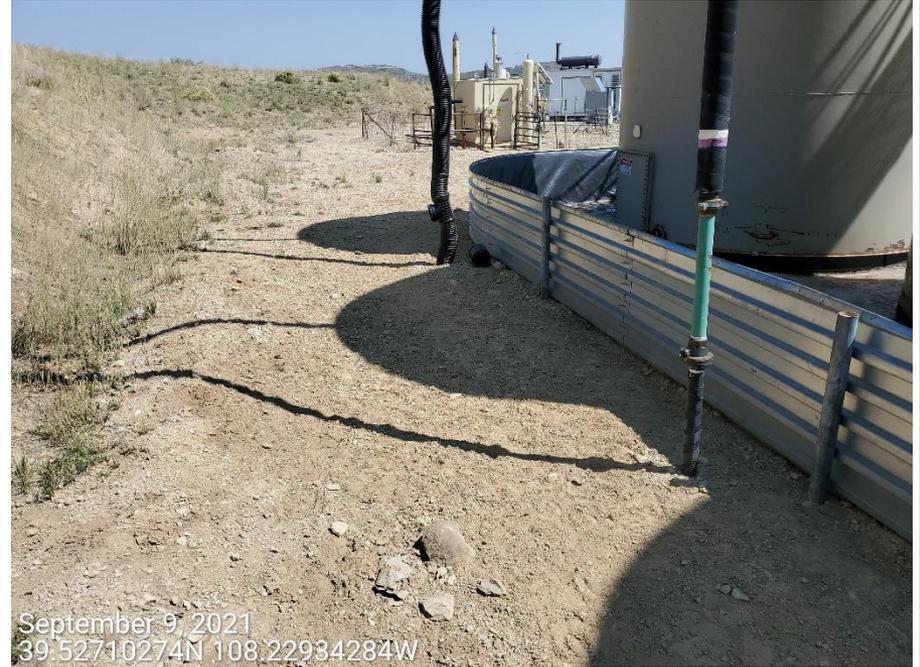
Photo 4: Photos show trash debris observed on the northwest end of the tank battery.

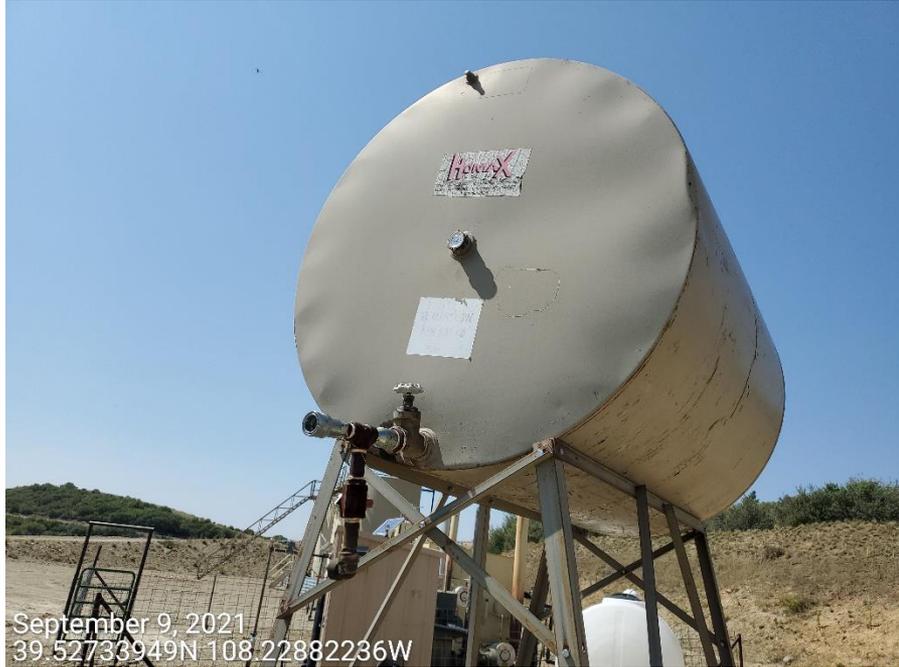
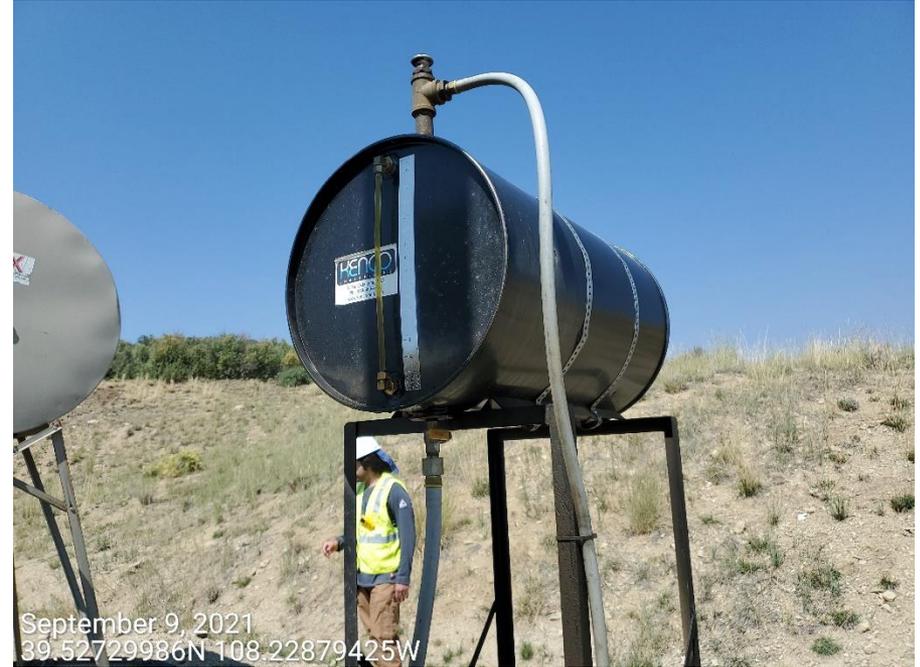
Photo 5: Photos provide examples of tanks on the Location with missing, or inadequate labeling information. Safety labeling is needed in order for COGCC Staff to properly identify contents within a container; if staff is unable to identify contents, staff is unable to accurately assess whether or not container is used to store, treat or otherwise handle hazardous material.

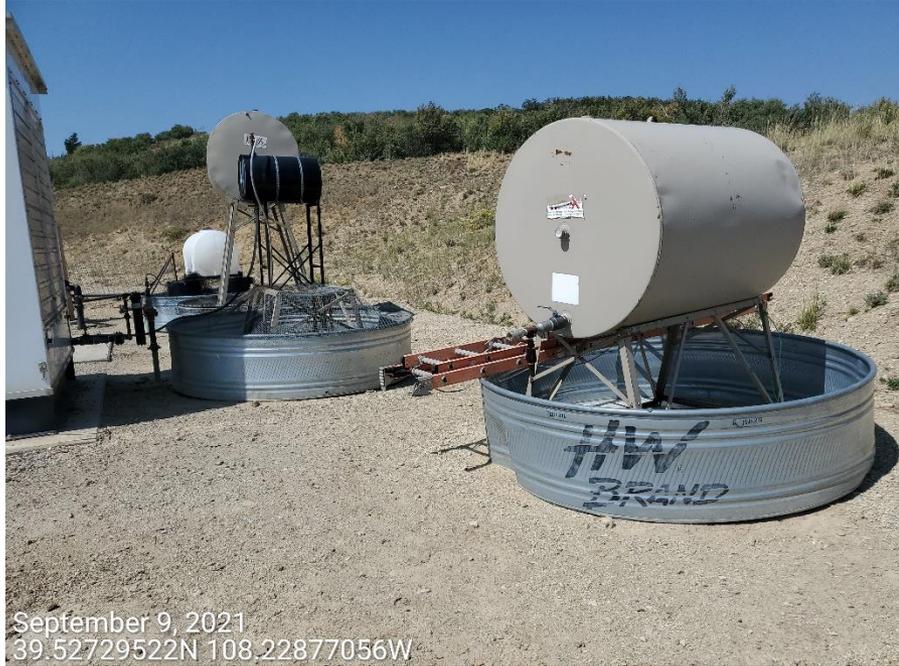
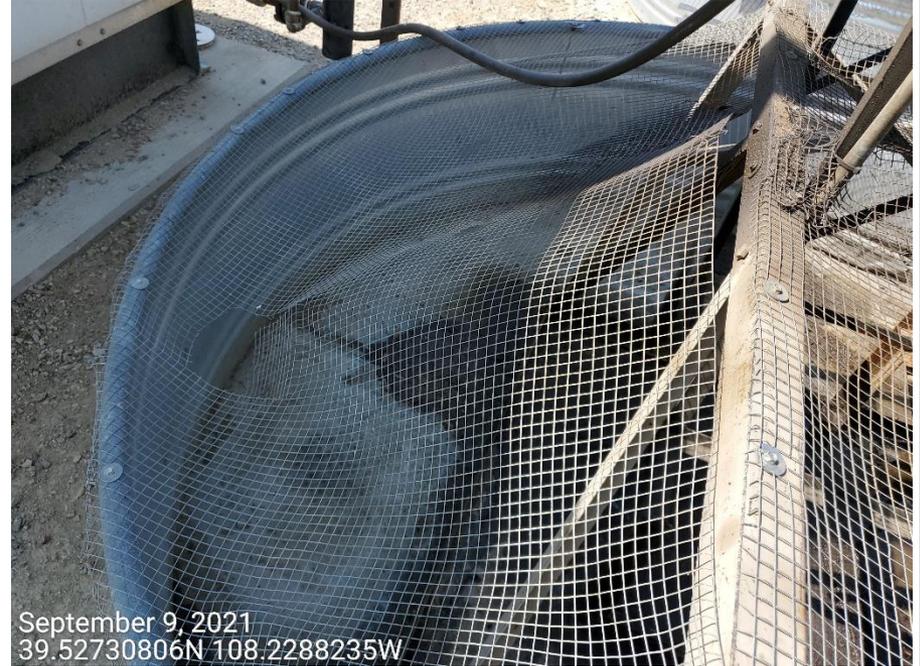
Photo 6: Photos provide examples showing that wildlife protection devices are missing or insufficient at several secondary containment BMPs.

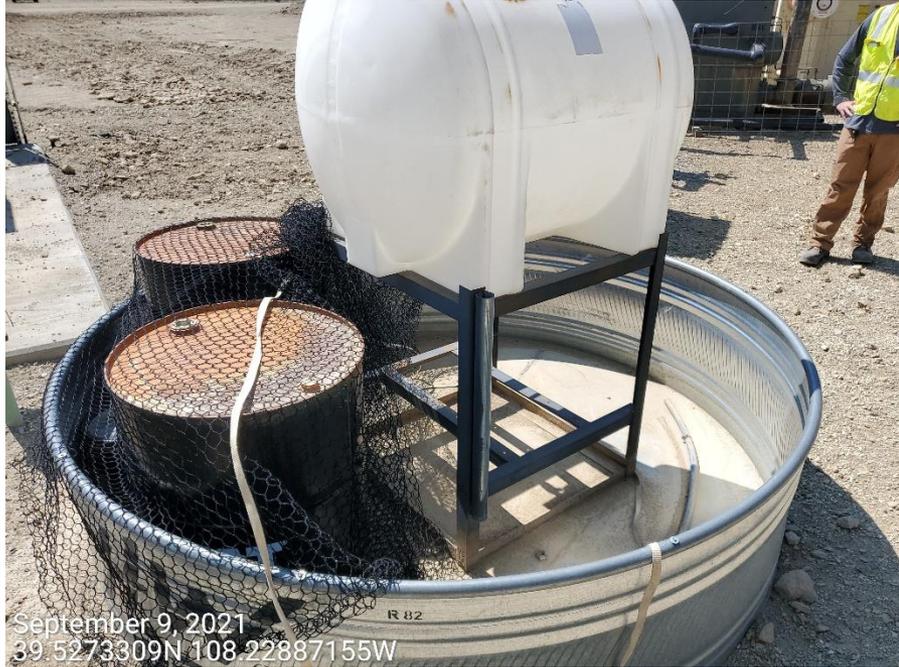
Photo 7: Photos provide examples showing that wildlife protection devices are missing or insufficient at several secondary containment BMPs.

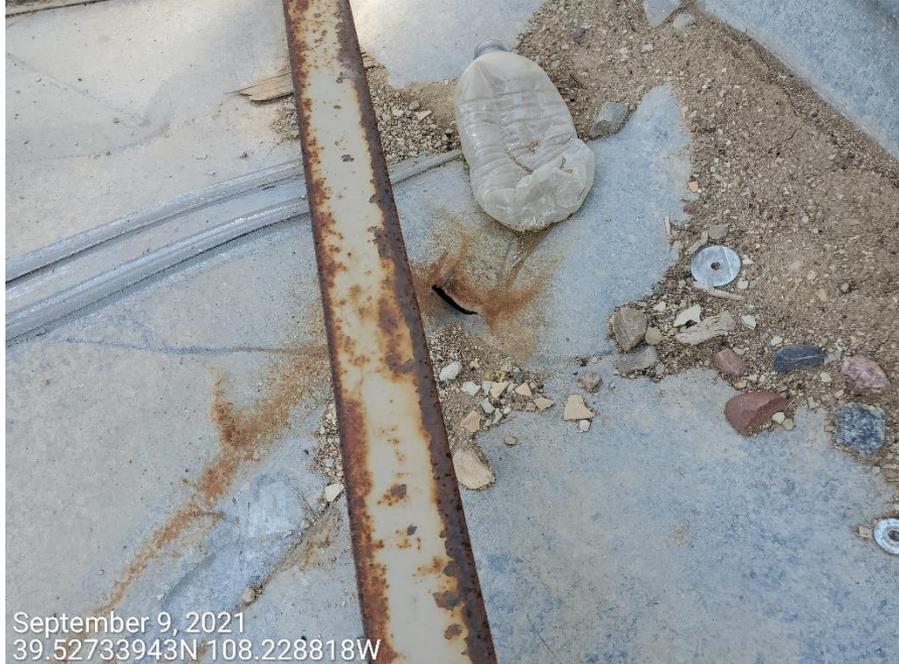
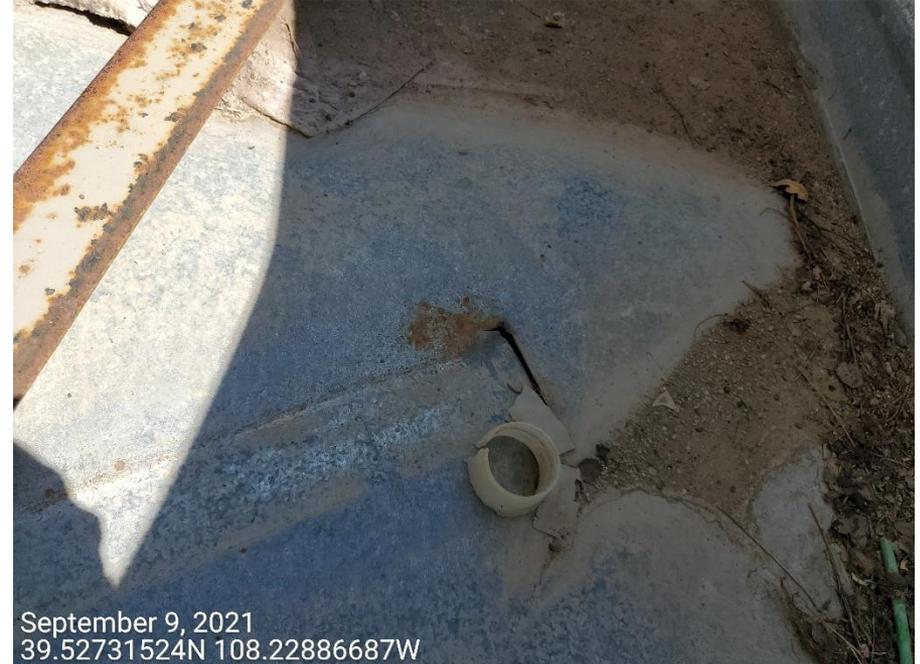
Photo 8: Photo taken from the containment BMP for the tank in left-photo 6. Photo shows multiple punctures observed at the base of the BMP.

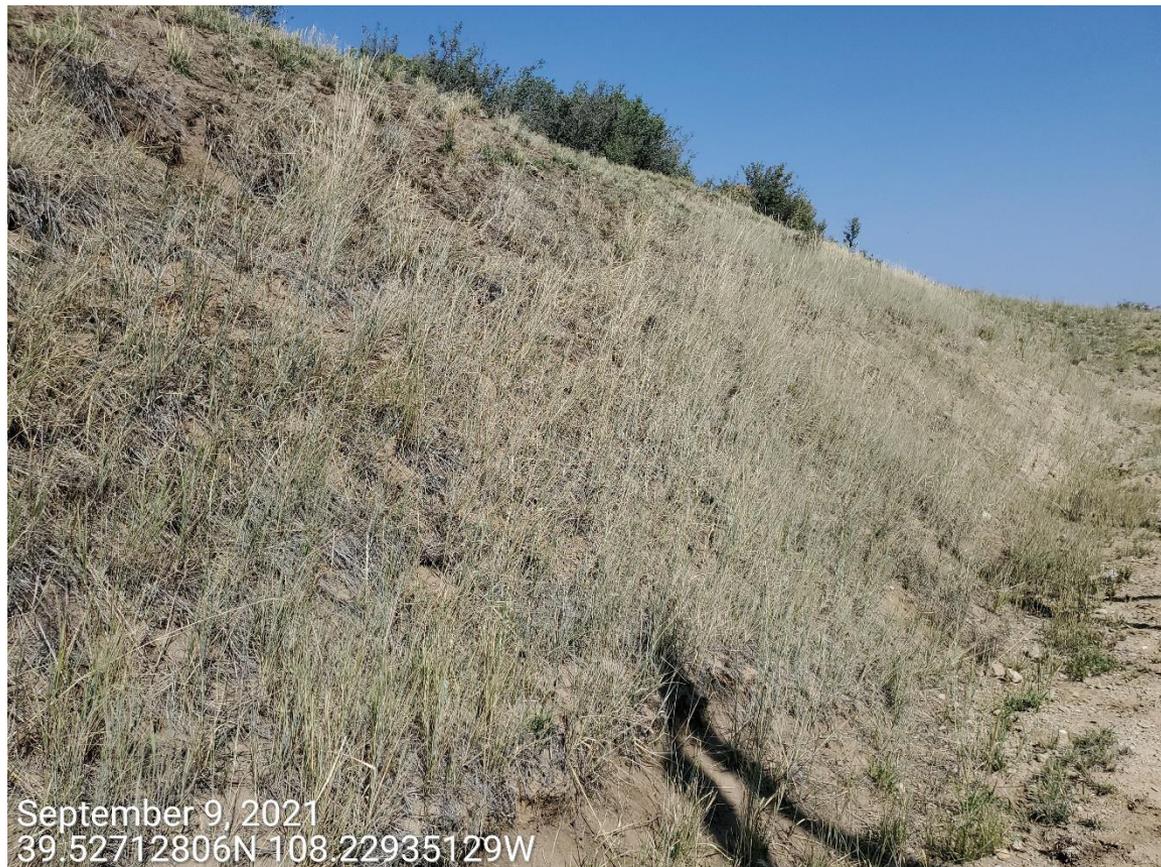
Photo 9: Photo taken from the interim areas on the north end of the Location. Vegetation appears to be progressing towards 1003 standards.
