# Inspection Photos

9/09/2021

Operator: LARAMIE ENERGY LLC # 10433

Location ID: 324288

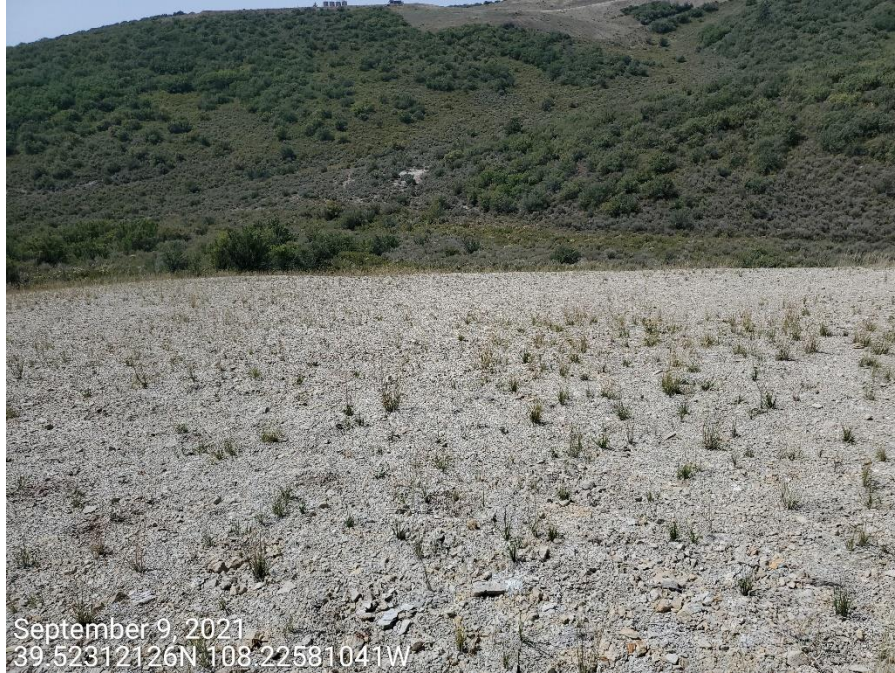
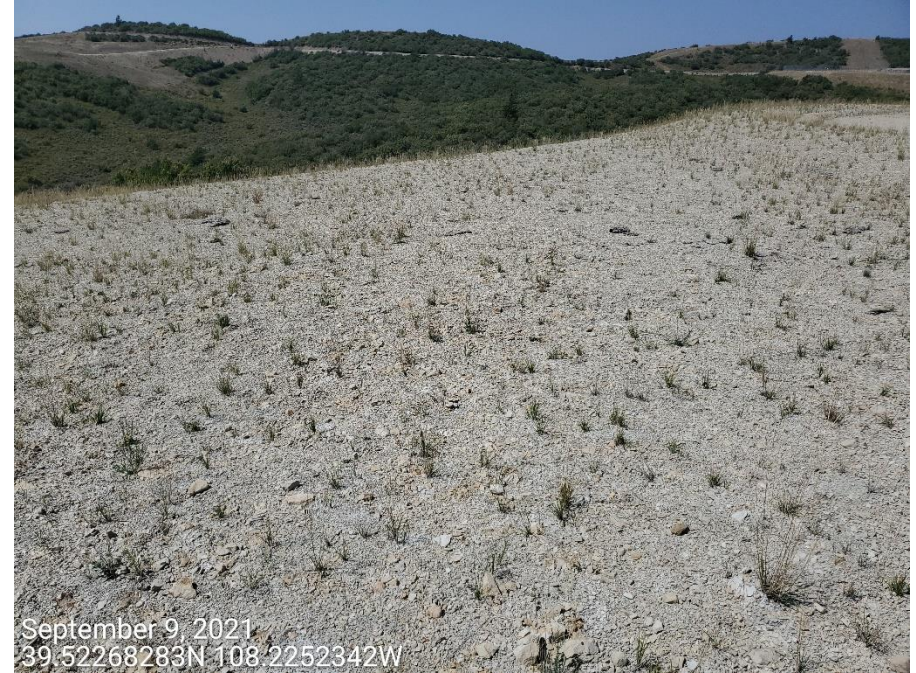
**Photo 1:** Photos show example of the interim areas of the Locaiton. At least 4 growing seasons have passed since interim work was performed. Photos show reclamation is not progressing towards an 80% uniform, desirable perennial vegetative establishment to that of the reference are. Photo also shows soils on the interim areas are subsoils; topsoil has not been placed onto the majority of interim areas.

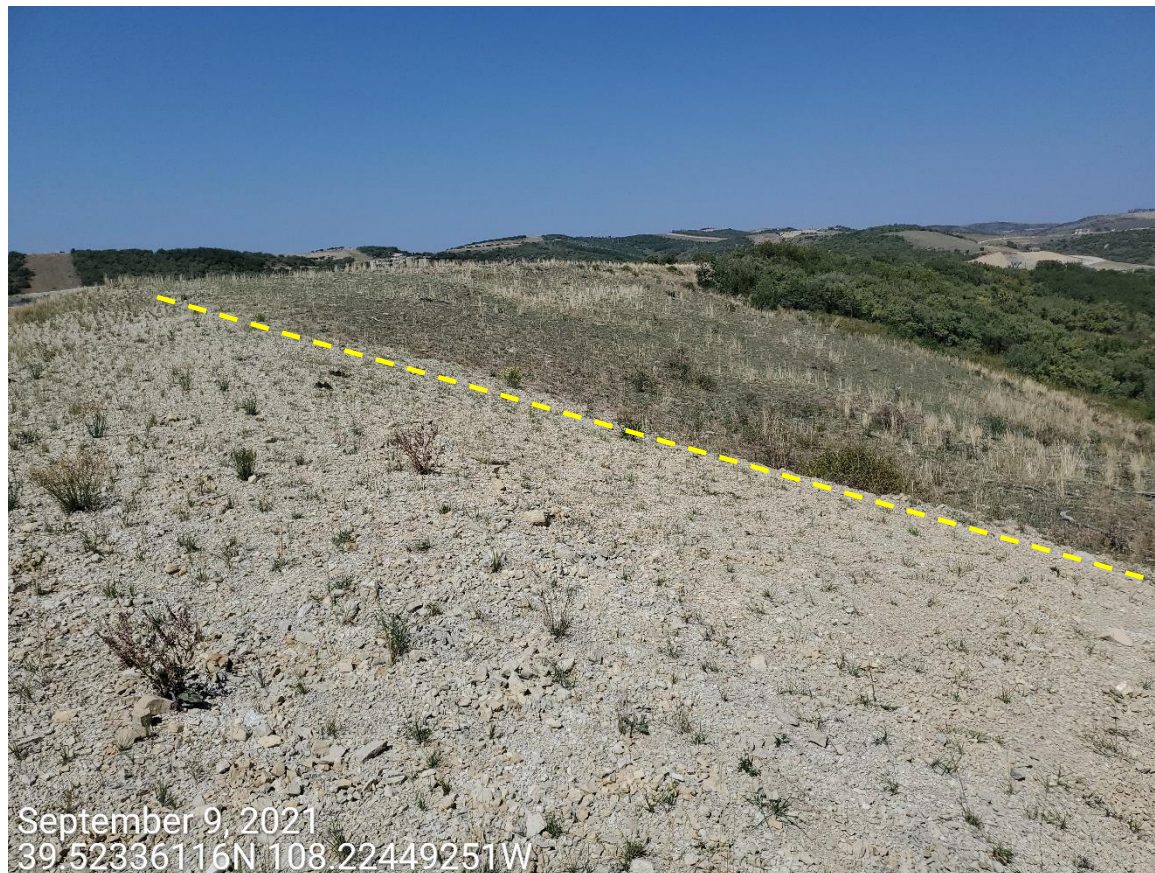
**Photo 2:** Photo taken from the interim areas on the northeast end of the Location. Photo shows interim areas in the foreground where topsoil was not replaced, and interim areas in the background where topsoil was replaced.

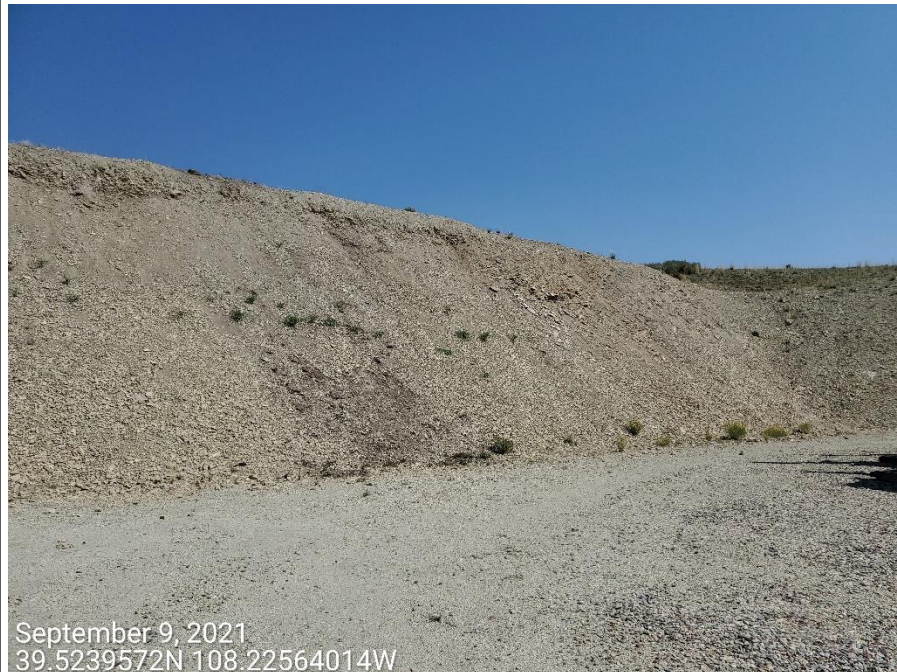
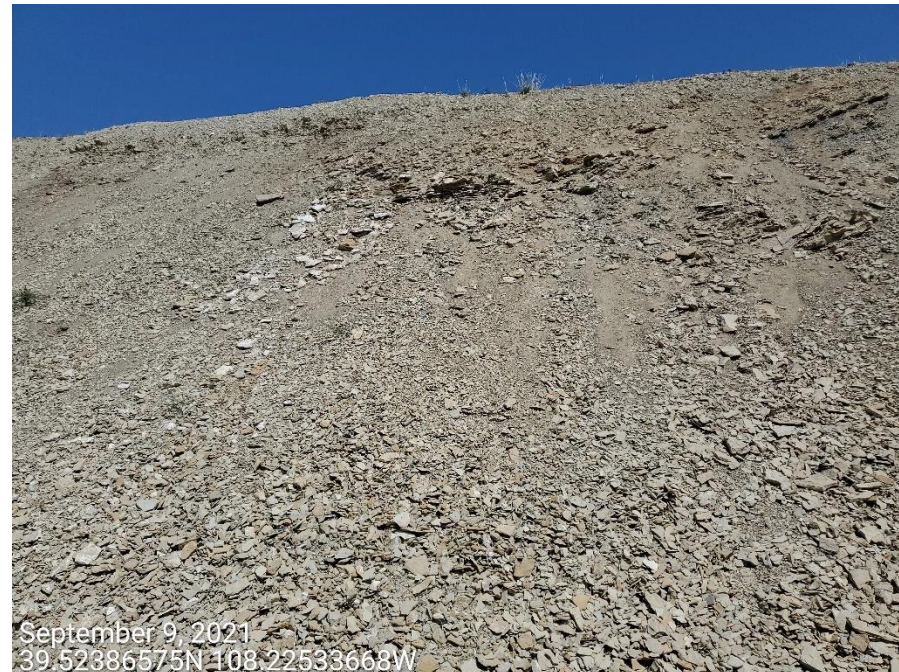
**Photo 3:** Photos shows example of the cut slopes, where BMPs to protect and stabilize the slopes are missing or insufficient on the Location.

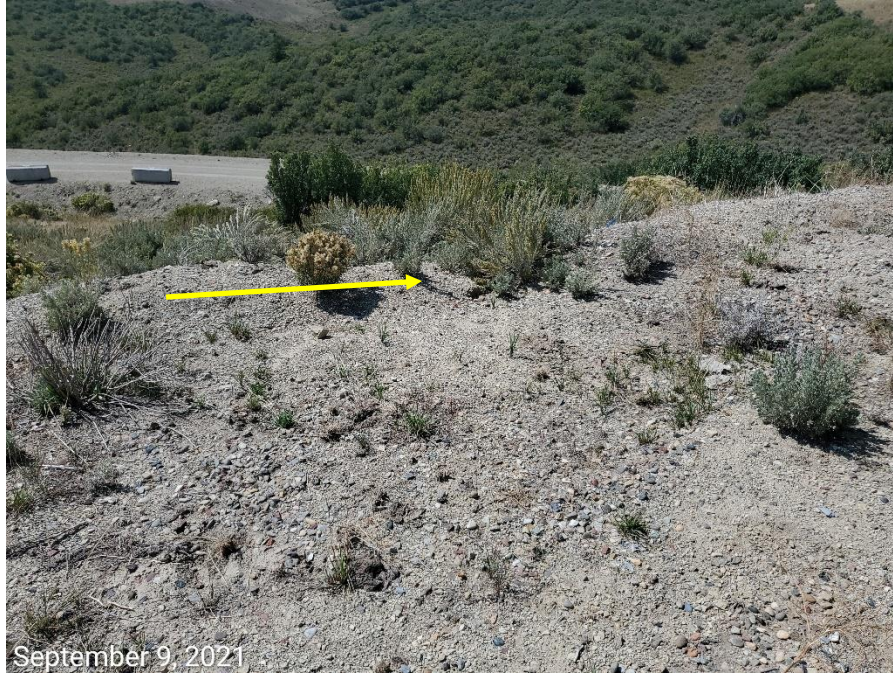
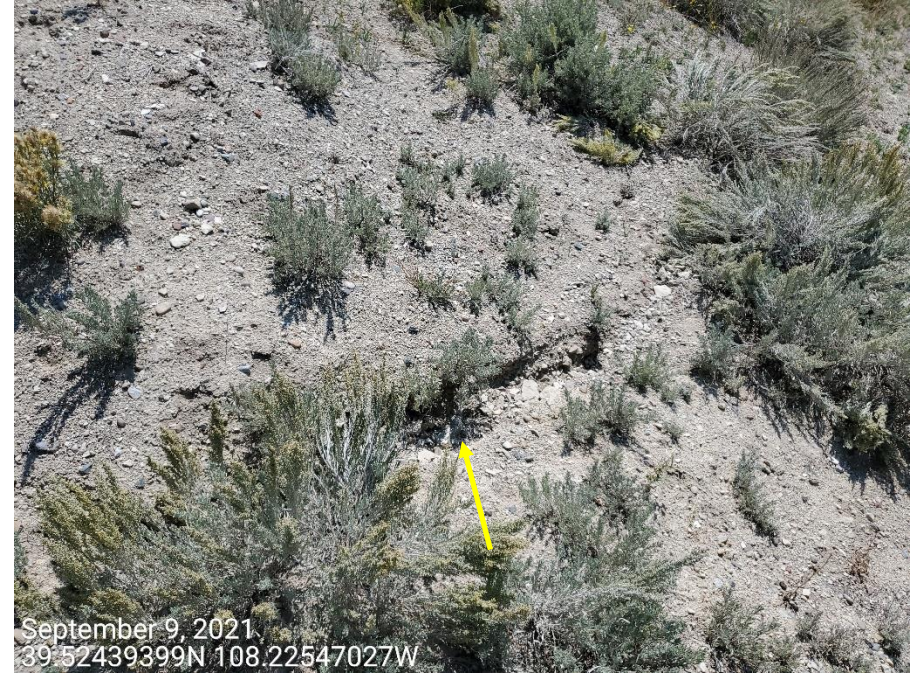
**Photo 4:** Photos shows erosion degradation due to runoff observed to the west of the tank battery.

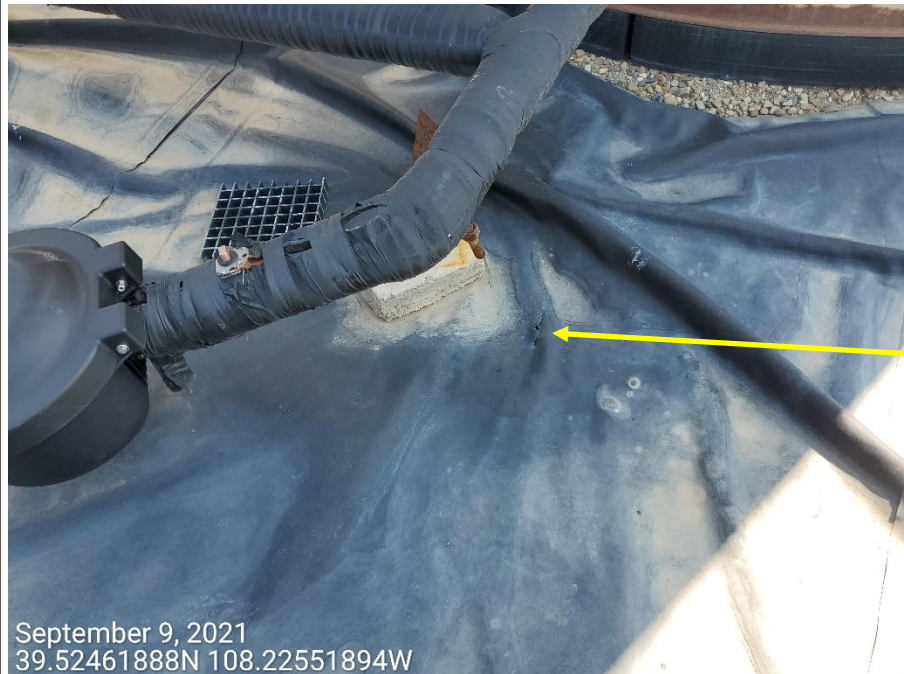
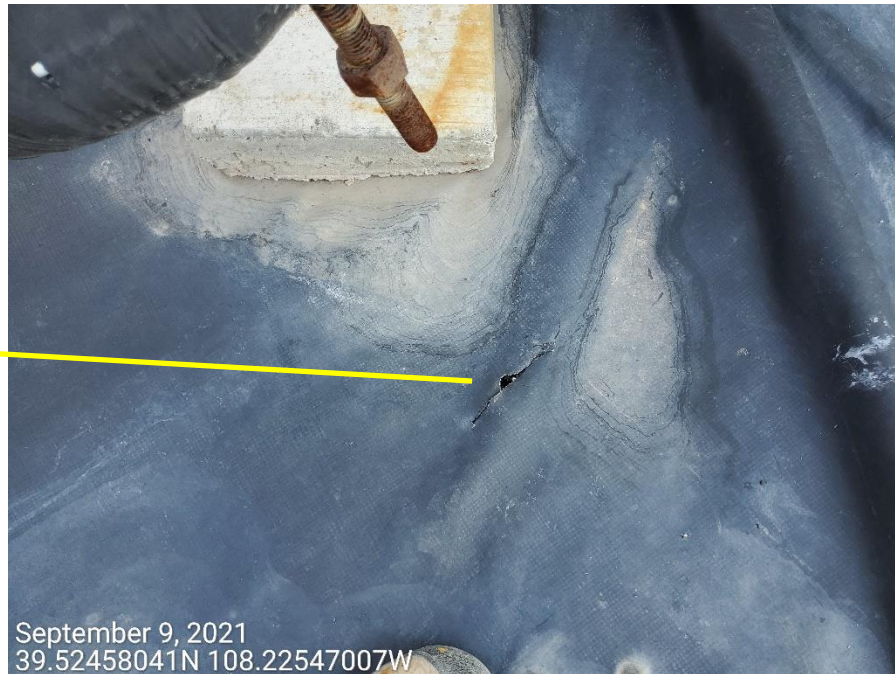
**Photo 5:** Photos show tear observed in the liner on the north side of the tank battery

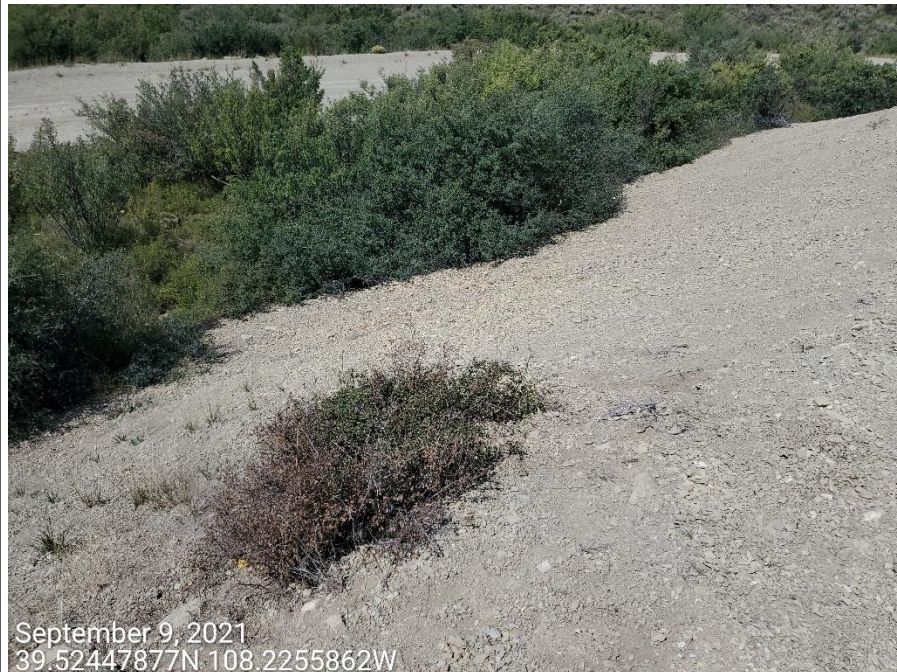
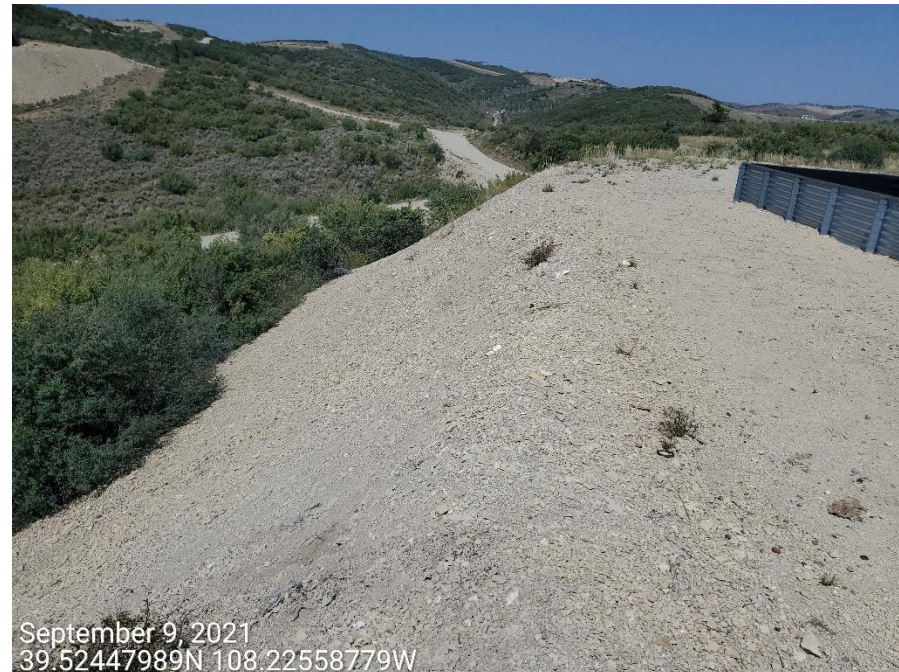
**Photo 6:** Photos shows control measures are missing or insufficient to protect and stabilize the fill slopes, and manage runoff on the northwest end of the Location.
