Inspection Photos
Operator: Enduring
API: 067-07914
Date: 9/9/2021

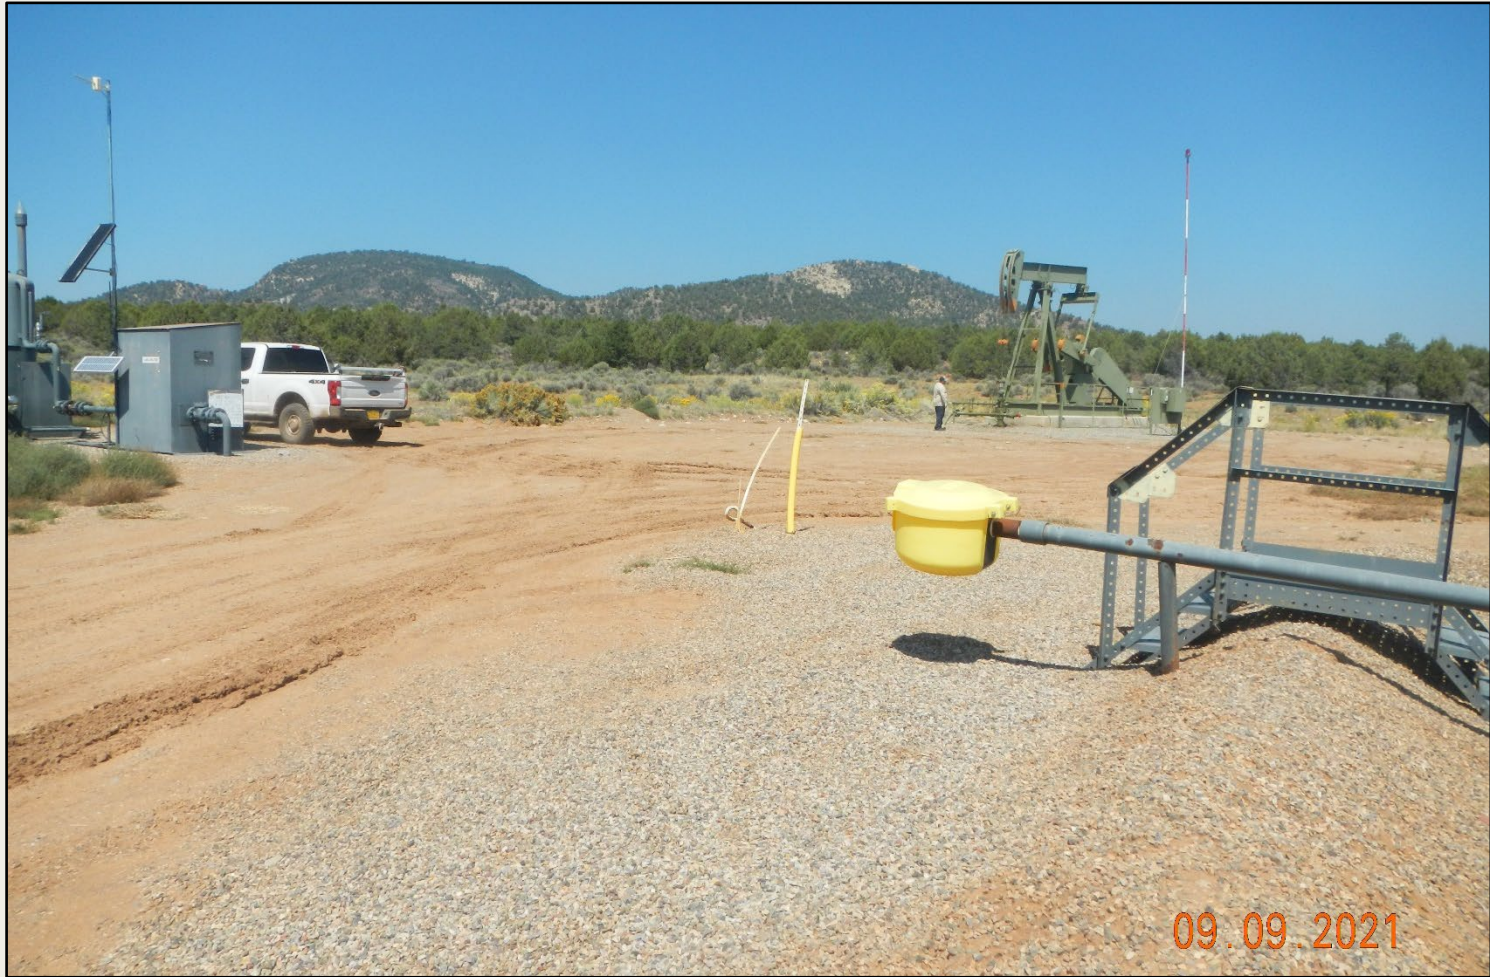
Photo 1. View of the project area from the southeastern corner facing center.

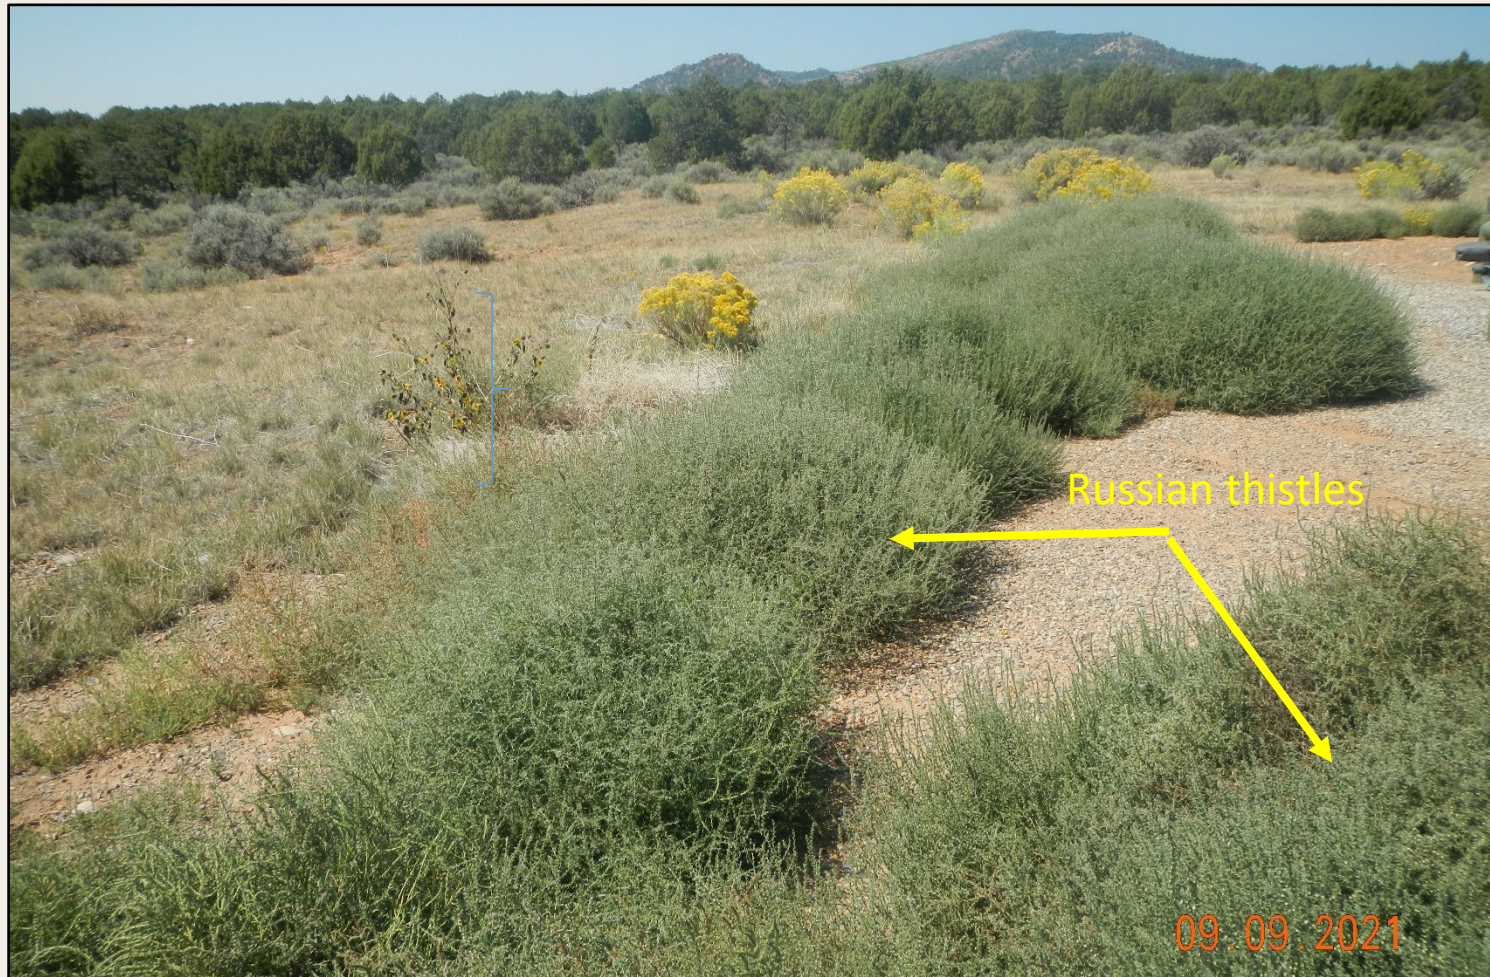
Photo 2. View of the southern project area from the southeastern corner facing westward. Revegetation is progressing with western wheatgrass, rubber rabbitbrush, and crested wheatgrass. Dense Russian thistles observed on the edges of the working area.

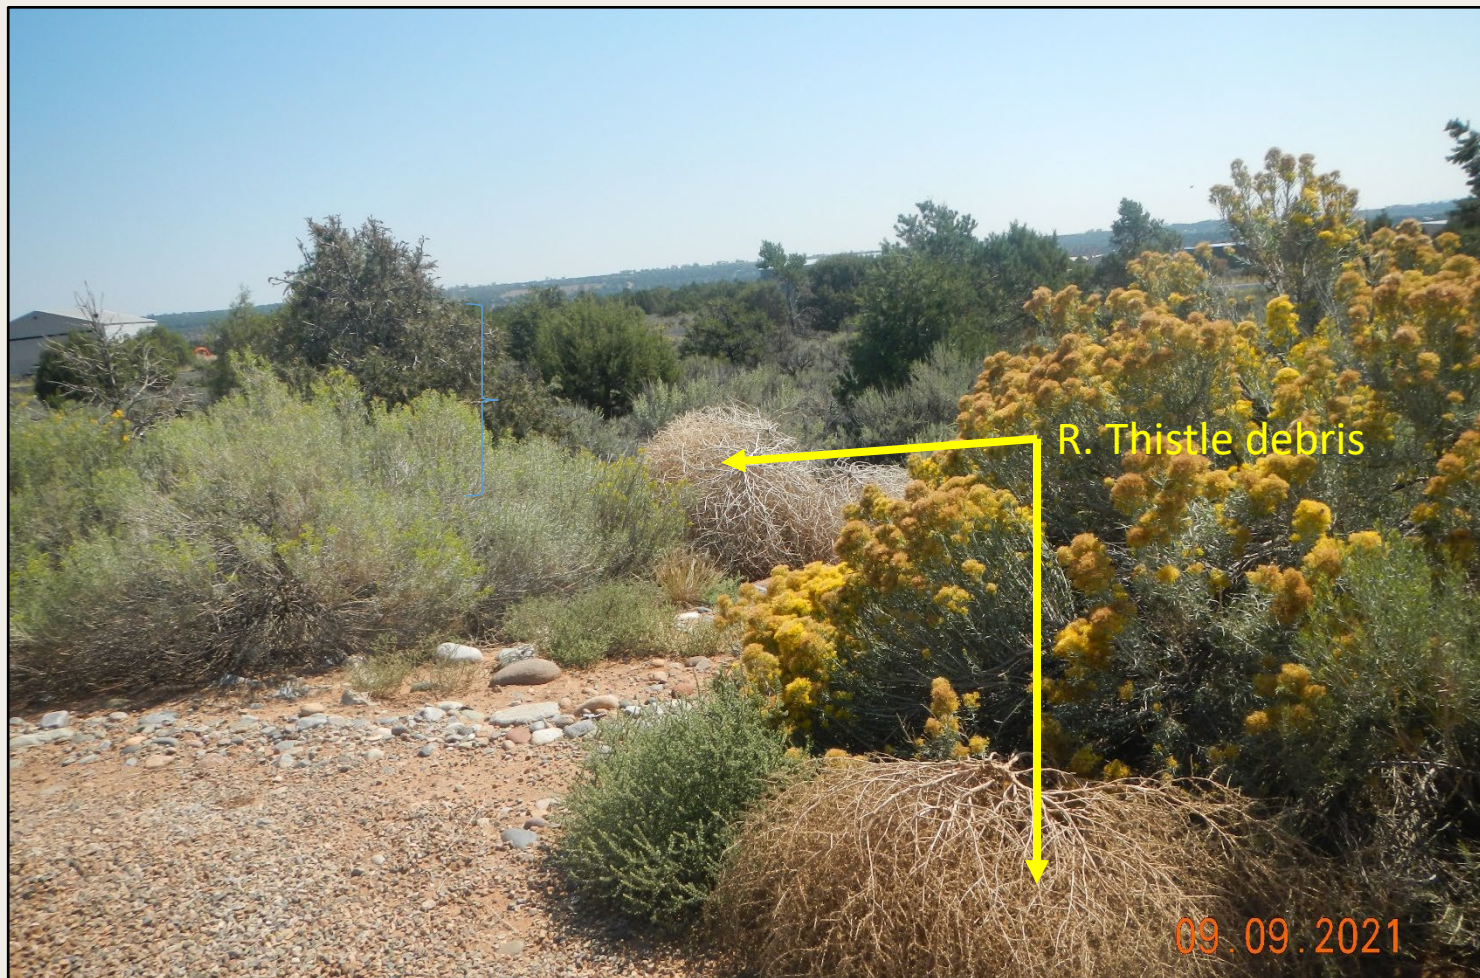
Photo 3. View of Russian thistle debris within the southeastern project area.

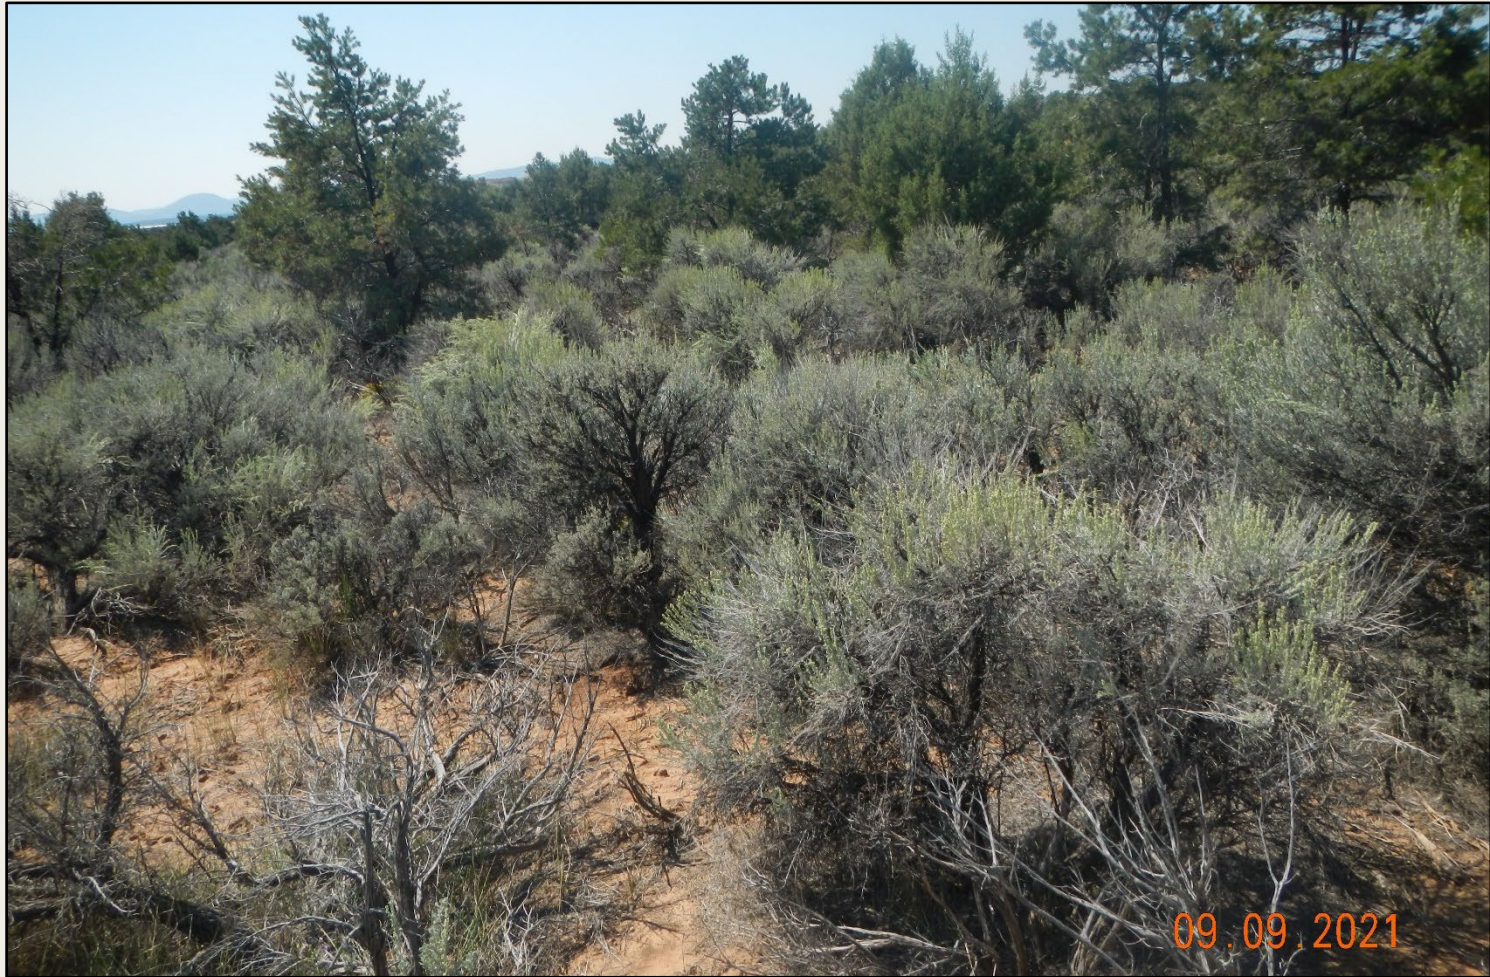
Photo 4. View of reference area comprised of sagebrush shrubland and pinyon/juniper woodland with understory of blue grama, western wheatgrass, snakeweed, and prickly pear.
