Inspection Photos  
Operator: Enduring  
API: 067-06692  
Date: 9/9/2021

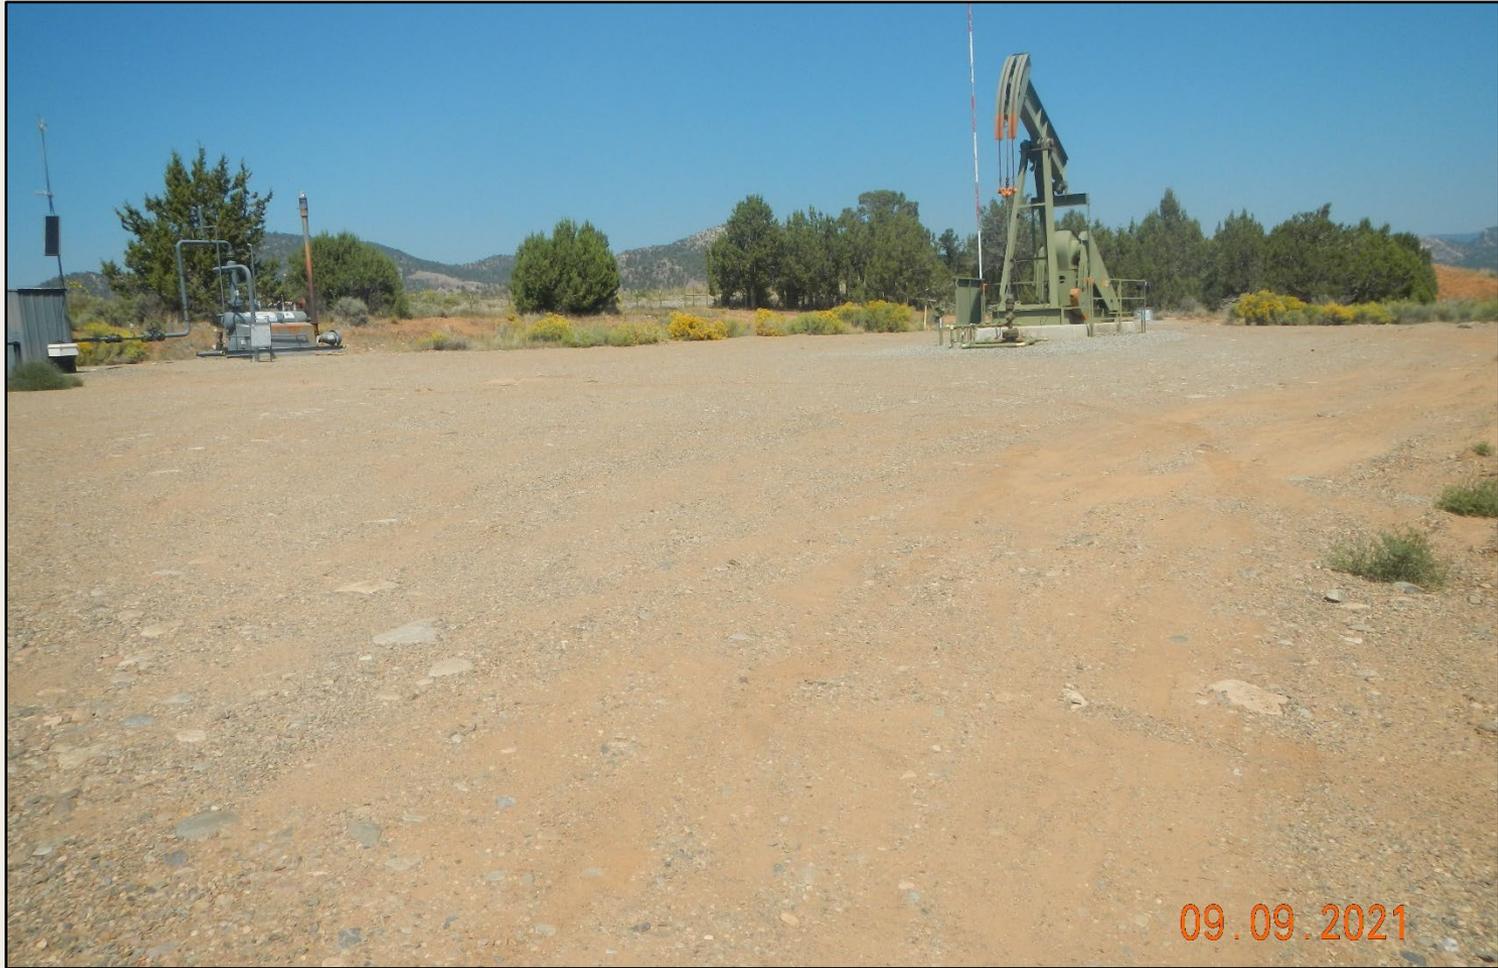
Photo 1. View of the project area from the well pad entrance facing center.

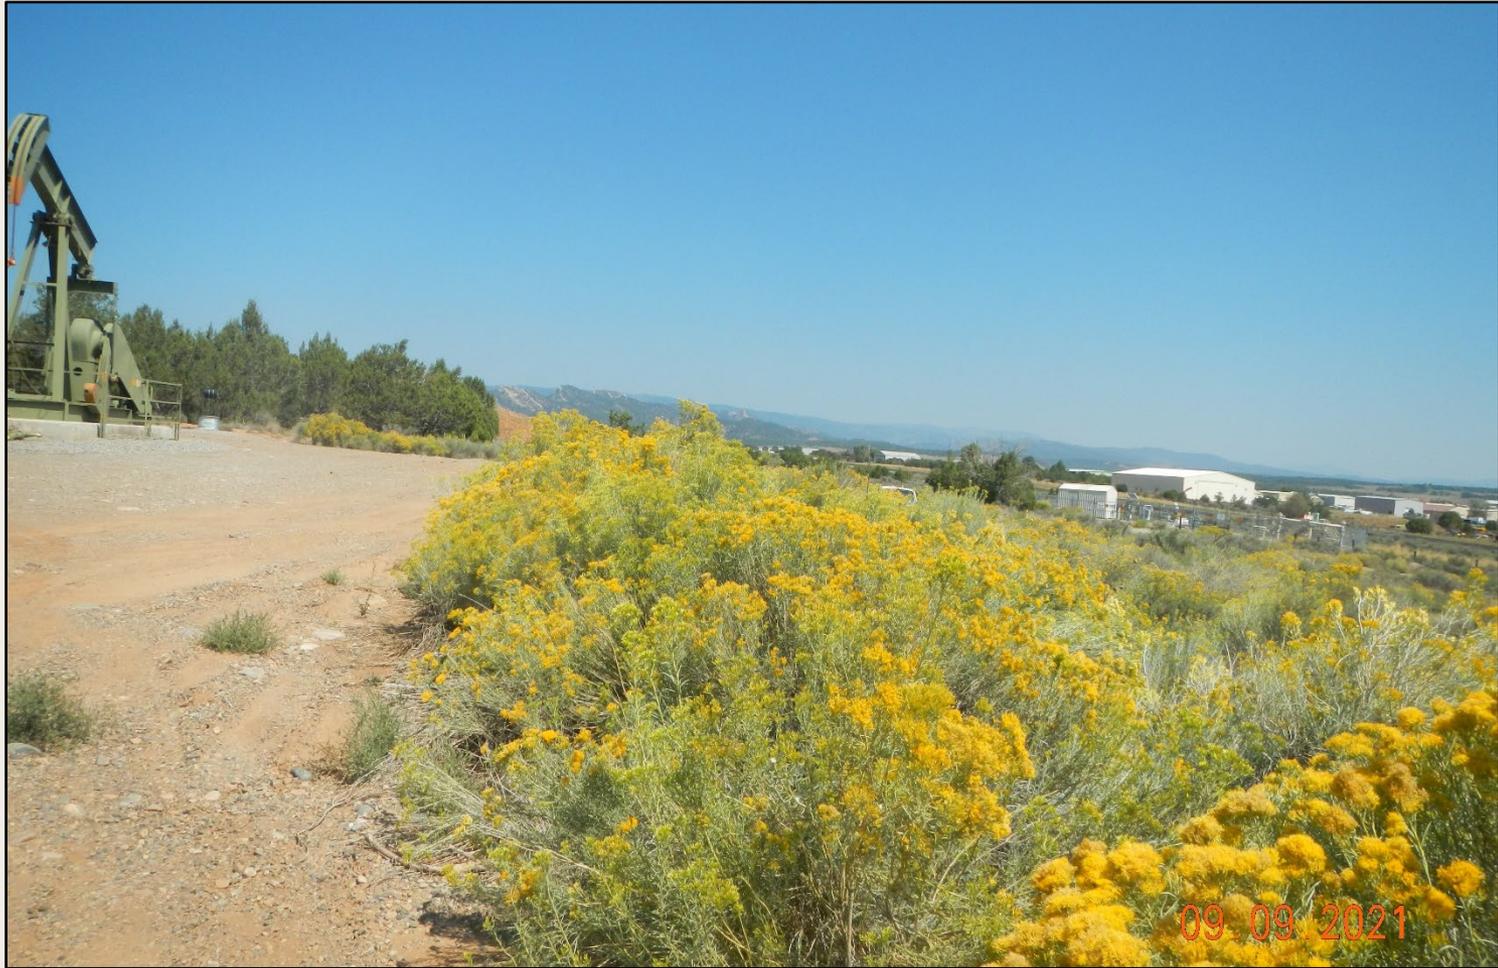
Photo 2. View of the eastern fill slope from the southeastern corner facing northward. Revegetation is progressing with western wheatgrass, rubber rabbitbrush, and smooth brome.

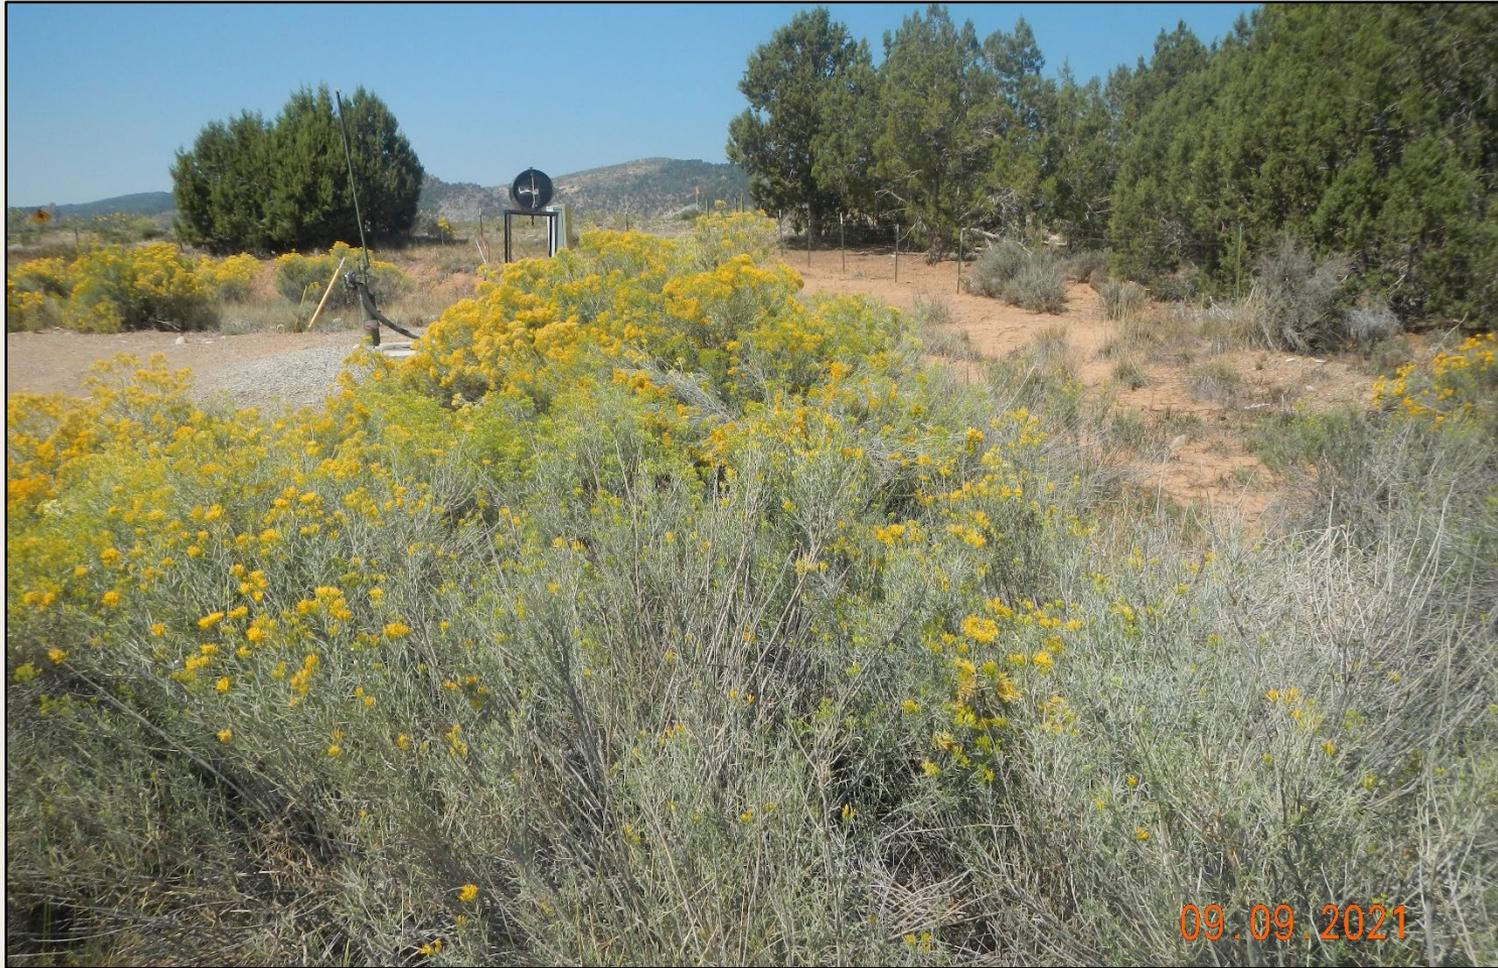
Photo 3. View of the northern project area from the northeastern corner facing westward.

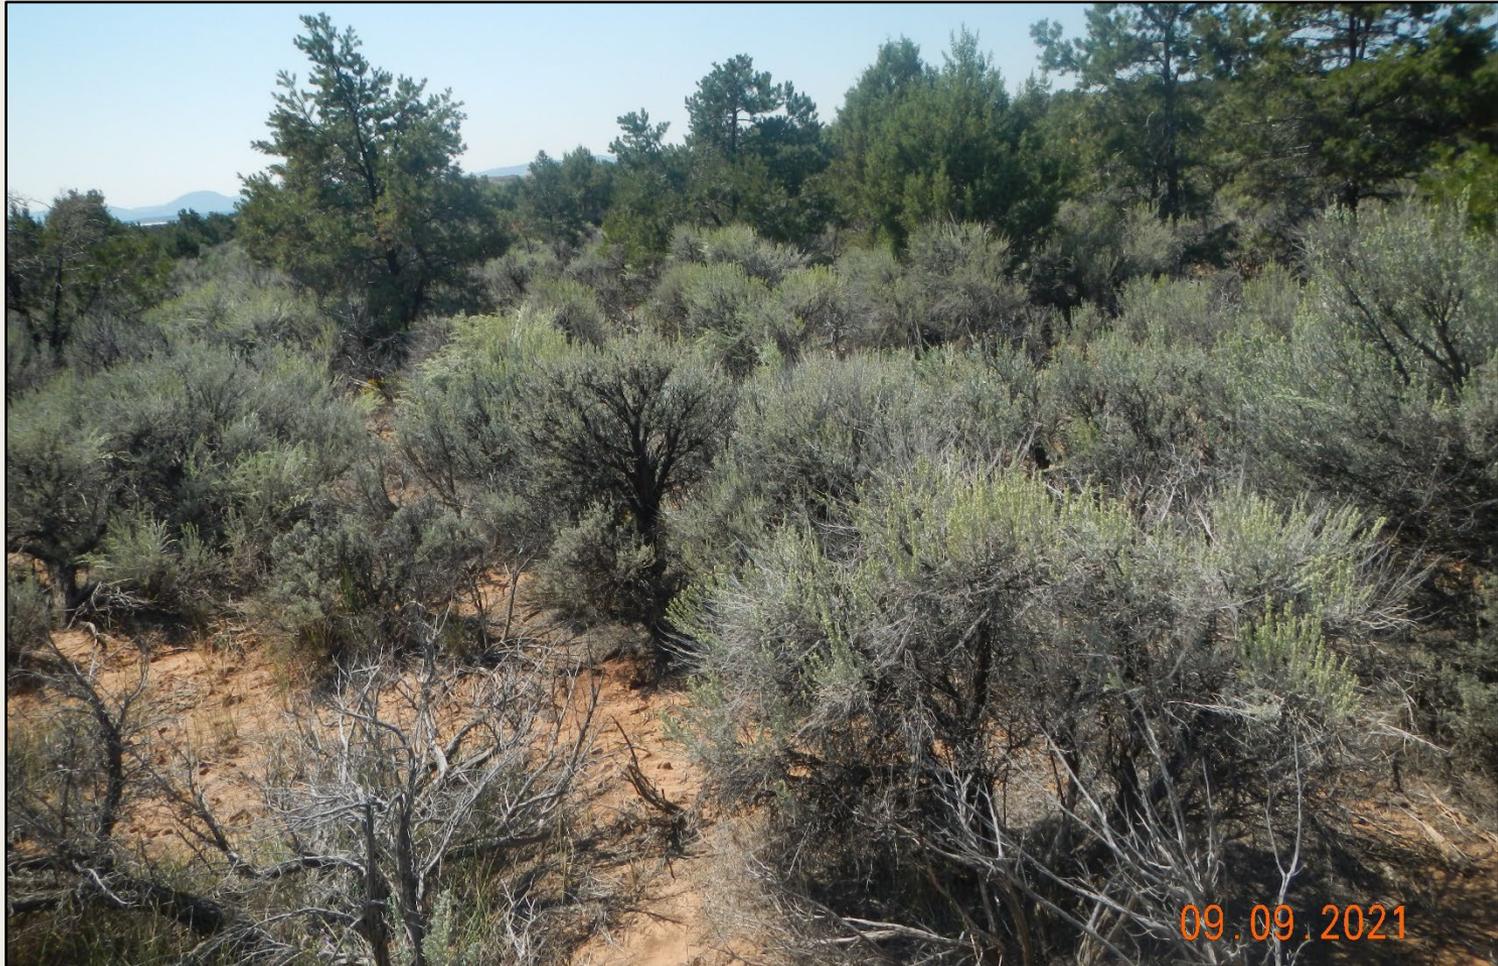
Photo 4. View of reference area comprised of sagebrush shrubland and pinyon/juniper woodland with understory of blue grama, western wheatgrass, snakeweed, and prickly pear.
