Inspection Photos  
Operator: Enduring  
API: 067-07650  
Date: 9/9/2021

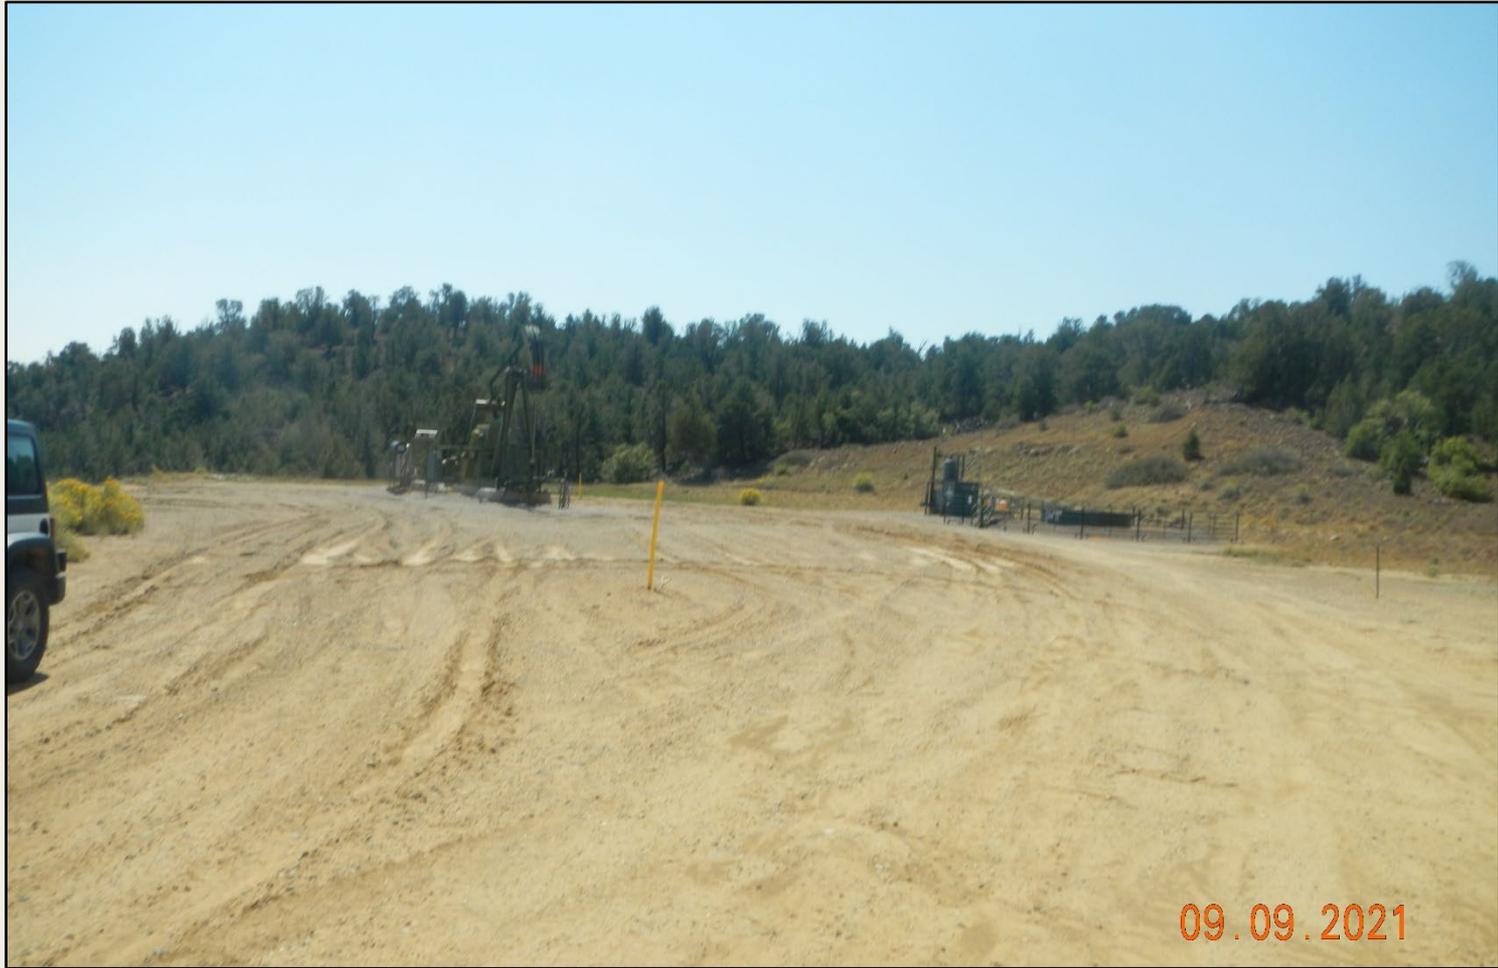
Photo 1. View of the project area from the well pad entrance facing center.

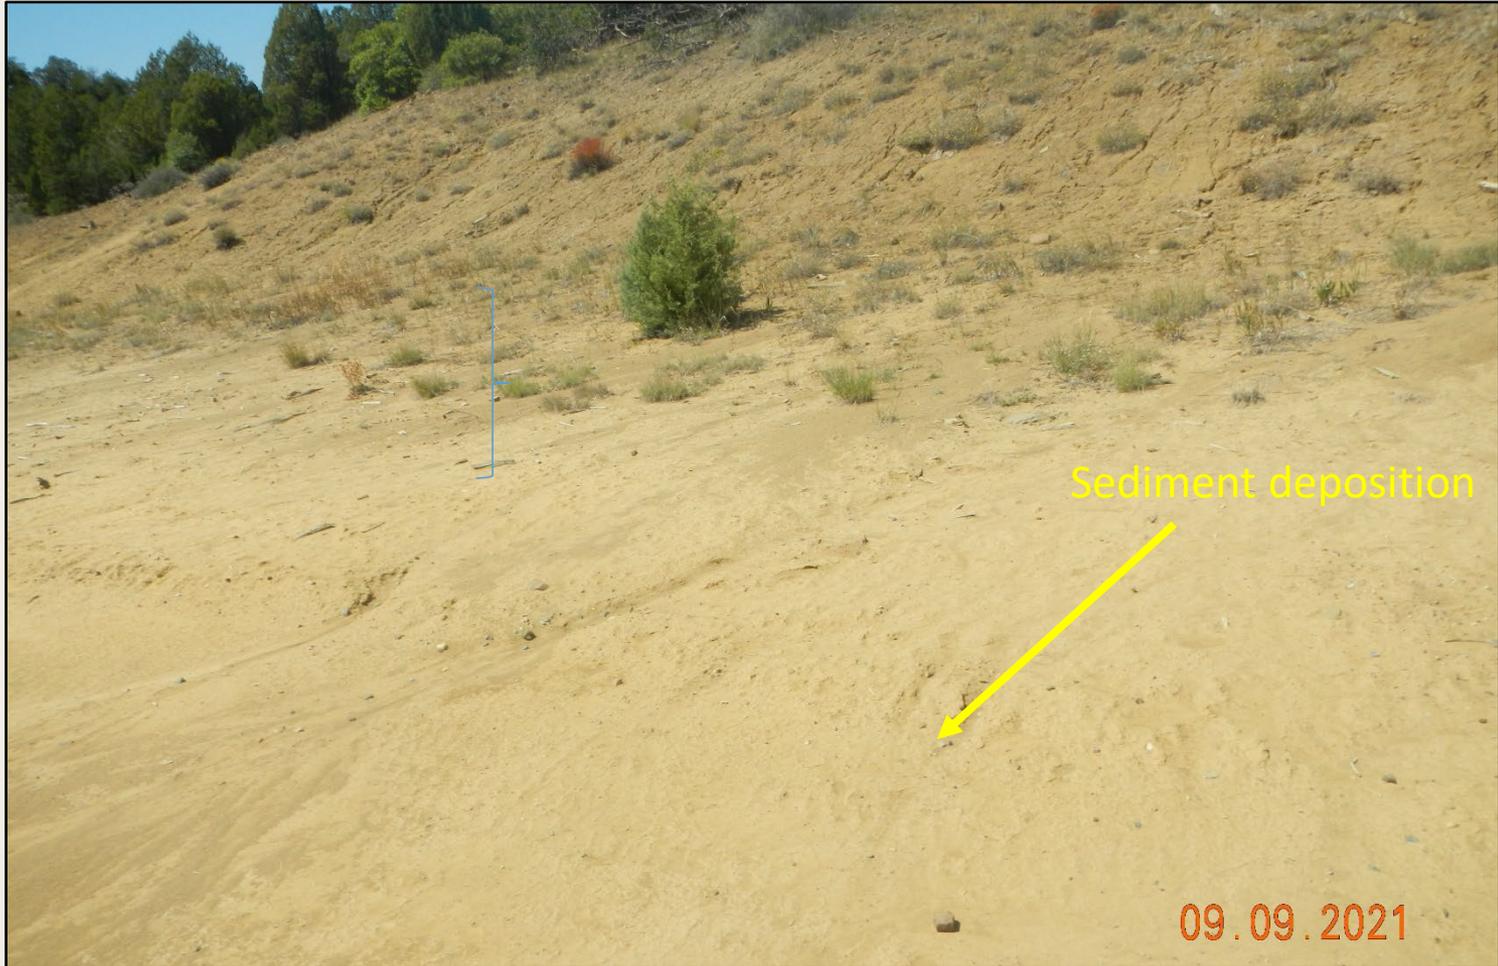
Photo 2. View of rilling and sediment deposition on northwestern well pad cut-slope.

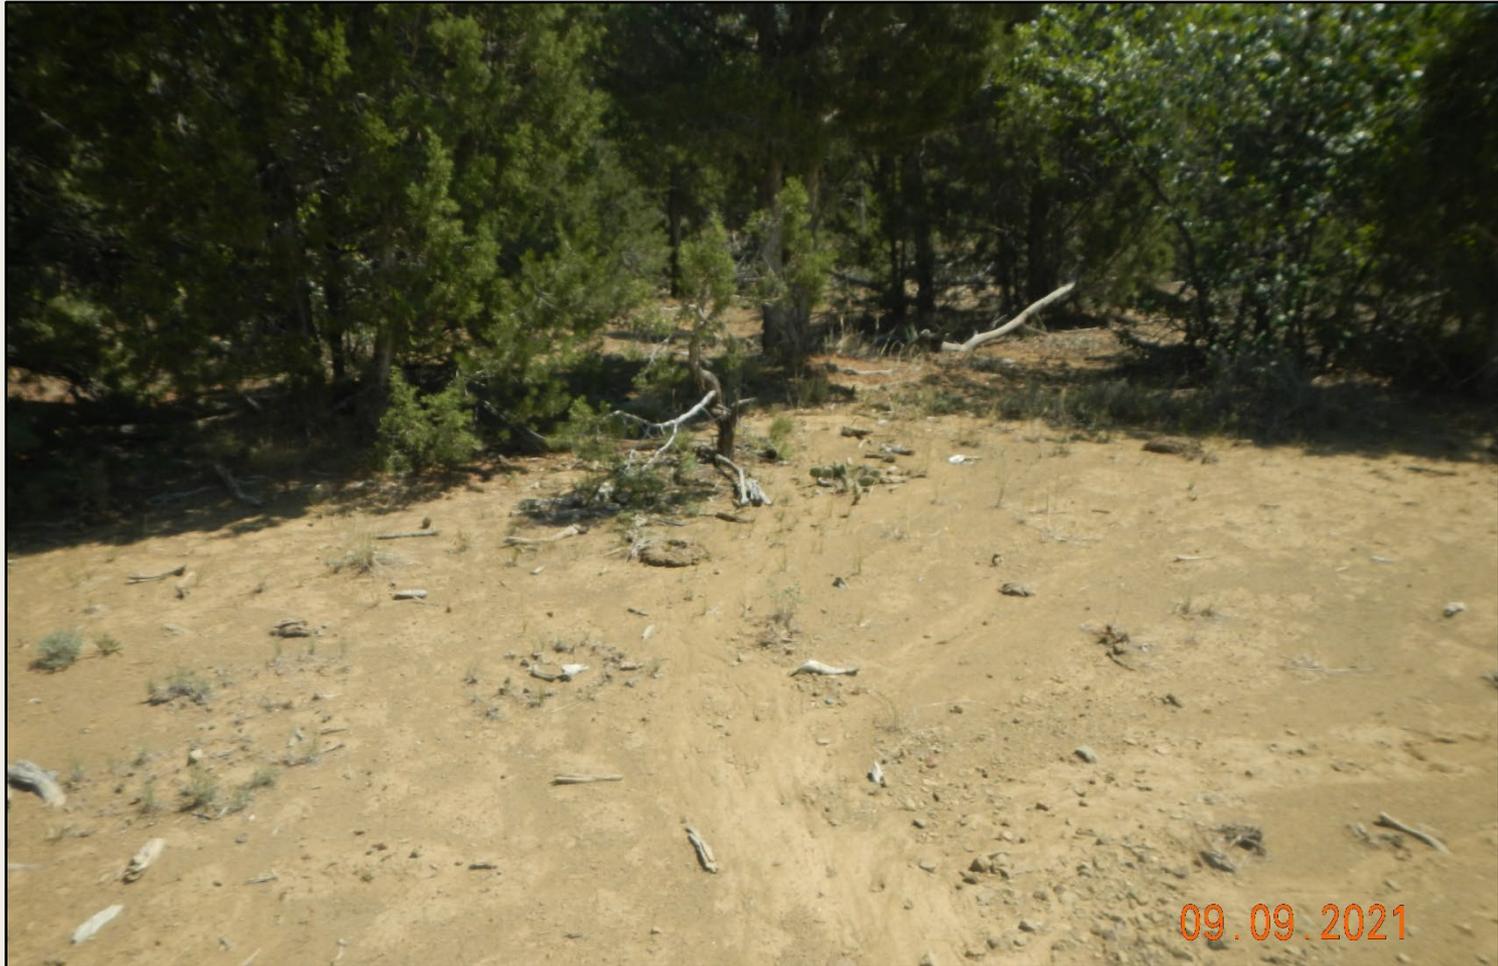
Photo 3. View of sediment deposition within the northeastern project area, and downslope from Photo 2. Sediment from the northwestern cut-slope is discharging from the edge of the project area here.

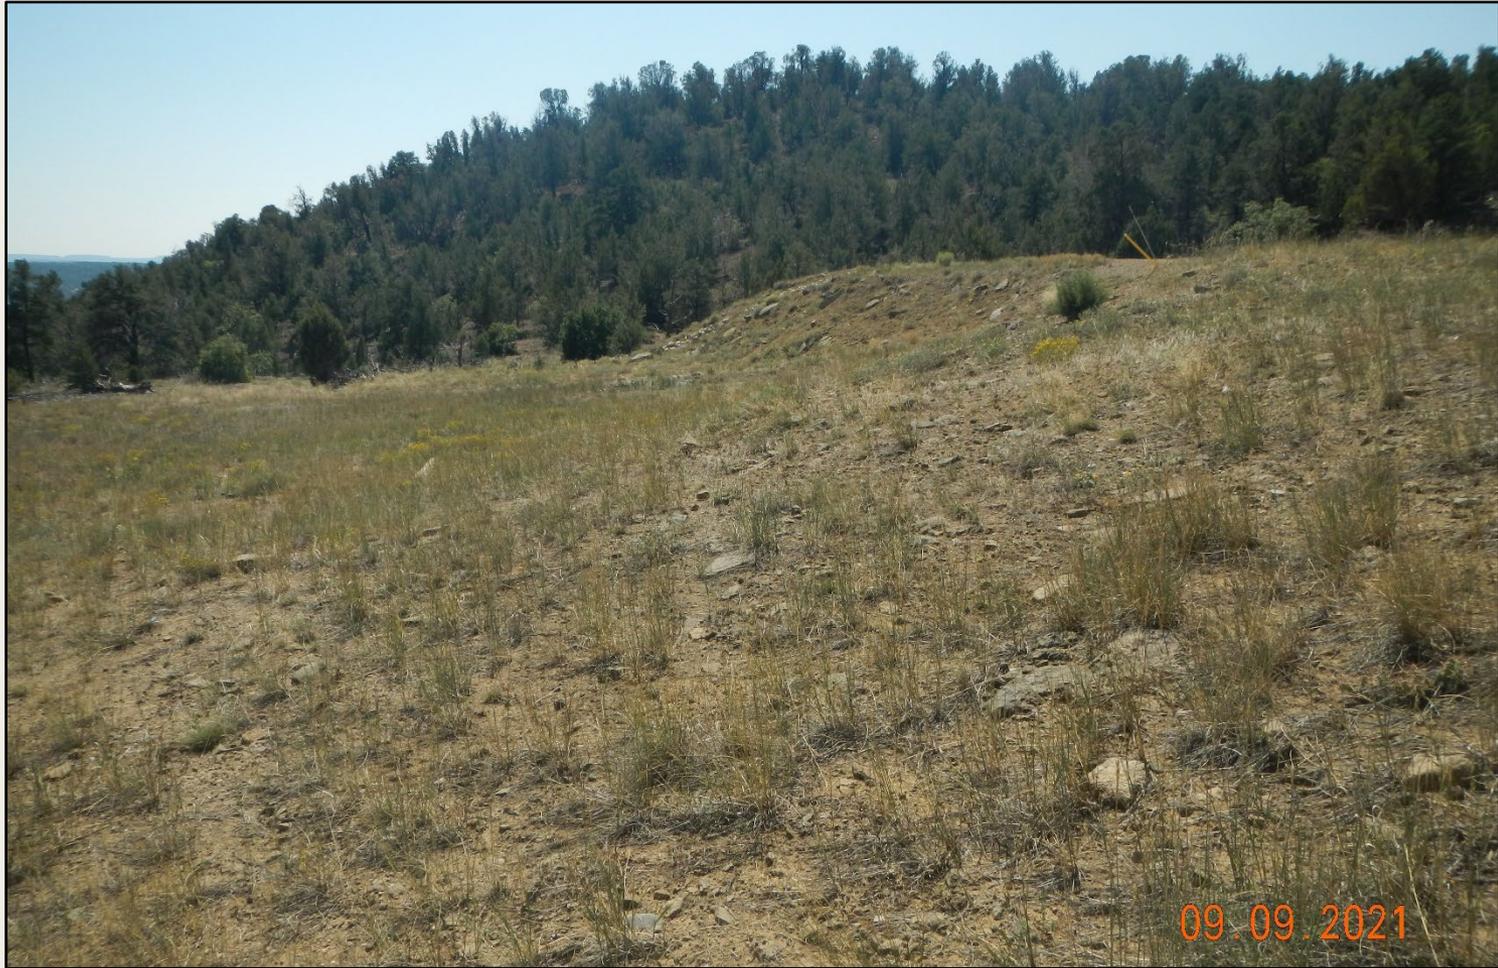
Photo 4. View of the eastern cut-slope from the northeastern corner facing southward.

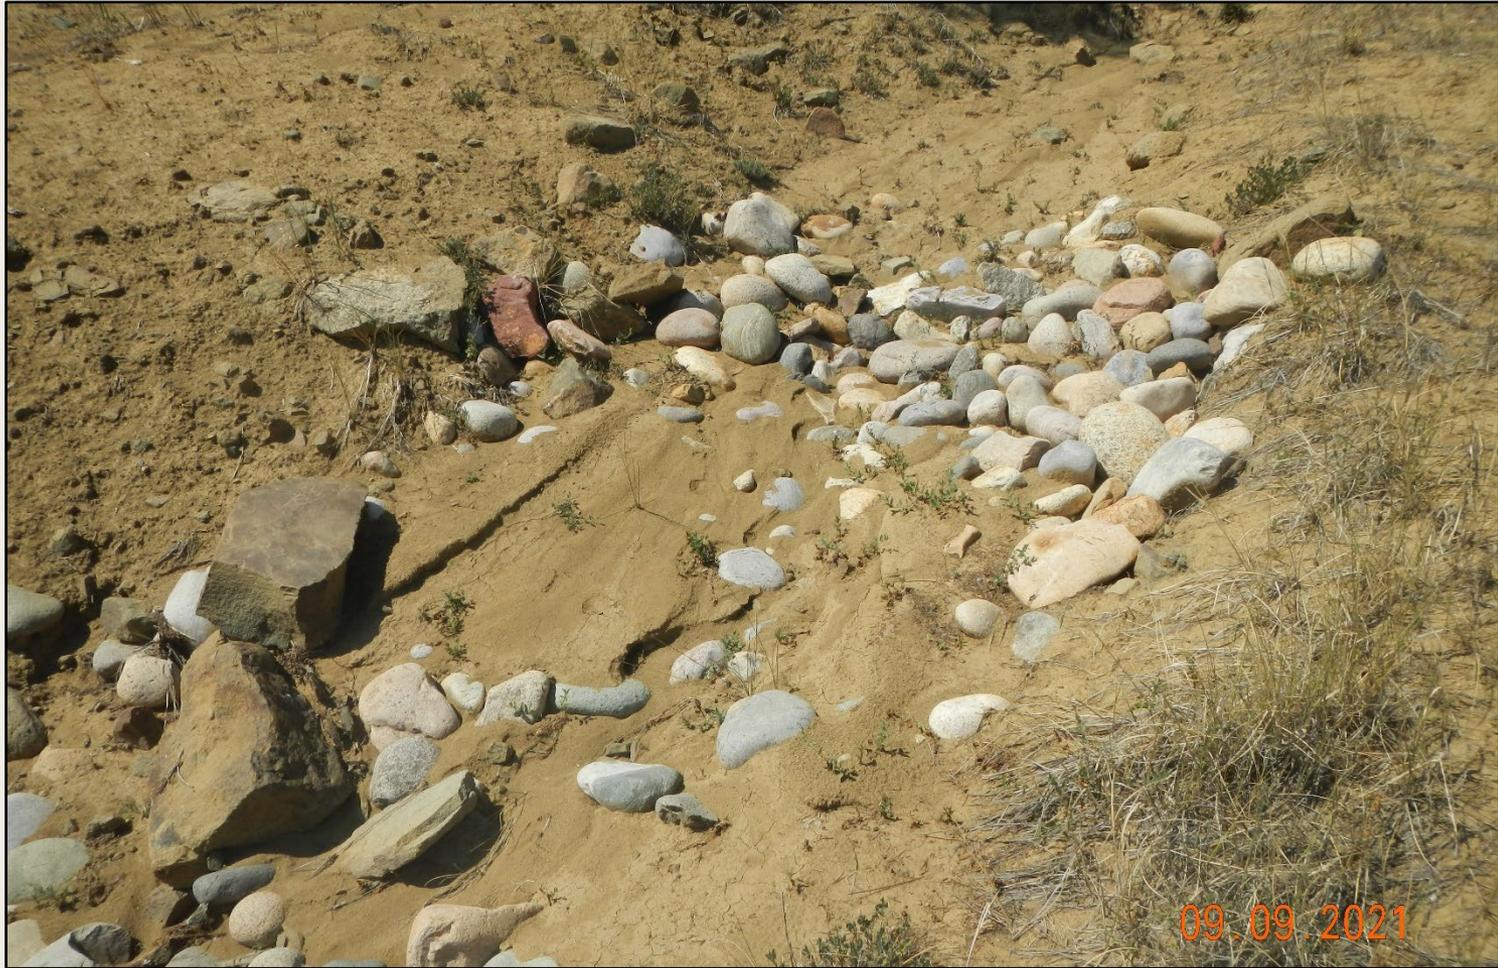
Photo 5. View of stormwater BMPs in the southeastern project area, that are full of sediment and eroding. BMPs do not appear adequate.

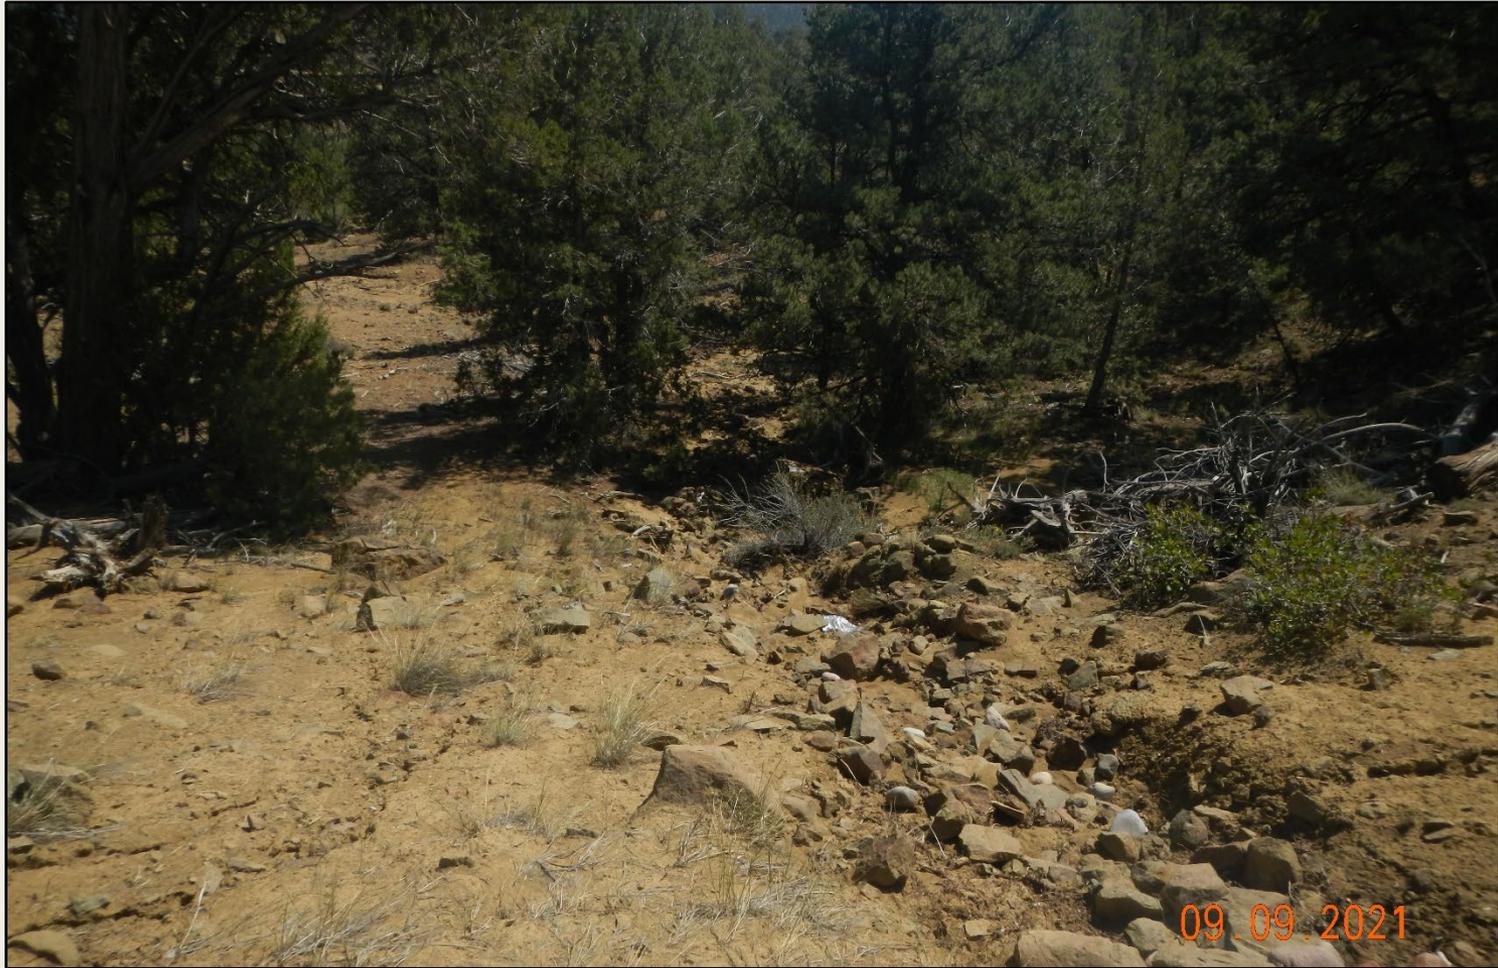
Photo 6. View of stormwater diversion down-slope from Photo 5, where significant scouring and erosion is occurring.

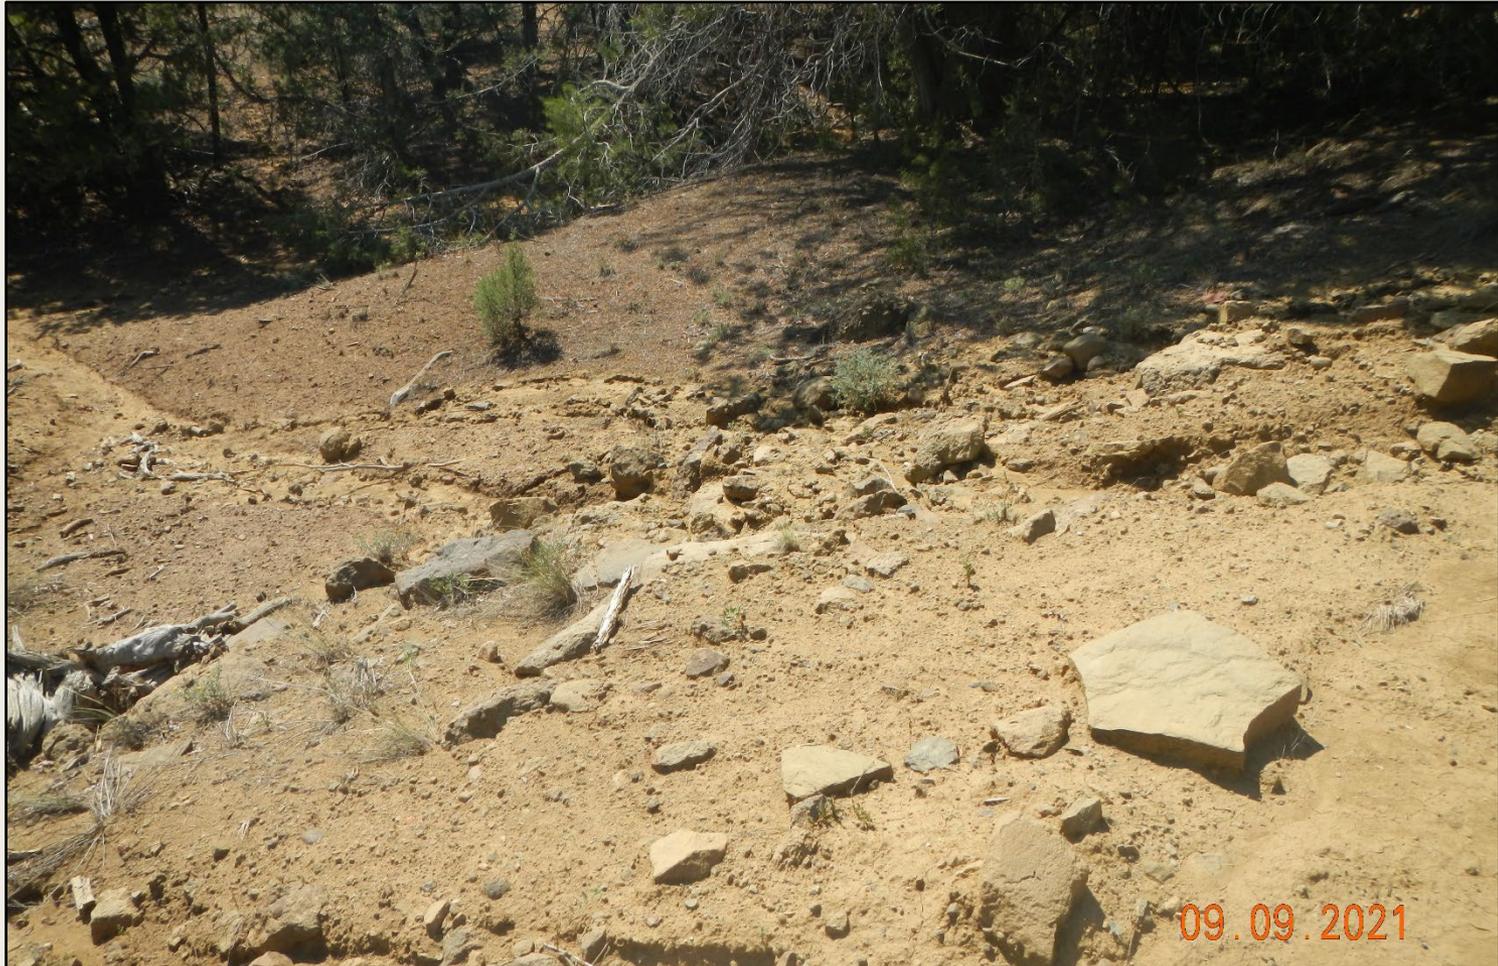
Photo 7. View of area (facing downslope) on the access road where stormwater flows are flowing down fill slope and eroding/carrying sediment offsite. Fill slope is not stabilized.

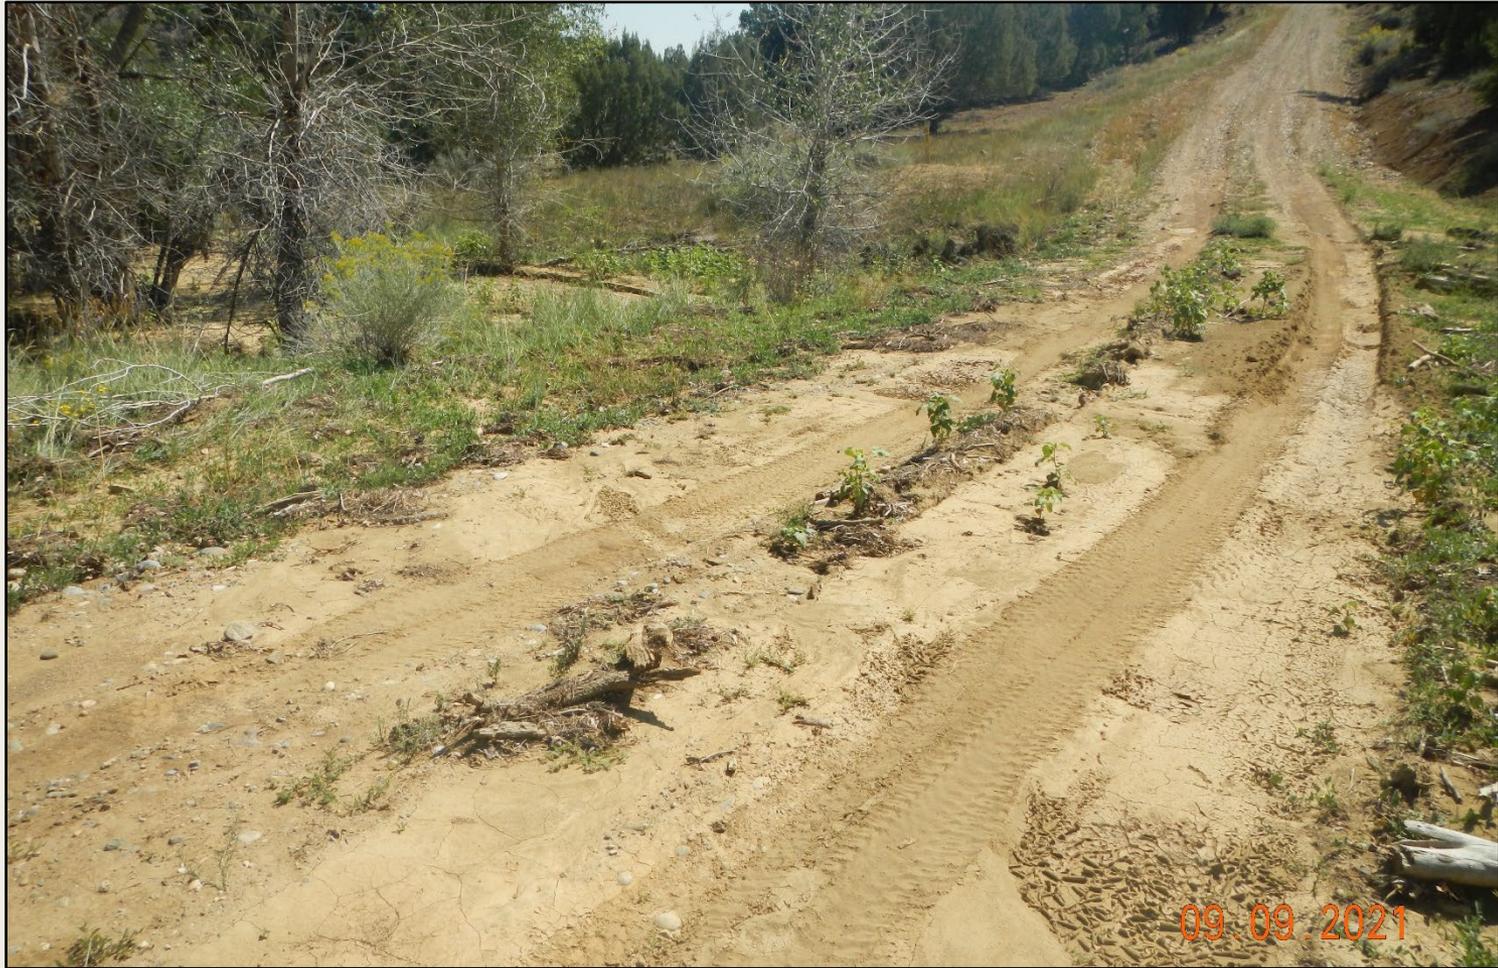
Photo 8. View of stream crossing along access road where stormwater flows are flowing over the crossing resulting in erosion and sediment discharge. Crossing is not properly designed to contain stormwater passage.

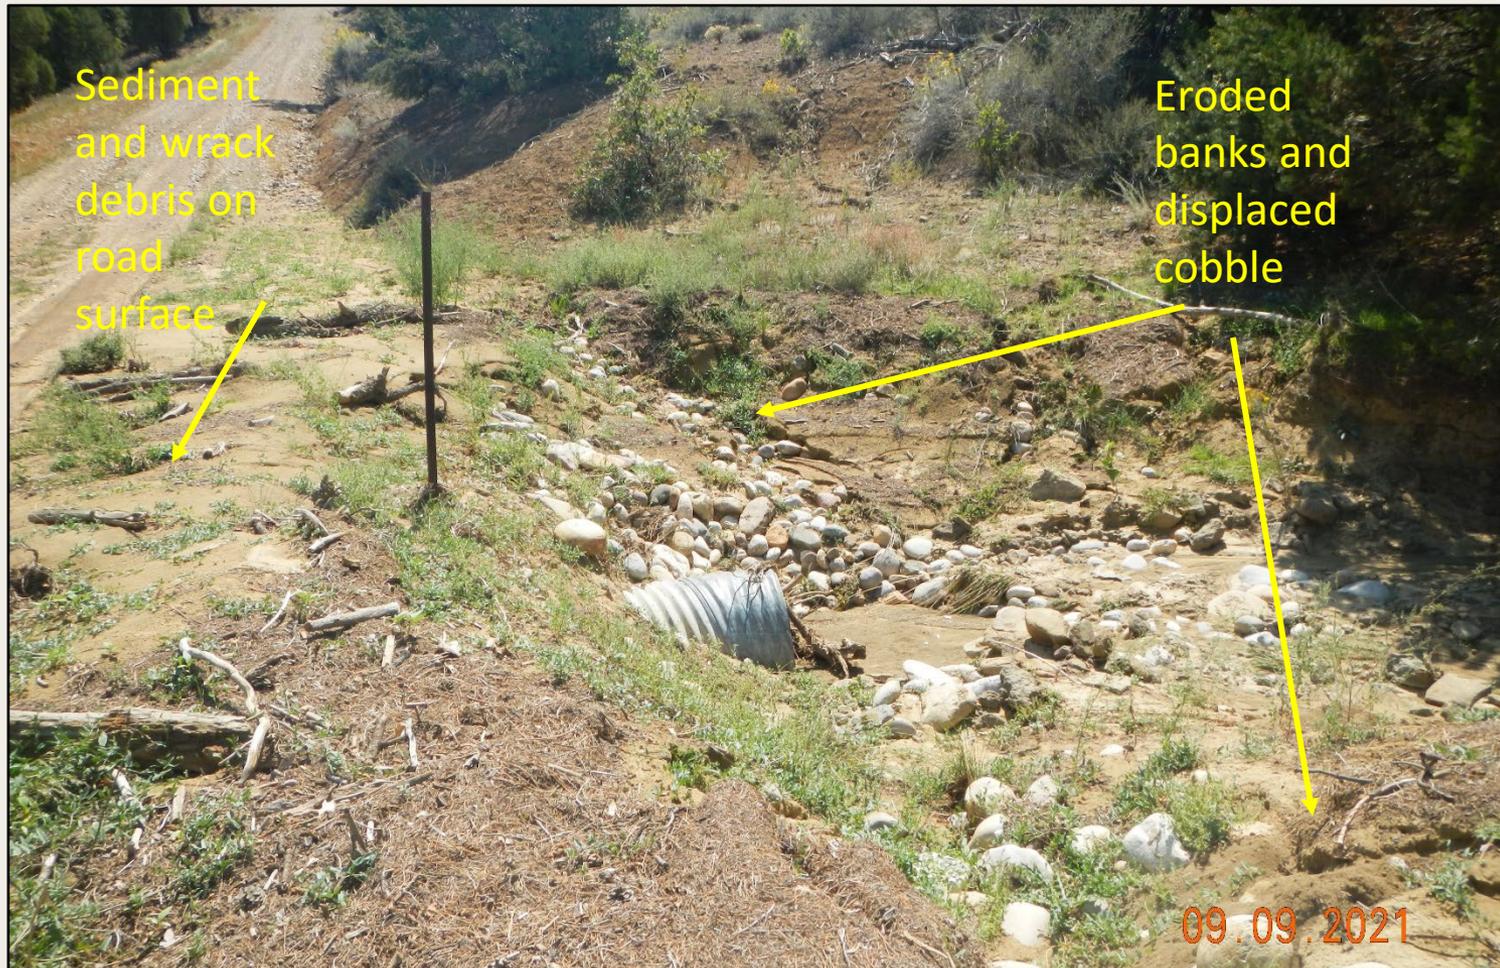
Photo 9. View of upstream side of culvert crossing where cobble is displaced, banks eroded, and sediment/wood wrack is settled on road surface.

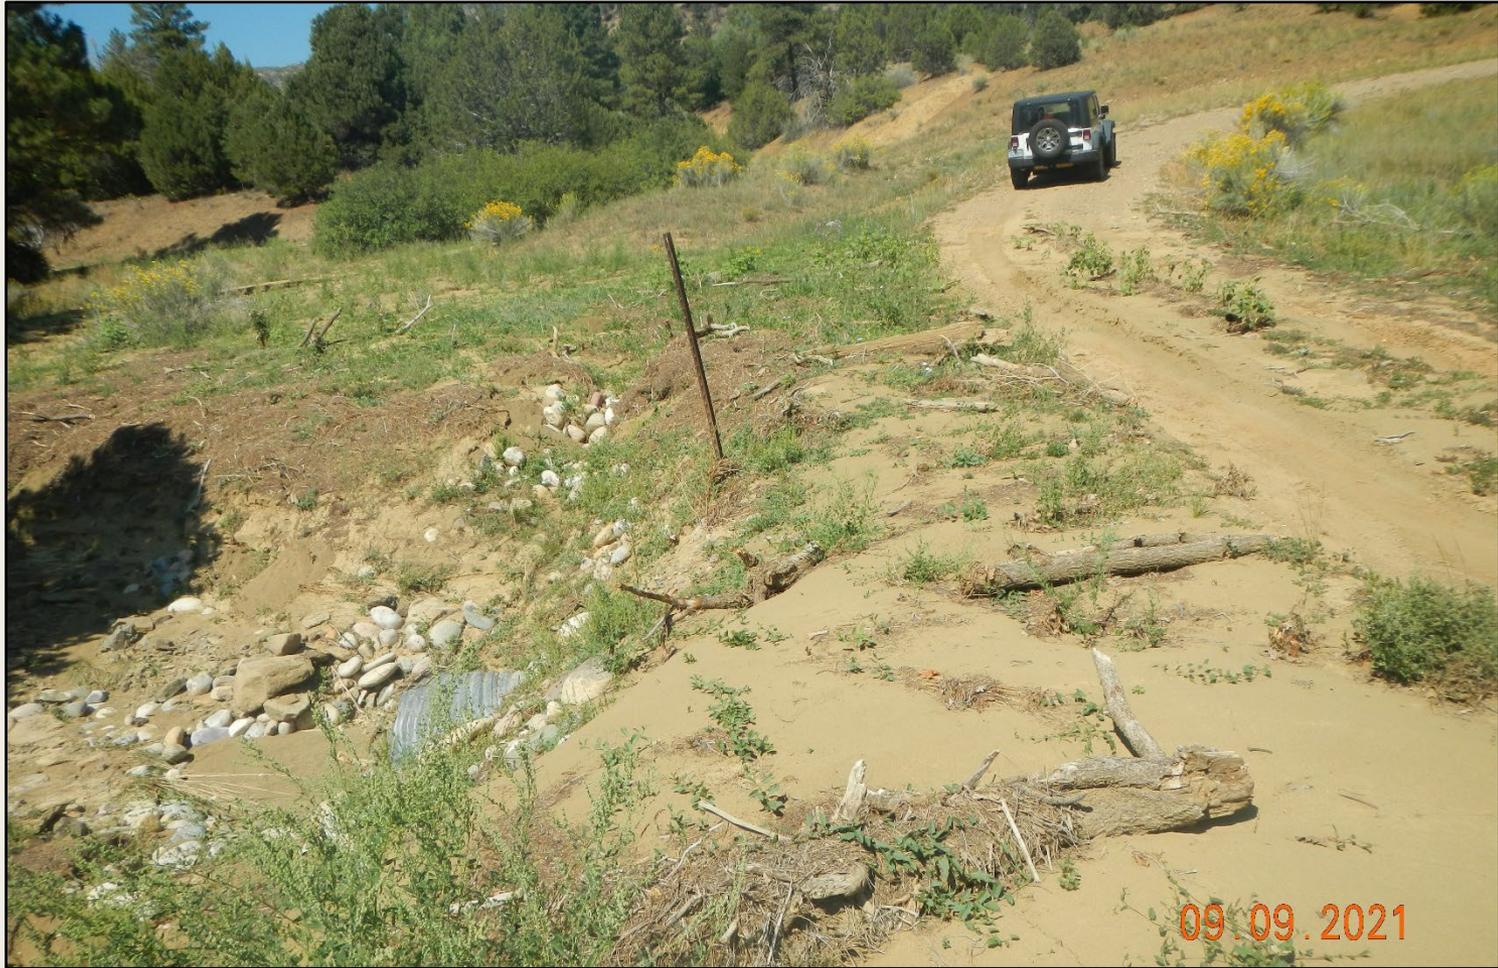
Photo 10. Another view of upstream side of stream crossing with wood wrack and sediment discharge observable in the foreground.

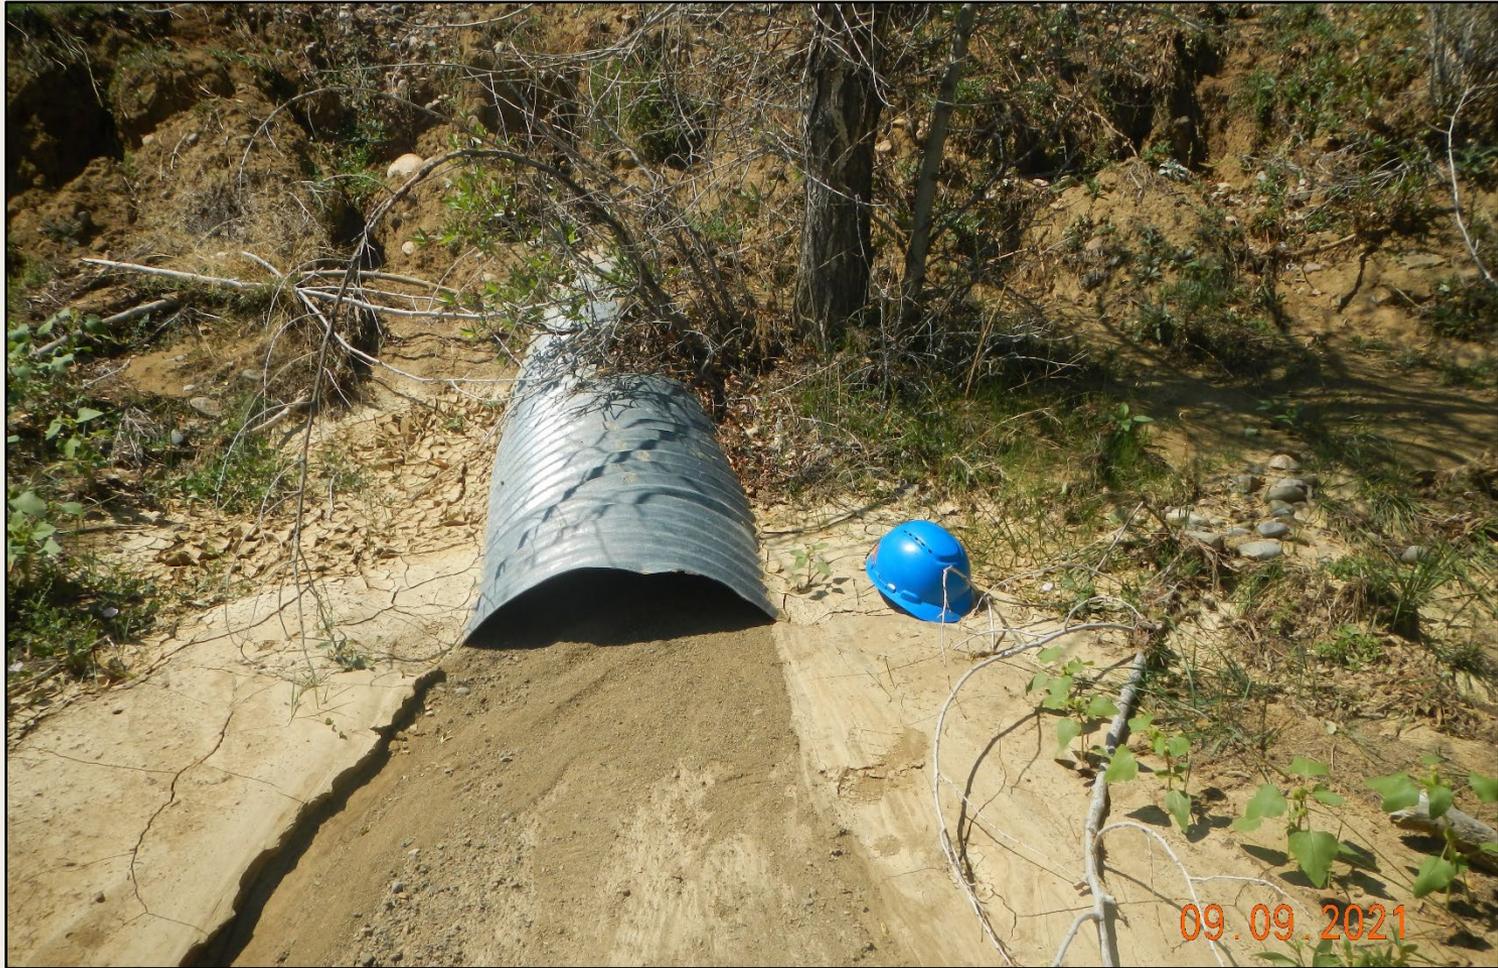
Photo 11. View of culvert outlet at stream crossing. Approx 3-ft culvert is full of sediment and not adequate to convey stormwater flows.
