Inspection Photos
Operator: Enduring
API: 067-08647
Date: 9/9/2021

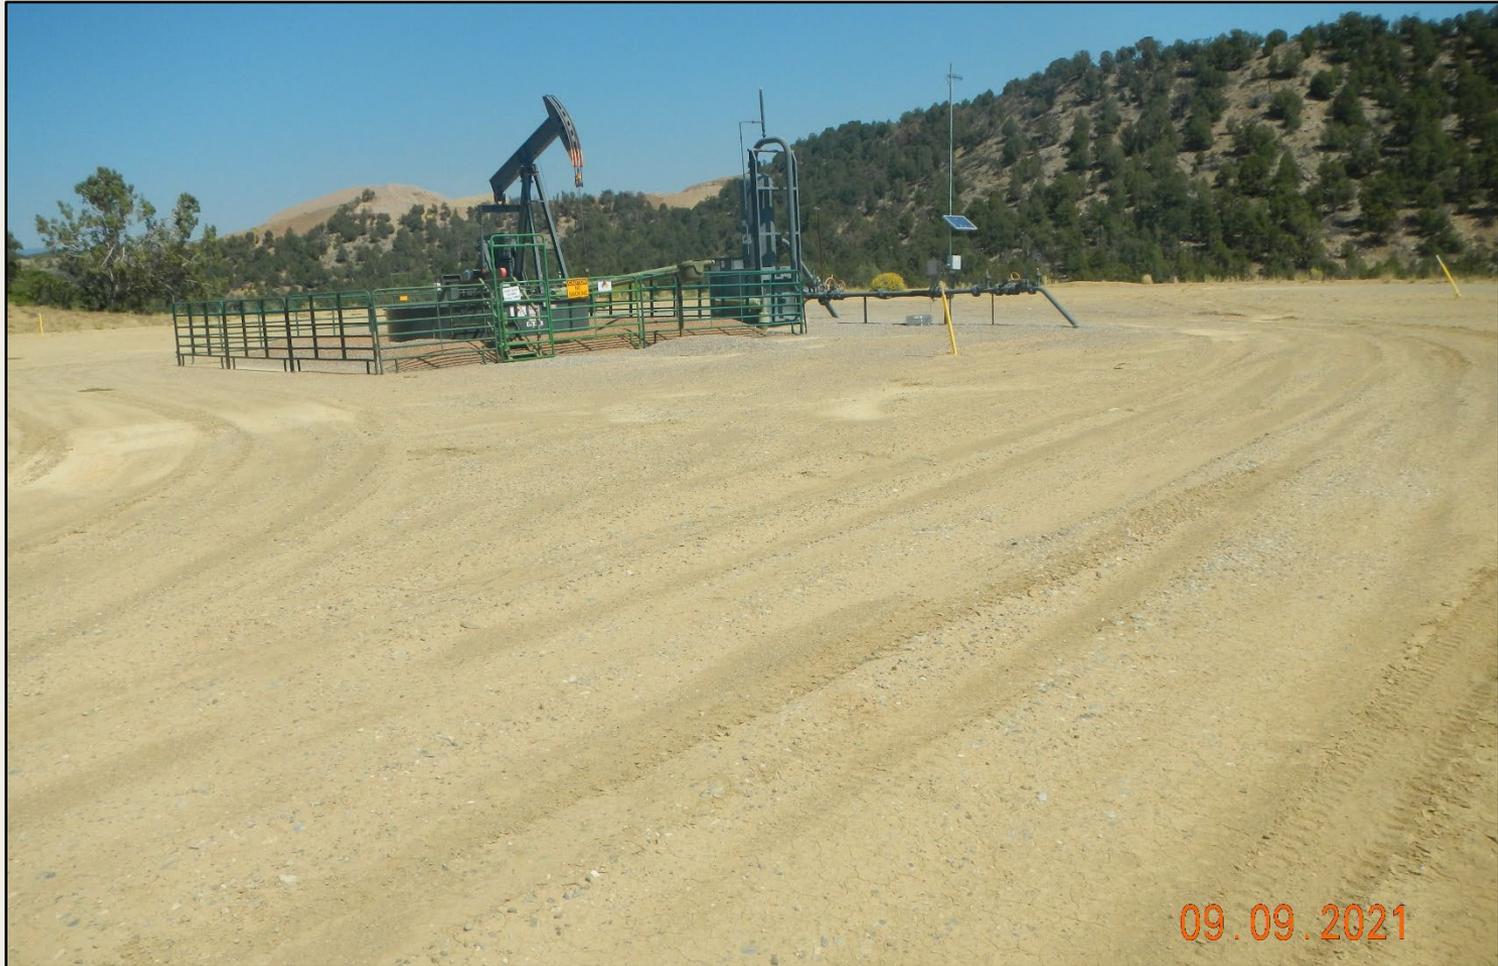
Photo 1. View of the project area from the well pad entrance facing center.

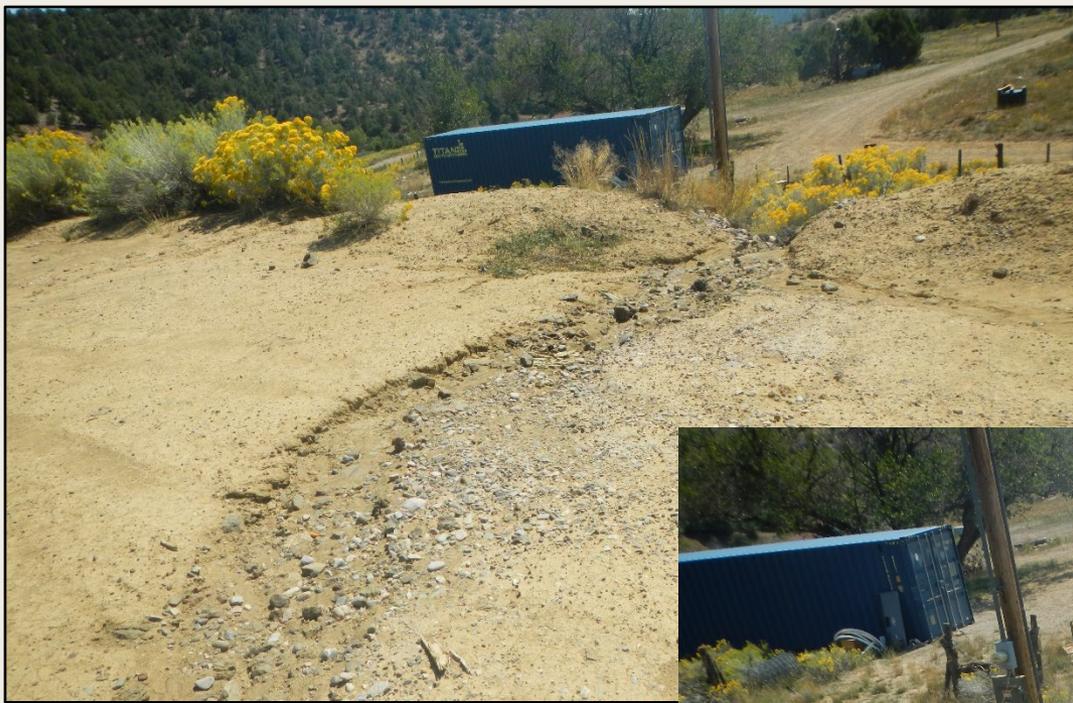
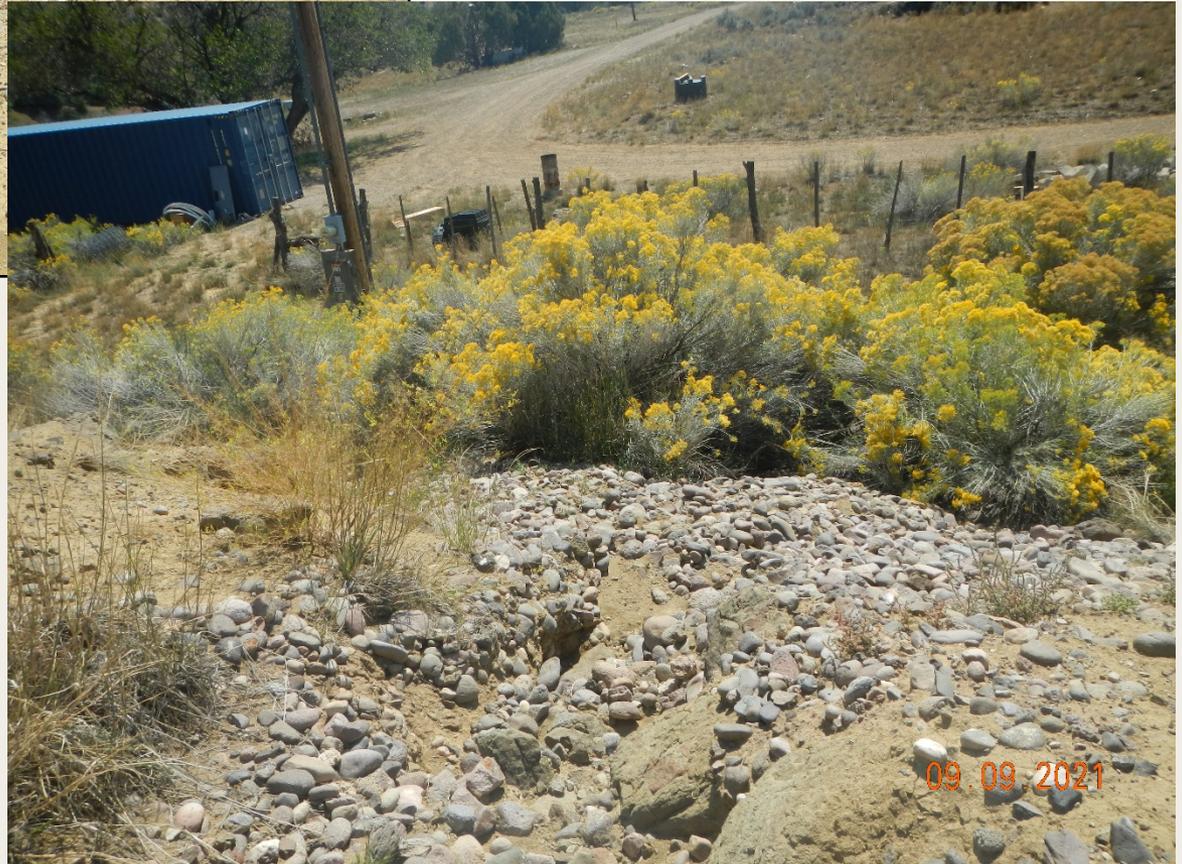
Photo 2. View of erosional channel on the well pad (left) and cobble BMP eroded and displaced on the fill slope (right).

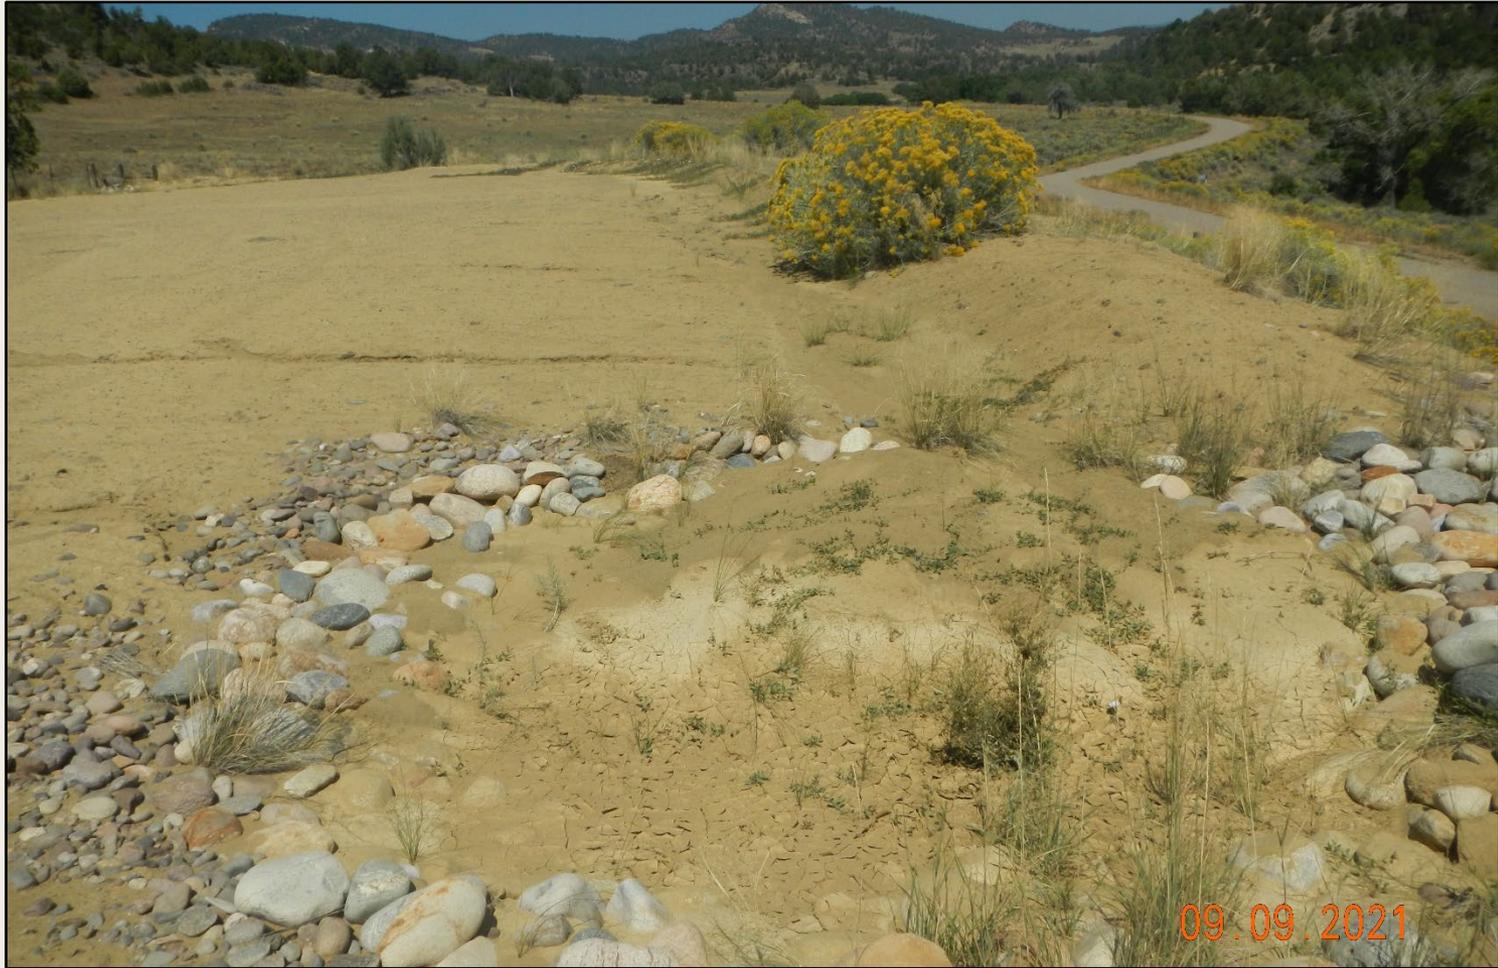
Photo 3. View of sediment deposition within the eastern sediment trap, largely full and needing maintenance.

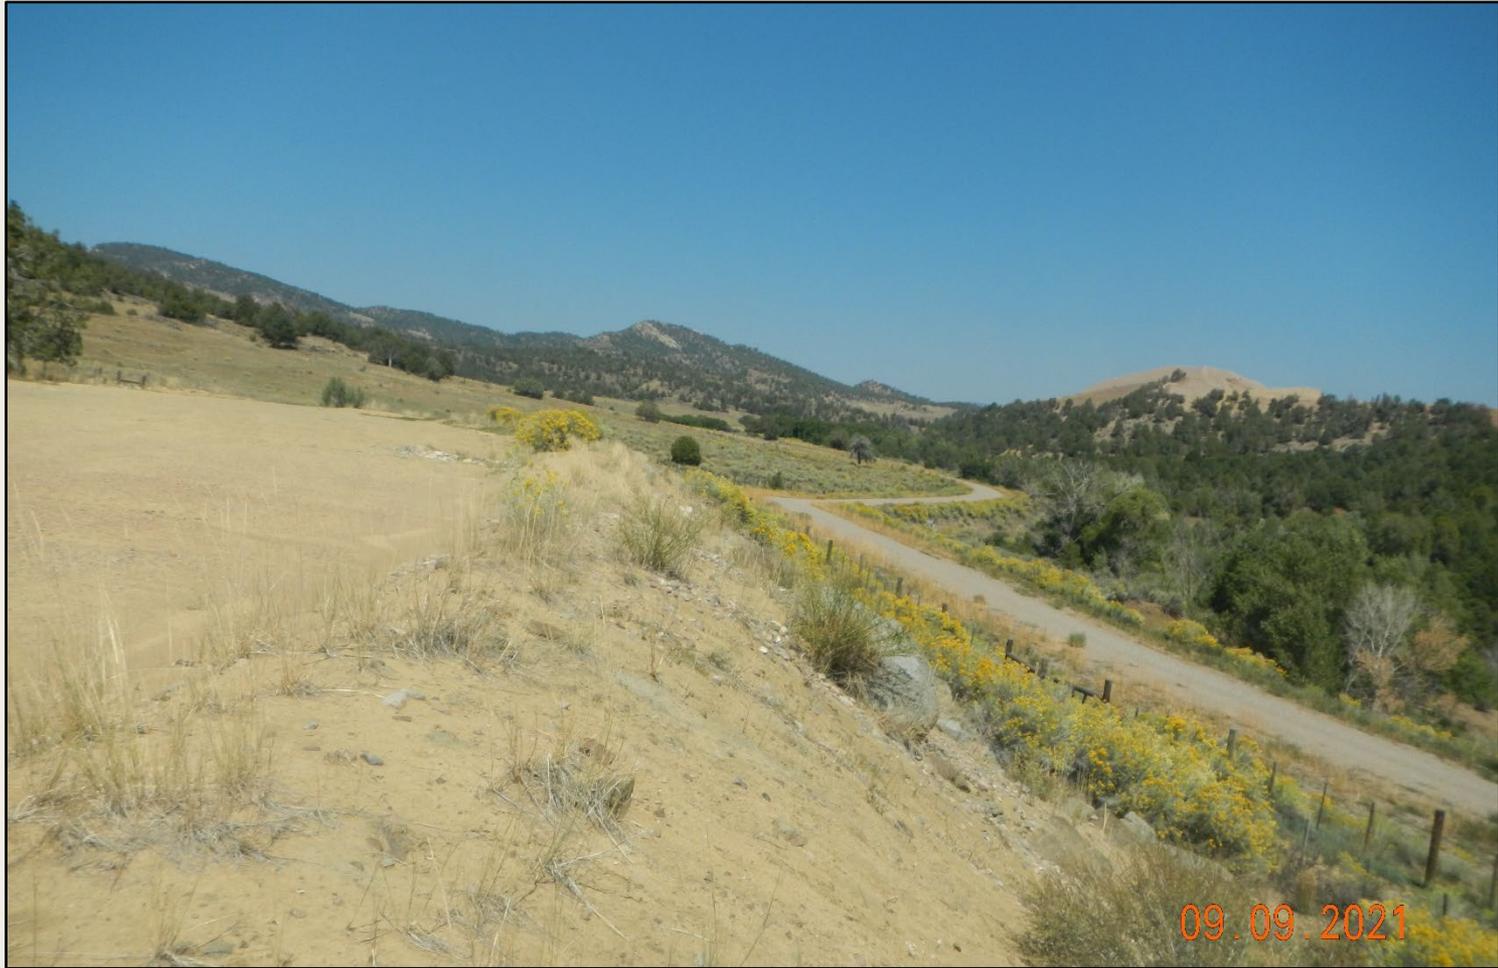
Photo 4. View of the eastern fill slope from the southeastern corner facing northward. Revegetation is progressing in portions of the fill slopes with rubber rabbitbrush, sand dropseed, and crested wheatgrass. Other portions remain bare and eroding and need spot seeding and stabilization.

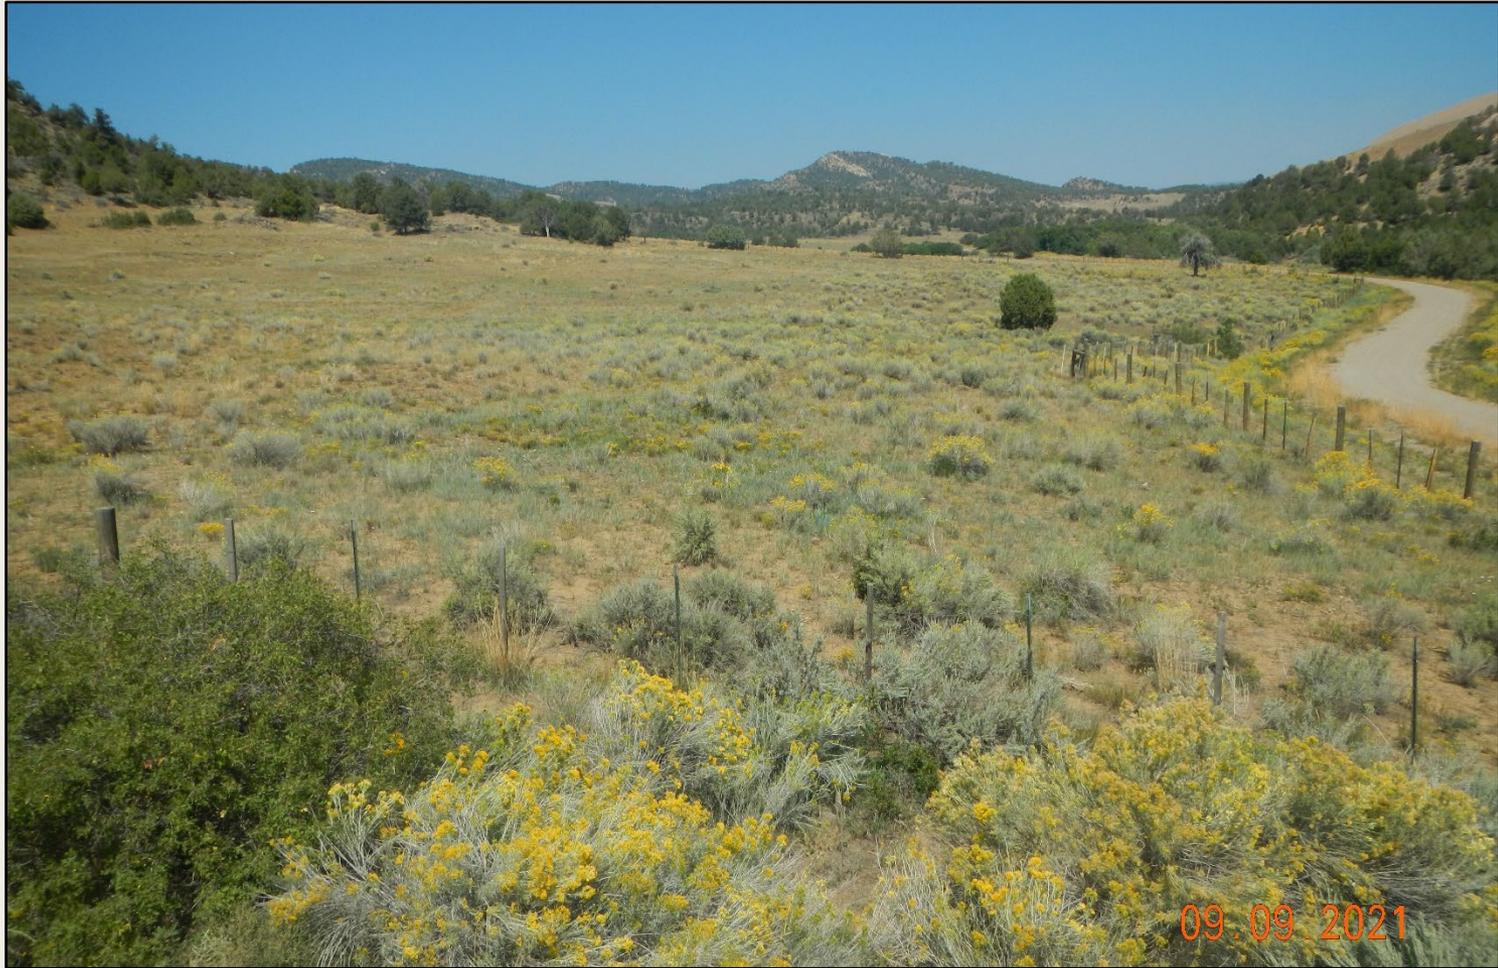
Photo 5. View of the reference area comprised of rubber rabbitbrush, western wheatgrass, smooth brome, and sagebrush.
