Inspection Photos
Operator: Enduring
API: 067-07636
Date: 9/9/2021

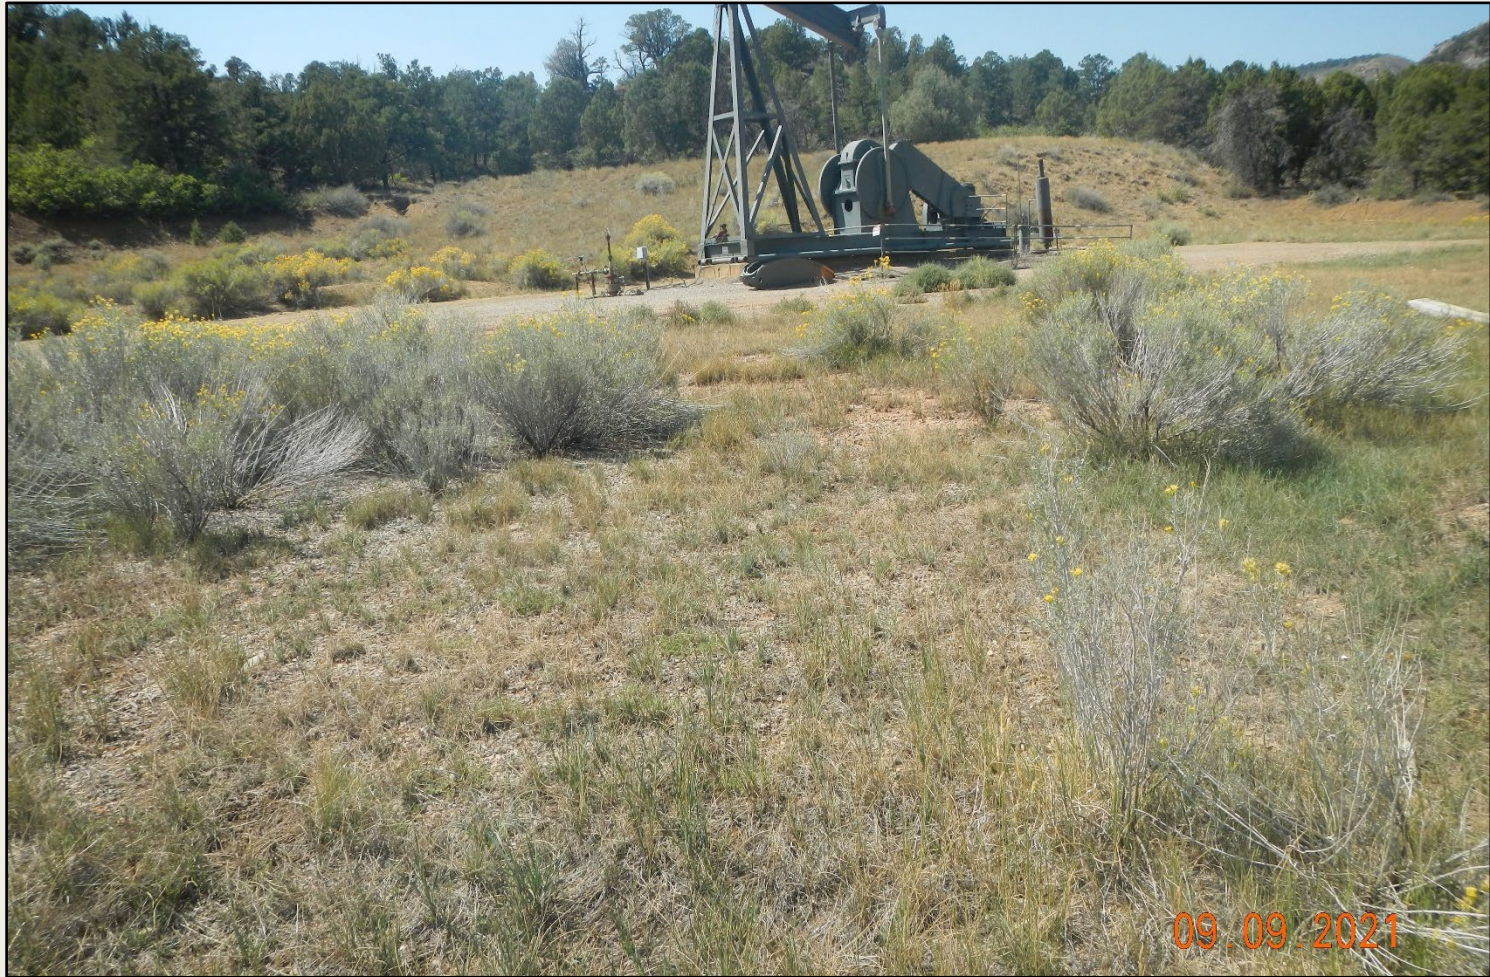
Photo 1. View of the project area from the northeastern corner facing center.

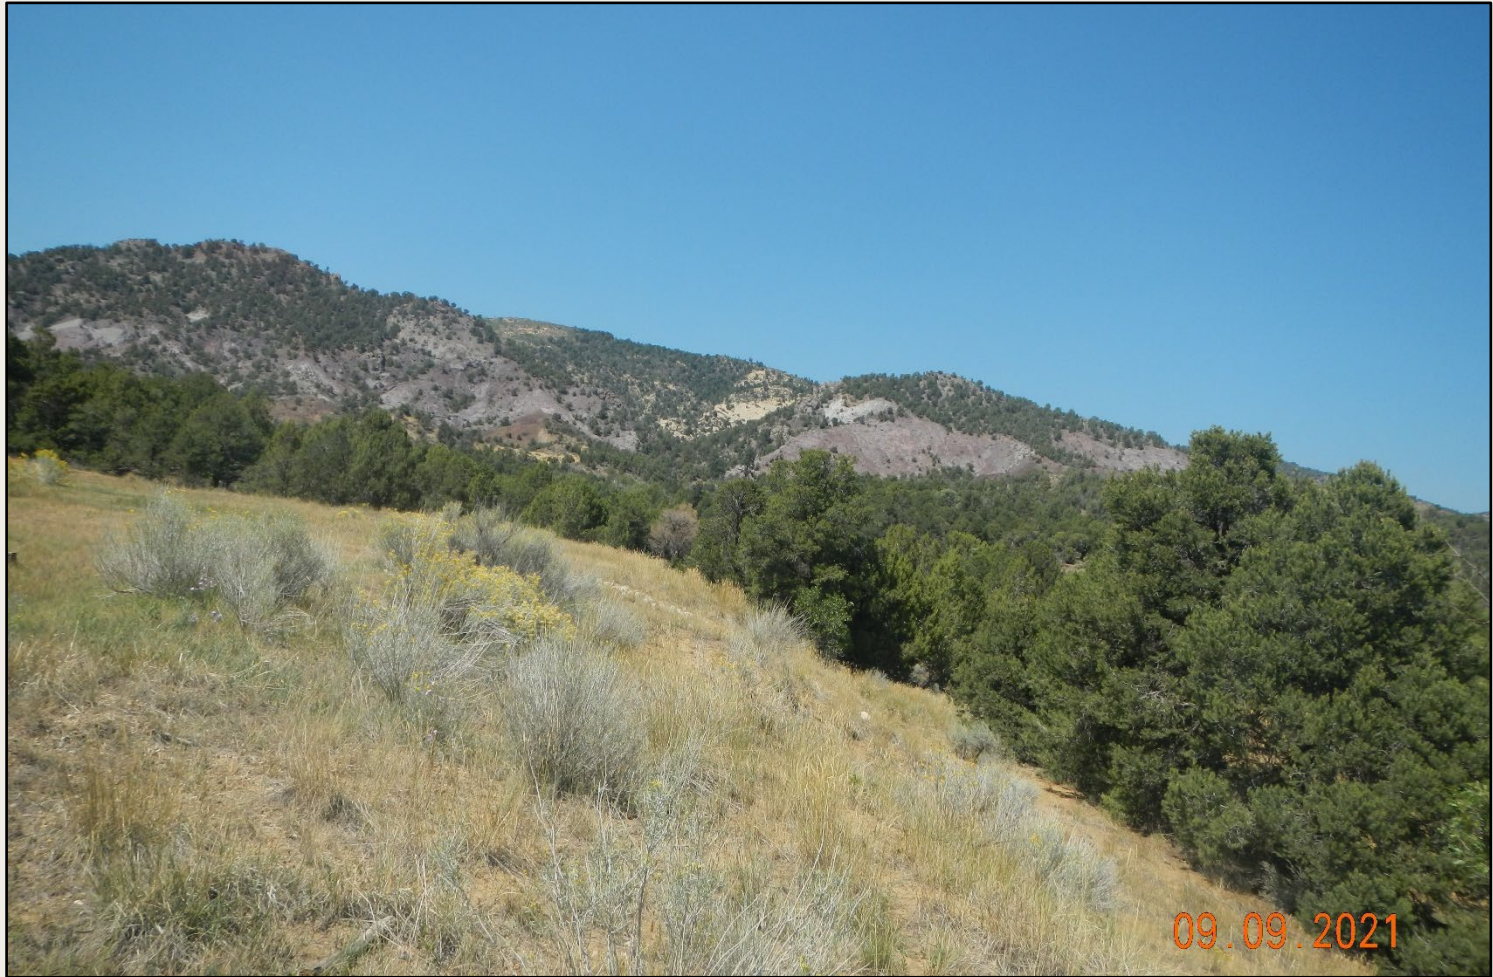
Photo 2. View of the northern project area from the northeastern corner facing westward. Revegetation is progressing with western wheatgrass, smooth brome, and rubber rabbitbrush.

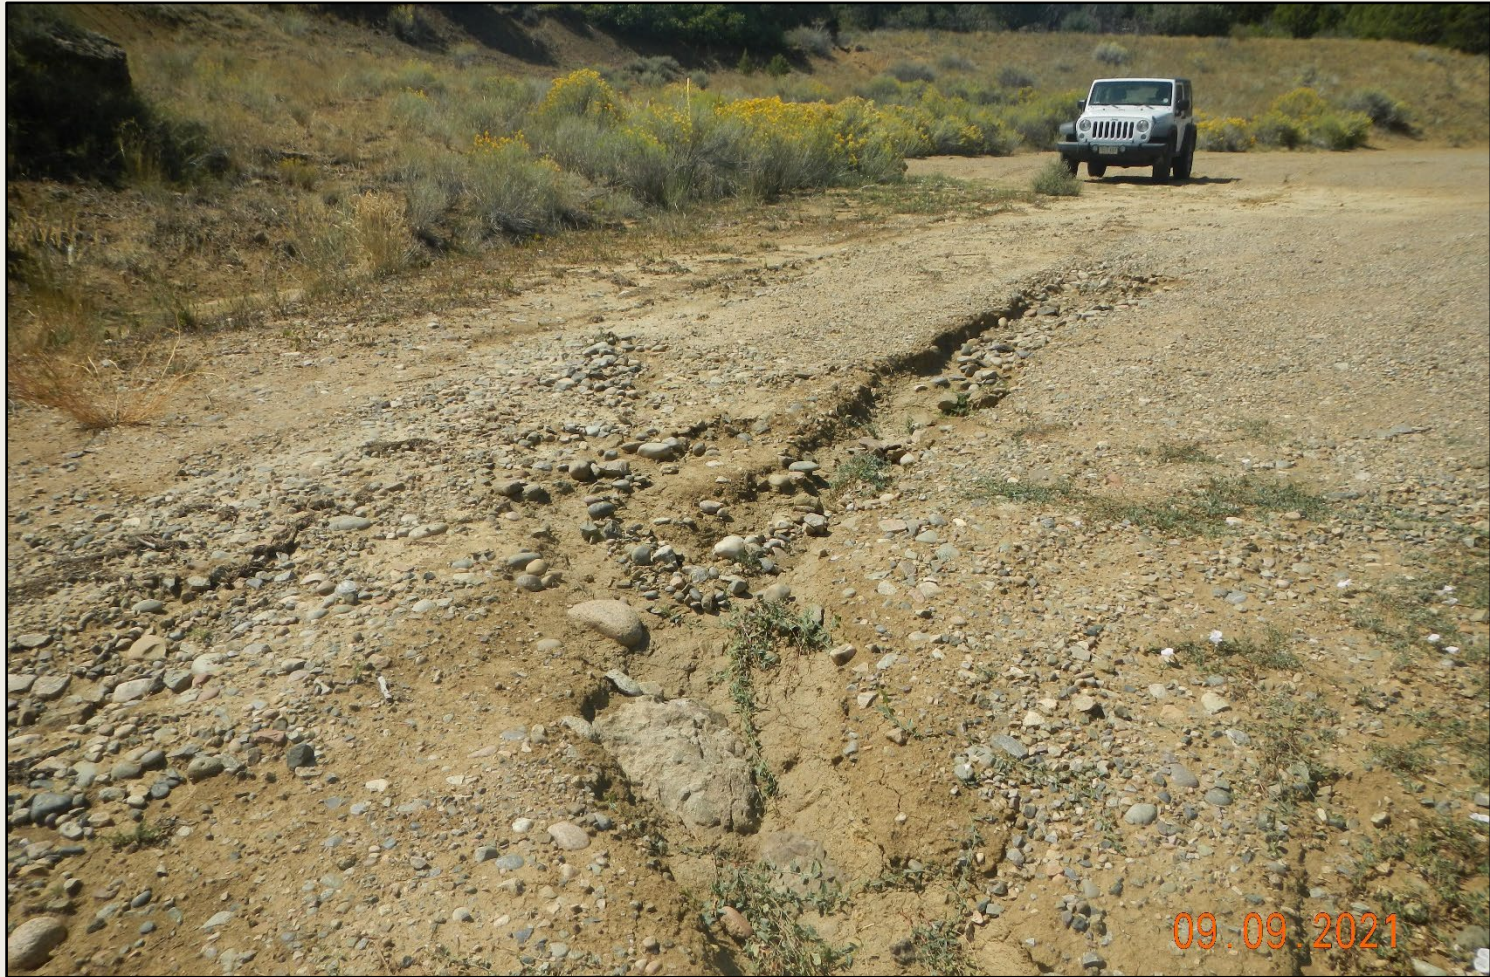
Photo 3. View of erosional channel forming on the well pad and flowing down the access road (facing upslope).

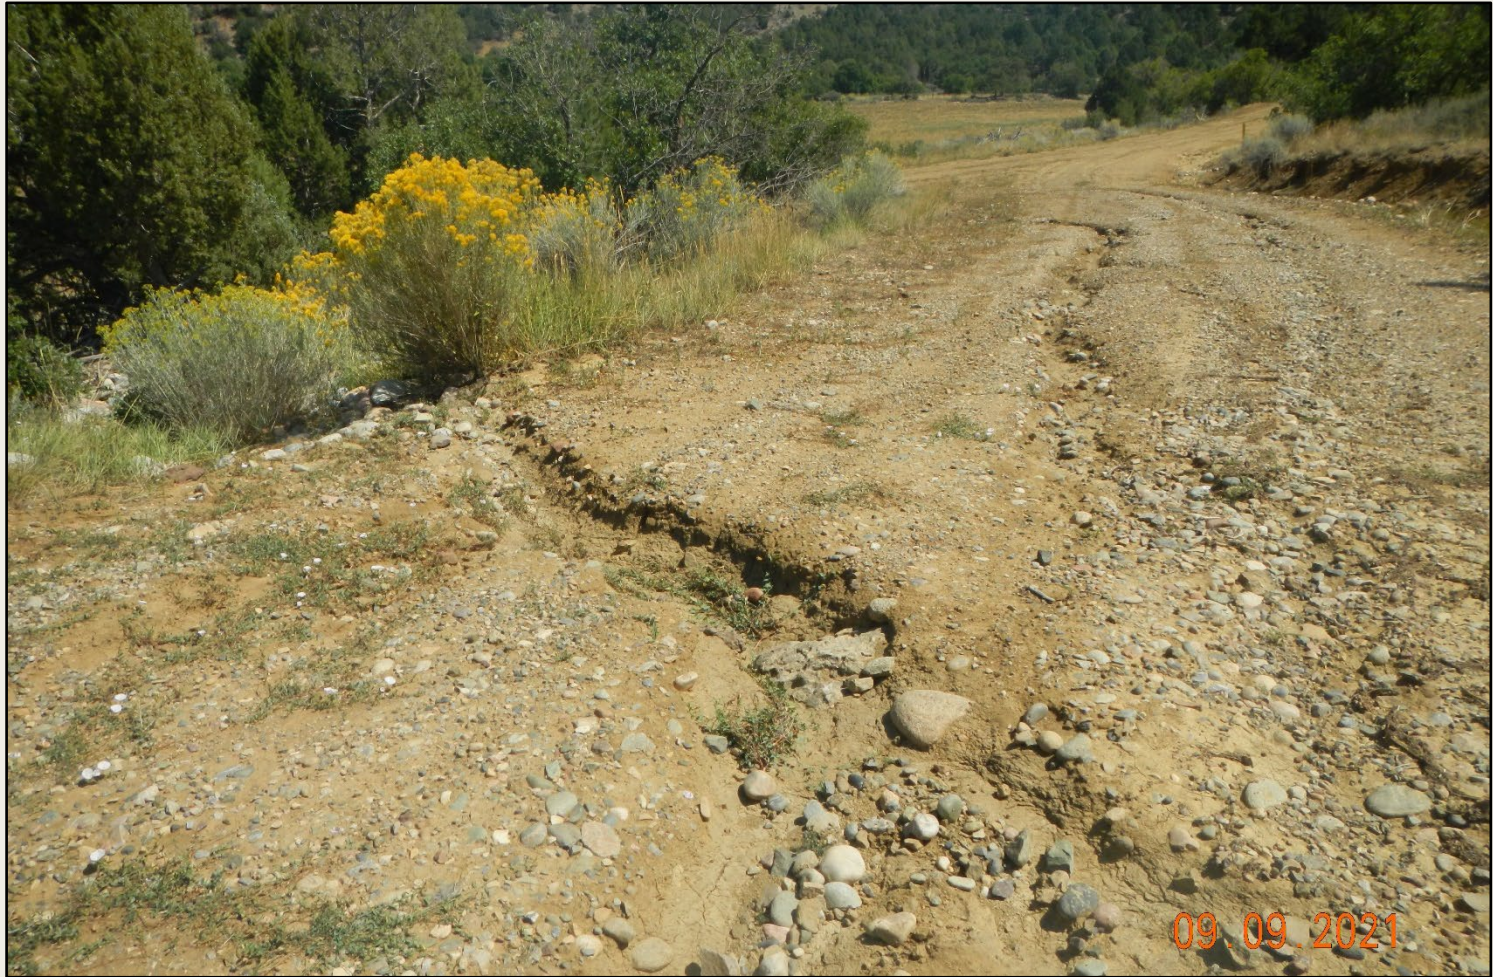
Photo 4. View of erosional channel shown in Photo 2, where it flows downslope eroding the access road surface and flowing off of the project area.

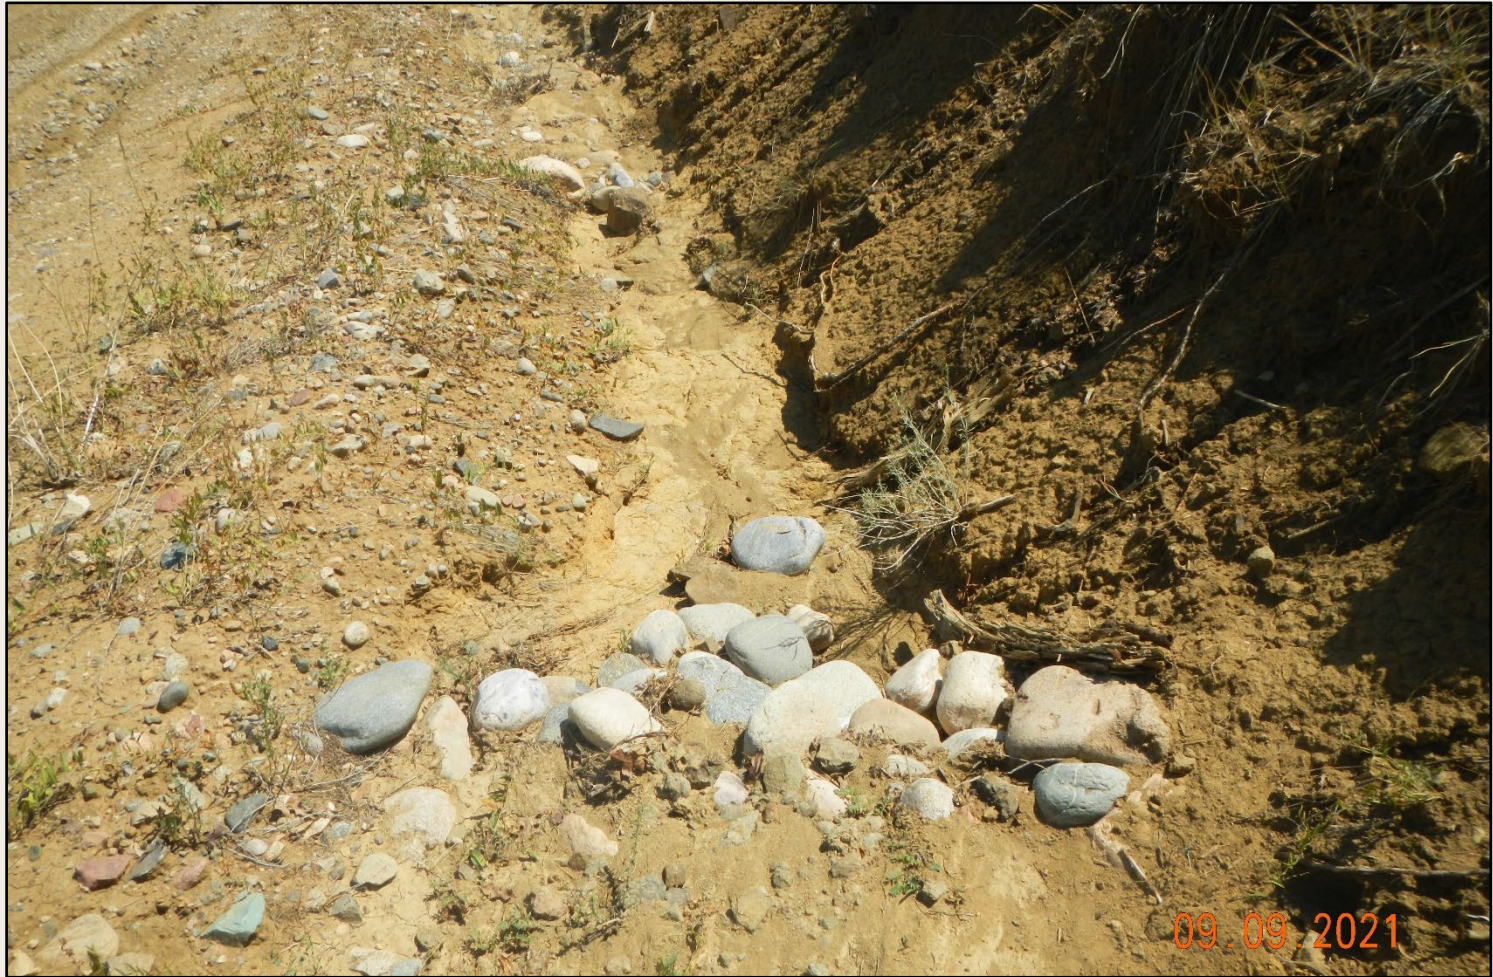
Photo 5. View of cobble BMPs along the southern project area that are full of sediment and not functioning, or adequate for this area. .

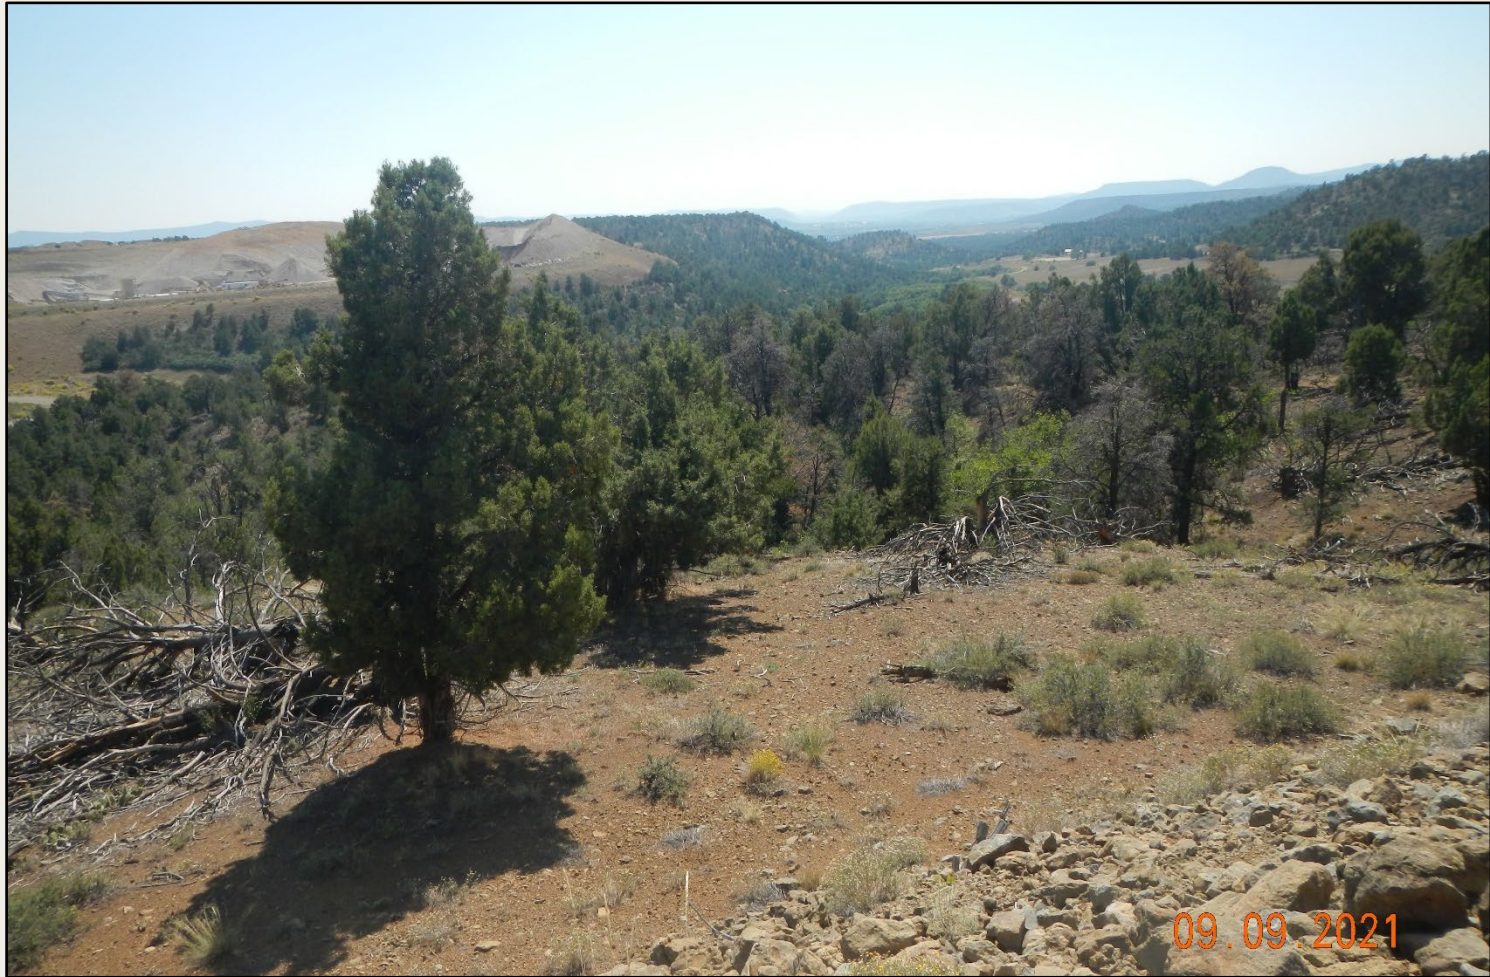
Photo 6. View of the reference area comprised of pinyon and juniper woodland with yucca, mountain mahogany, purple threeawn, and blue grama.
