Inspection Photos
Operator: Petrox
Facility: 471016
Date: 9/13/2021

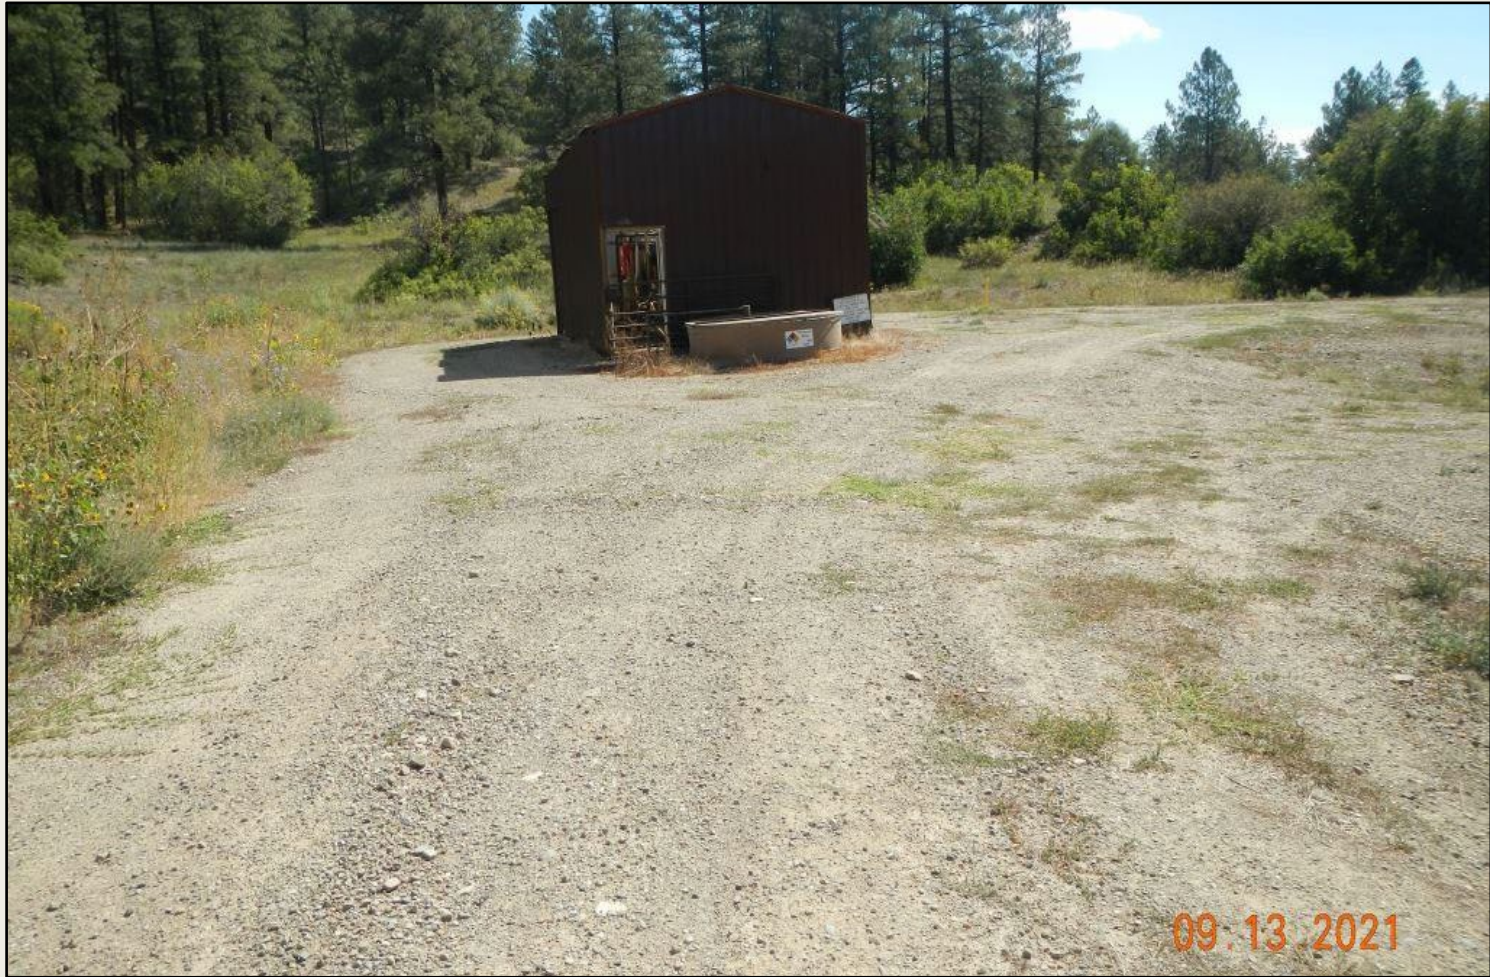
Photo 1. View of the project area from the facility entrance facing center.

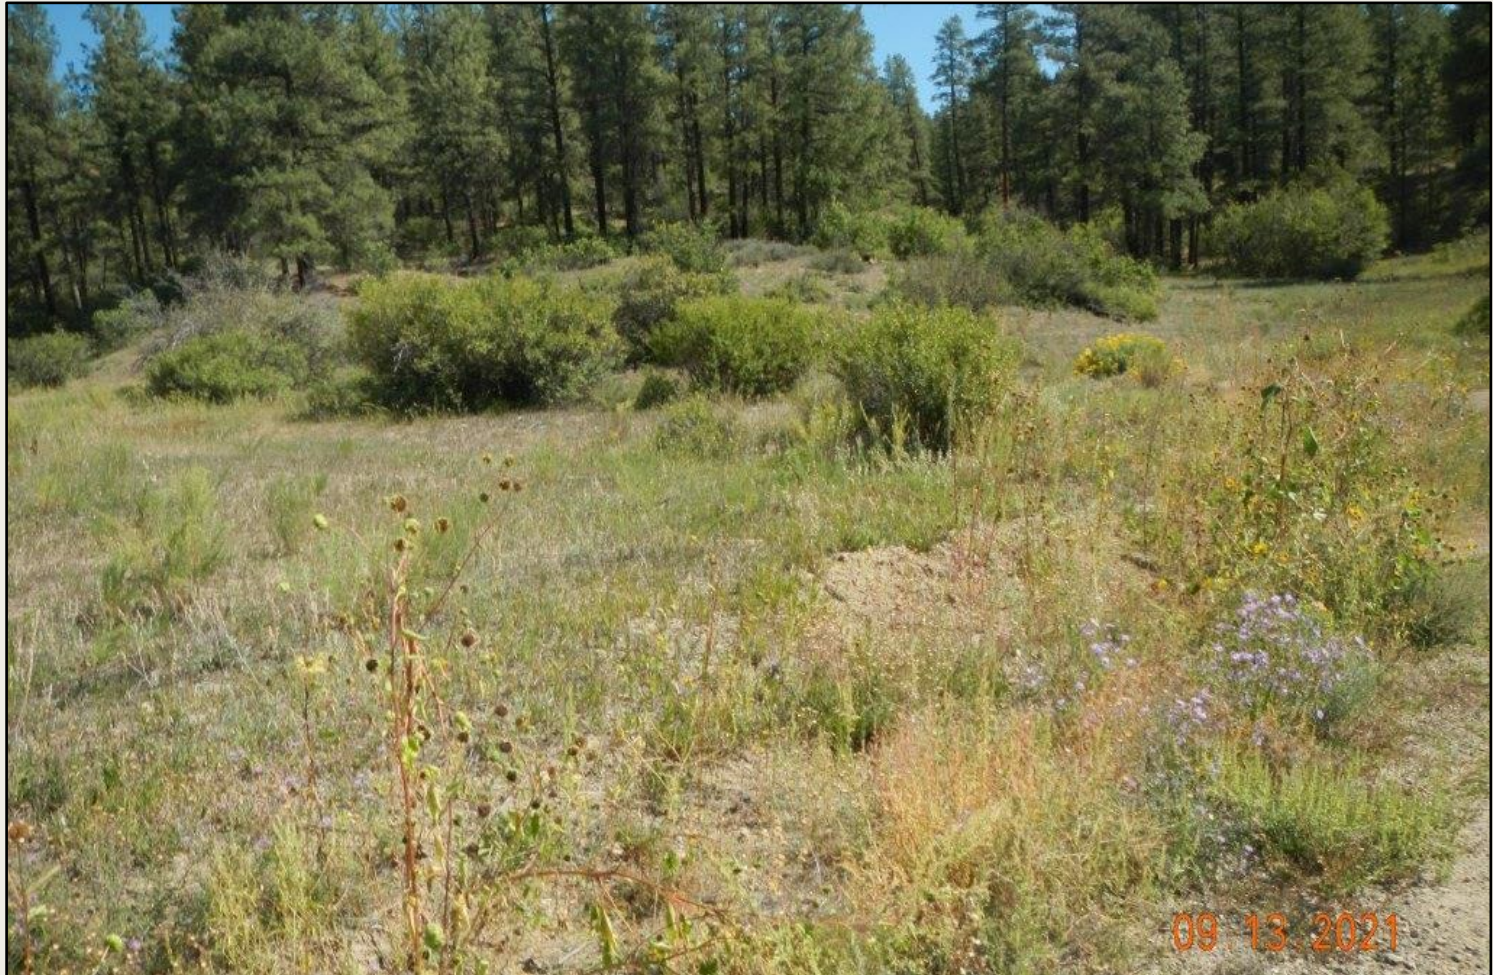
Photo 3. View of the northern project area from the northwestern edge facing eastward. Revegetation is progressing in non-weedy areas with smooth brome.

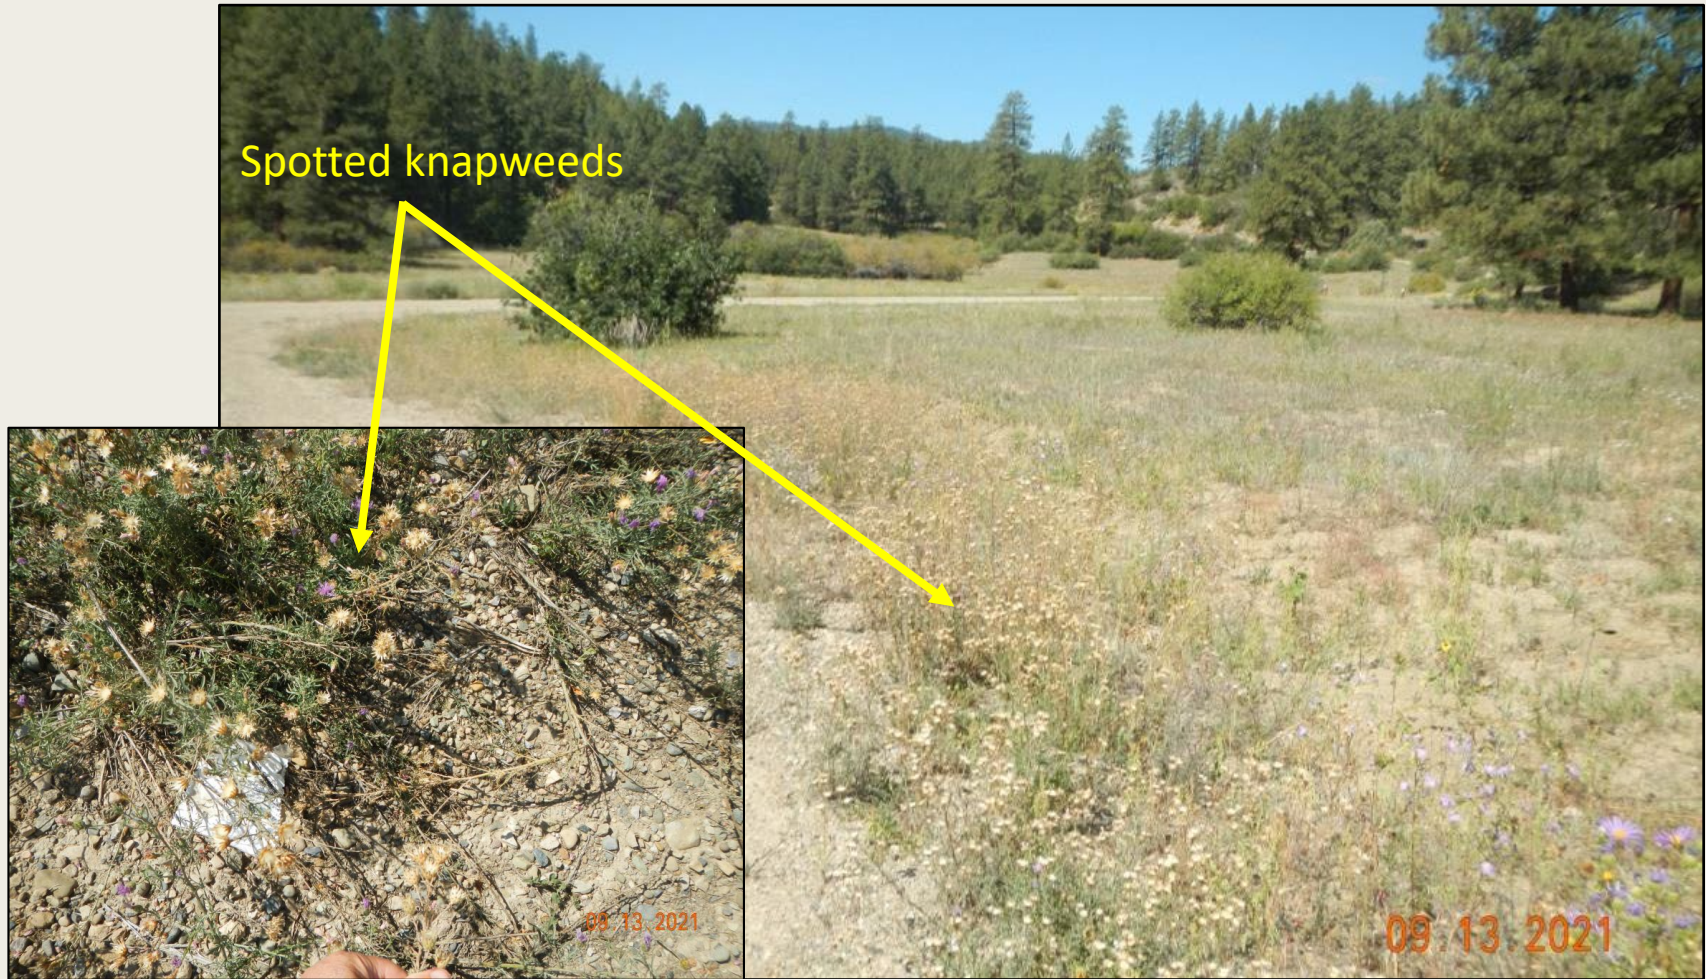
Photo 2. View of spotted knapweeds growing along the northern edge of the project disturbance. Approximately 3000 individuals observed in infestation.

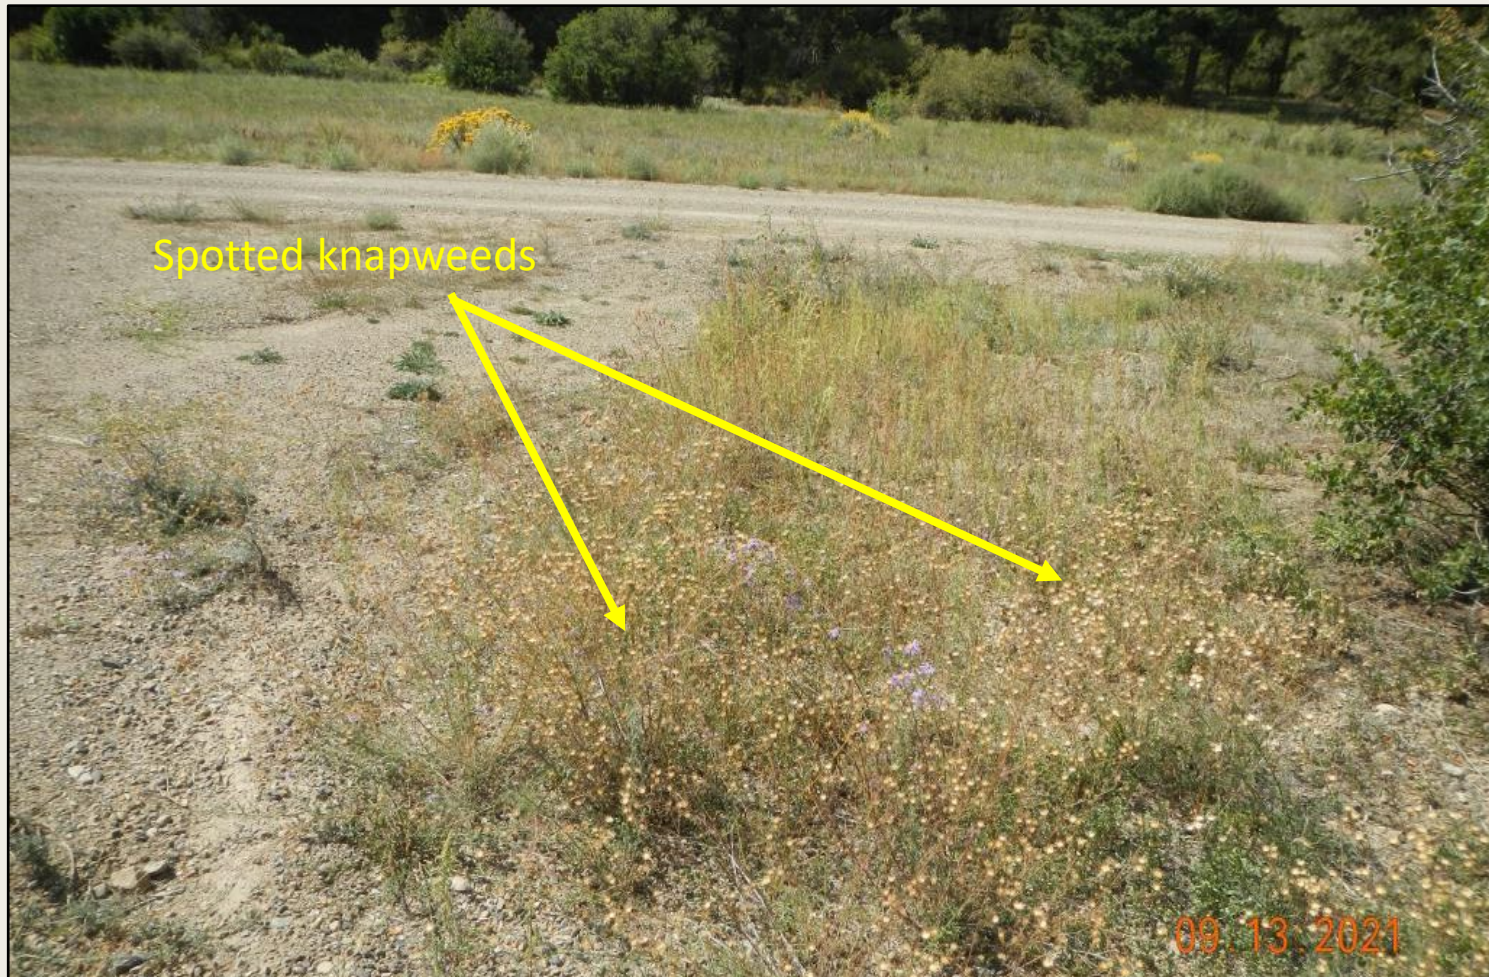
Photo 4. View of more spotted knapweeds growing at facility entrance.

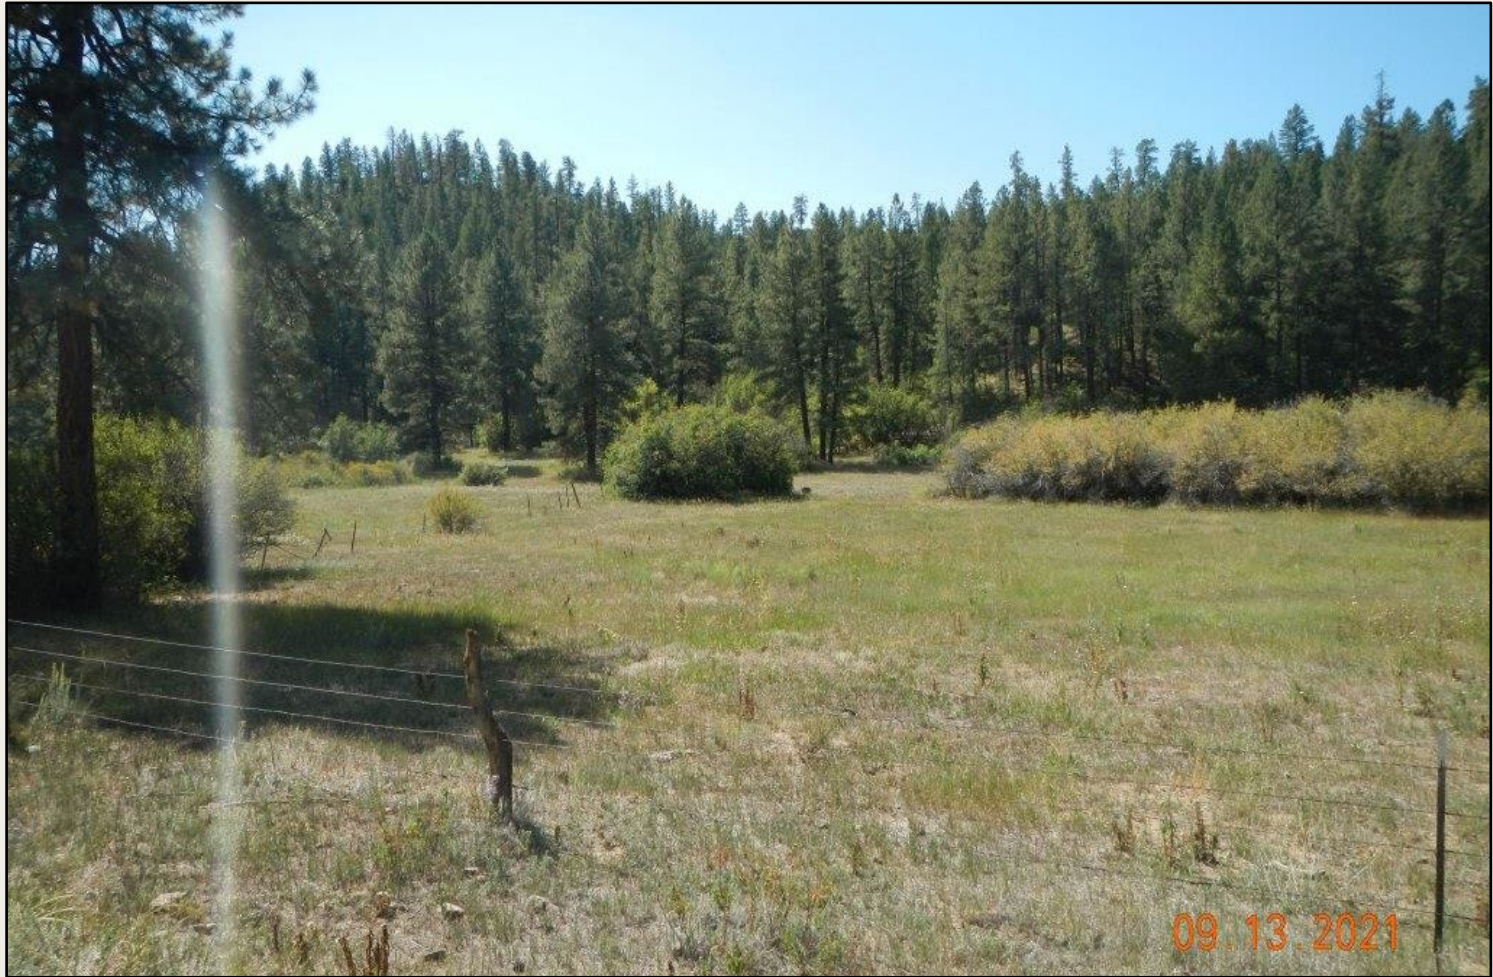
Photo 5. View of the reference area comprised of mixed grass field, with ponderosa pine forest, and western wheatgrass, smooth brome, serviceberry, and gambel oak in the understory.
