UTAH GAS OP LTD DBA UTAH GAS CORP DRAGON TRAIL UNIT-62S102W 26SWSE Location # 314307

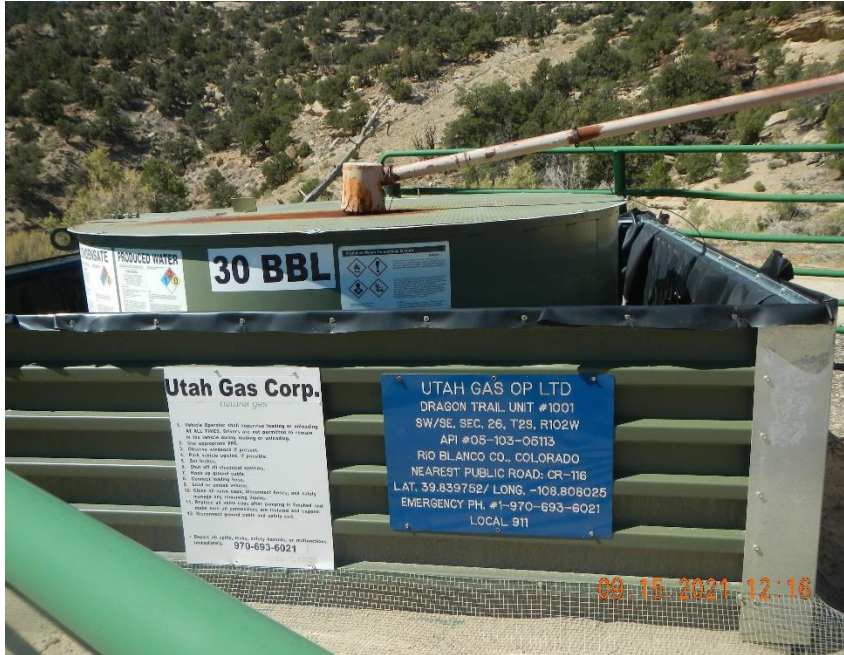
Battery sign installed at tank battery.

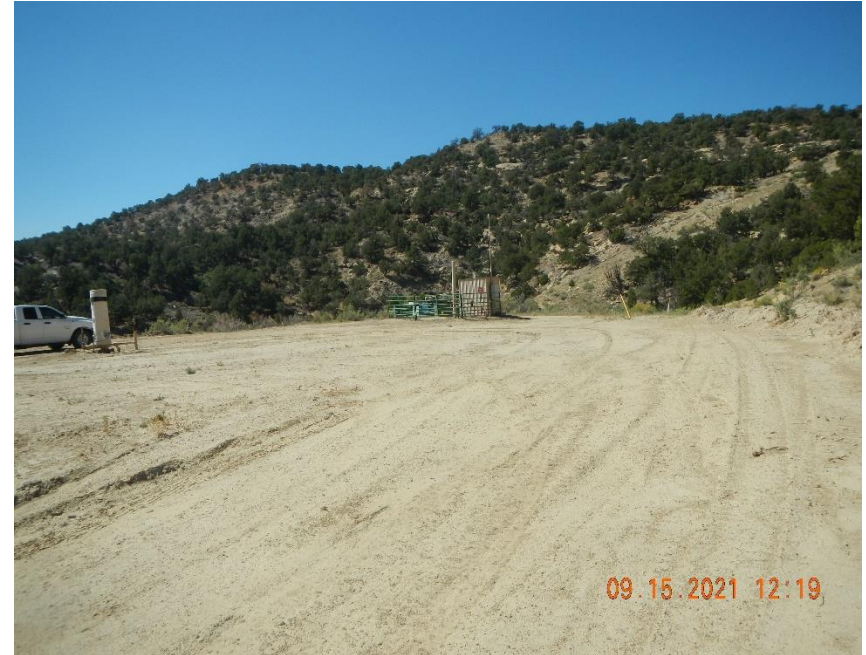
Weeds have been addressed.

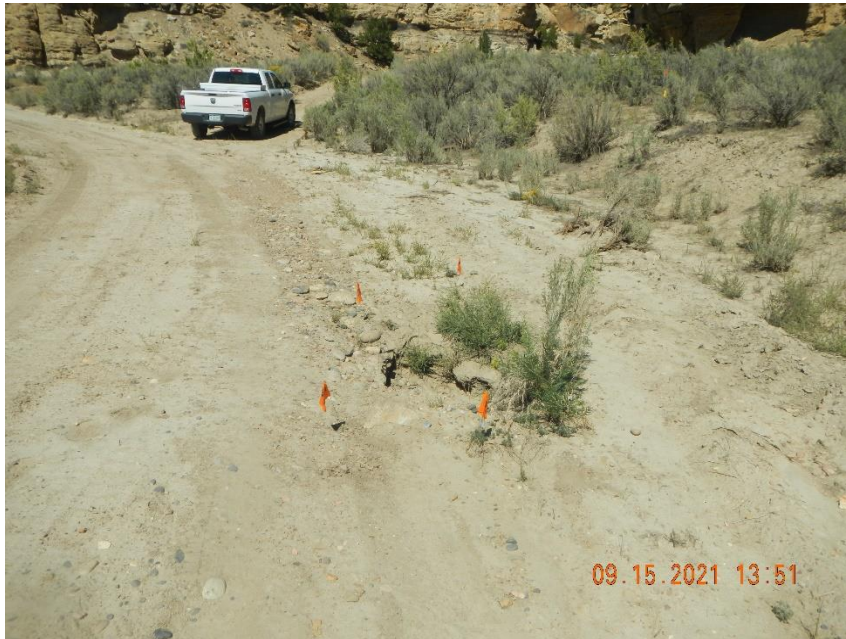
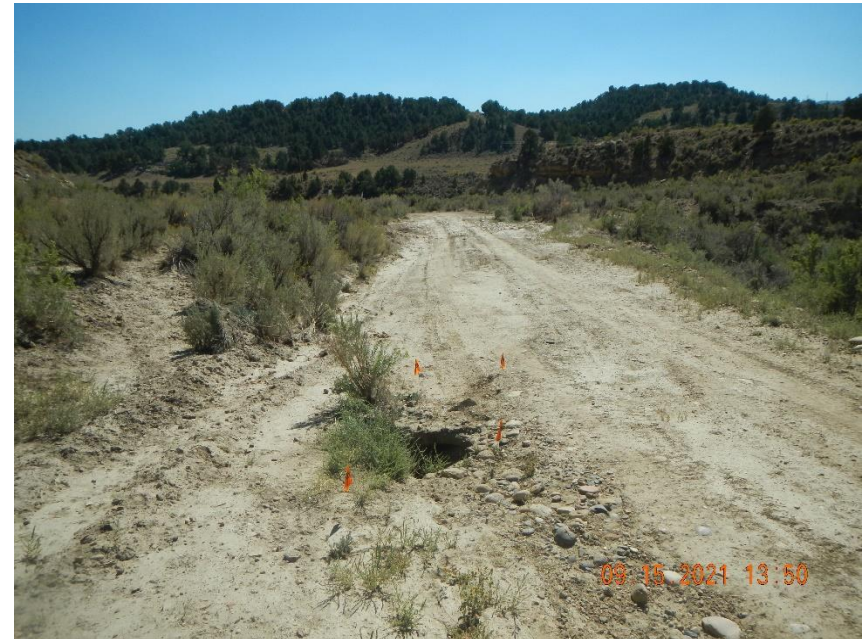
**Sink hole in shoulder of access road. Just south of
DTU 1056 entrance.**

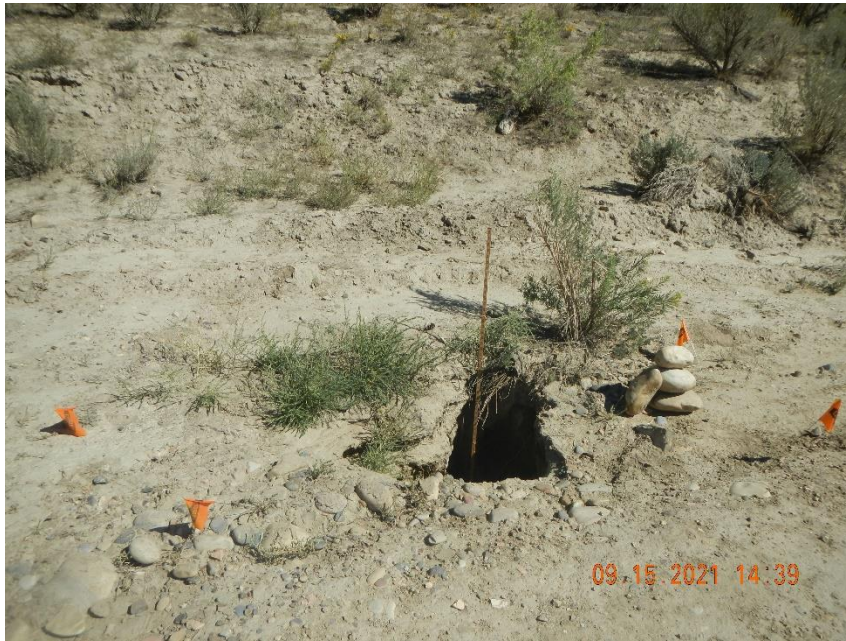
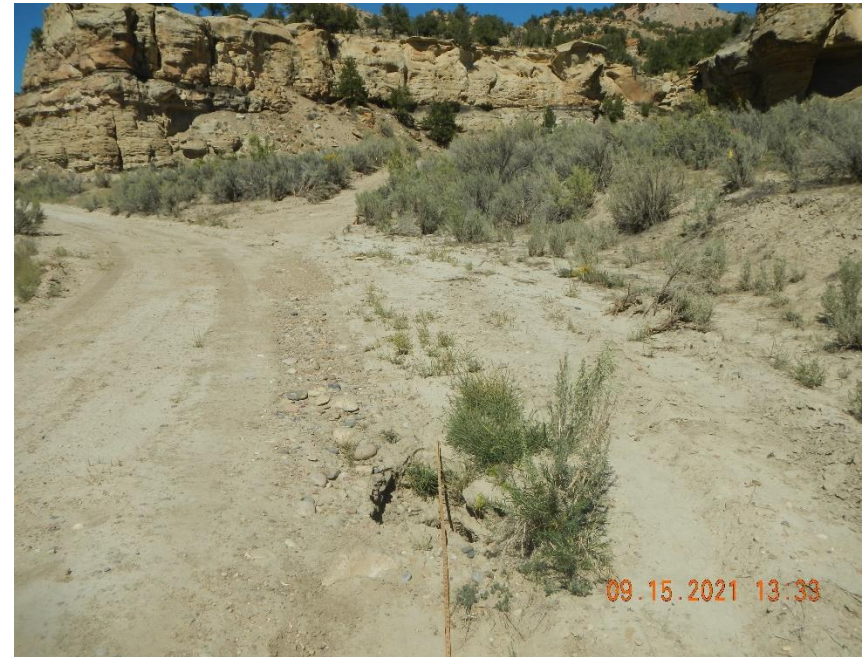
**Sink hole in shoulder of access road. Just south of
DTU 1056 entrance.**

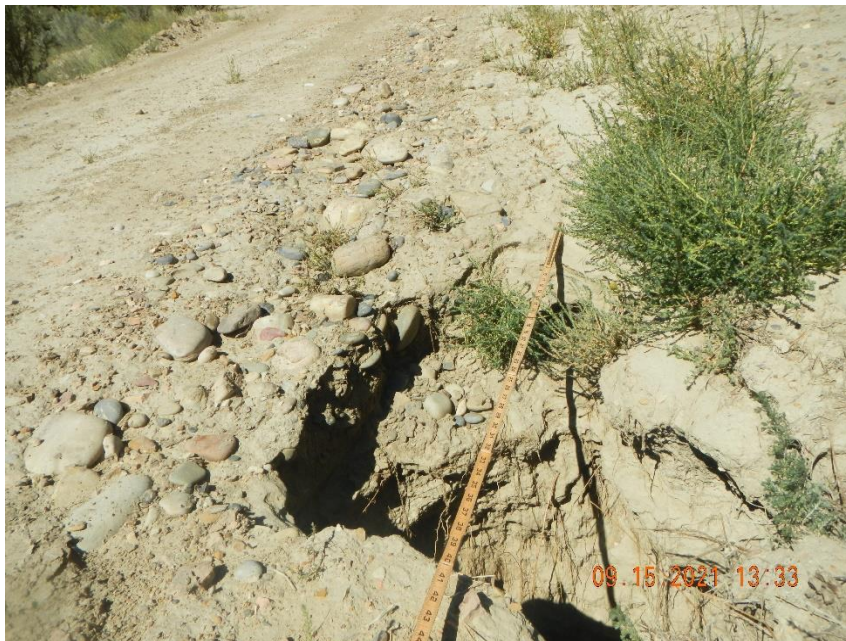
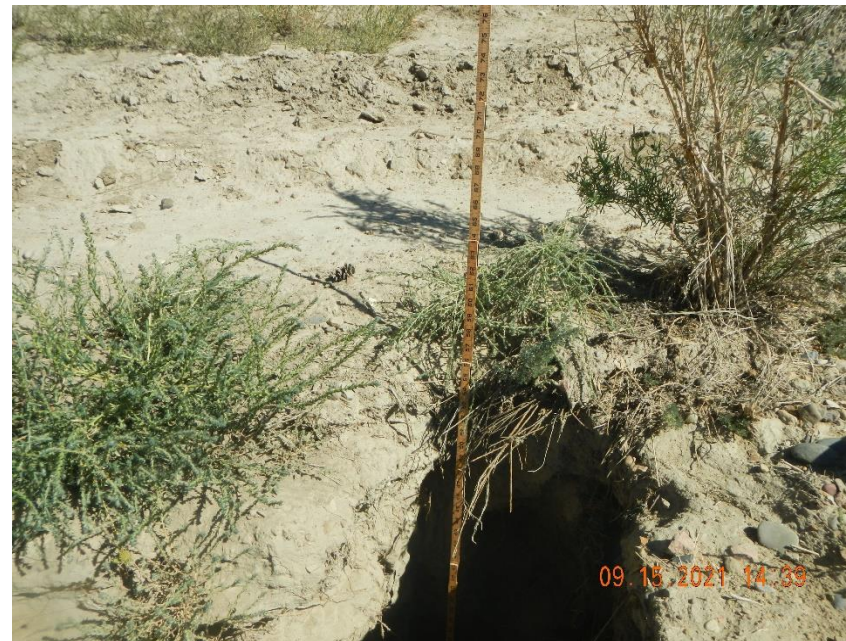
**Sink hole in shoulder of access road. Just south of
DTU 1056 entrance.**

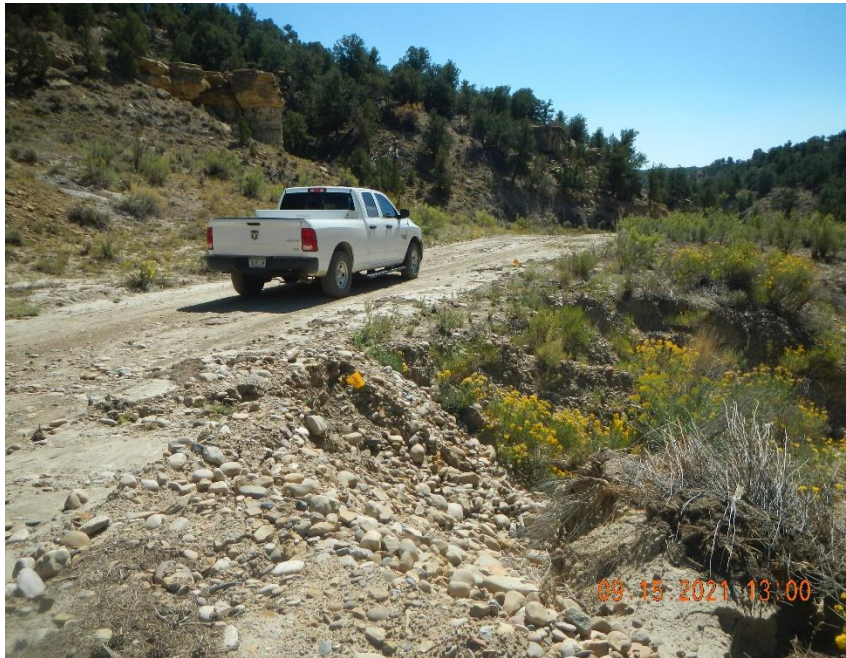
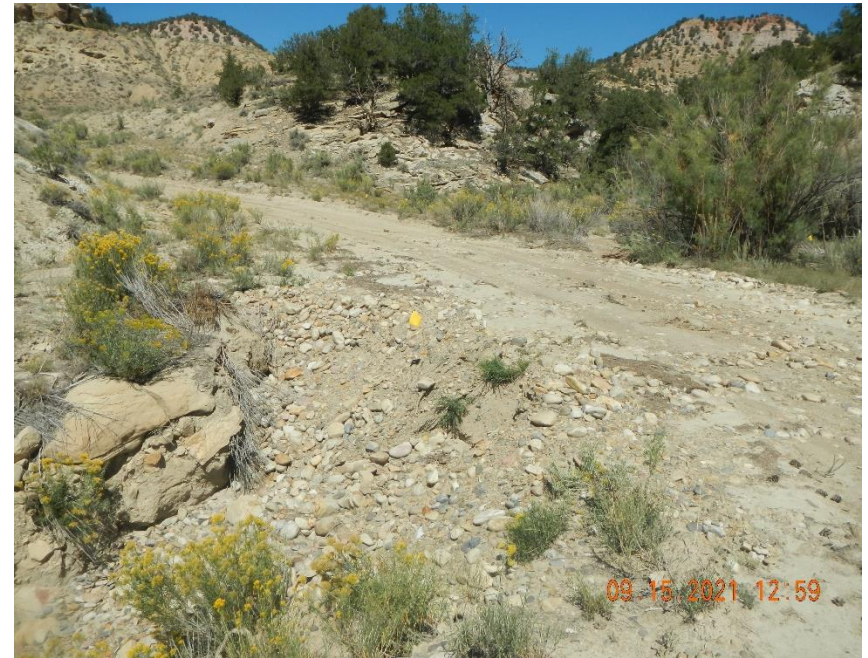
Storm water erosion of access road.

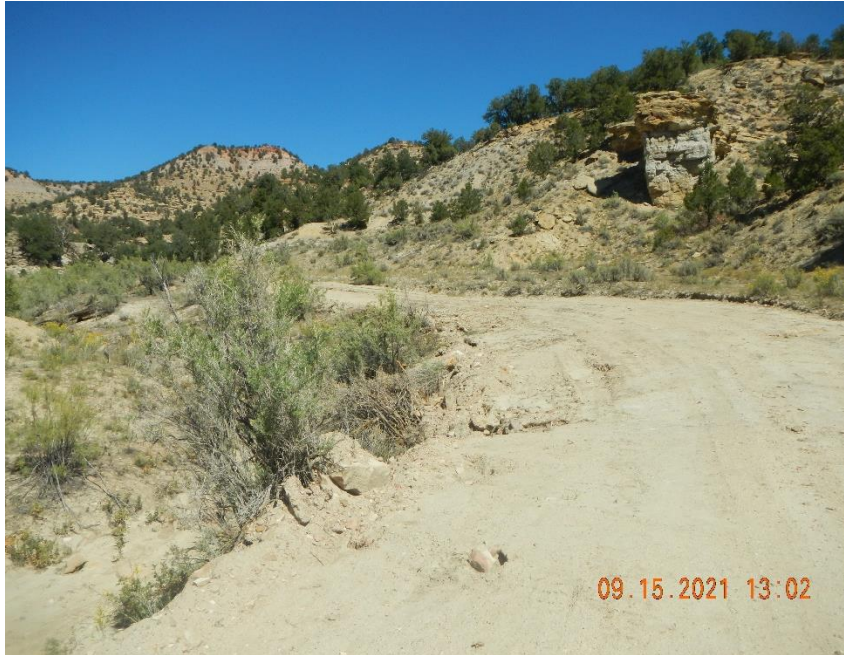
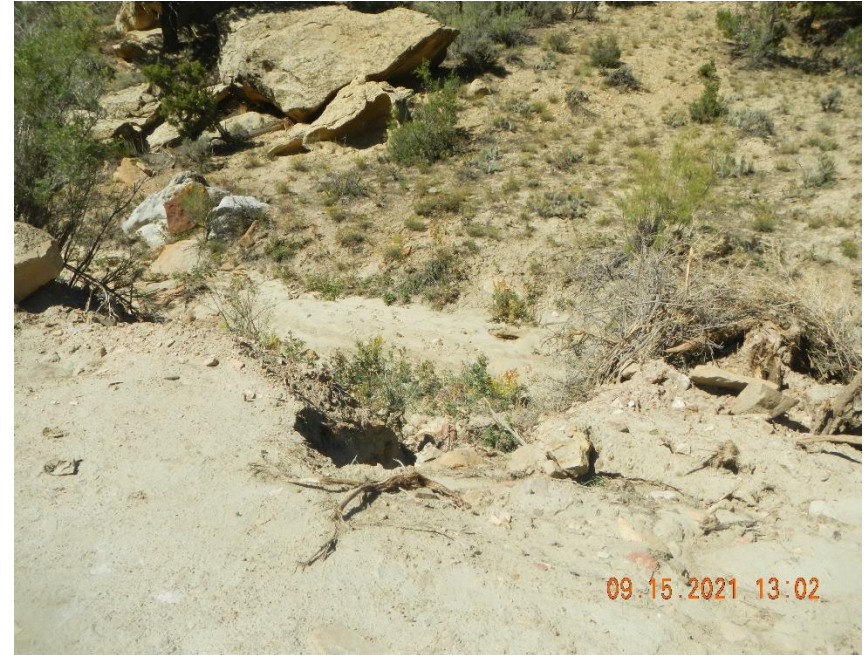
Storm water erosion of access road.

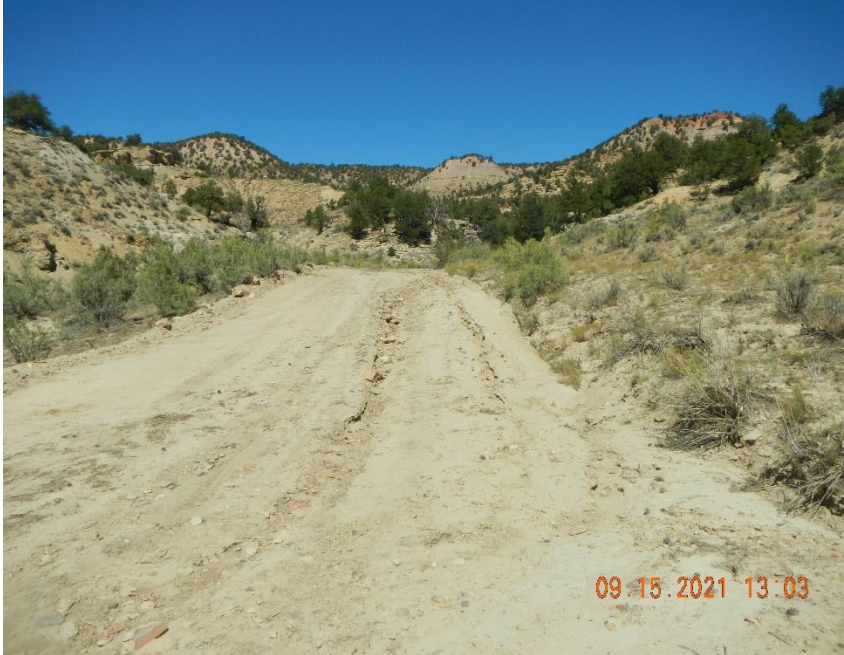
Erosion rills in roadway.

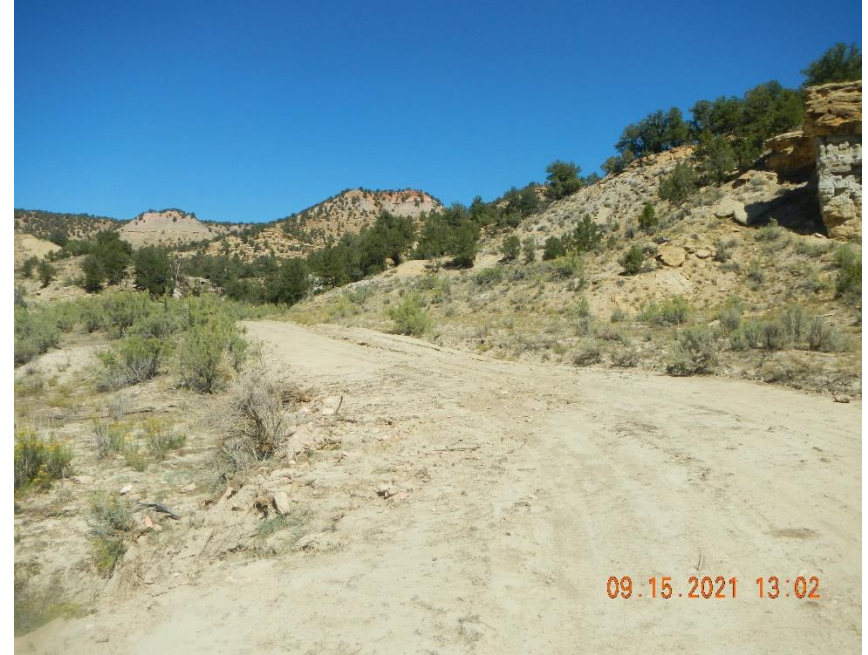
Storm water movement of sediment on access road.

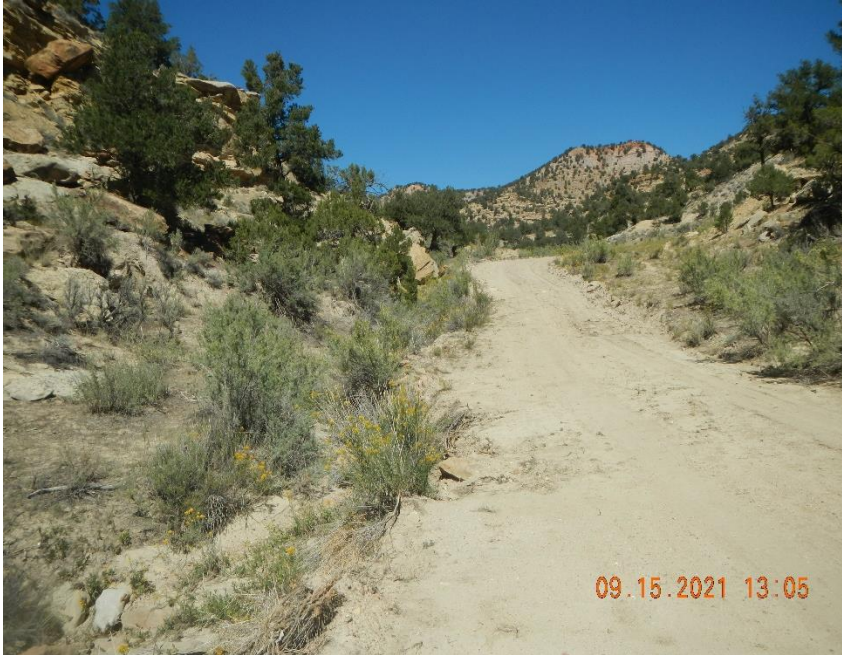
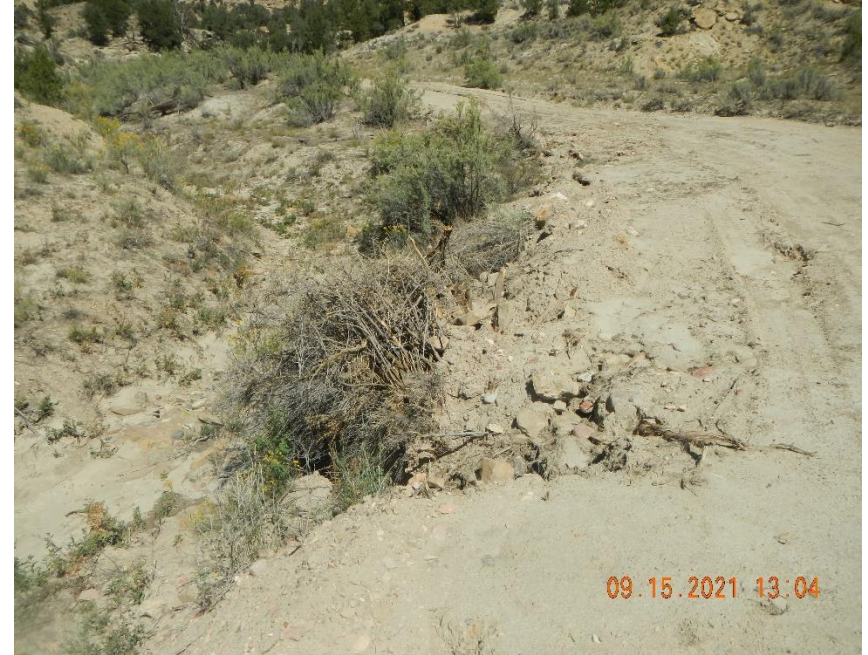
Storm water erosion of access road.

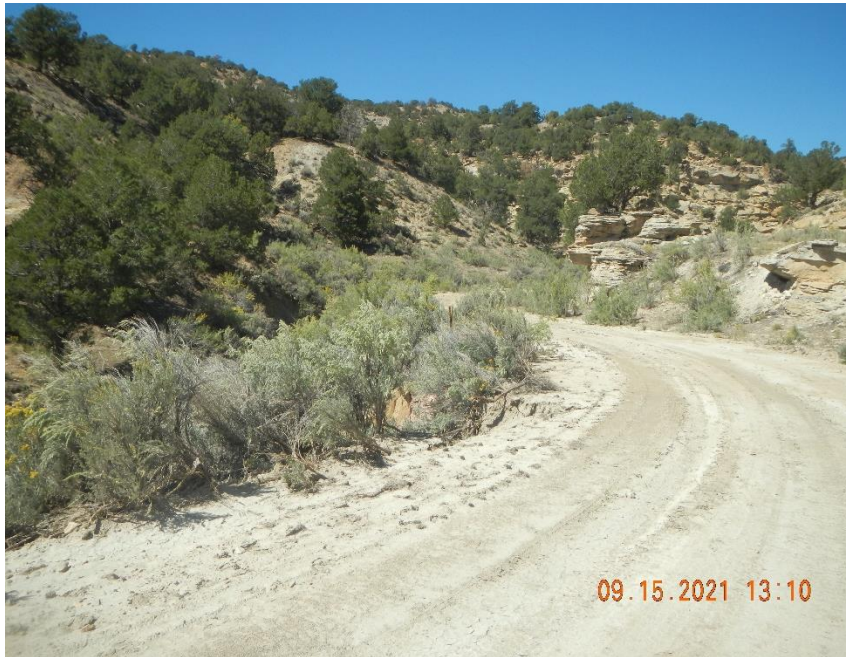
Storm water erosion of access road.

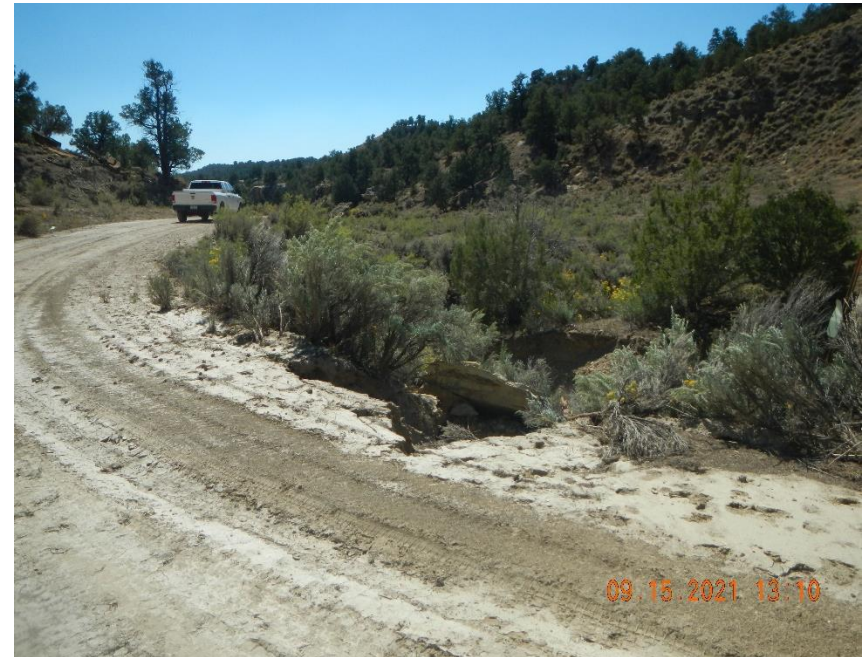
Storm water erosion of access road.

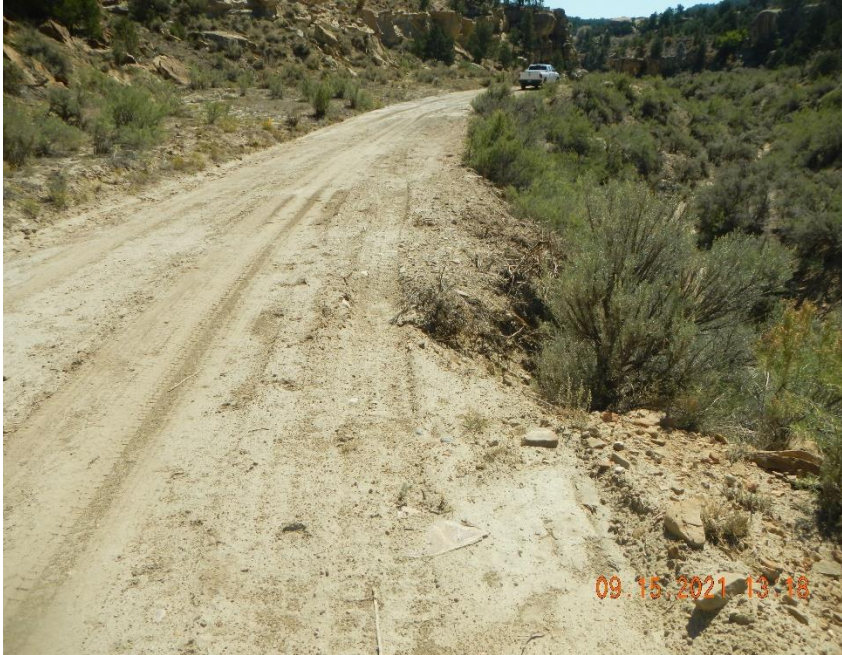
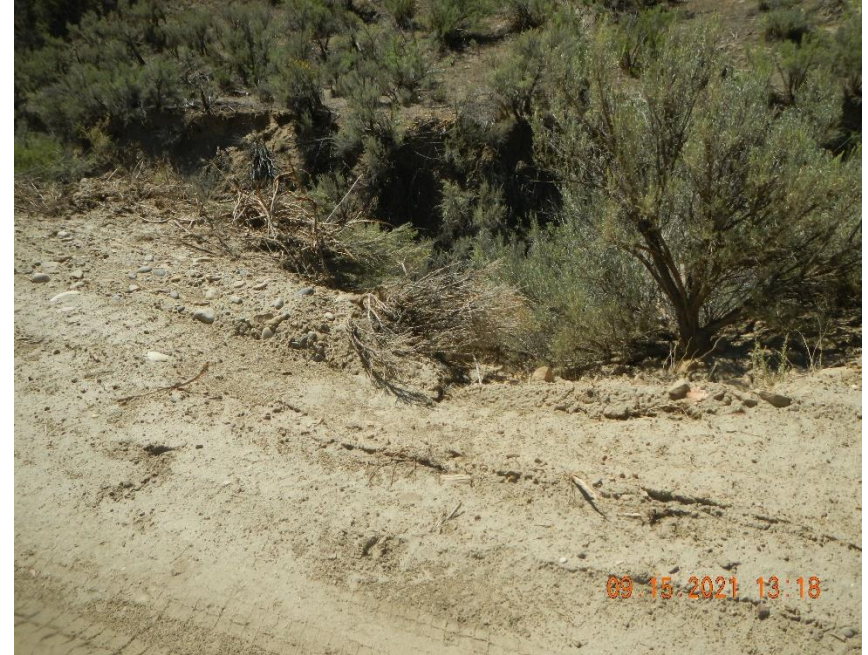
Storm water erosion of access road.

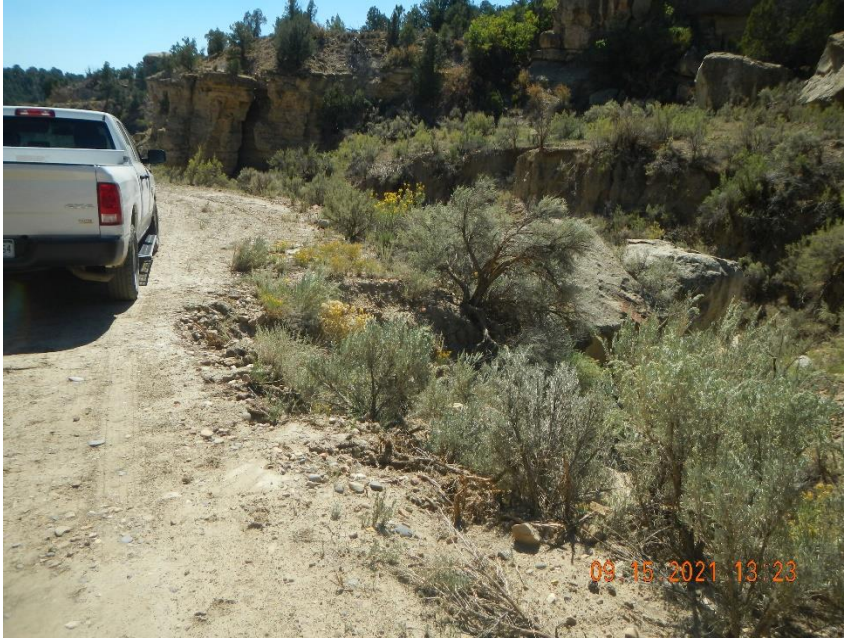
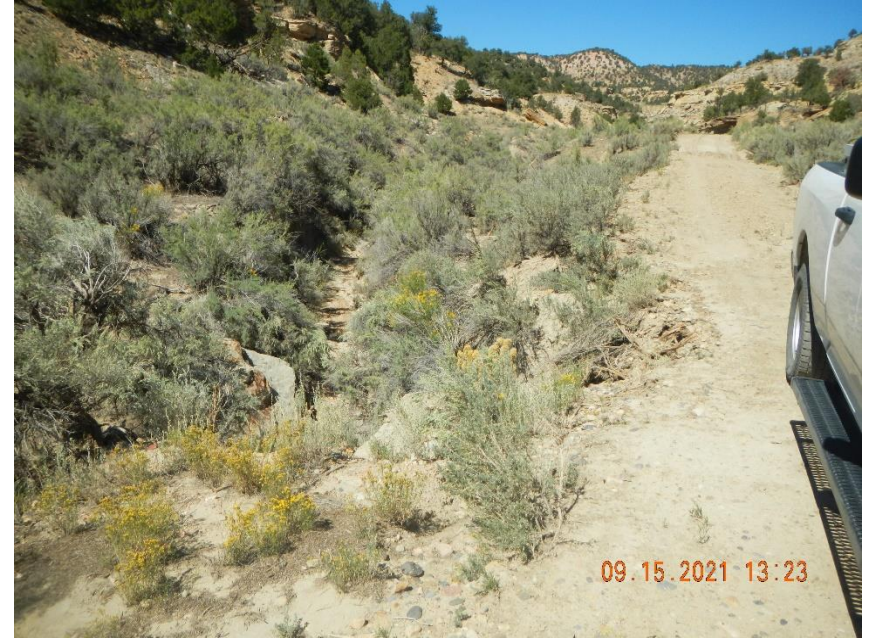
Storm water erosion of access road and narrowing roadway.

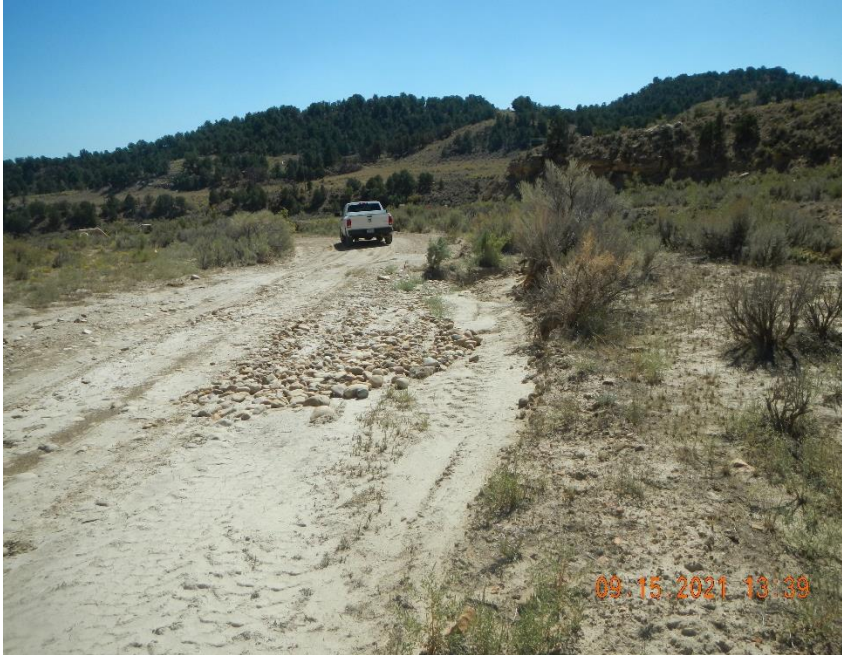
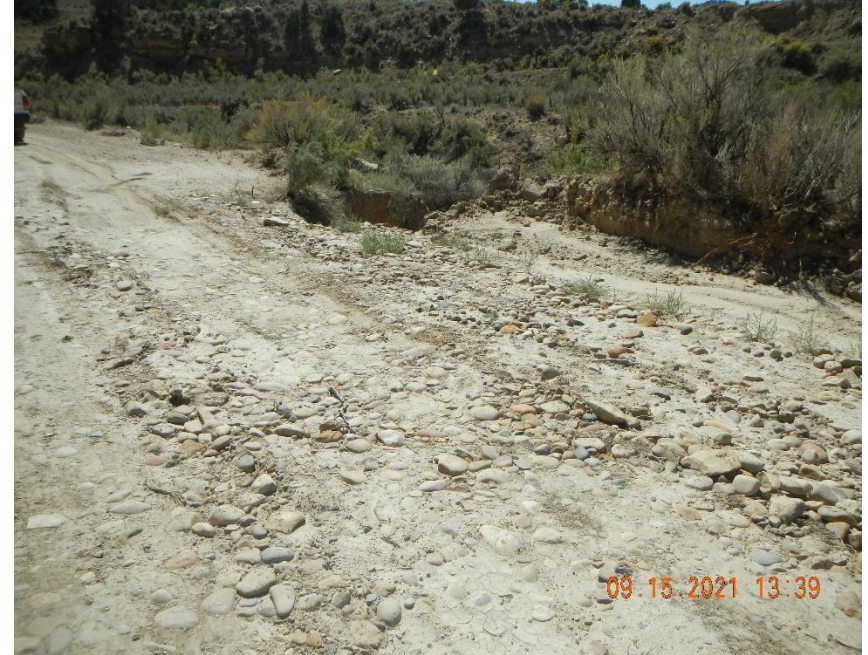
Storm water erosion of access road.
