**Inspection Photos**  
**Location Name: Horth 41-15-1**  
**Location ID:**

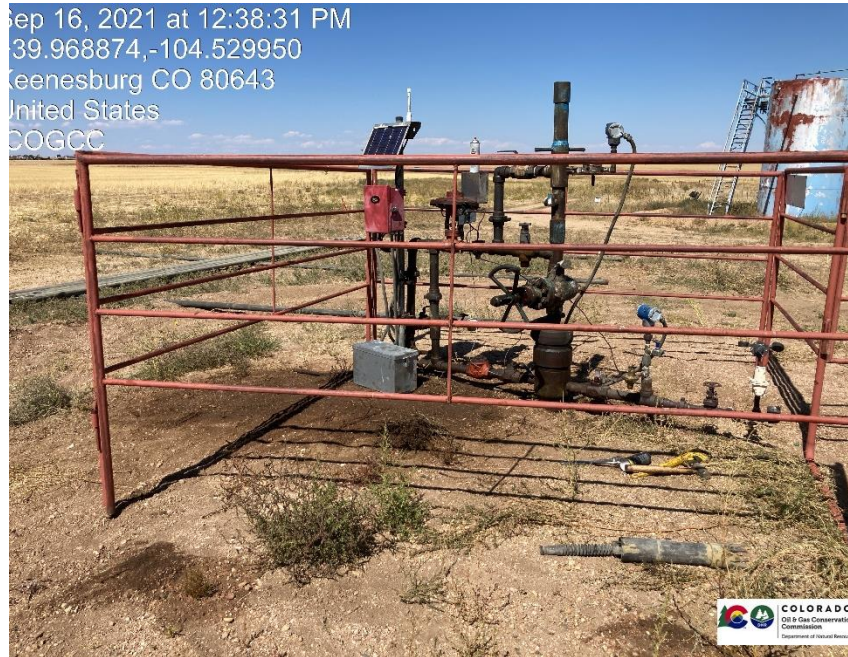
**Pic 1 stained soil from recent workover**

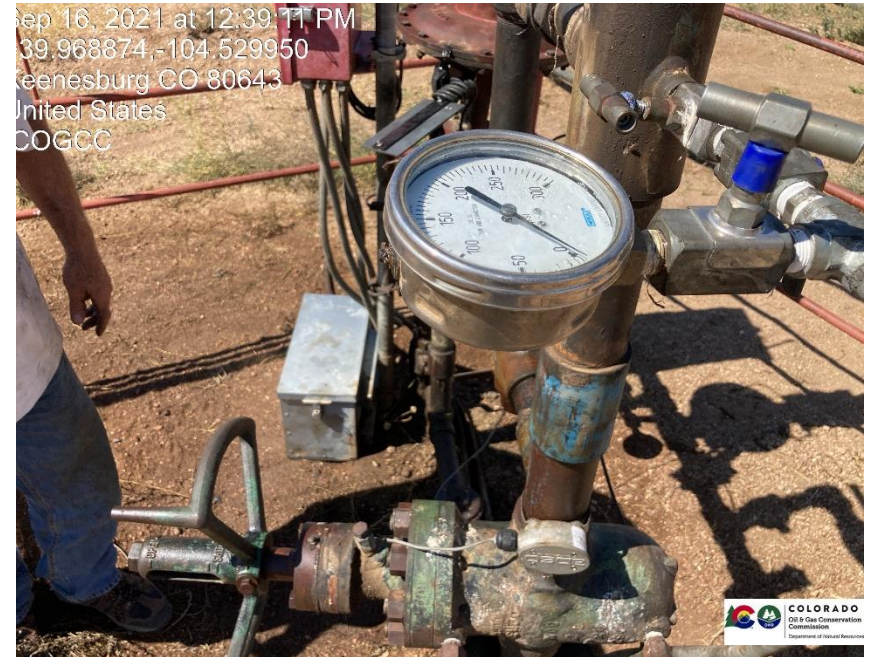
**Pic 1 Tubing gauge**

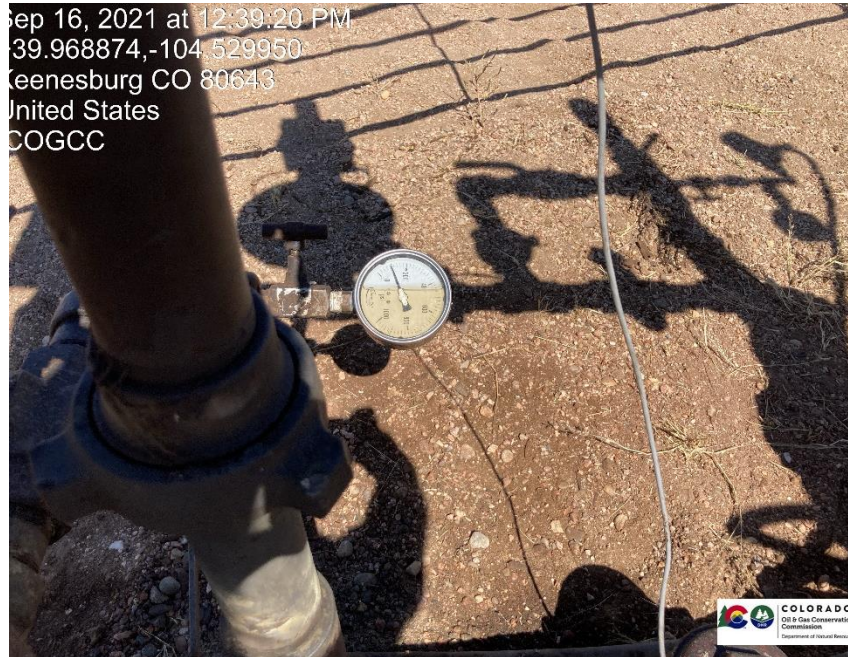
**Pic 3 casing gauge**

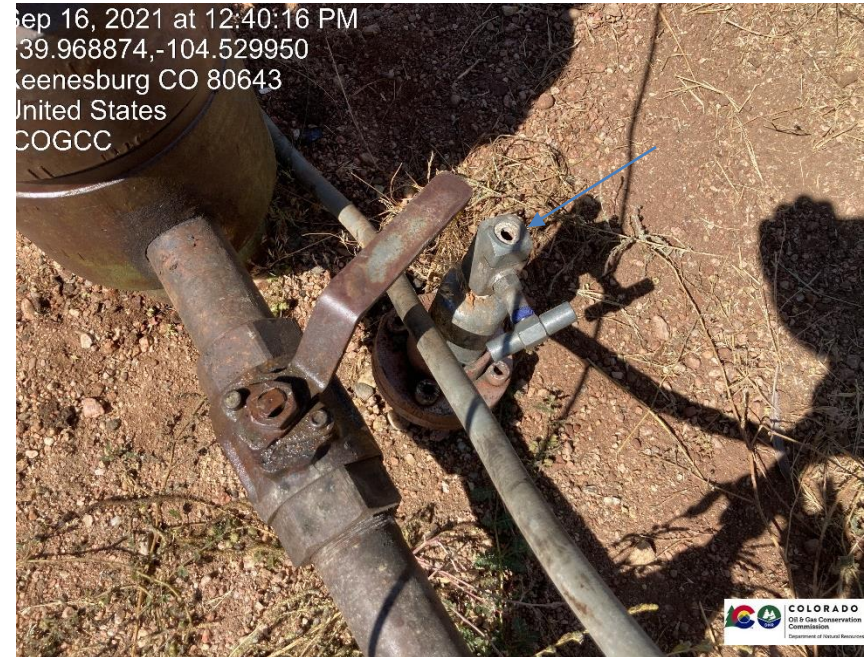
**Pic 4 bradenhead unaccusable due to broken threads in  
needle valve**
