## Stormwater Inspection Report

<b>Operator:</b>	Laramie Energy, LLC
<b>Project:</b>	Cascade Creek
<b>Location:</b>	CC 697-16A & CC 697-16A2 Pads
<b>Date:</b>	Wednesday, September 15, 2021
<b>Weather:</b>	Clear, Light Wind, Hi 89°, Lo 50°

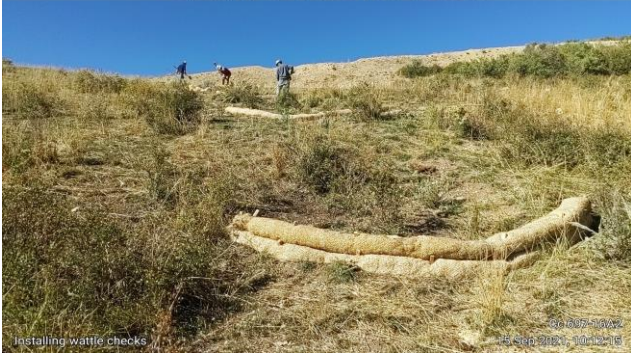
**Photo 1**

*Installing Additional Excelsior Wattle Checks to Provide Additional Protection during Runoff*

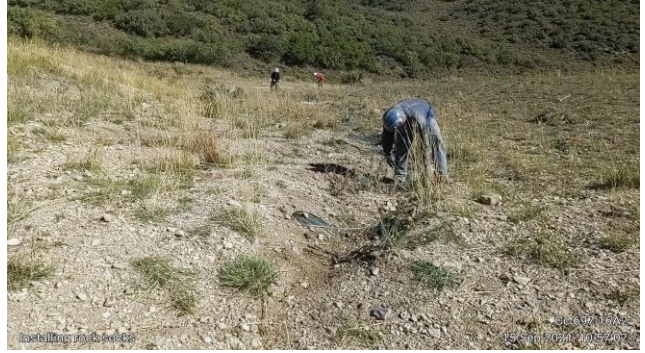
**Photo 2**

*Maintaining Existing Rock Sock Checks*

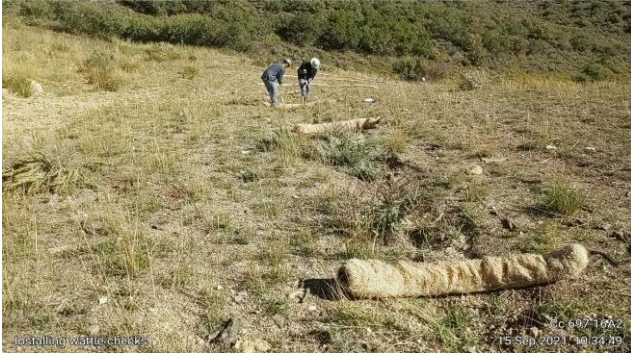
**Photo 3**

*Installing Additional Excelsior Wattle Checks*

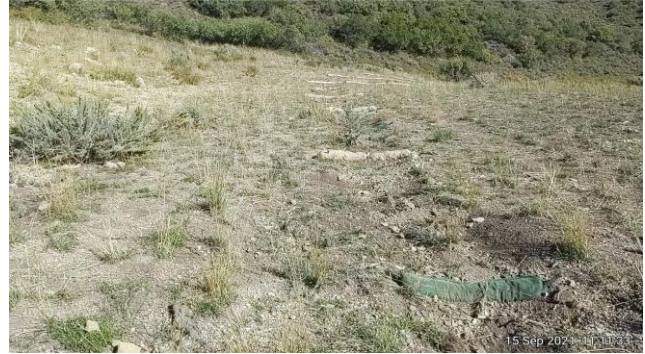
**Photo 4**

*Drainage Feature after BMPs were Installed and Maintained*
