Final Reclamation Inspection

Operator: PDC ENERGY INC - 69175

Location ID: 309667

Inspection Photos
Location Name: Hergenreder 13-33U
Location ID: 309667

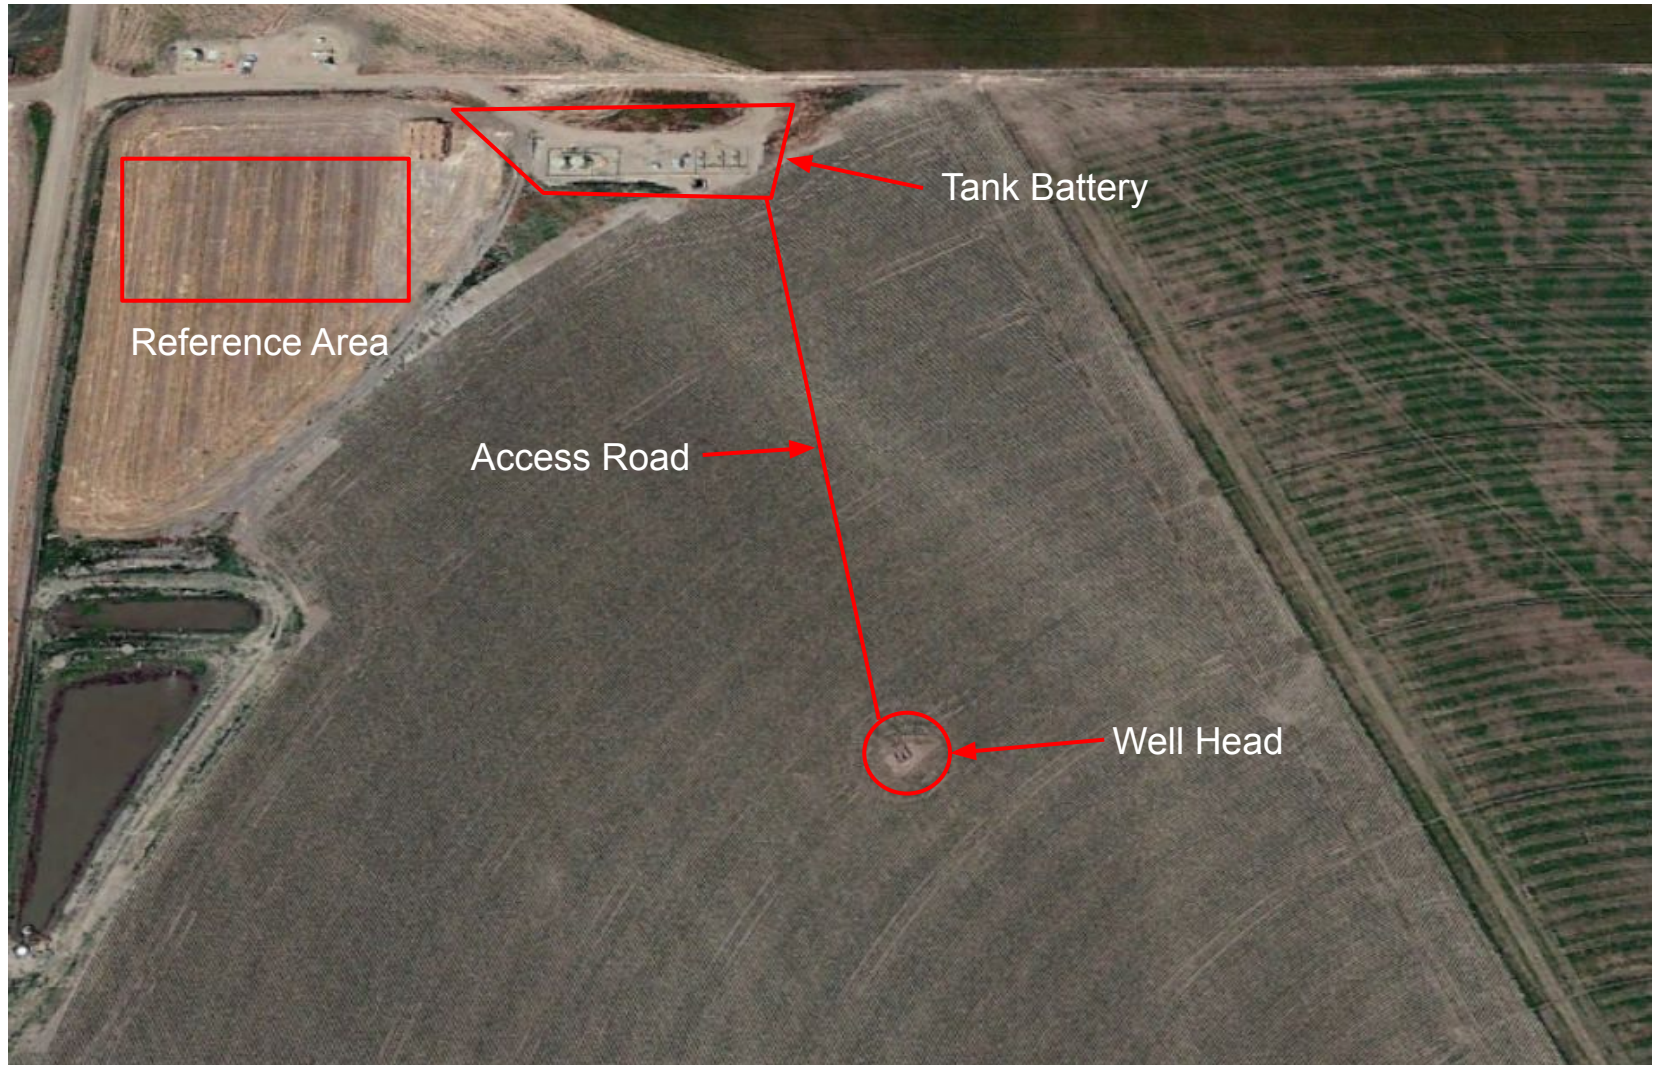
Photo 1. 2016 aerial imagery of the well head, tank battery, access road and reference area.

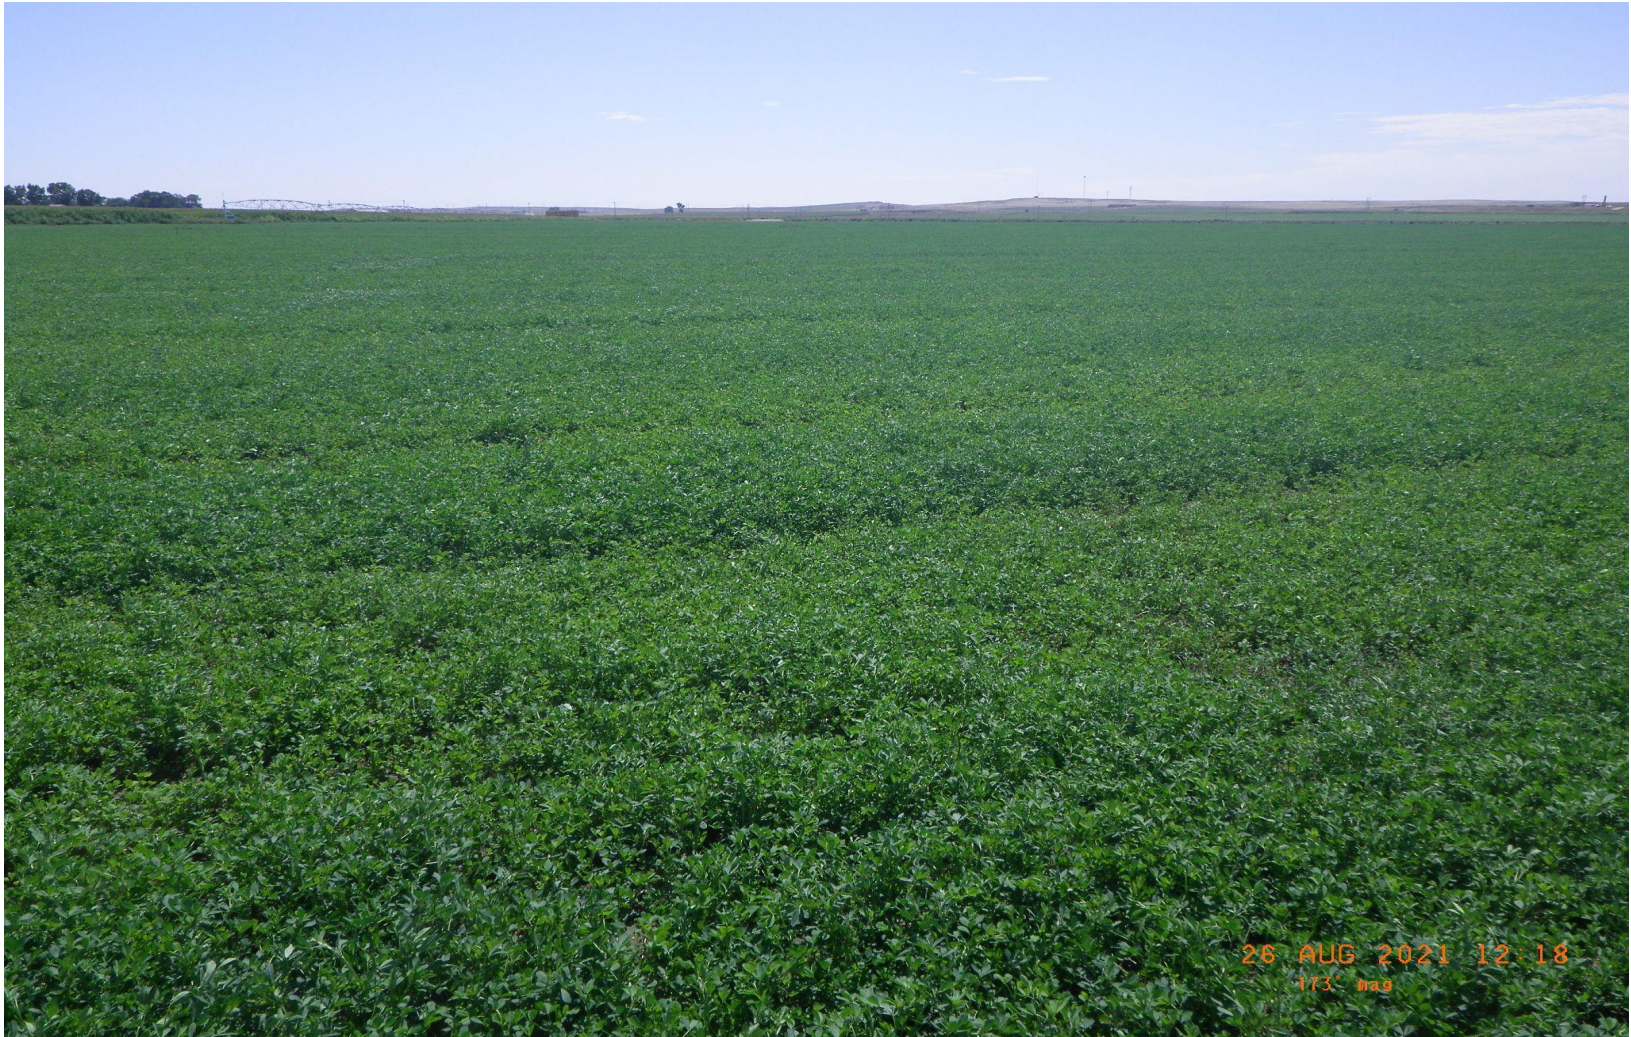
Photo 2. Well Pad overview photo taken at ground level from northern edge of tank battery looking south down access road. Photo shows alfalfa crop within well head disturbance pad appears consistent with the rest of the crop field.

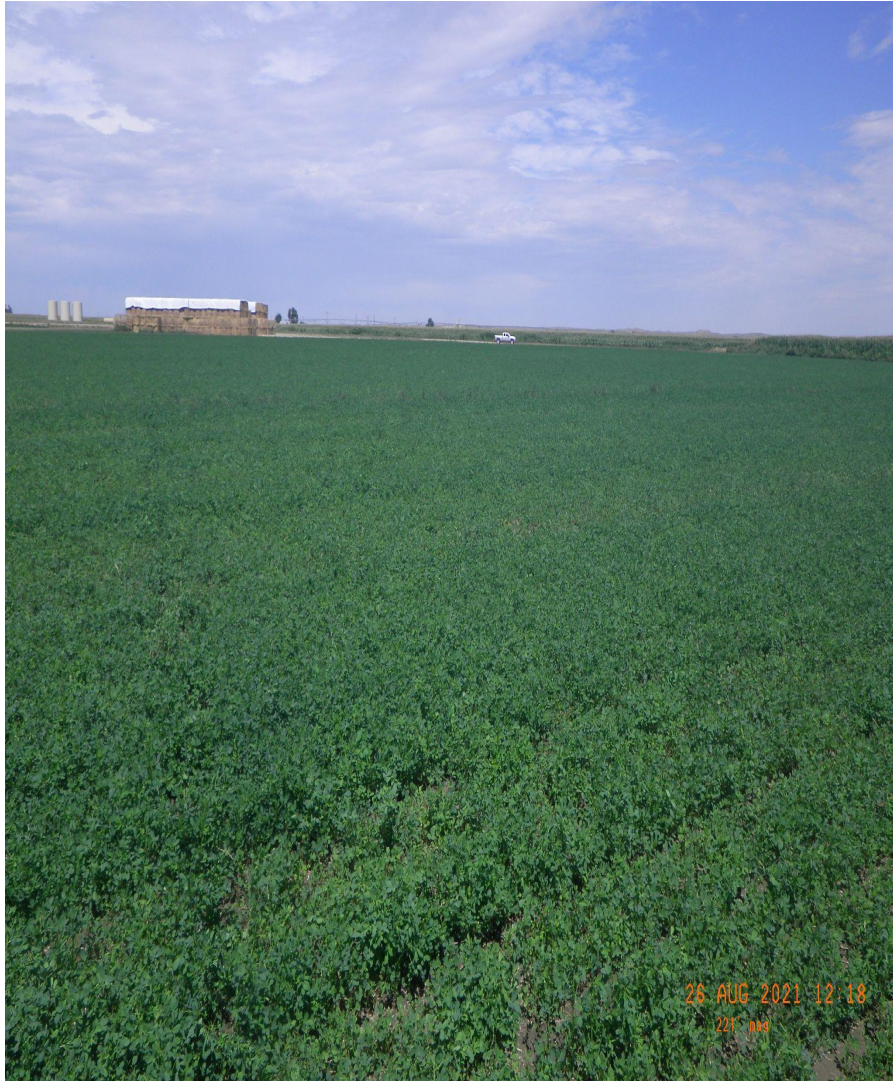
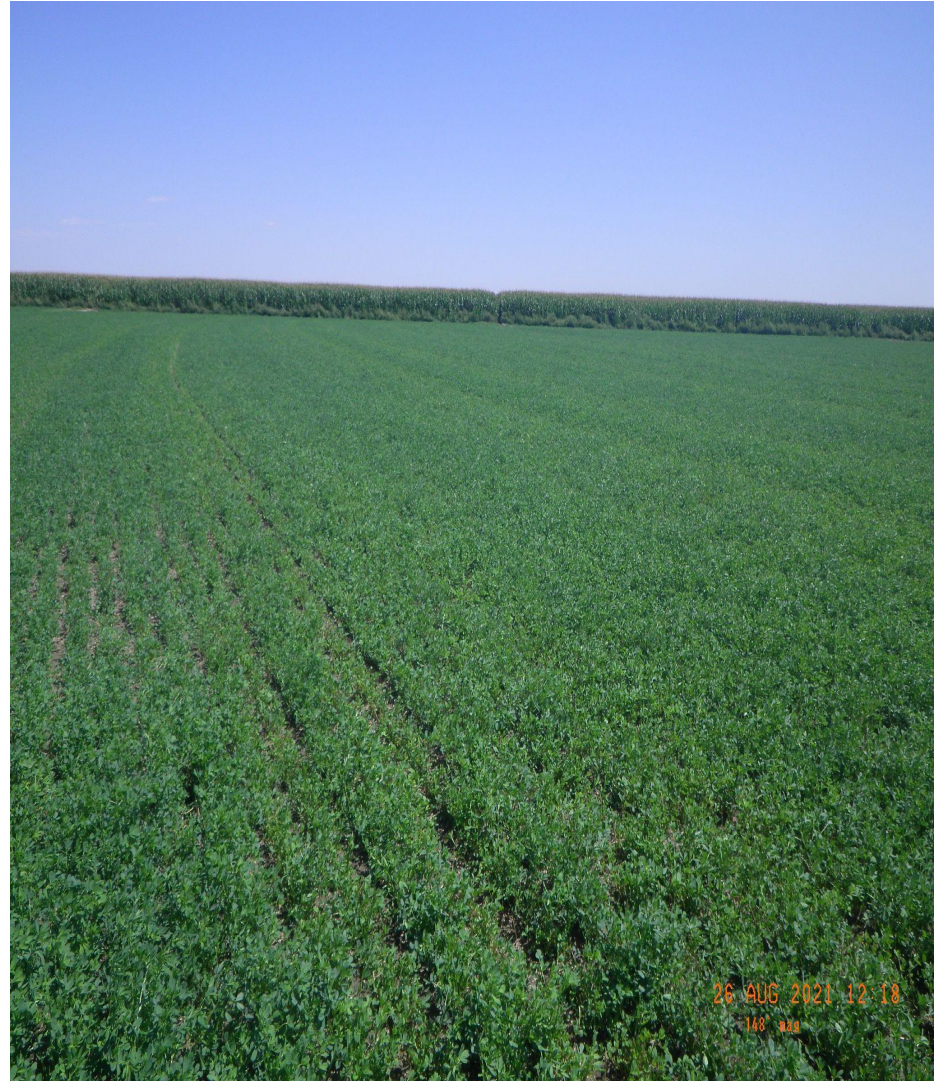
Photo 3. Ground photos taken from the middle of the well head. Left photo facing north, right photo facing east.

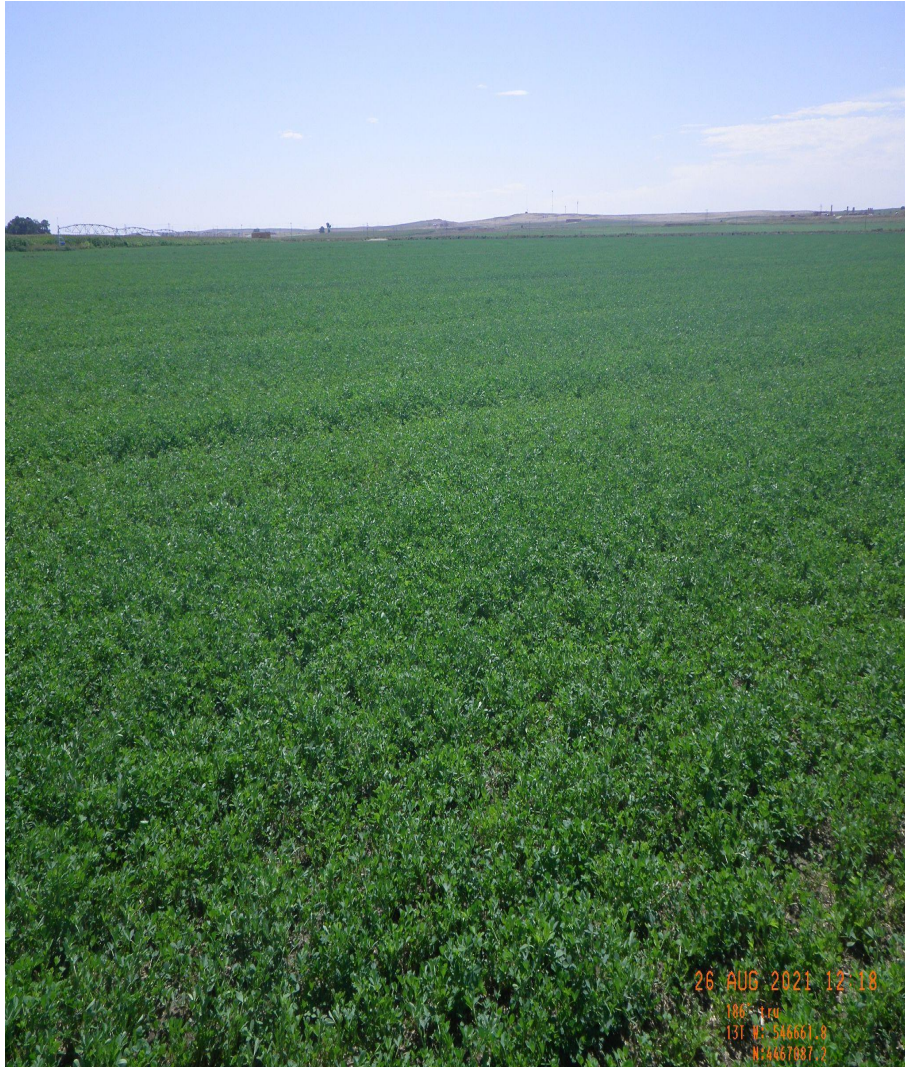
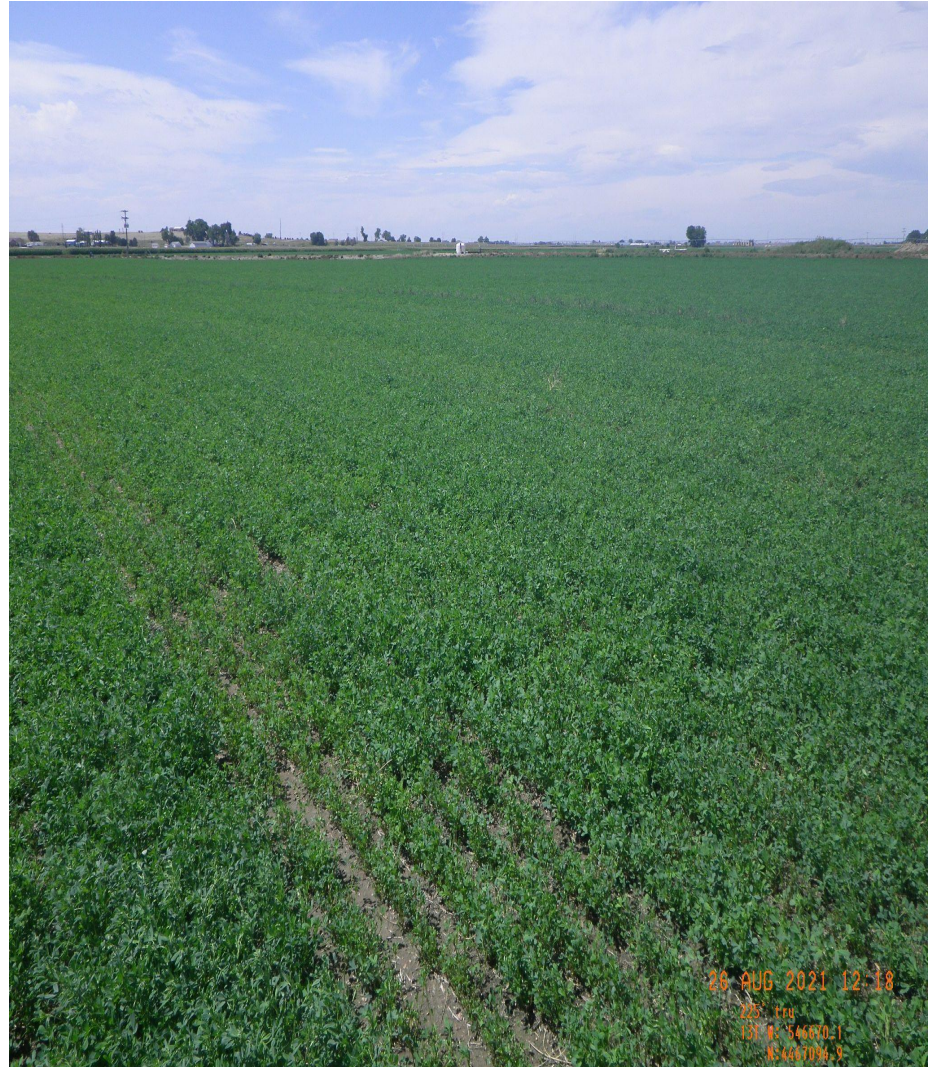
Photo 4. Ground photos taken from the middle of the well head. Left photo facing south, right photo facing west.

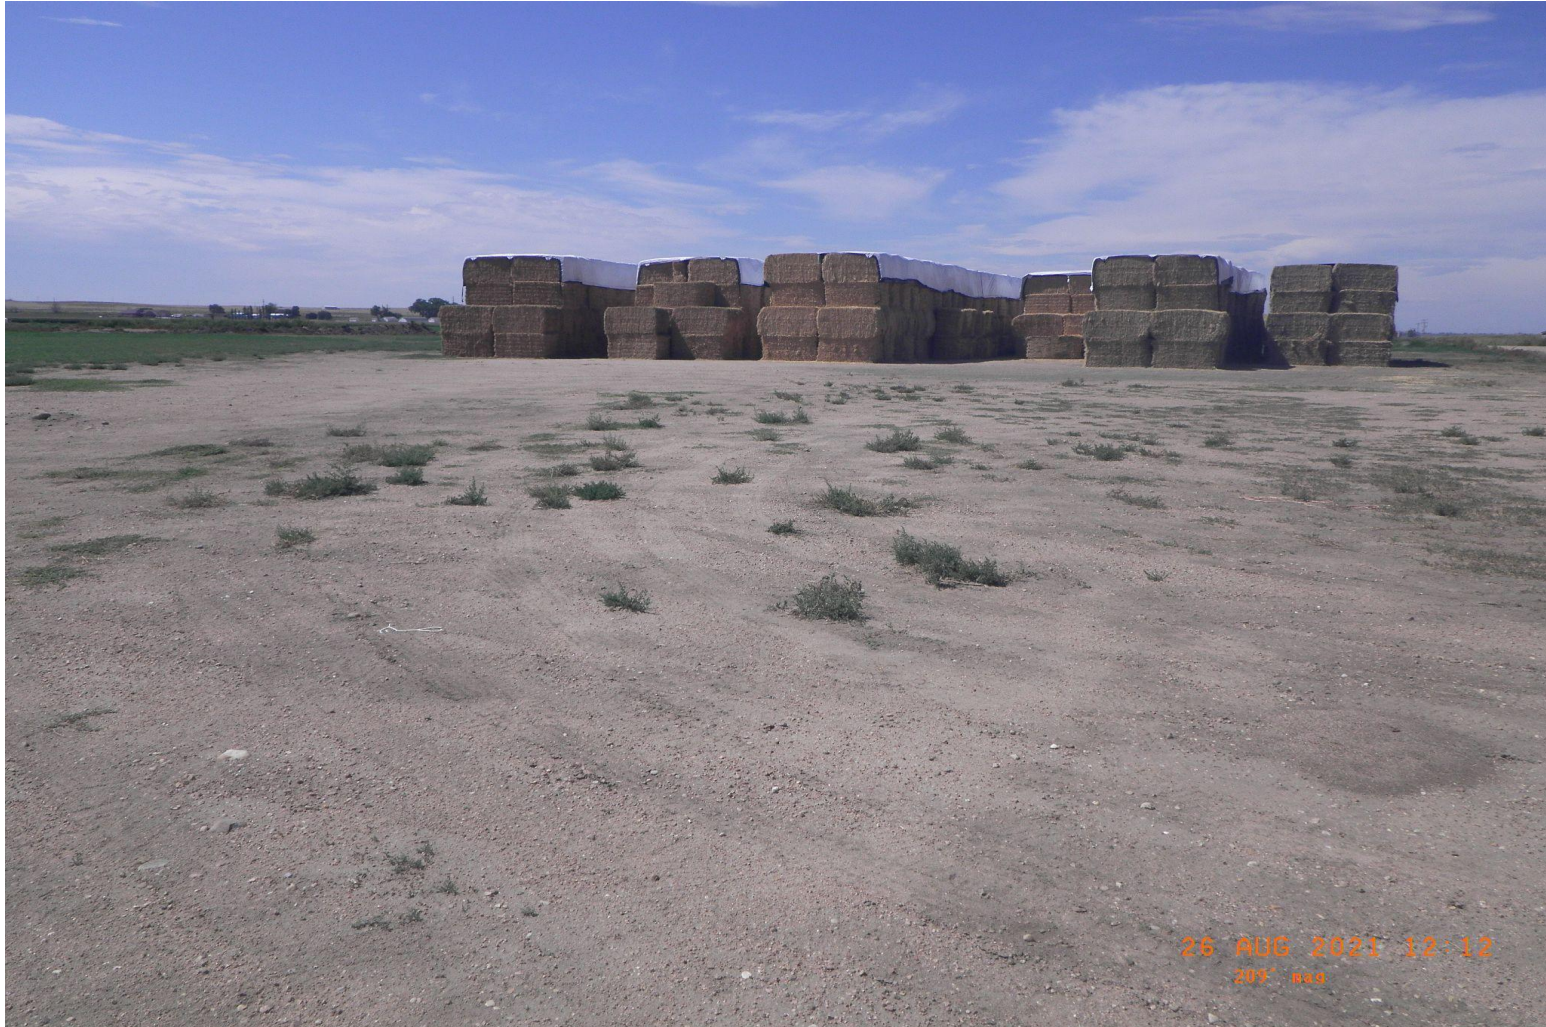
Photo 5. Overview photo of tank battery taken at ground level from the eastern edge of the disturbance pad, looking west. Photo shows Gravel remains on site with dispersed kohia and puncture vine growth. Historical imagery shows that the pre disturbance area was used to grow hay crop (see photo 6). Note: staged hay is just outside of the tank battery disturbance area.

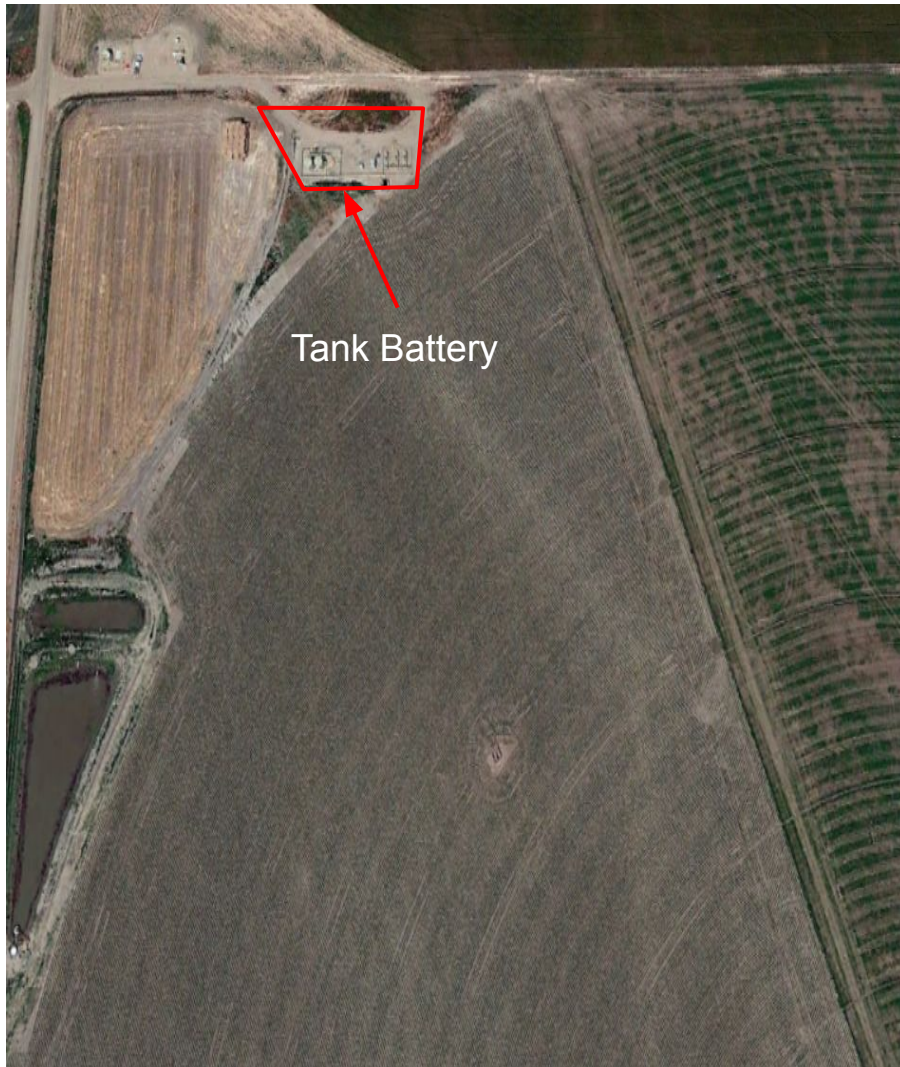
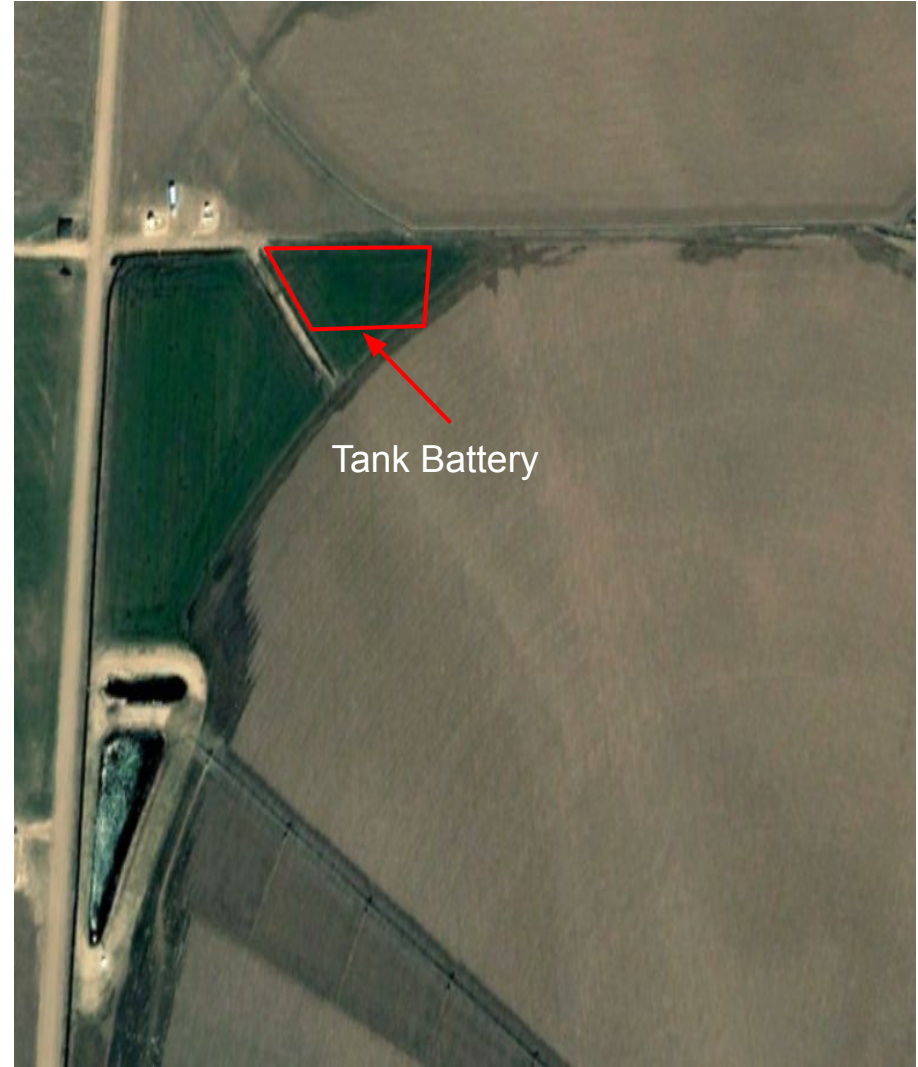
Photo 6. 2016 aerial imagery on the left and 2006 imagery on the right (tank battery highlighted in red). Photo shows tank battery was used to harvest hay crop pre disturbance.
